Inspection Photos
Location Name: Centennial 32-33
API: 05-123-21239

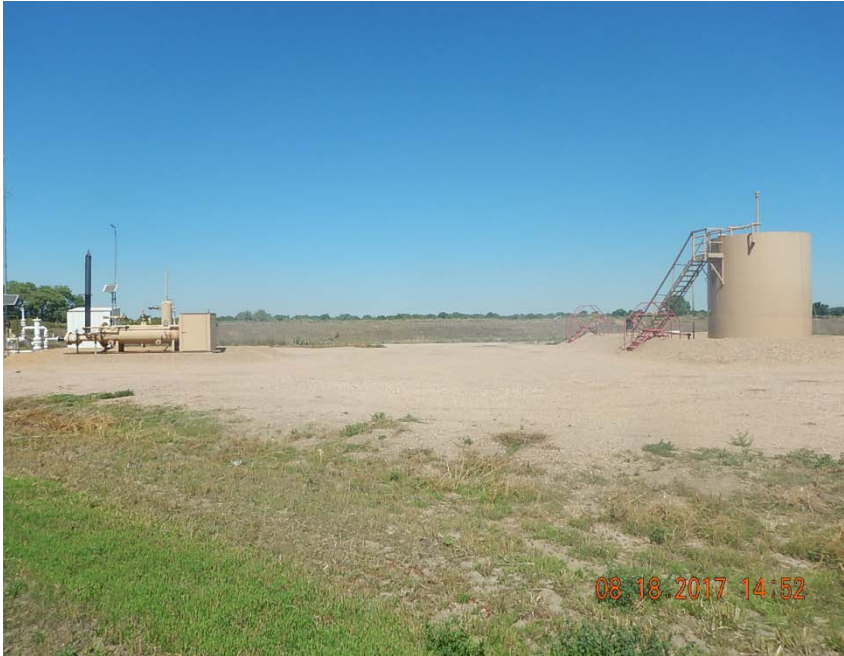
Photo 1: Location, looking NE

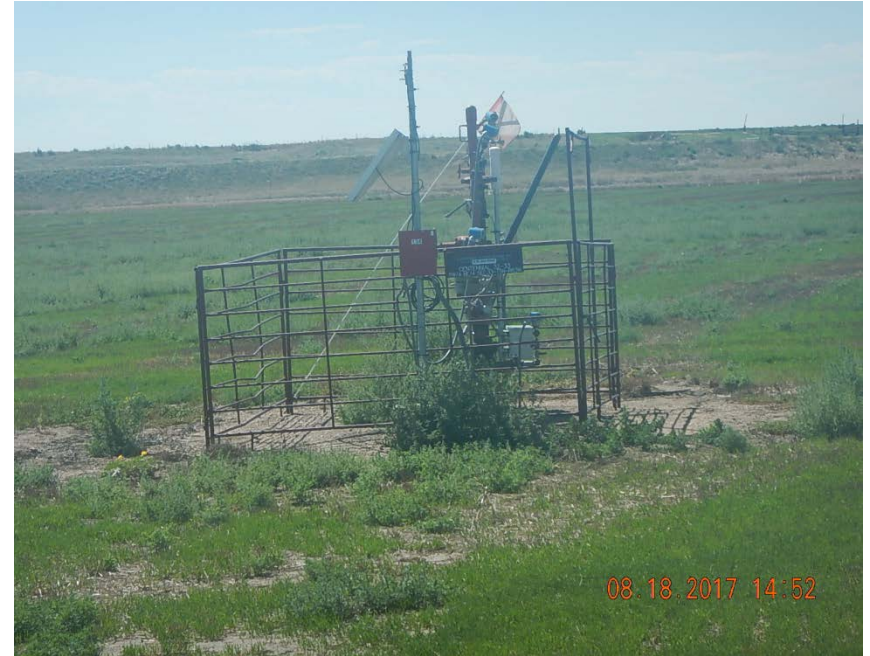
Photo 2: Wellhead looking SW

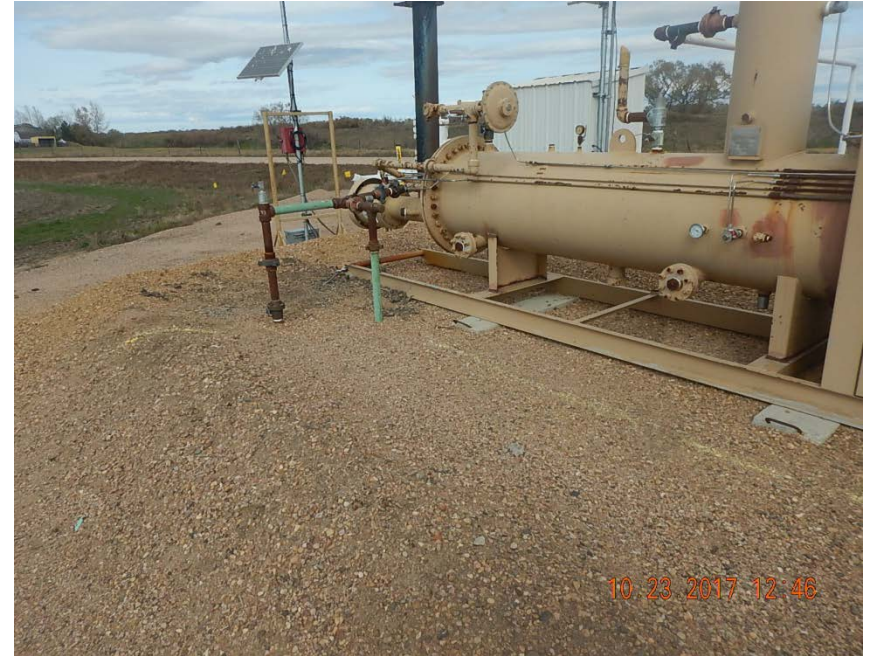
Photo 3: Separator anchored

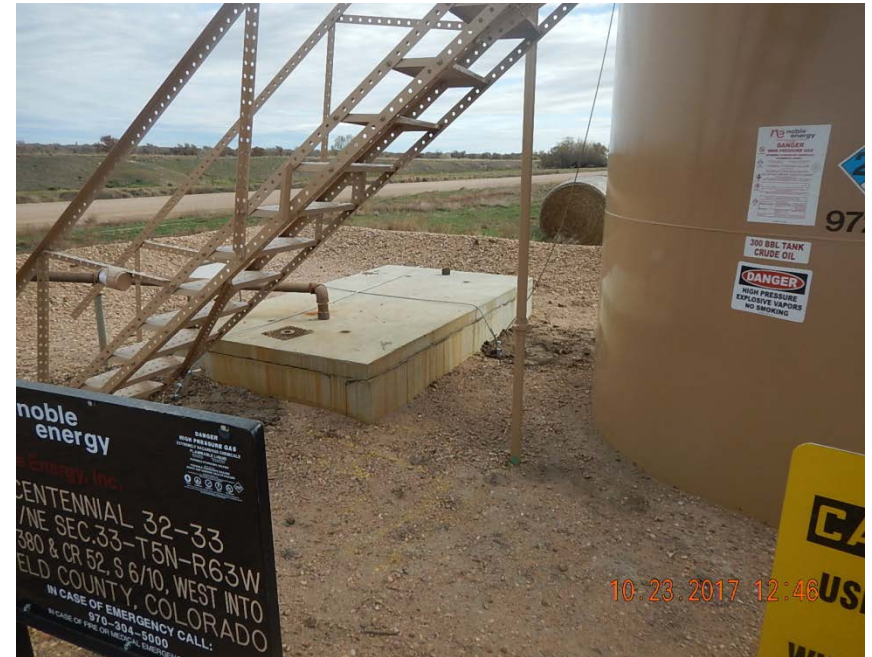
Photo 4: Concrete vault anchored. Berm is earthen in floodplain.

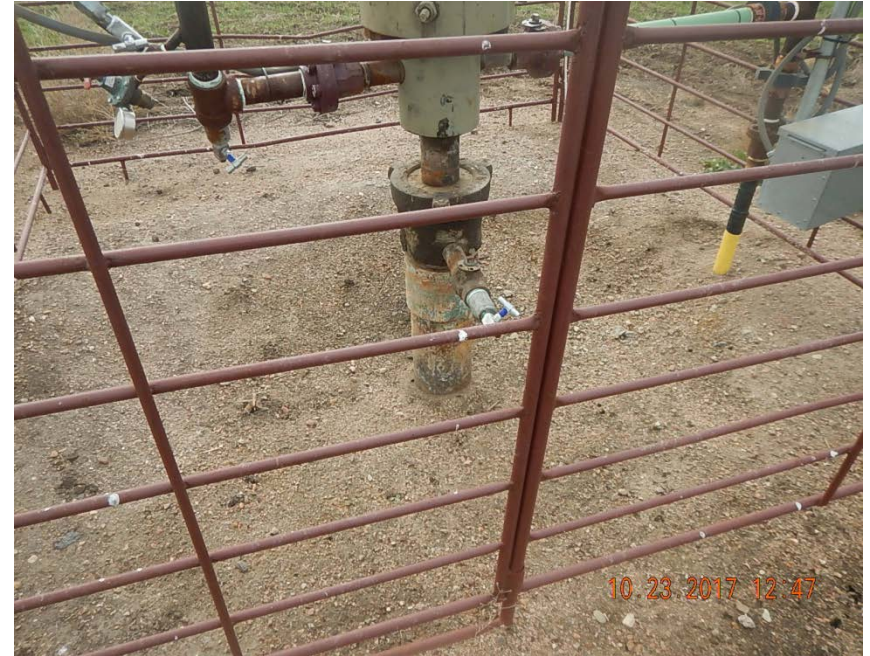
Photo 5: Riser removed.
