**Inspection Photos**  
**Location Name: Hill 6-1**  
**API: 05-123-20169**  
**Inspection Date: October 17, 2017**

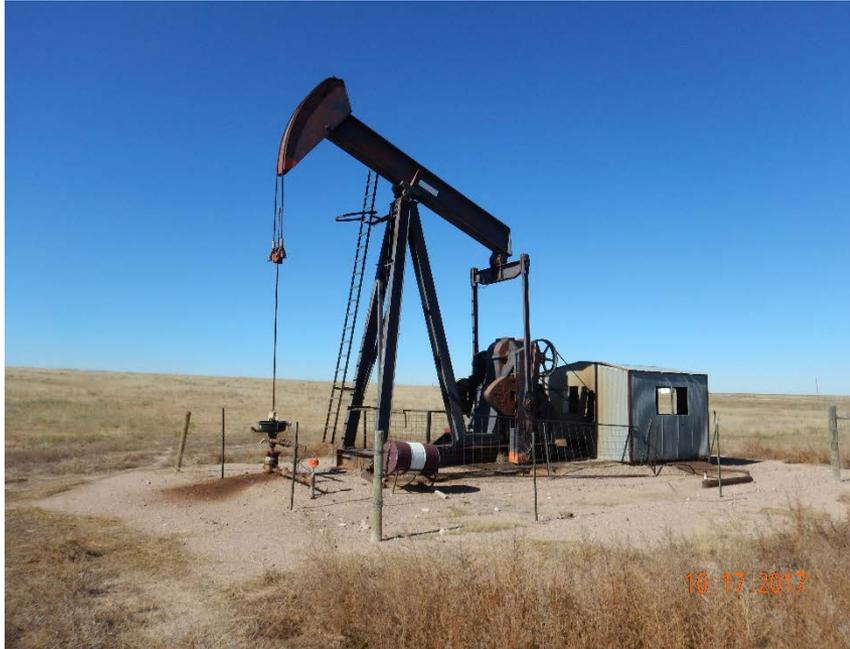
**Photo #1 – View of pump jack and wellhead from SE corner.  
Note oil-stained soil beneath wellhead and shed.**

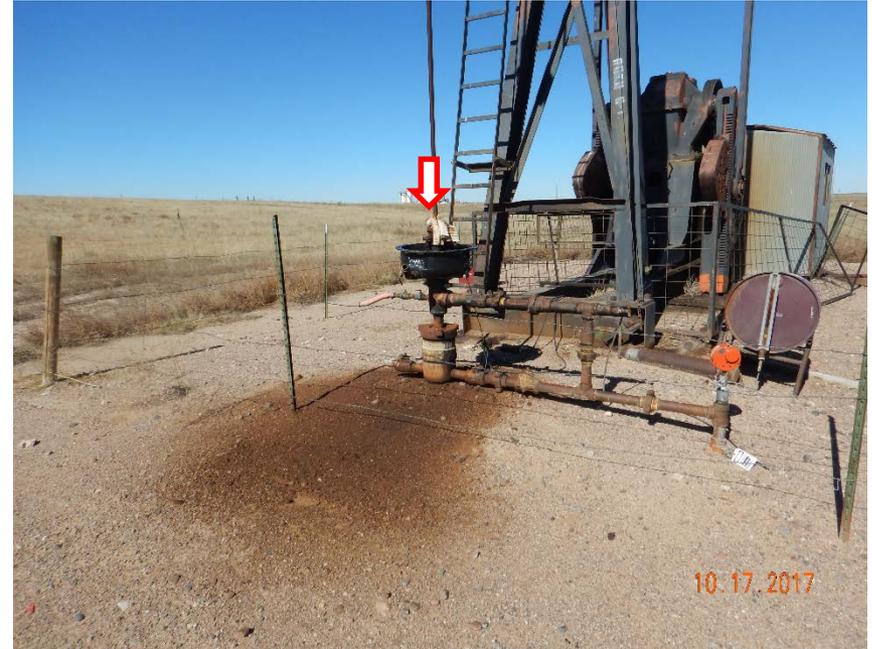
**Photo #2 – Oil-stained soil at wellhead and day tank lacking secondary containment at SE corner of pump jack. Note oily rag attached to polished rod/wellhead and damaged panel fence at shed.**

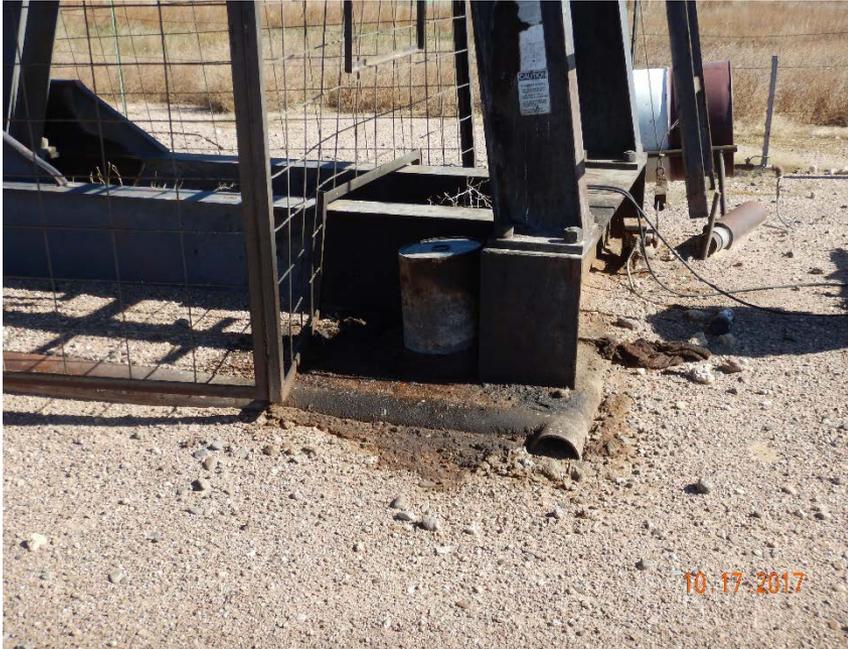
**Photo #3 – Localized oil-stained soil beneath 1-gallon chemical storage container (which lacks secondary containment device) at SW corner of pump jack.**

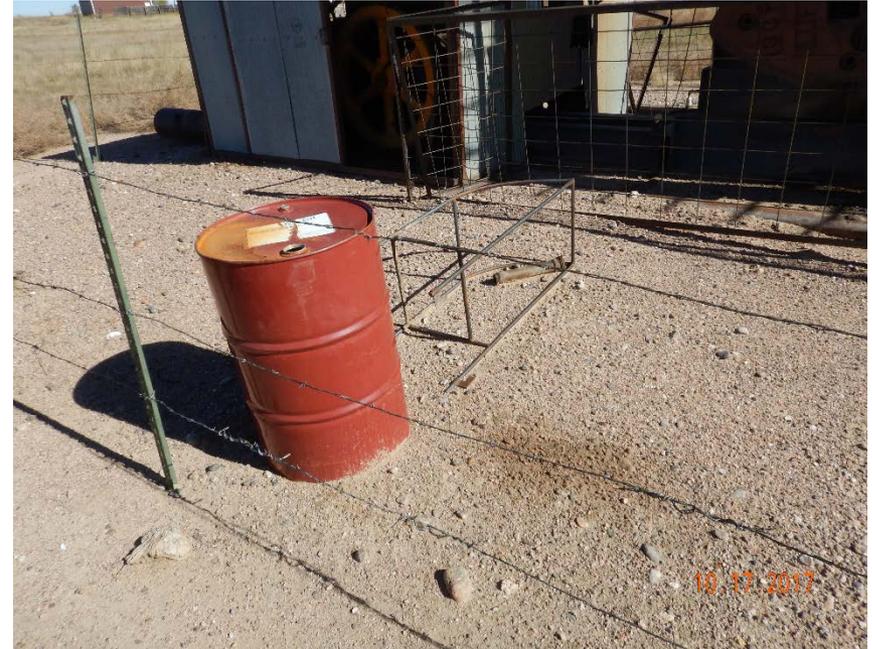
**Photo #4 – 55-gallon drum on west side of pump jack is open to atmosphere and lacking secondary containment device. Drum contained unknown amount of fluid on date of inspection.**

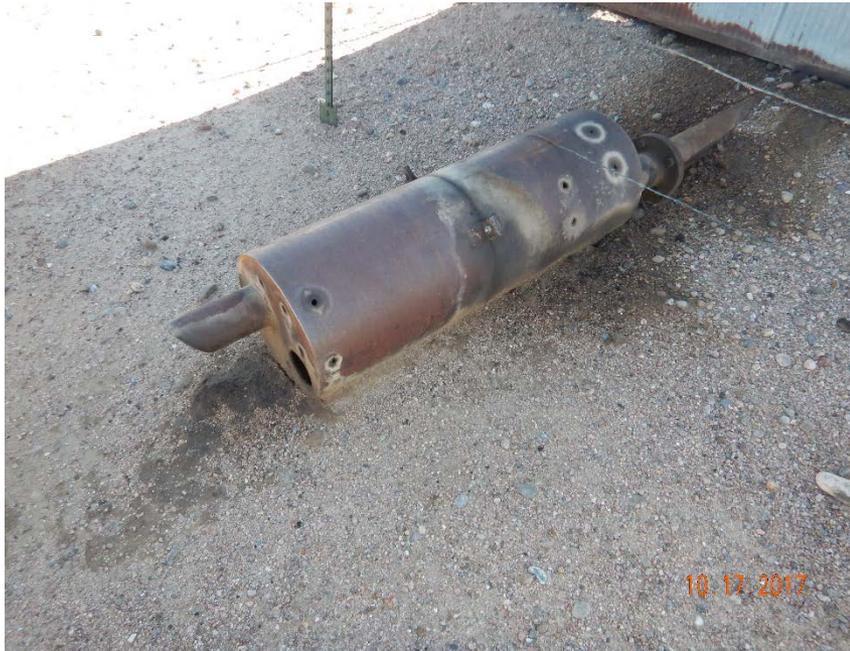
**Photo #5 – Localized, oil-stained soil beneath pump jack exhaust and north side of shed.**

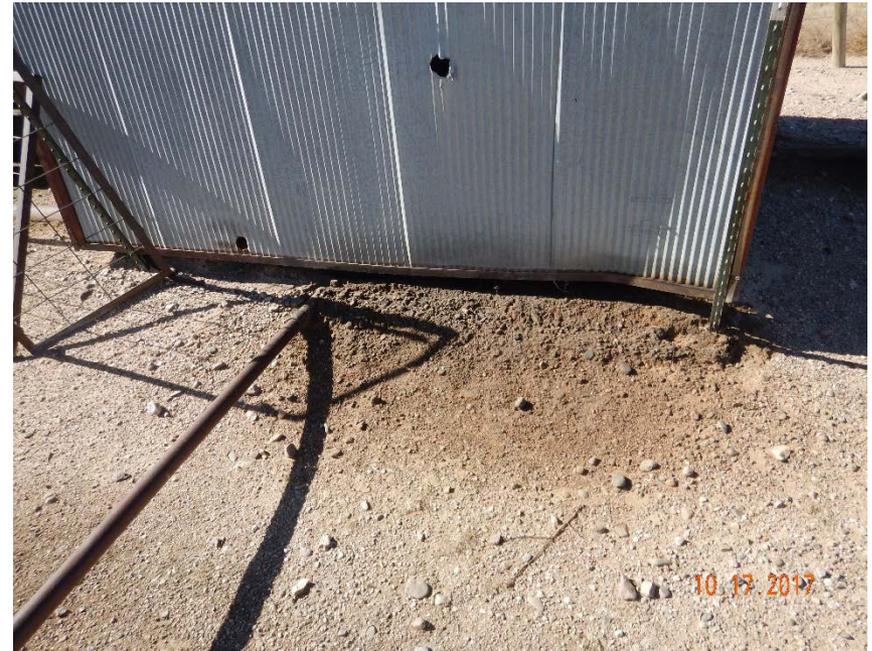
**Photo #6 – Localized, oil-stained soil seeping from east side of shed.**

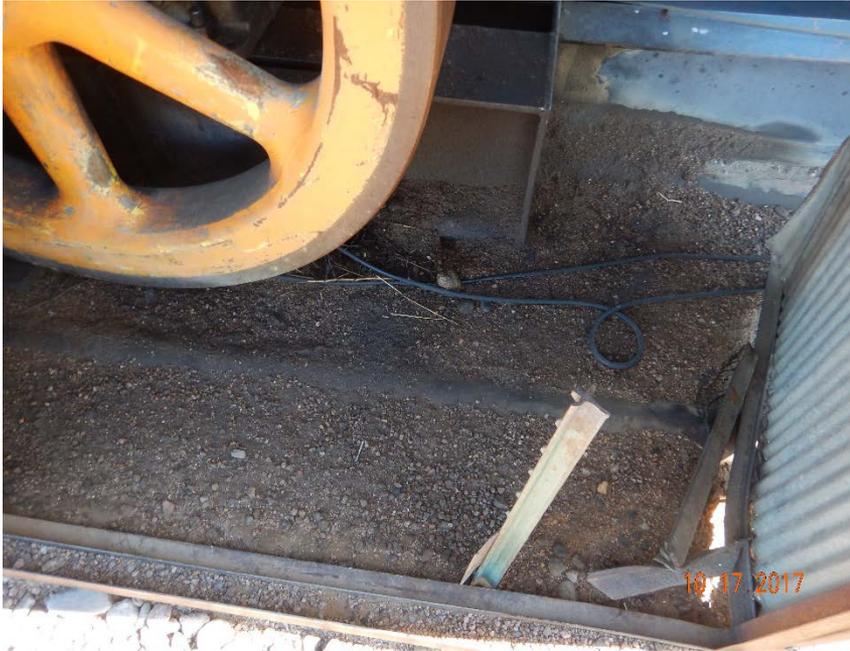
**Photo #7 – Oil-saturated soil beneath prime mover (1).**

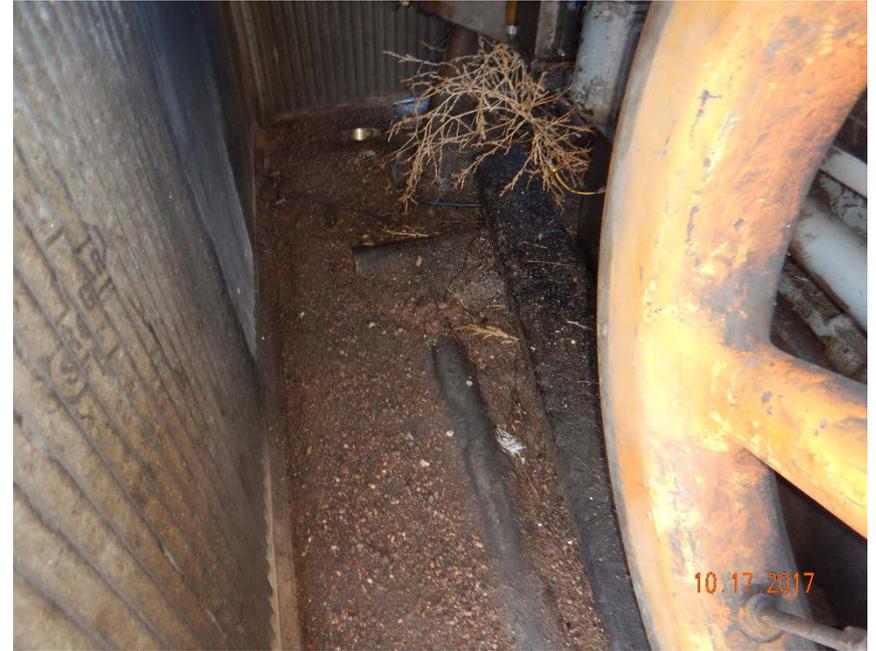
**Photo #8 - Oil-saturated soil beneath prime mover (2).**

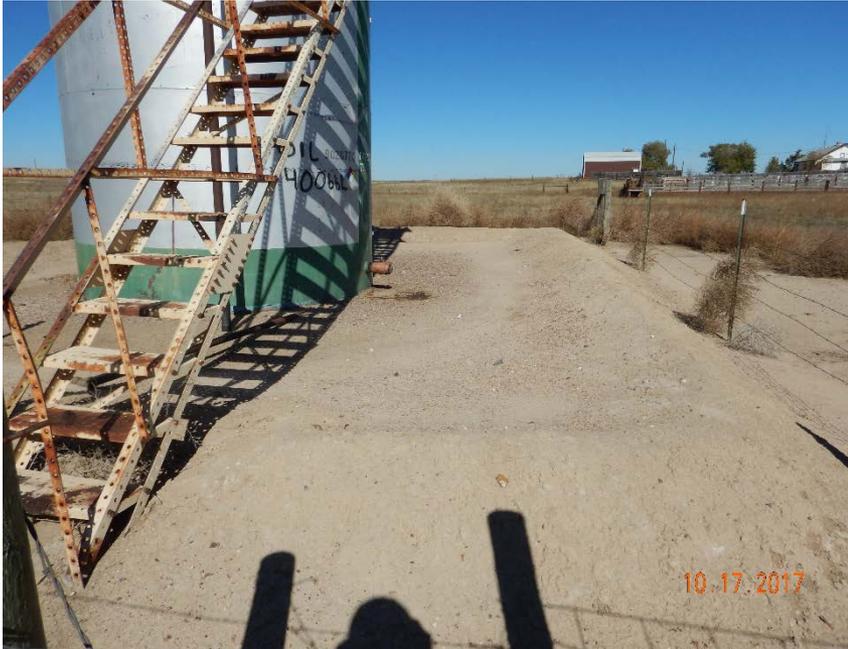
**Photo #9 – Localized accumulation of oily waste beneath valve on east side of 400 bbl crude oil AST. Note proximity of production facility to inhabited buildings to NE.**

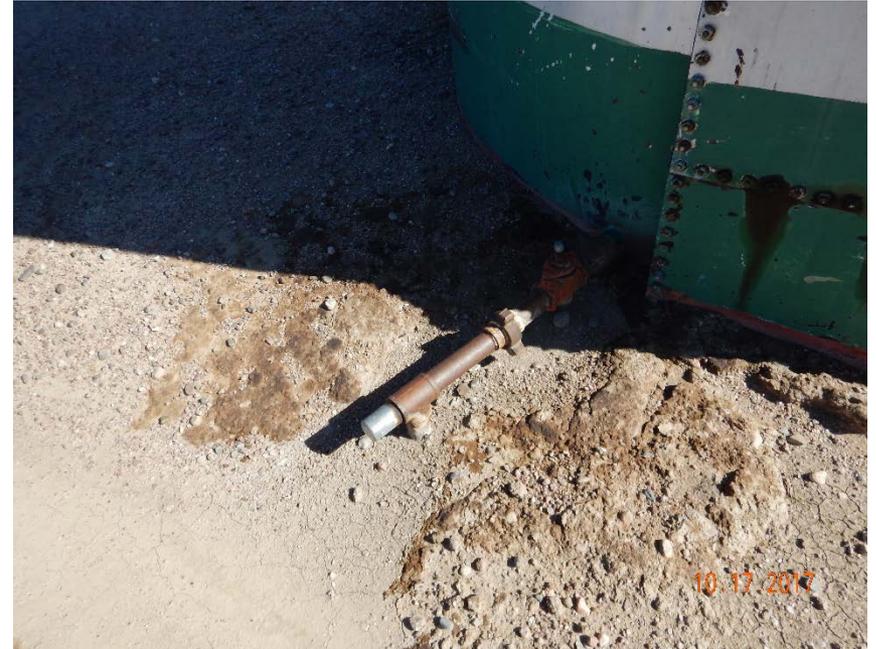
**Photo #10 – Historical accumulation of oily waste beneath valve on west side of crude oil AST.**

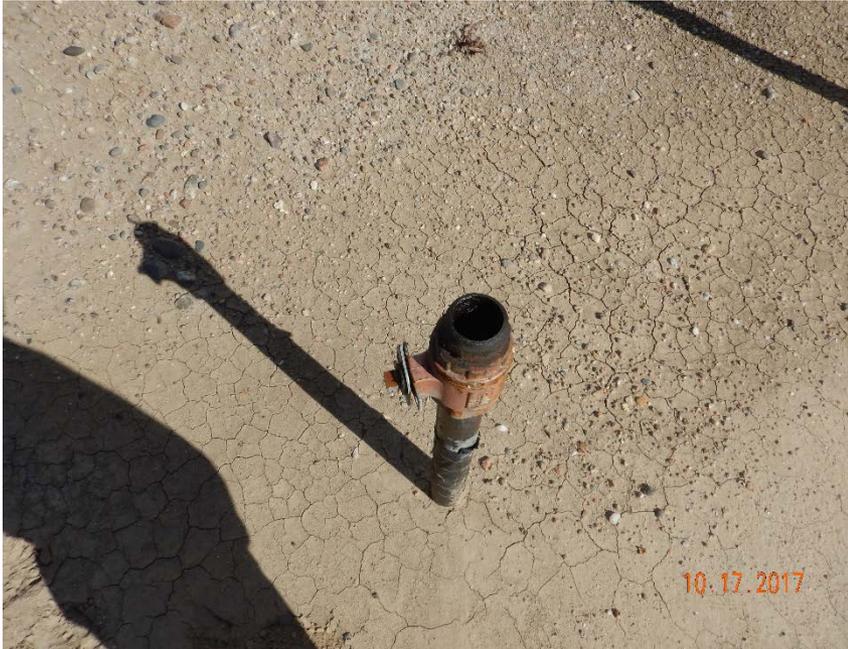
**Photo #11 – Uncapped 2" flowline riser SW of crude oil AST.**

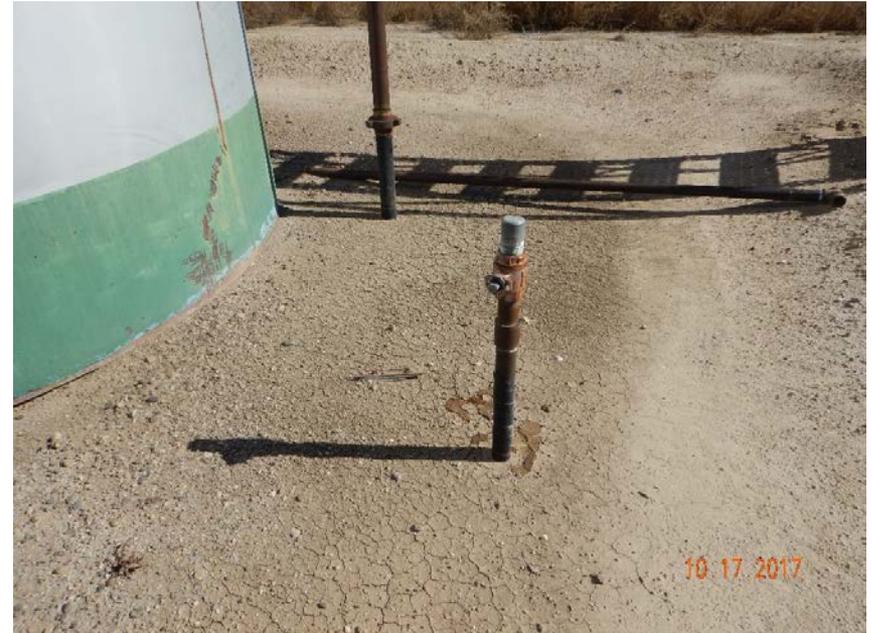
**Photo #12 – Bullplugged 2" riser south of crude oil AST.**

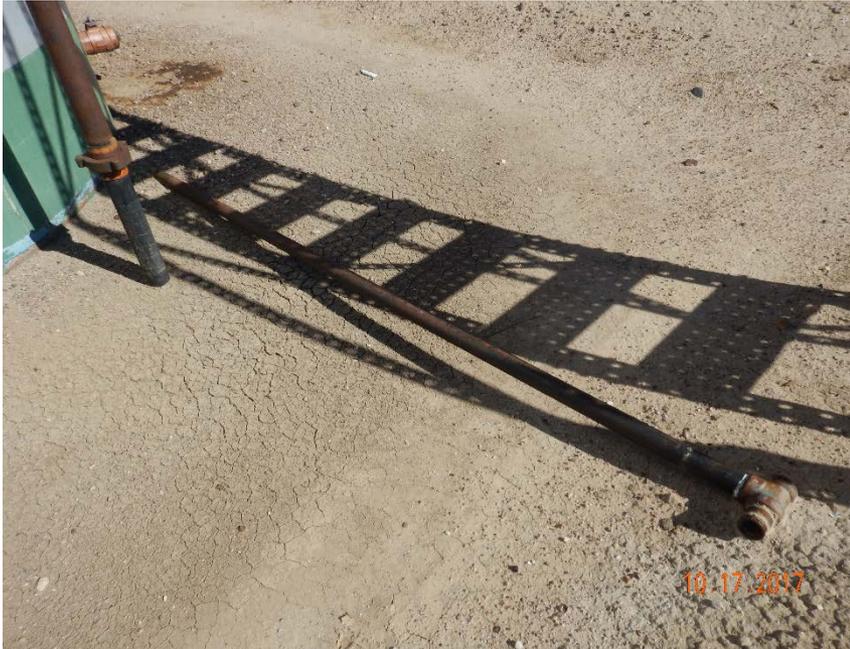
**Photo #13 – Unused pipe at SE corner of crude oil AST.**

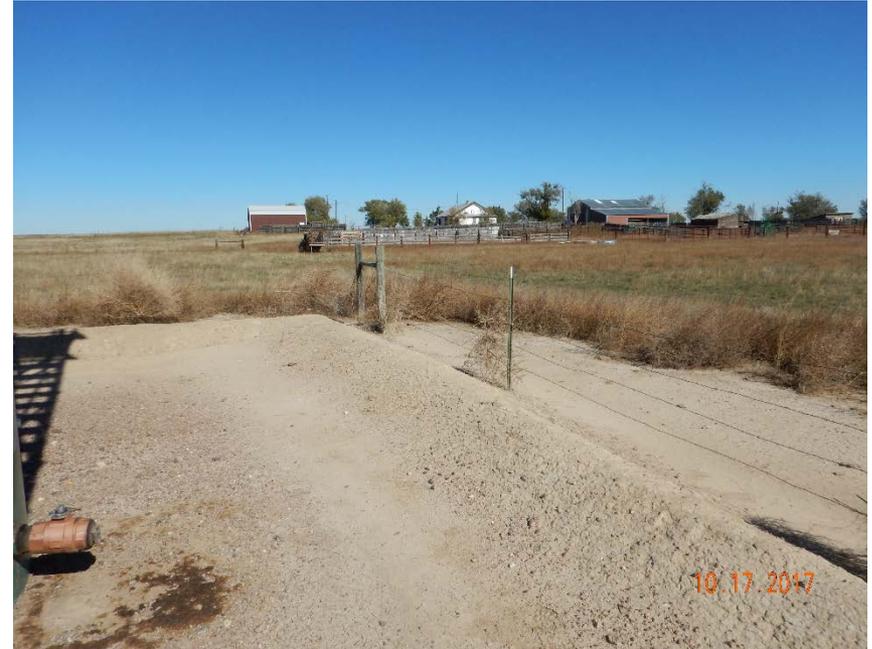
**Photo #14 - Shallow, eroded earthen berm NE of crude oil AST and proximity to occupied buildings NE of production facility.**

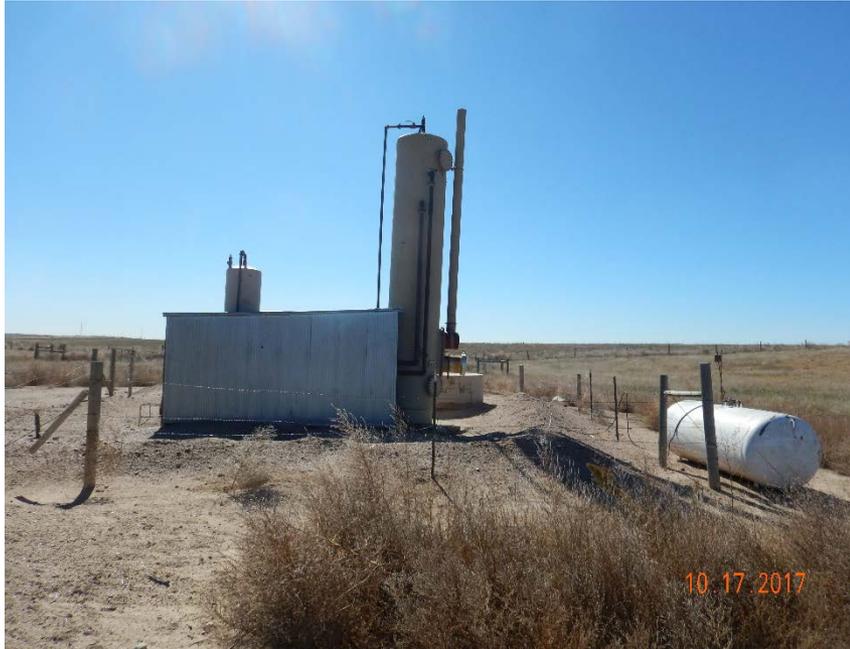
Photo #15 – View of separator shed and propane tank from NW corner.

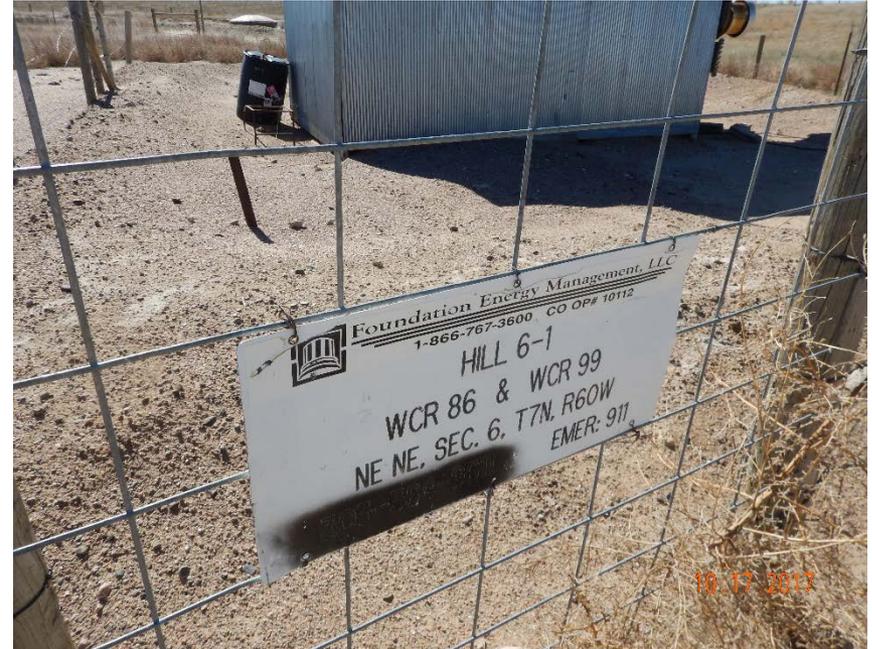
Photo #16 – Battery sign located at NE corner of separator shed fenceline.

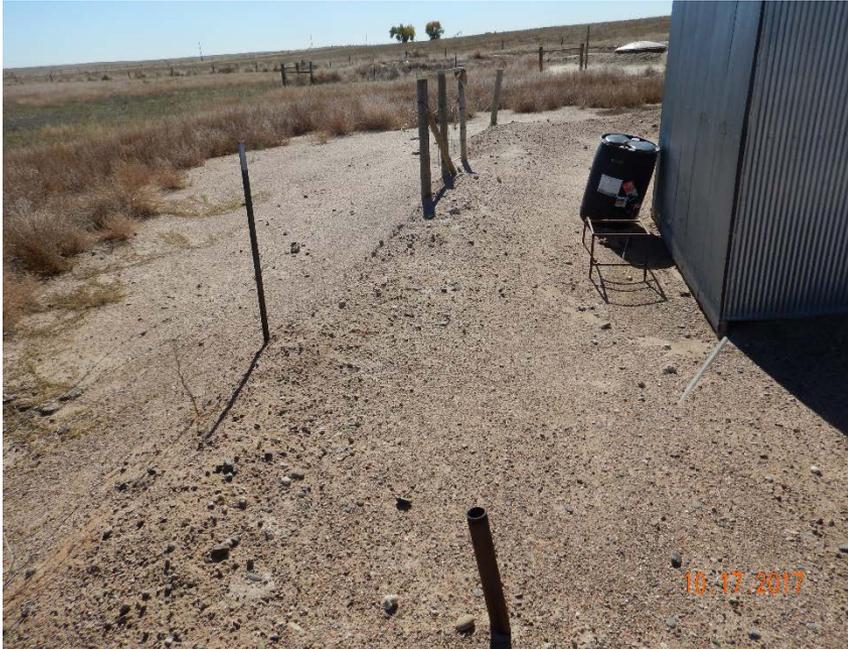
**Photo #17 - 55-gallon drum lacking secondary containment and damaged barbed wire fence on east side of separator shed. Note uncapped 2" pipe riser in foreground.**

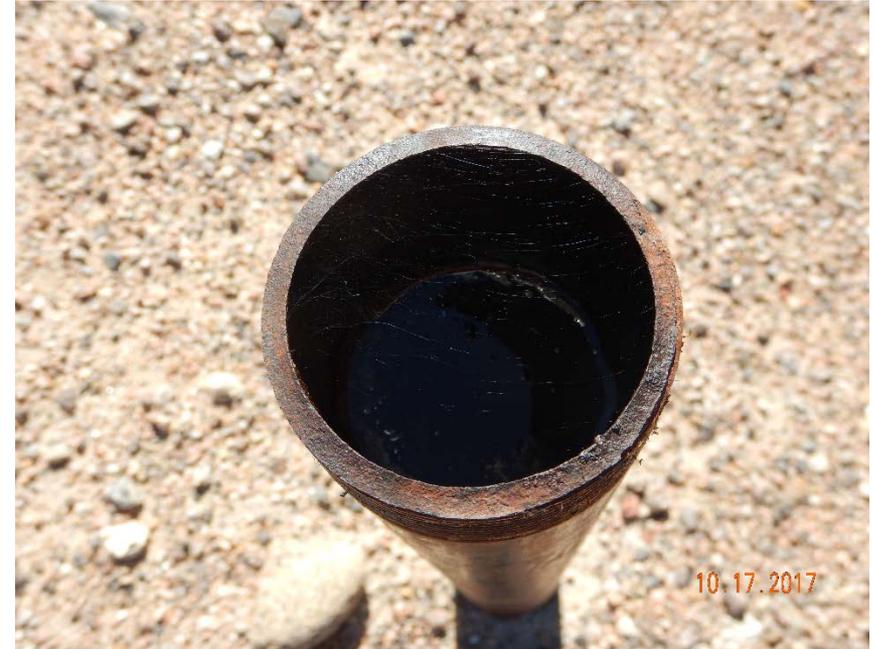
**Photo #18 – Uncapped 2" pipe riser NE of separator shed contained crude oil.**

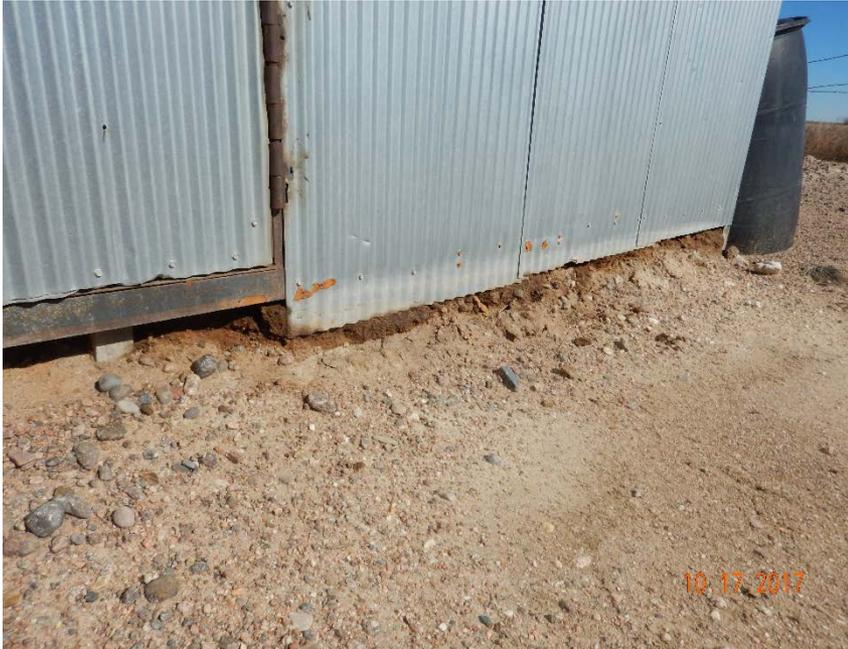
**Photo #19 – Historical accumulation of oily waste beneath SE corner of separator shed.**

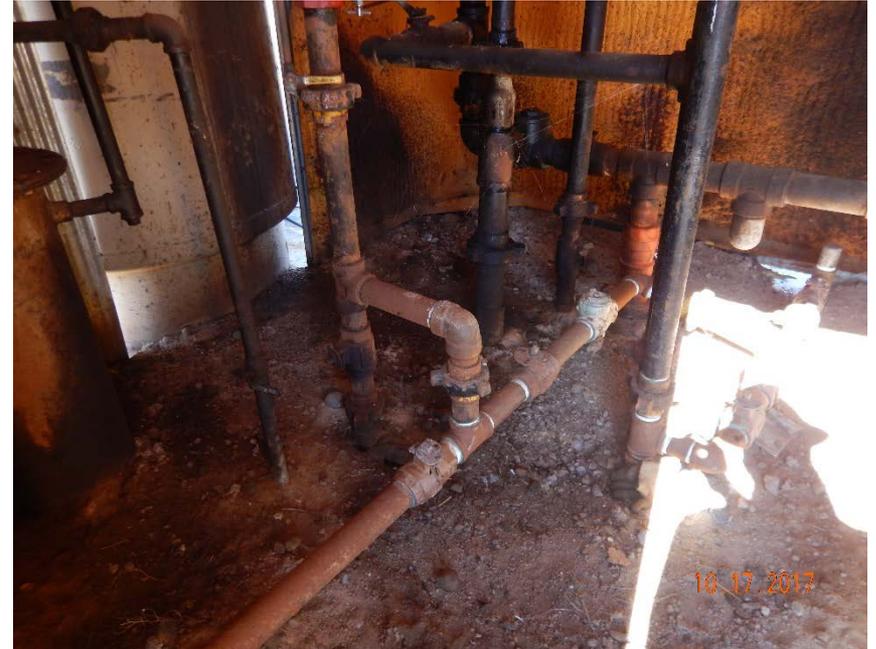
**Photo #20 – Oil-stained soil and historical accumulations of oily waste inside of separator shed (1).**

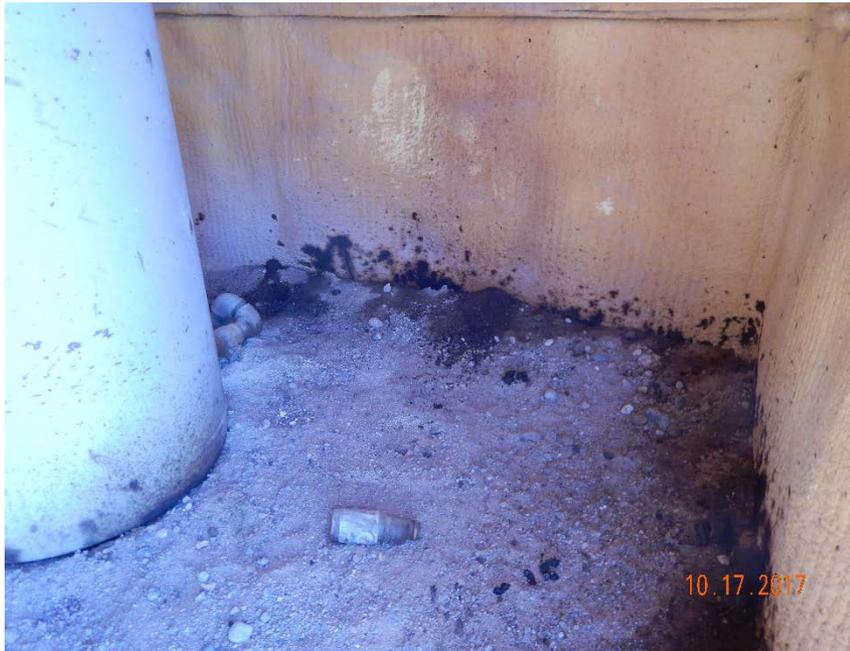
**Photo #21 - Oil-stained soil and historical accumulations of oily waste inside of separator shed (2).**

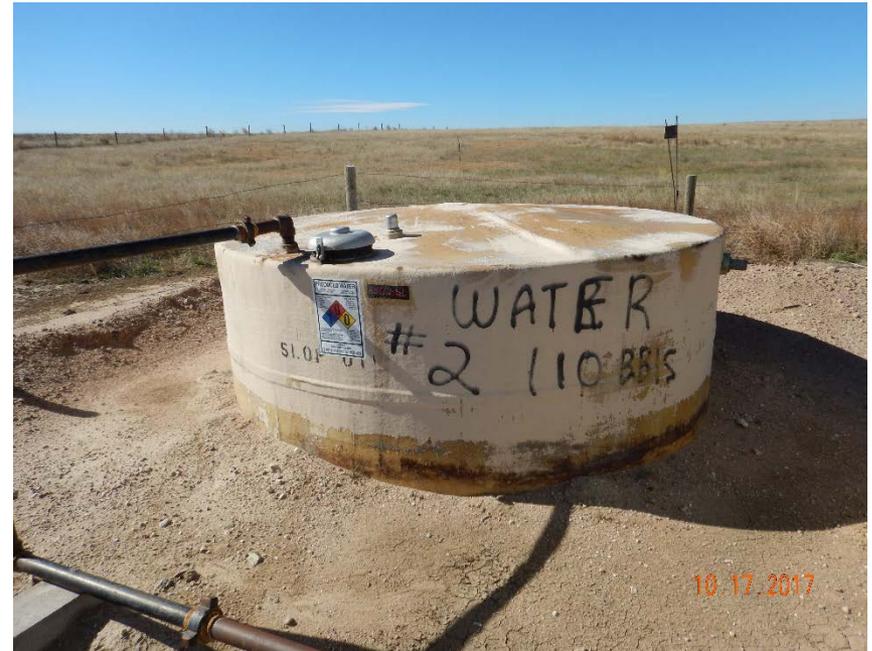
**Photo #22 – 110 bbl fiberglass PBV SW of separator shed.**

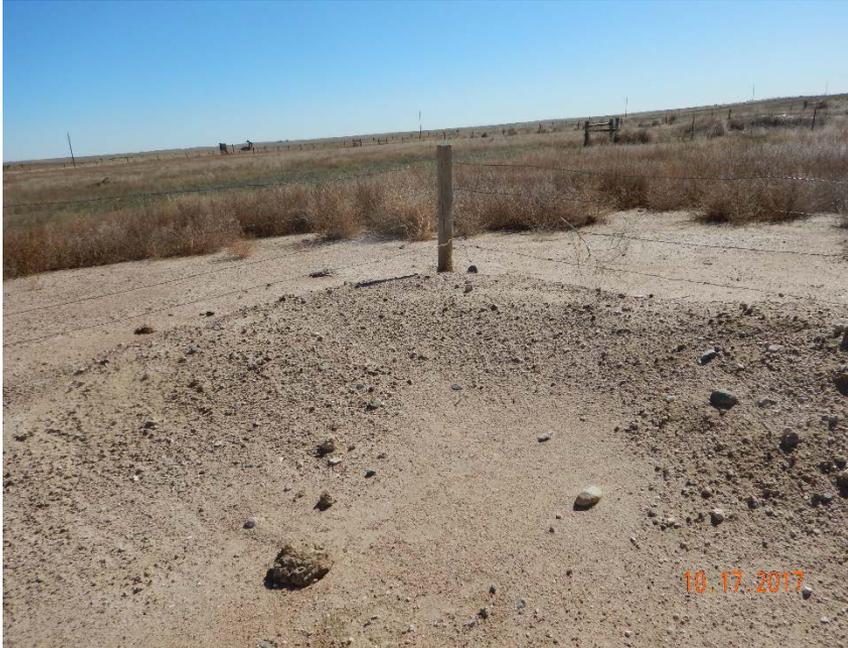
**Photo #23 – Earthen berm for fiberglass produced water PBV is shallow at SE corner.**

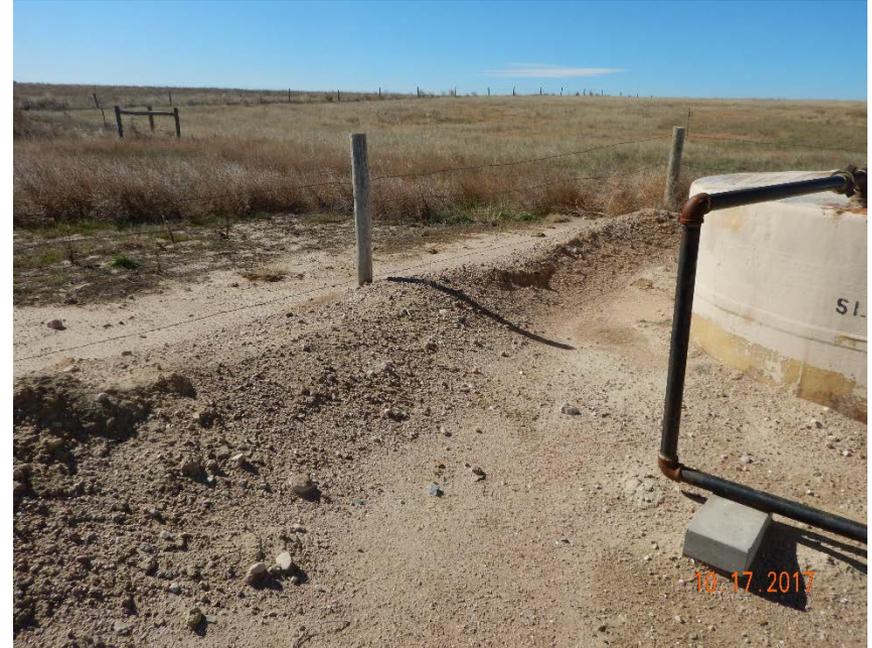
**Photo #24 – Earthen berm for fiberglass produced water PBV is shallow south of tank.**

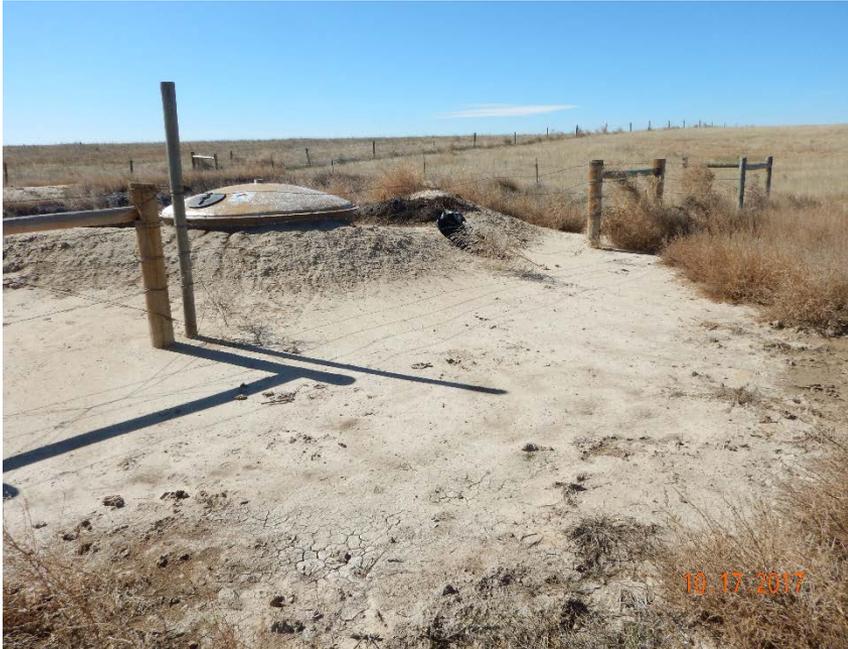
**Photo #25 – Off-site sediment transport from pit berm onto area north of pit fence.**

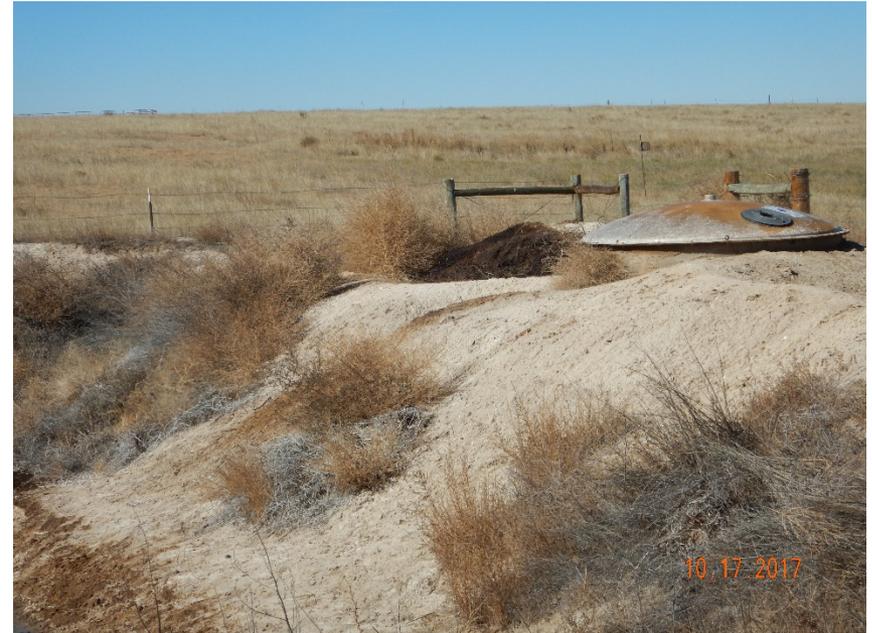
**Photo #26 – Stockpile of oily waste remains west of skim tank.**

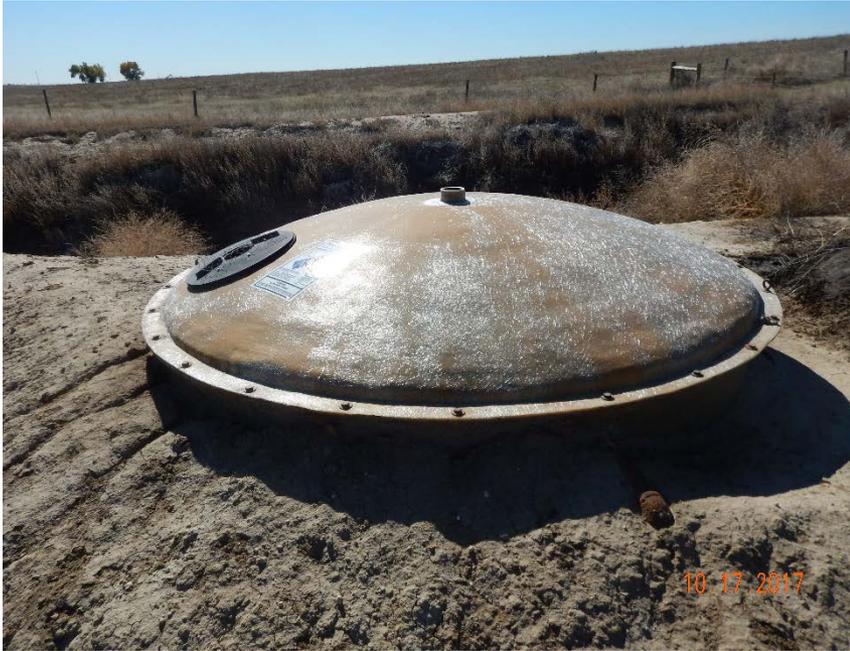
**Photo #27 – Fiberglass skim tank lacks earthen berms on west, north, and east sides as well as volume label.**

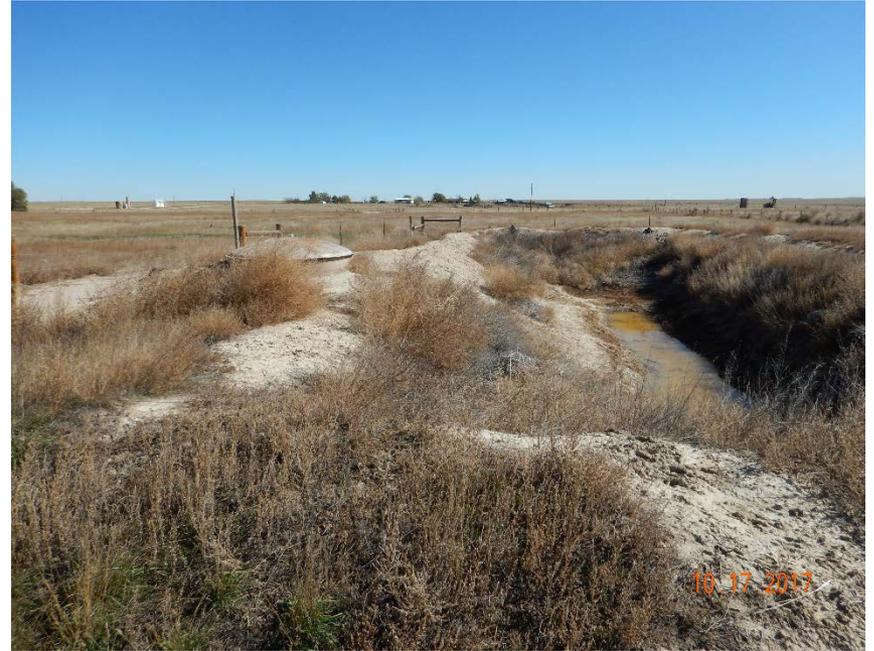
**Photo #28 – Uncontrolled weeds growing inside of and around pit.**

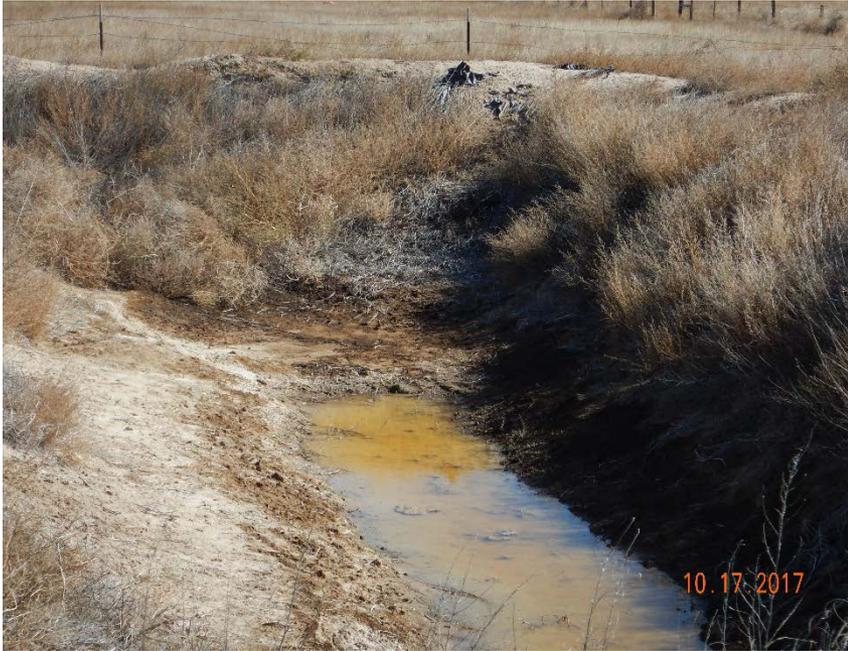
**Photo #29 – Oil-stained soil inside of pit (1), SE corner.**

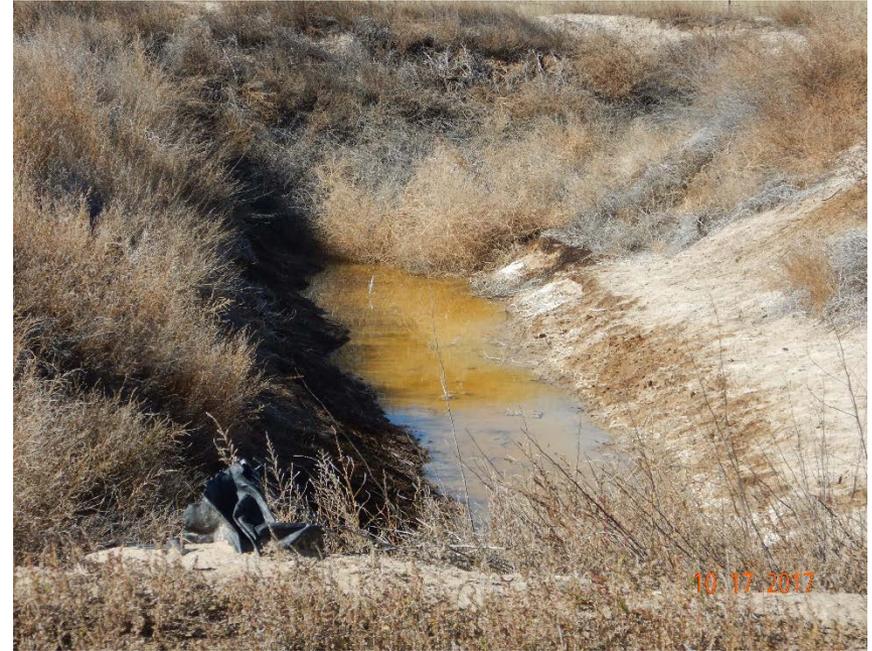
**Photo #30 - Oil-stained soil inside of pit (2), NW corner.**
