Inspection Photos
Location Name: Hoffman 34-10
API: 05-123-20097
Inspection Date: October 17, 2017

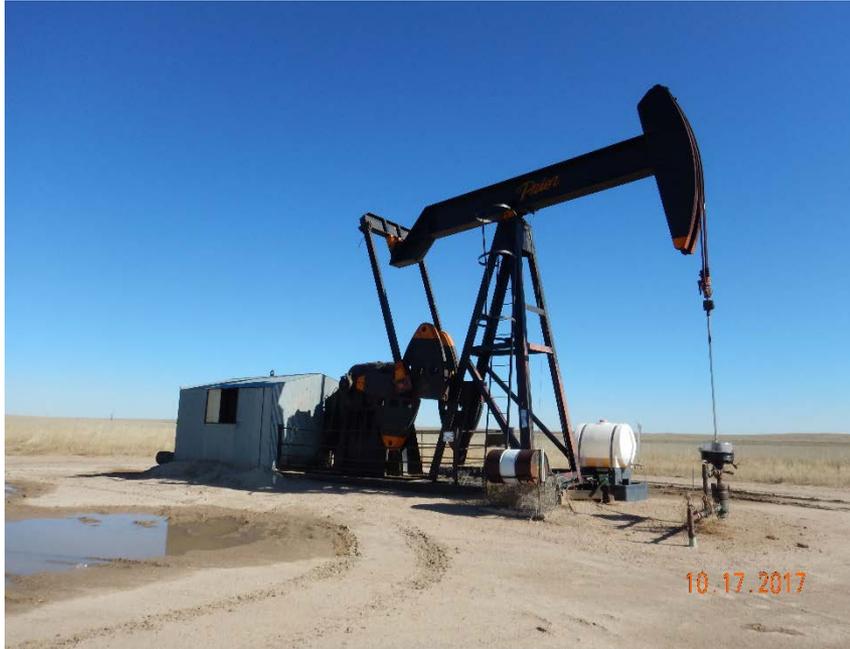
Photo #1 – View of wellhead and pump jack from the northwest. Note that precipitation is pooling on well pad.

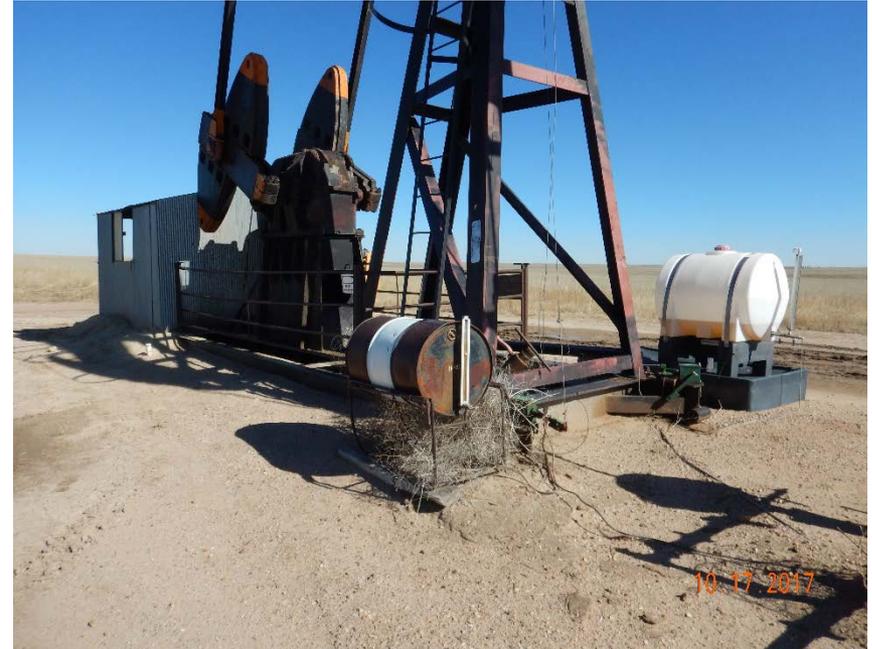
Photo #2 – Day tanks at south end of pump jack. 55-gallon drum/day tank lacks secondary containment device and exhibits historical accumulation of both impacted soil and wind-blown weeds underneath.

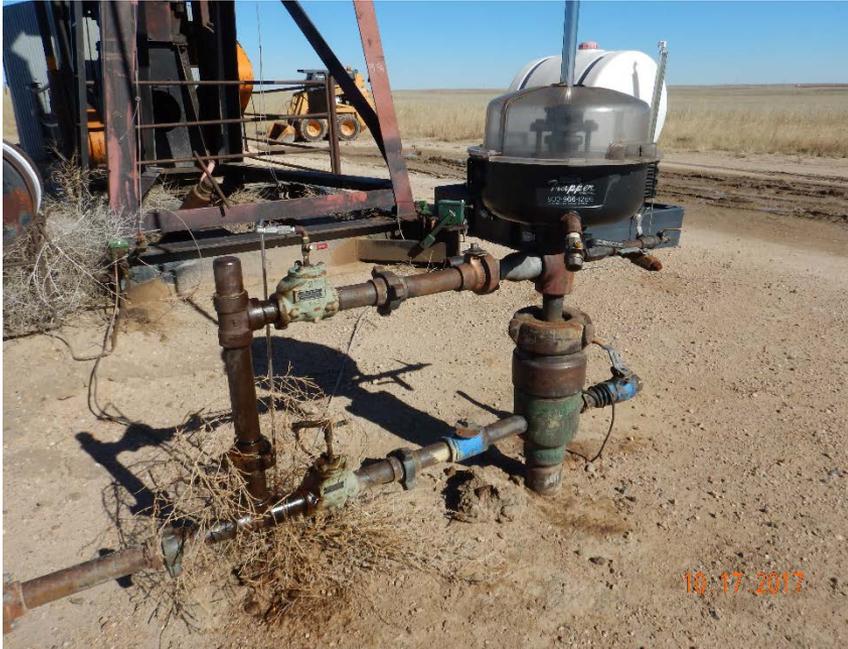
Photo #3 – Localized accumulations of oil-stained soil and wind-blown weeds at wellhead. Note fresh crude oil stains on equipment.

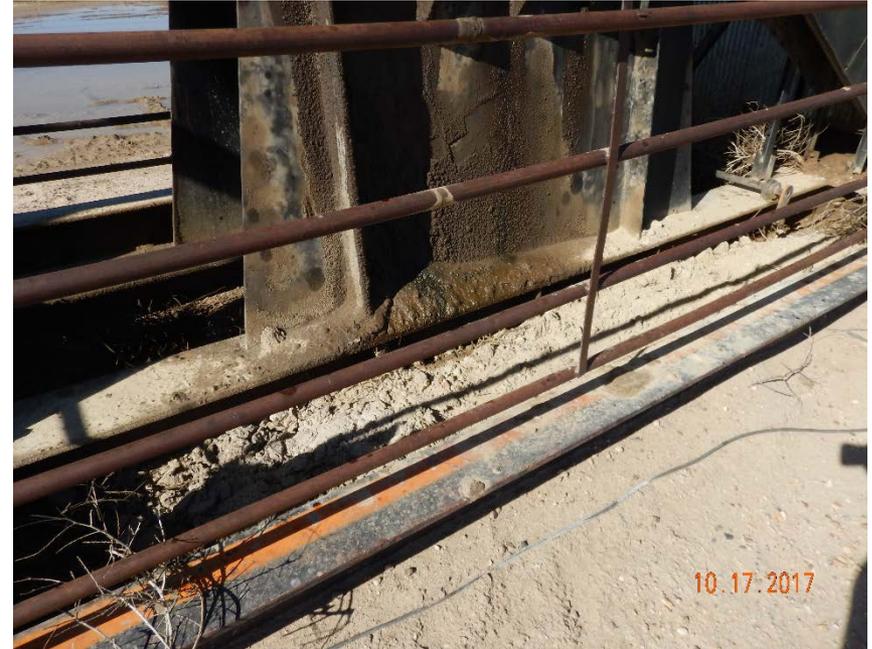
Photo #4 – Recent lube oil stains on east side of pump jack.

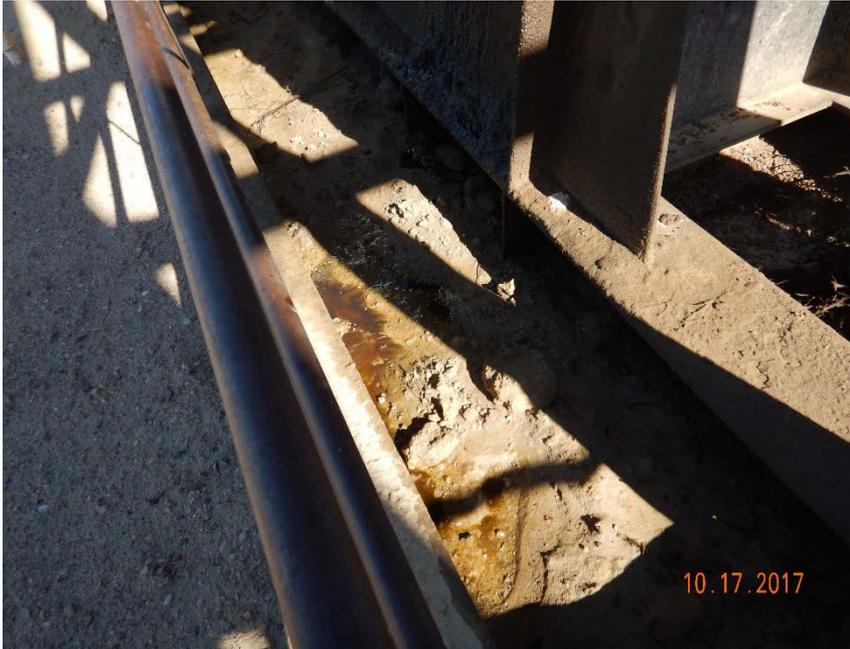
Photo #5 – Oil-stained soil and pooling fluid on west side of pump jack.

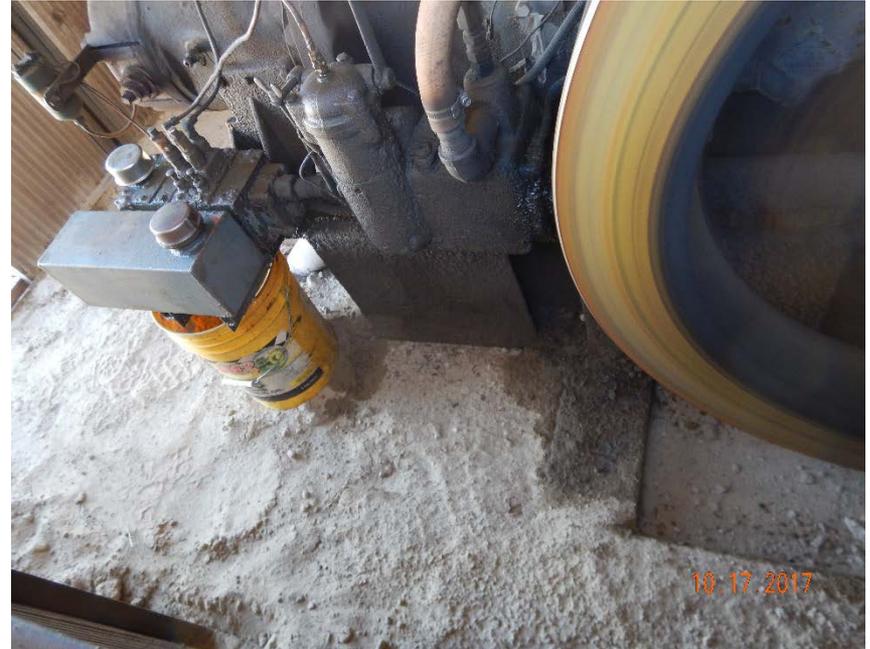
Photo #6 – Localized accumulations of oil-stained soil beneath prime mover.

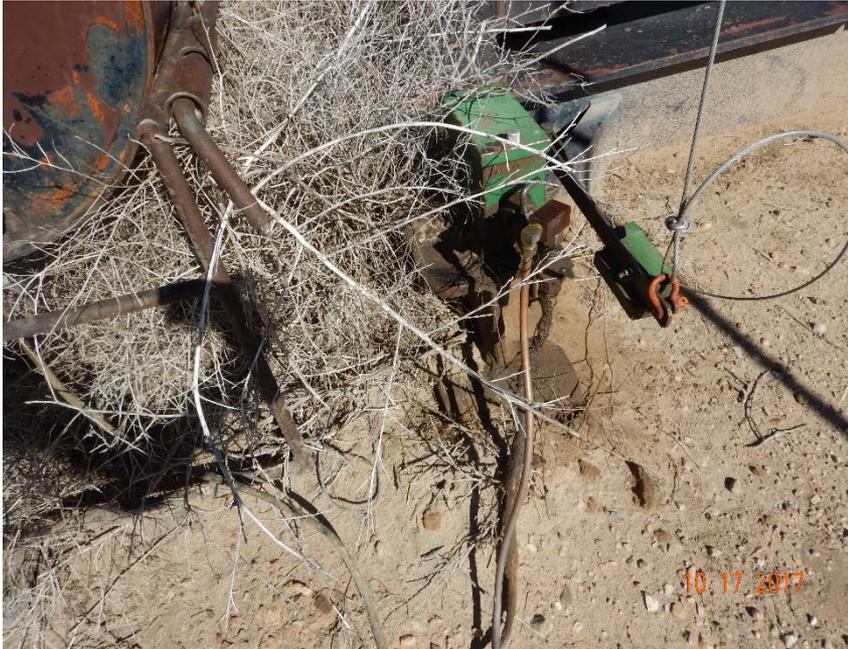
Photo #7 – Localized accumulation of oil-stained soil and wind-blown weeds at SW corner of pump jack.

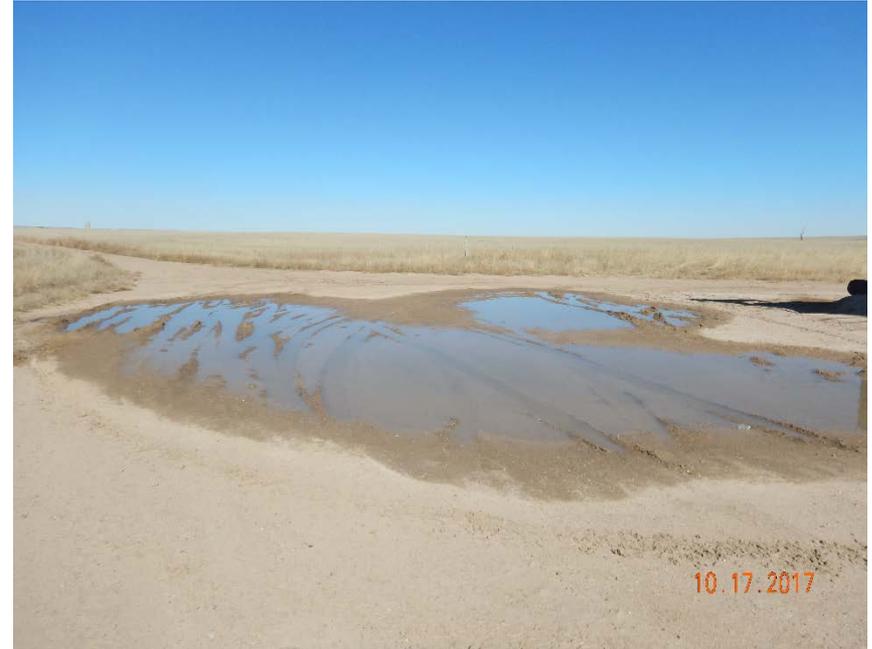
Photo #8 – Precipitation accumulation and ruts NW of pump jack.

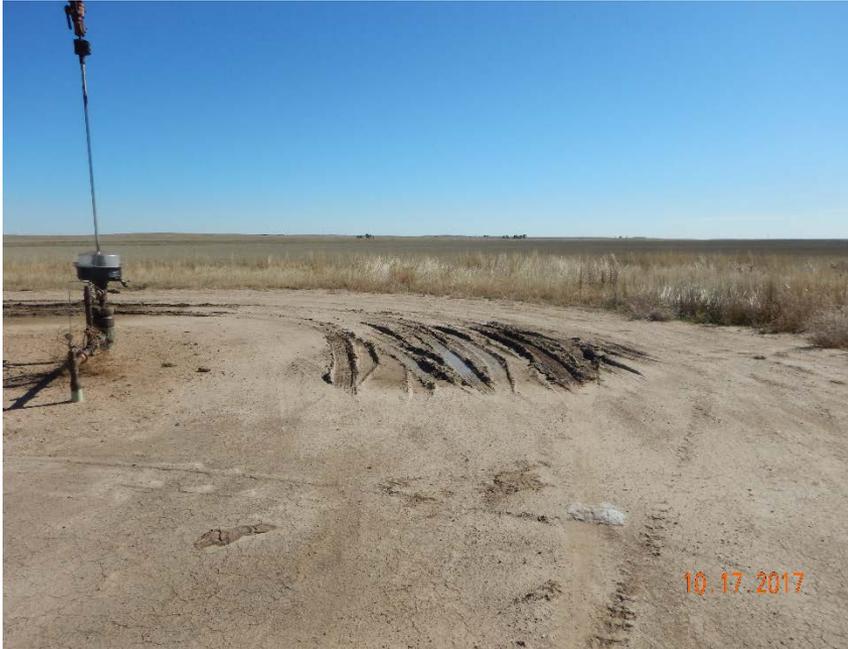
Photo #9 – Ruts and precipitation pooling SE of pump jack.

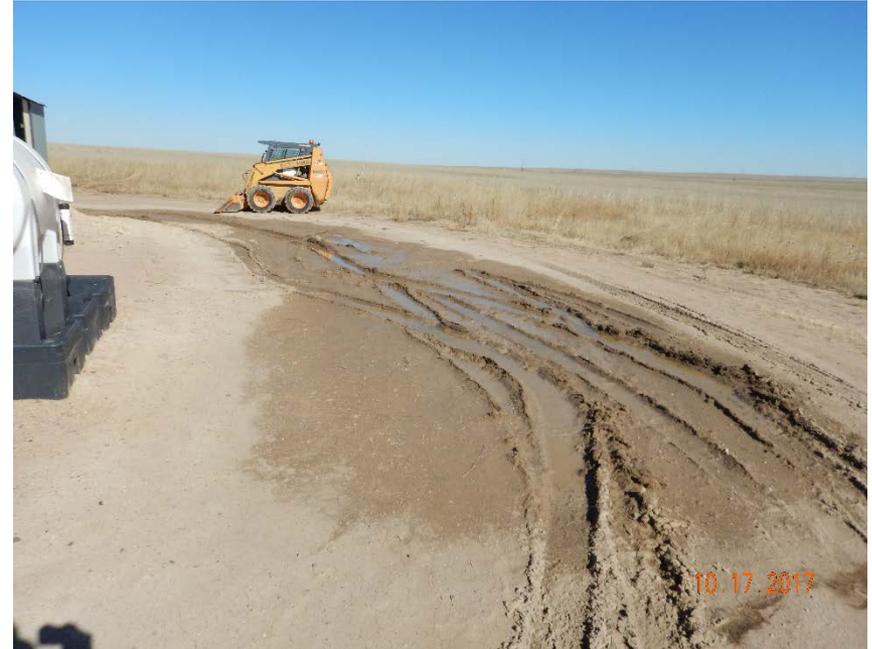
Photo #10 – Precipitation and ruts east of pump jack.

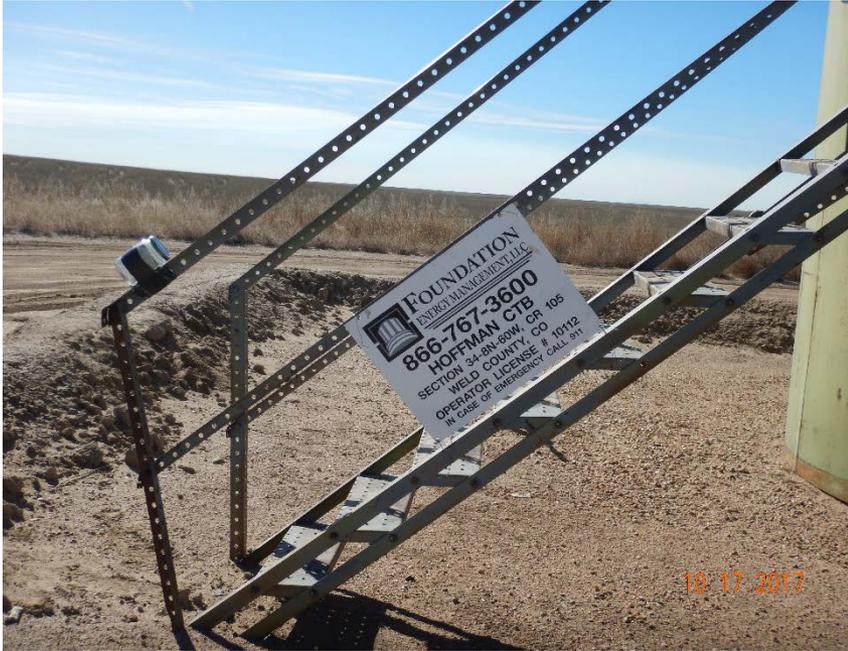
Photo #11 – Battery sign and eroded berms at SE corner of crude oil ASTs.

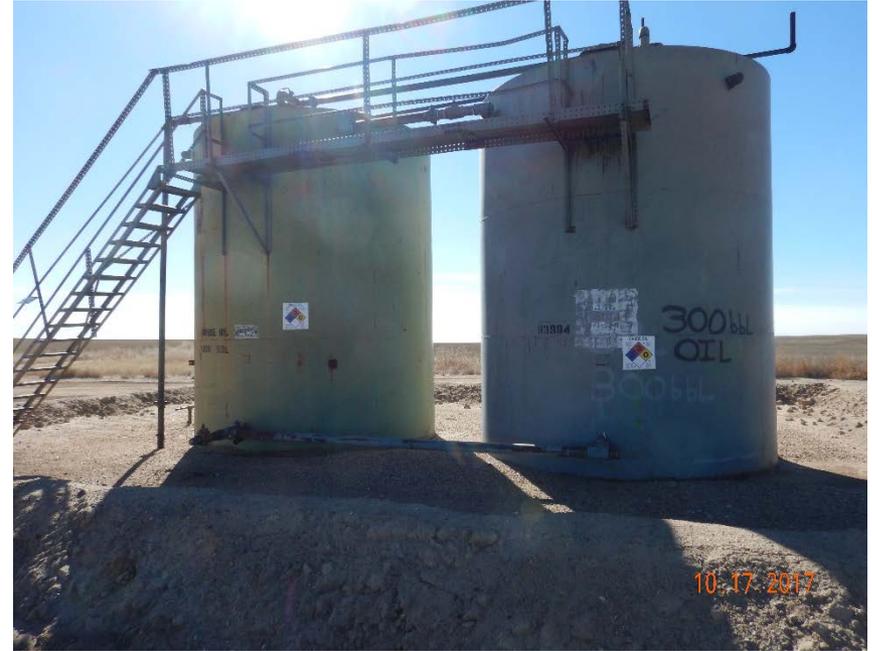
Photo #12 – Crude oil ASTs.

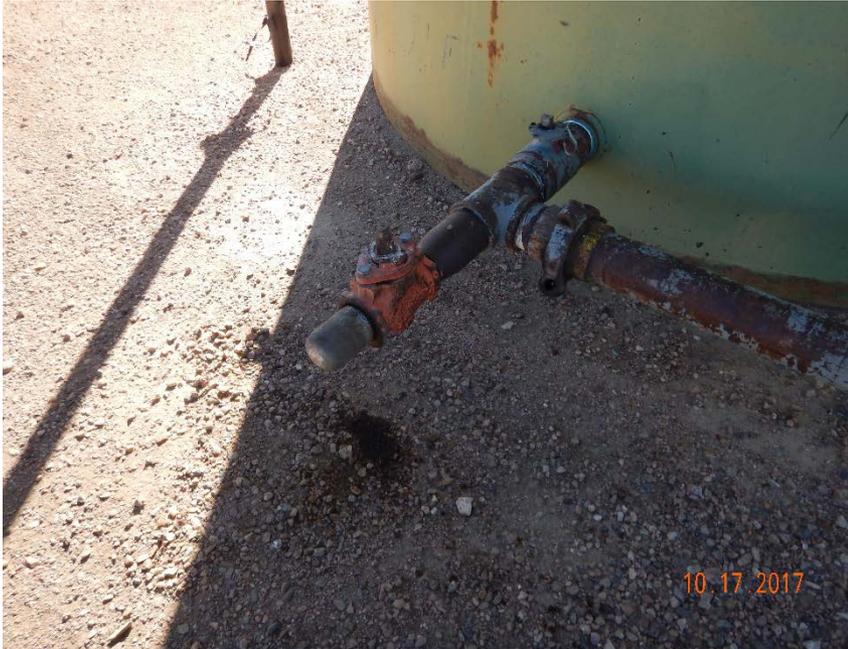
Photo #13 – Localized, oil-stained soil at crude oil AST loadout valve.

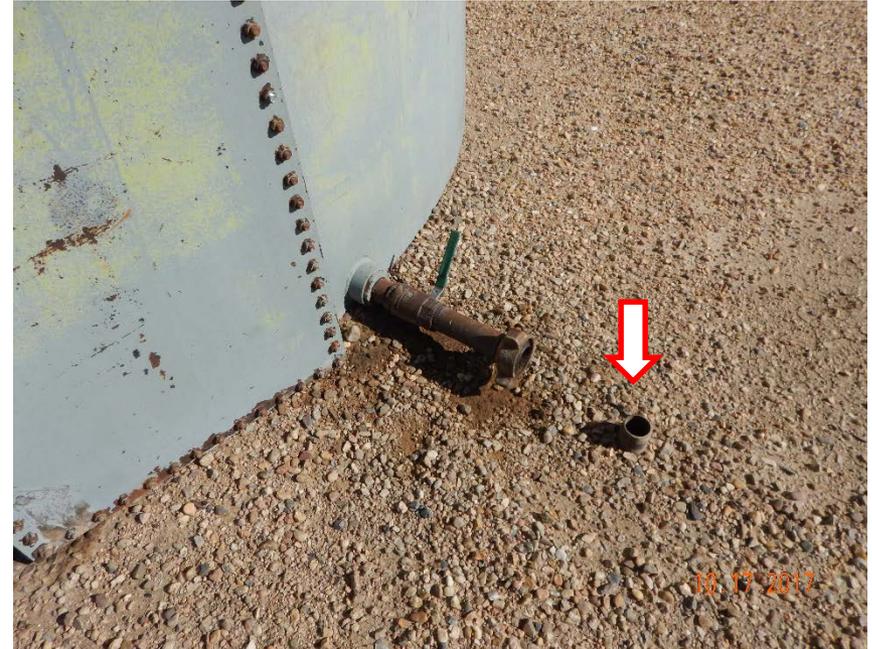
Photo #14 – Localized, oil-stained soil and 2" pipe riser beneath uncapped valve on west side of northern crude oil AST.

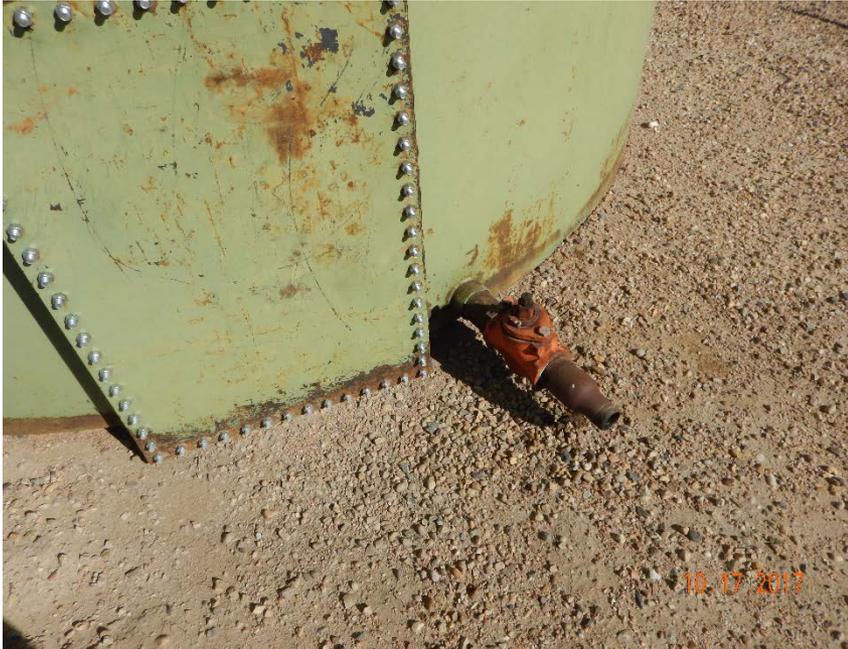
Photo #15 – Valve on west side of southern crude oil AST lacks bullplug.

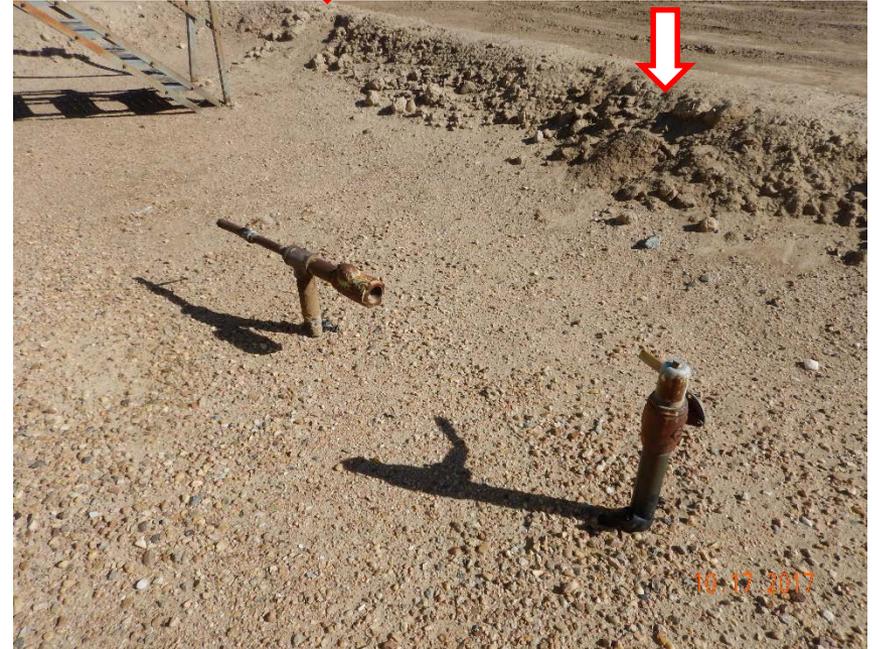
Photo #16 – 2" steel flowline risers SE of crude oil ASTs. Note that berms in background are eroded and damaged.

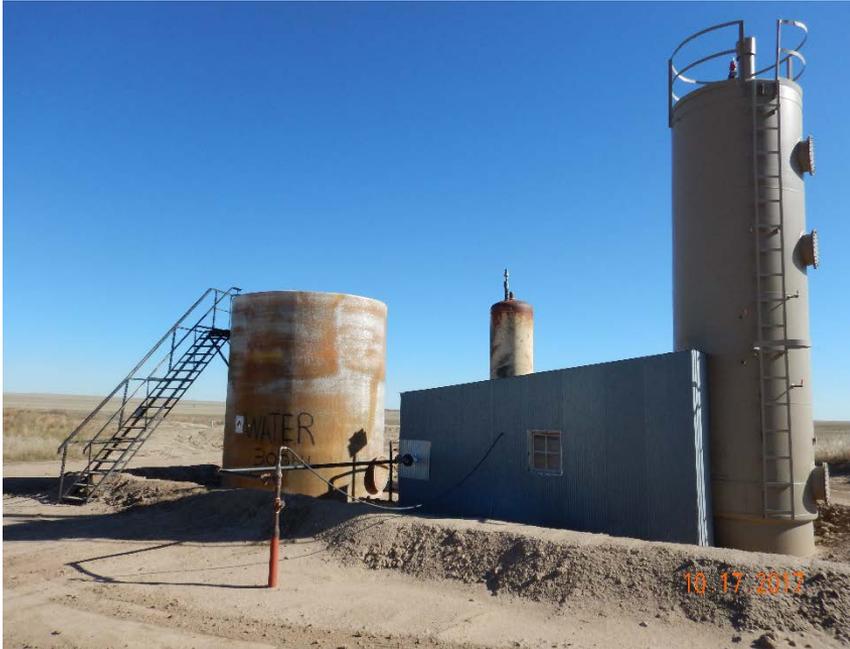
Photo #17 – Produced water AST and separator shed.

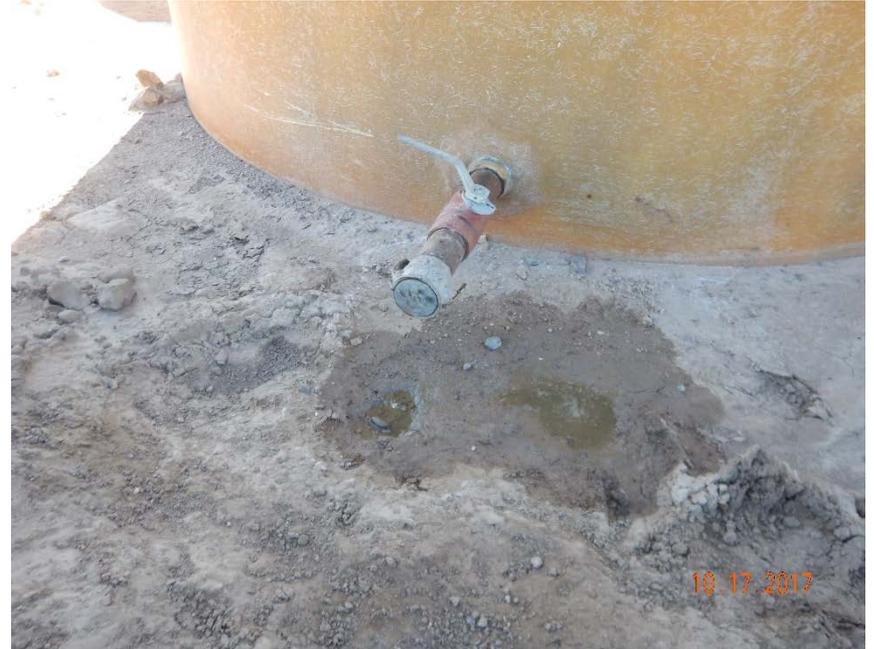
Photo #18 – Puddle of water at 300 bbl produced water AST loadout.

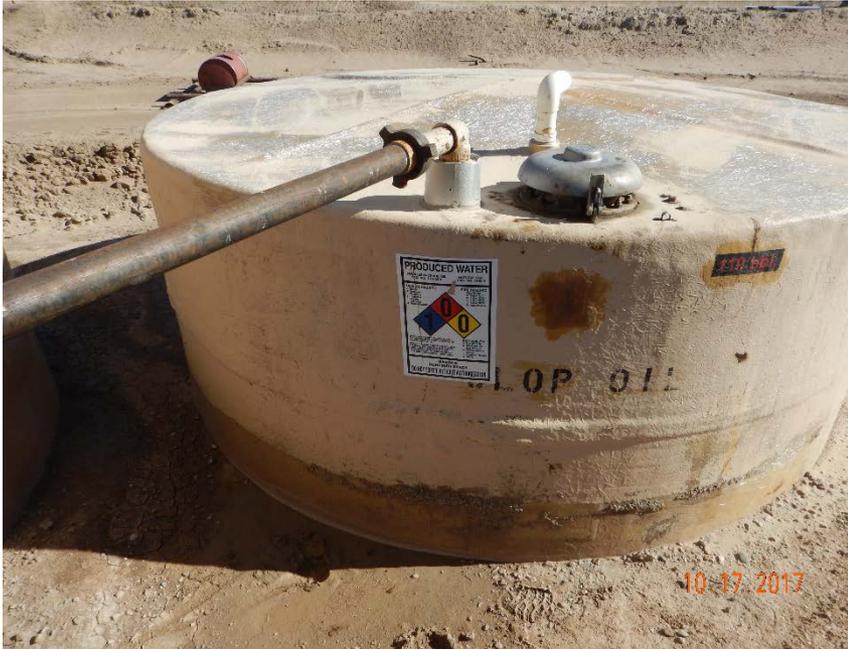
Photo #19 – 110 bbl produced water fiberglass PBV.

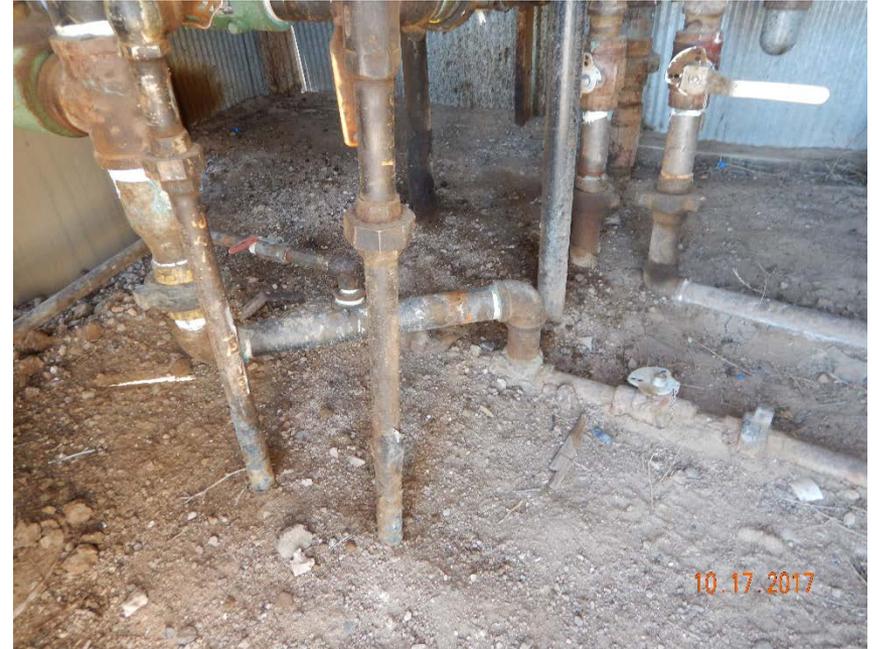
Photo #20 – Localized accumulations of oil-stained soil inside of separator shed (1).

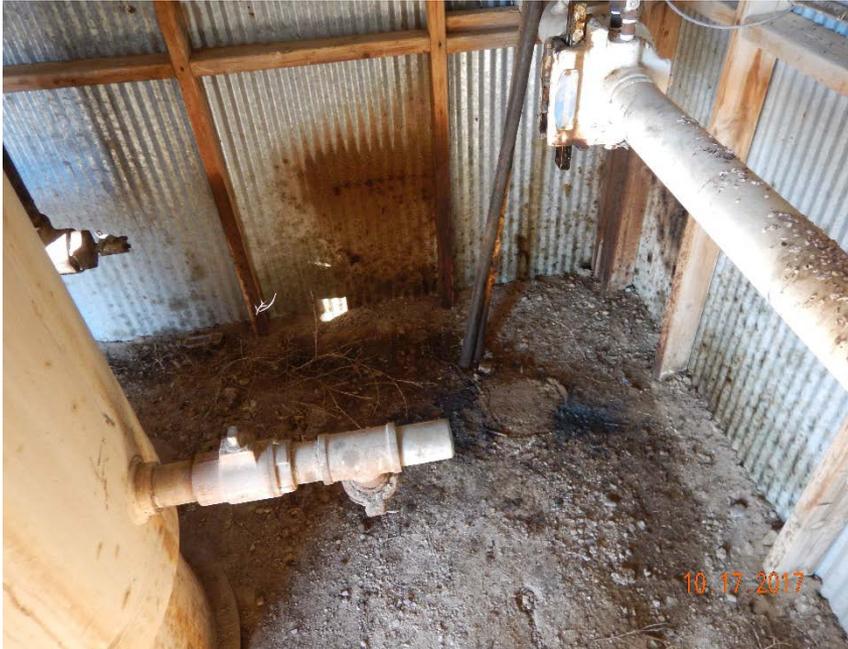
Photo #21 - Localized accumulations of oil-stained soil inside of separator shed (2).

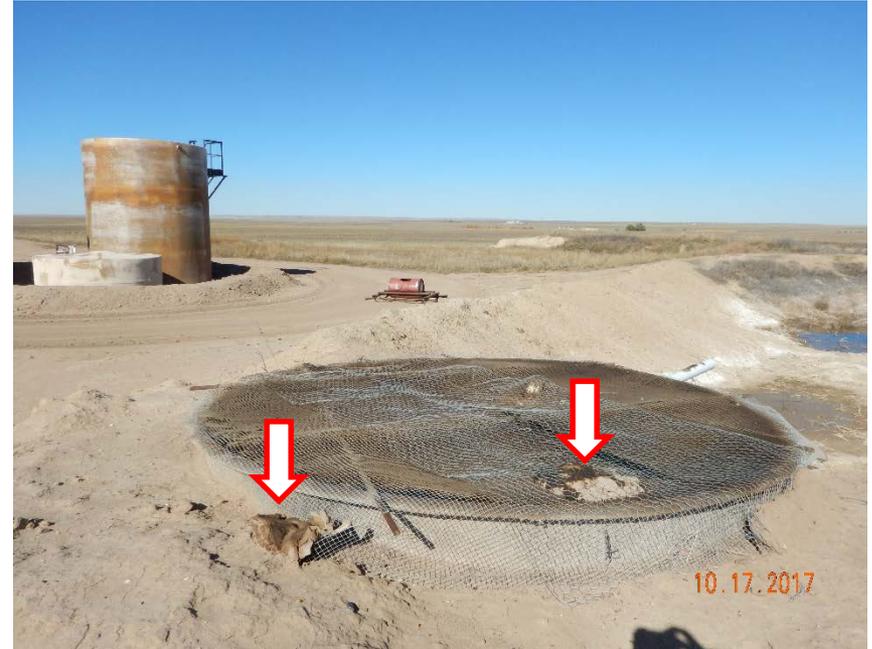
Photo #22 – Open-top skim tank at SE corner of production facility. Note oily rag and small pile of oily waste. Tank lacks NFPA placard and volume/content labels.

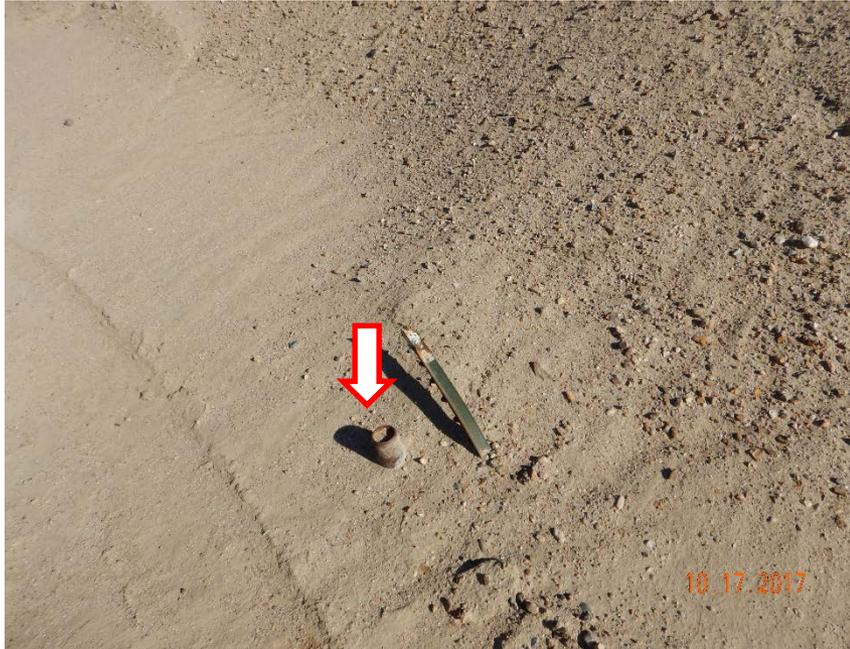
Photo #23 – 2” pipe riser north of produced water pit.

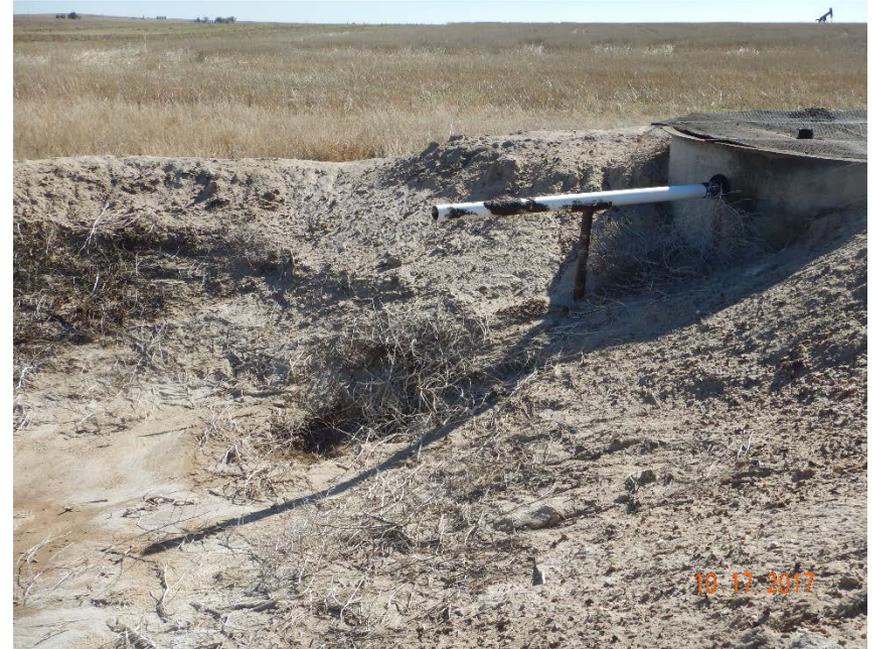
Photo #24 – Localized accumulations of oil-stained soil and weeds at SW corner of produced water pit #273442.

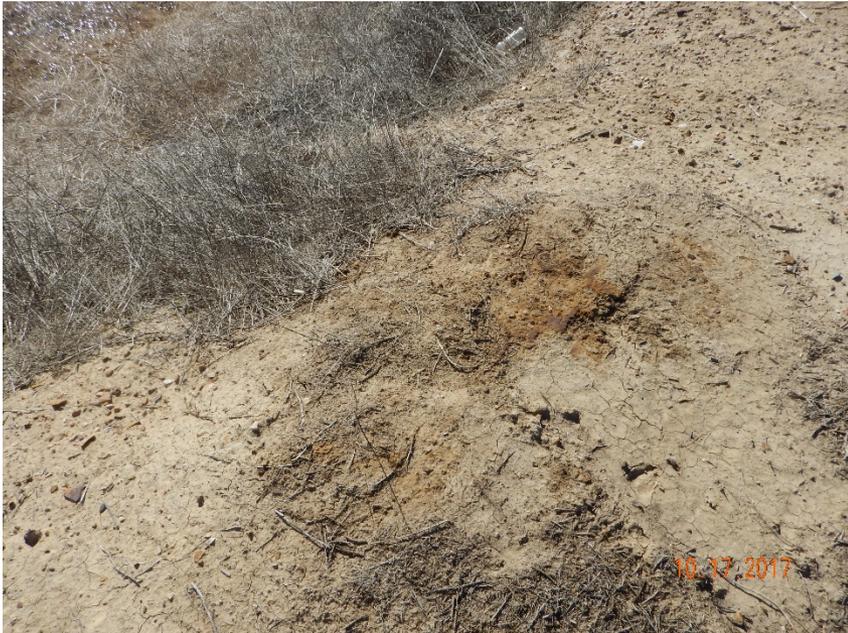
Photo #25 - Localized accumulations of oil-stained soil and weeds at NE corner of produced water pit #273442.

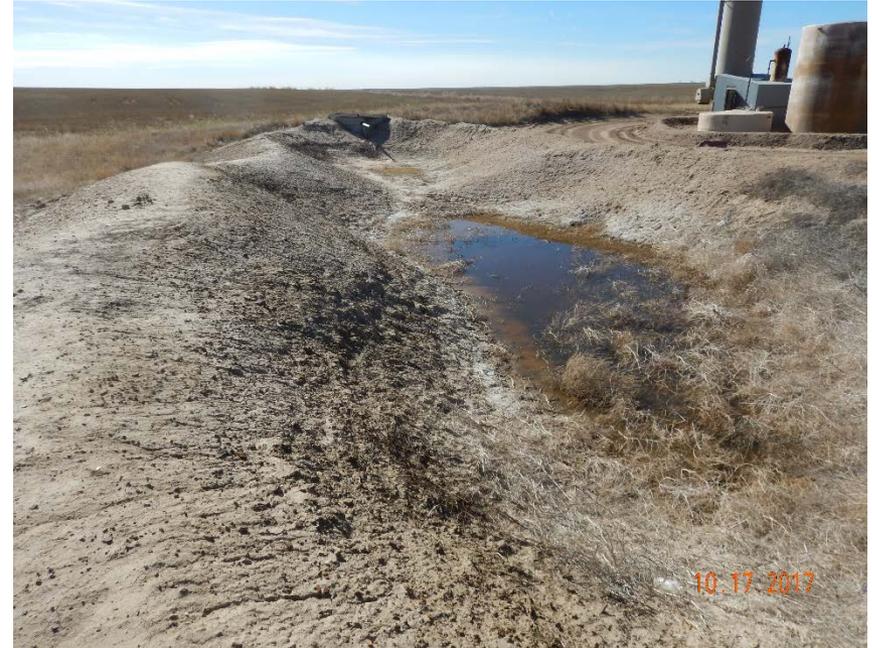
Photo #26 – View into first produced water pit #273442 from NE corner.

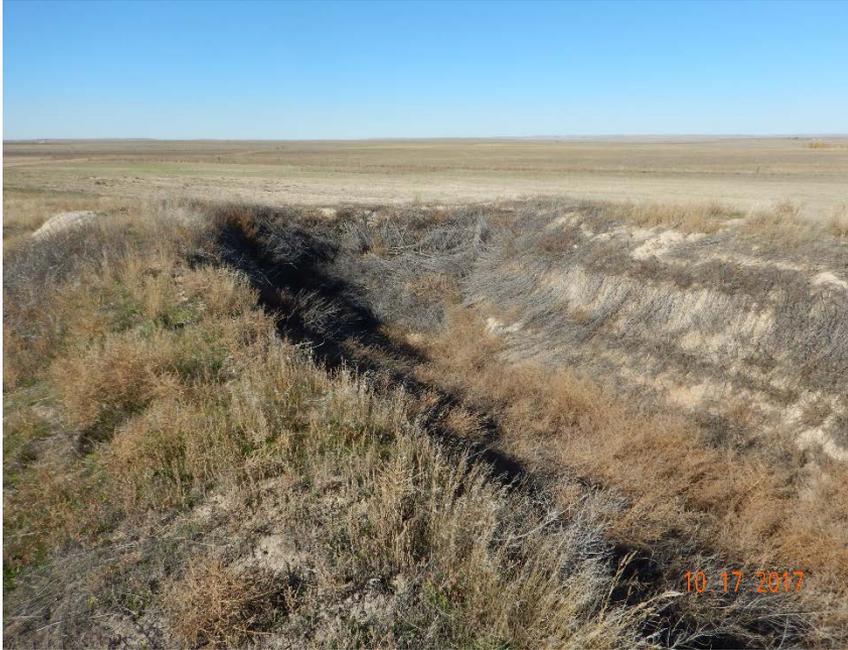
Photo #27 – Uncontrolled weed growth in NW portion of L-shaped pit (#273443).

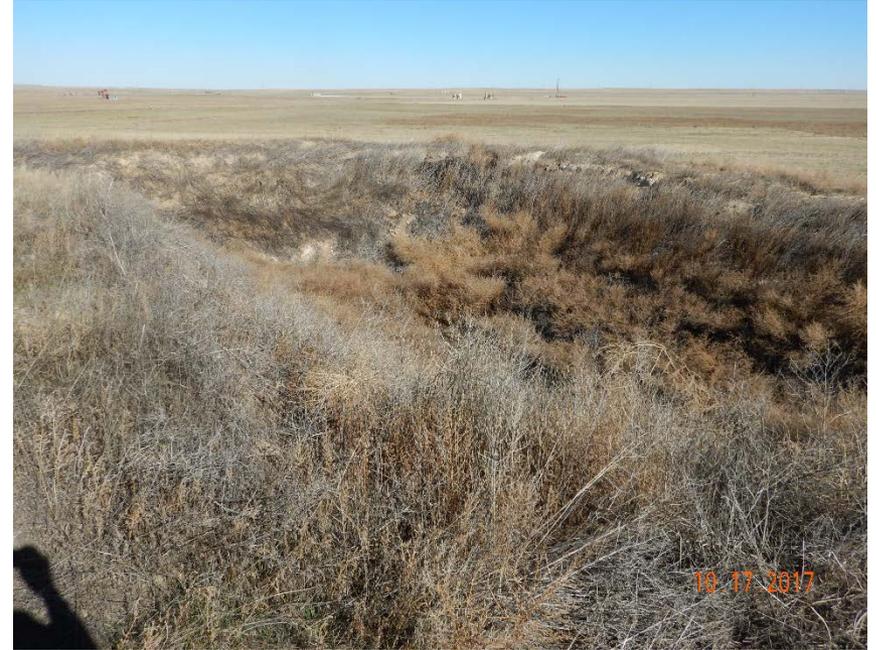
Photo #28 – Uncontrolled weed growth in southern portion of L-shaped pit (#273443).
