Inspection Photos
Location Name: Furr F3 Pad follow up
Location ID: 335021

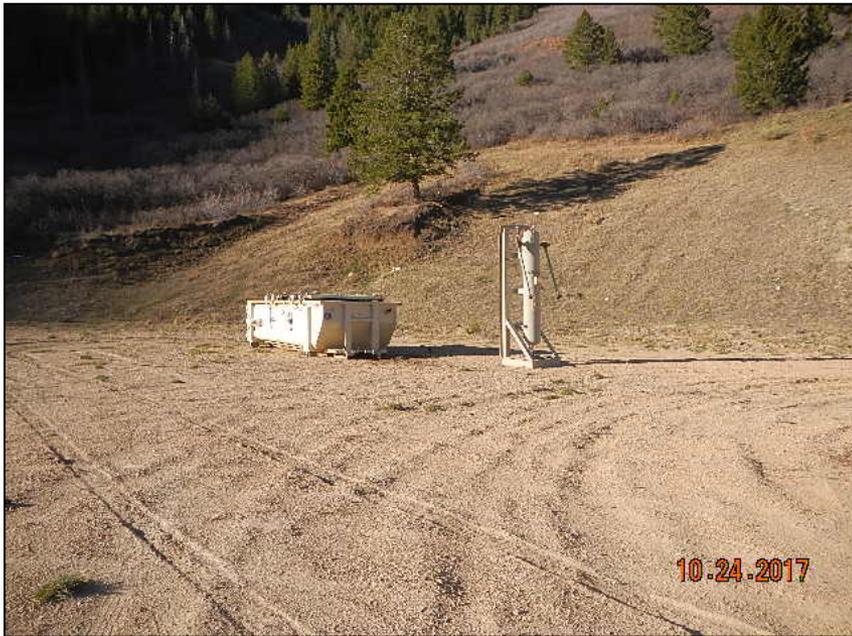
Photo 1. Tank and sand trap have been disconnected from well but not removed from site as stated in FIRR Doc#401438181 CA# 104930 and 104931

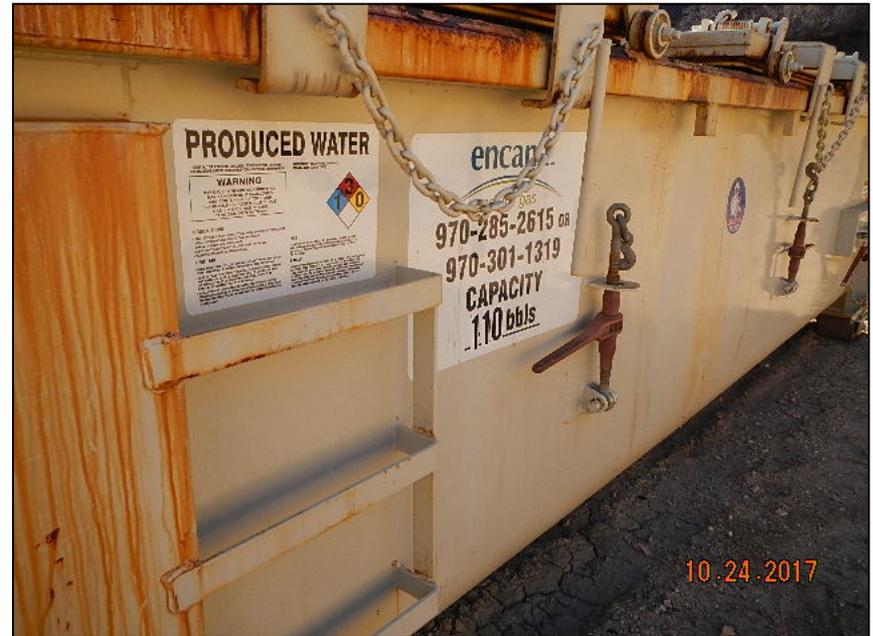
Photo 2. Signs on tank still have incorrect operator information.

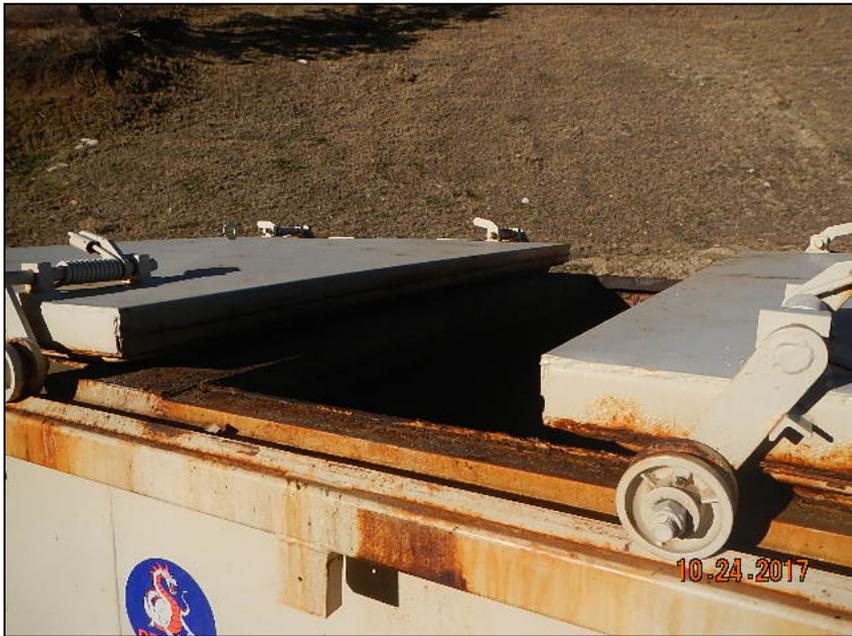
Photo 3. Hatch on tank was found open by FIU staff.

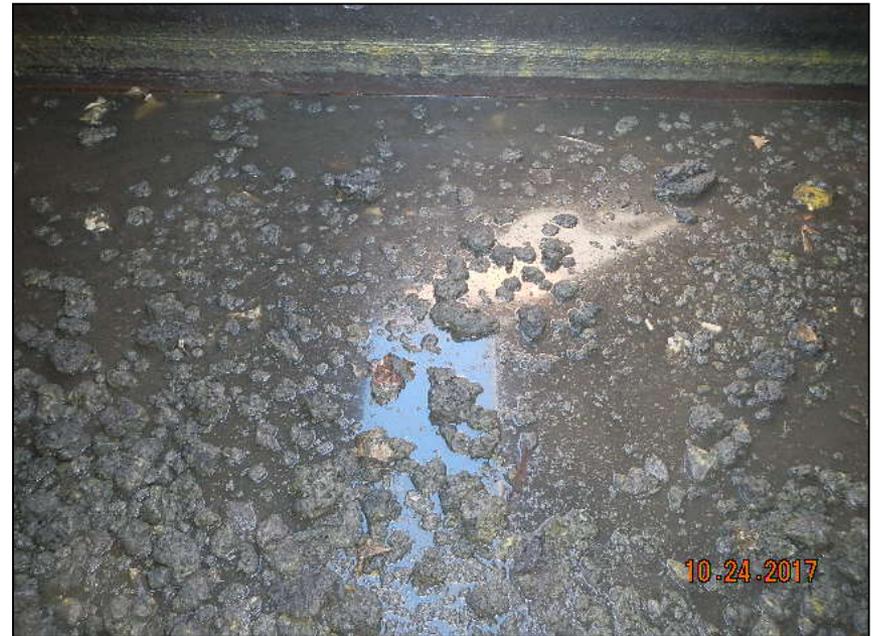
Photo 4. Tank contained sand AND produced water.
