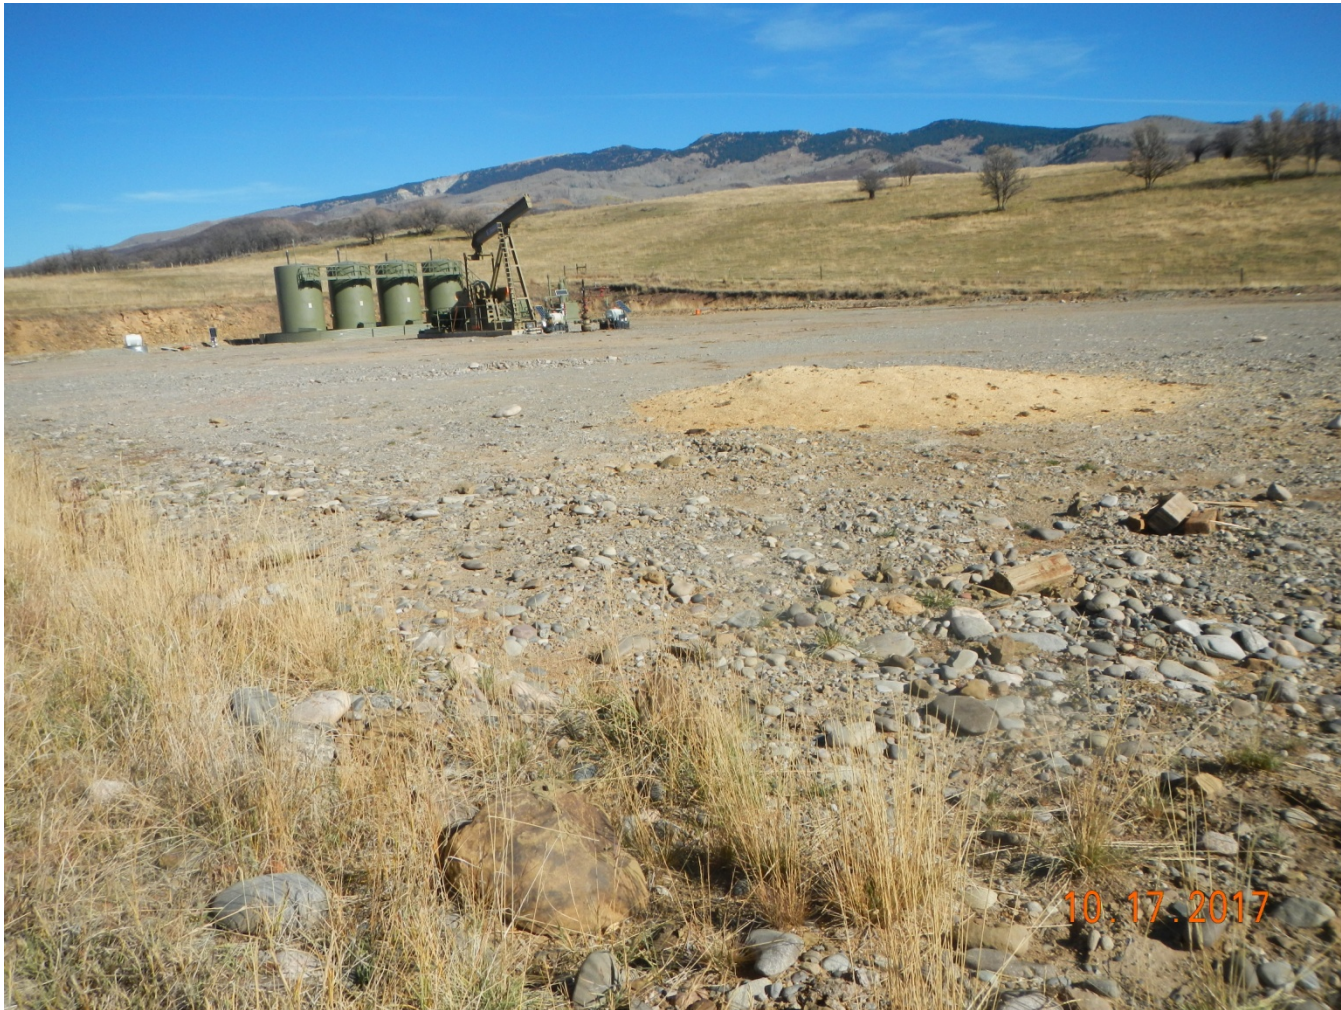
Photo 1. View of the project area from the southwestern corner of the working area facing center.

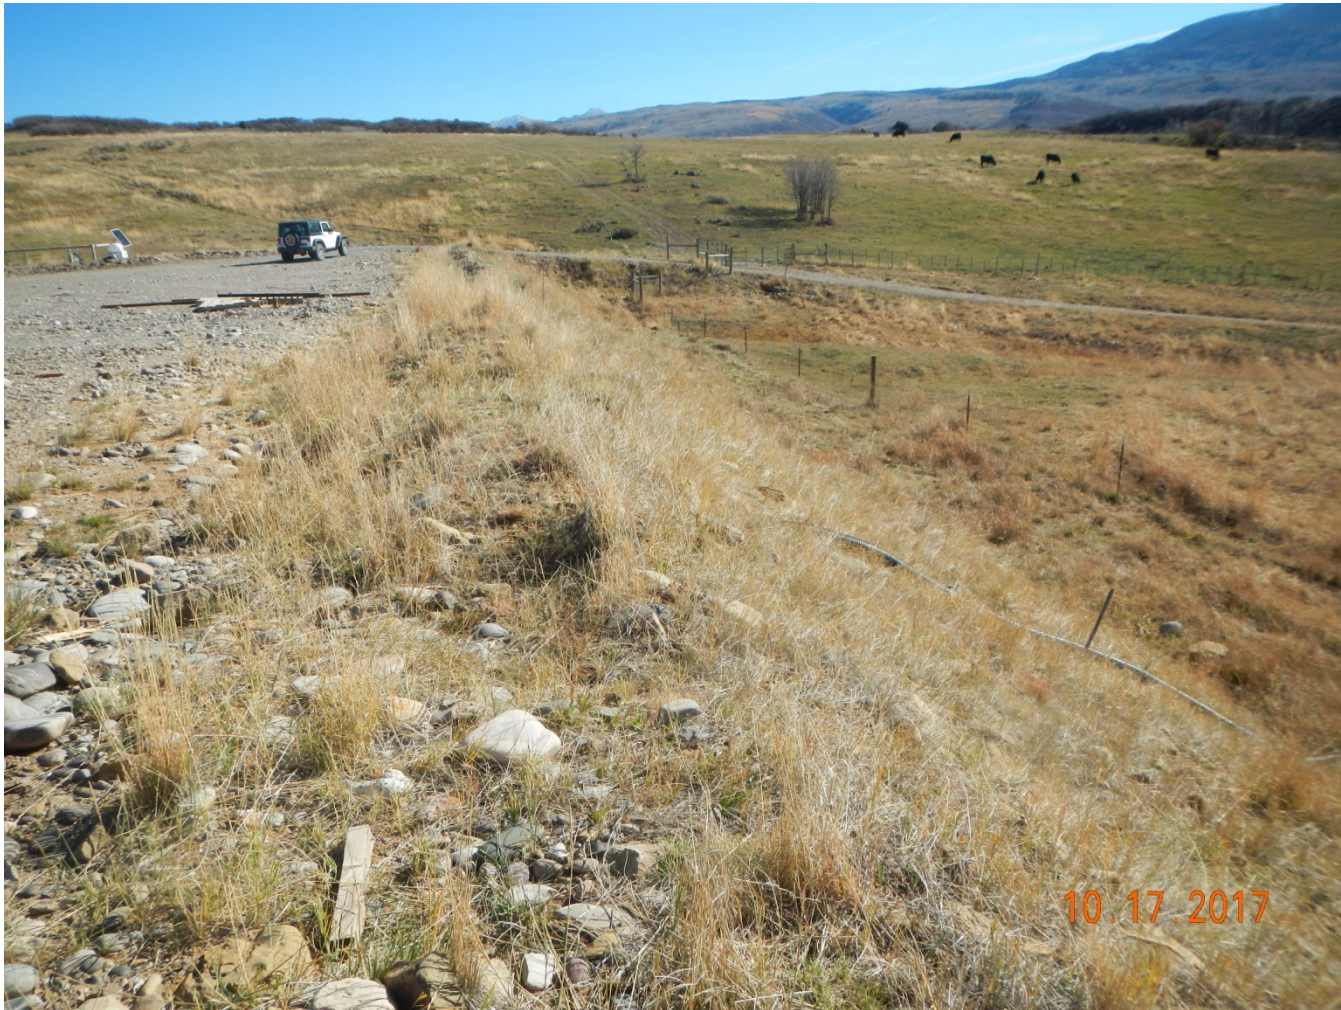
Photo 2. View of the southern portion of the project area from the southwestern corner of the working area facing eastward. Vegetation is well established on the southern fill slope, and largely comprised of western wheatgrass (*Pascopyrum smithii*), squirreltail (*Elymus elymoides*) and smooth brome (*Bromus inermis*).

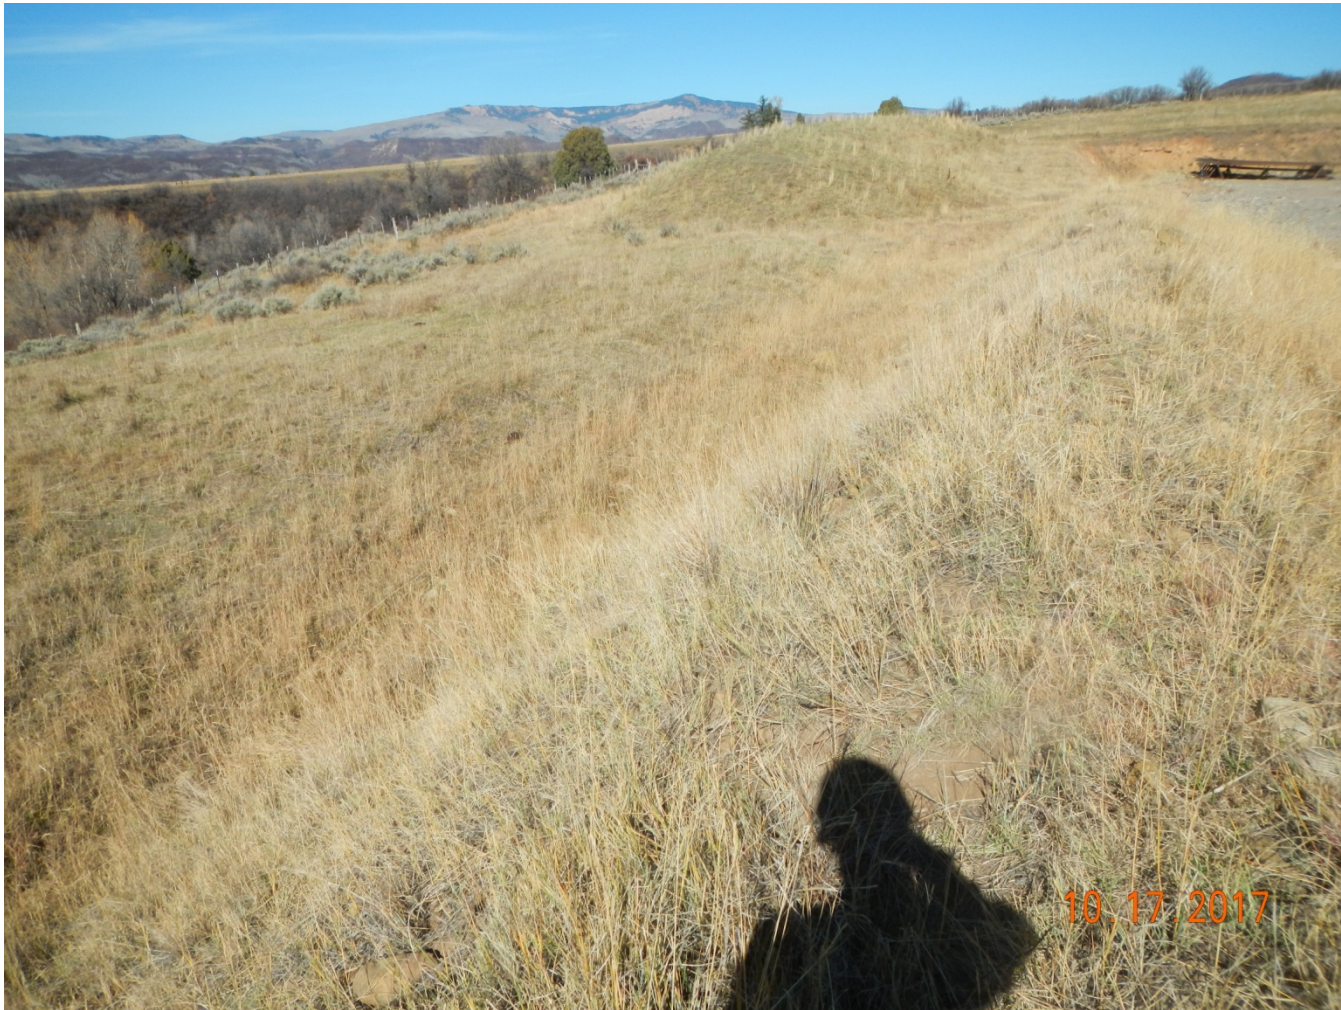
Photo 3. View of the western portion of the project area from the southwestern corner of the working area facing northward. What appears to be a vegetated topsoil stockpile is present in the northwestern portion of the project disturbance.

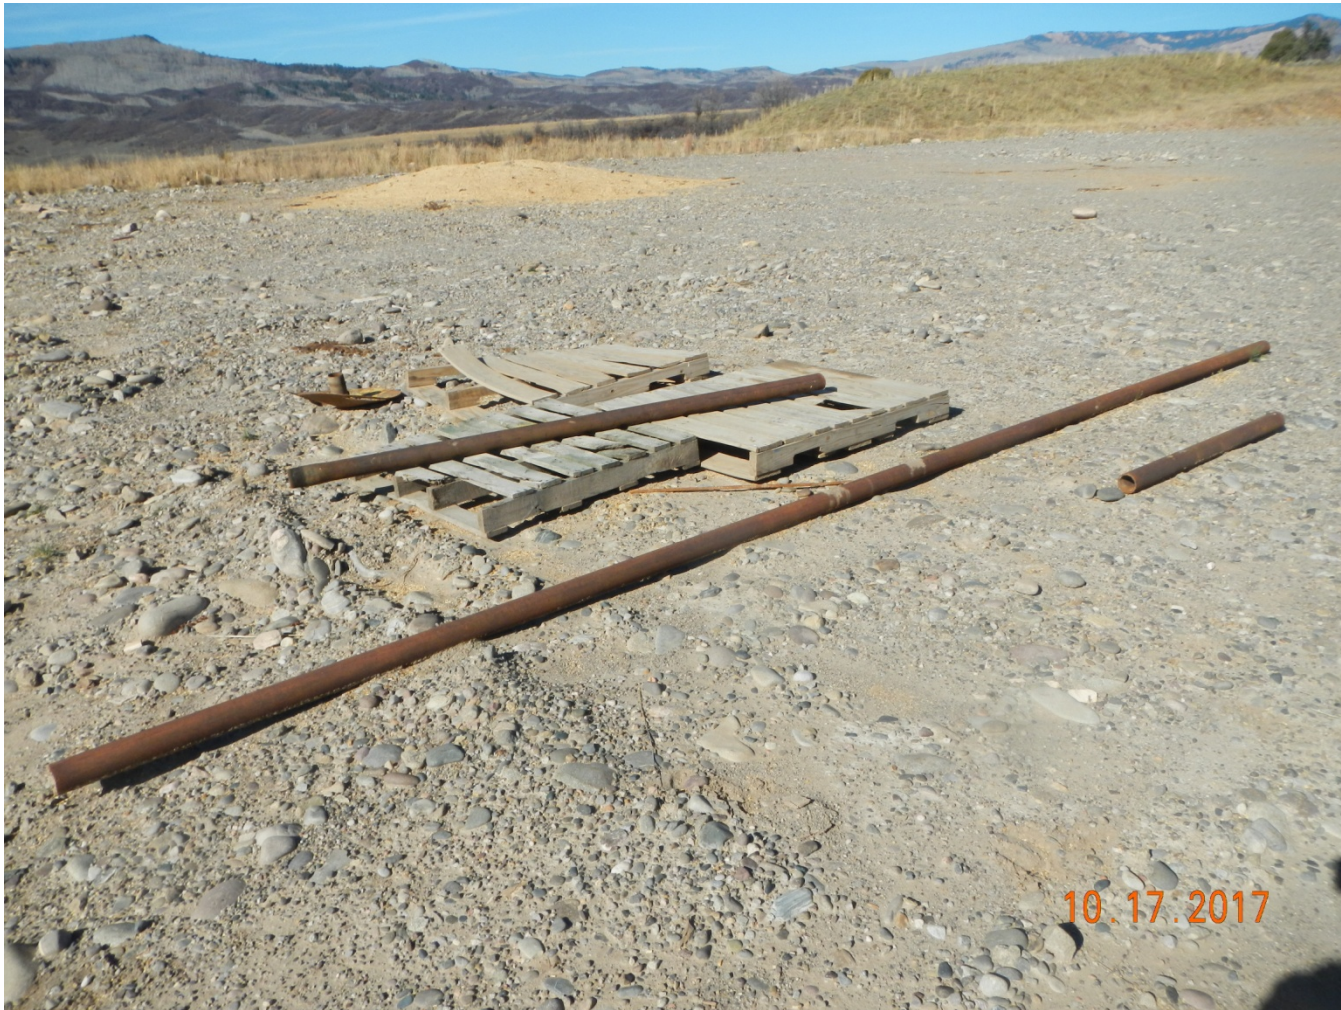
Photo 4. View of wood debris and unused pipes in the southern portion of the project area. These need to be removed.

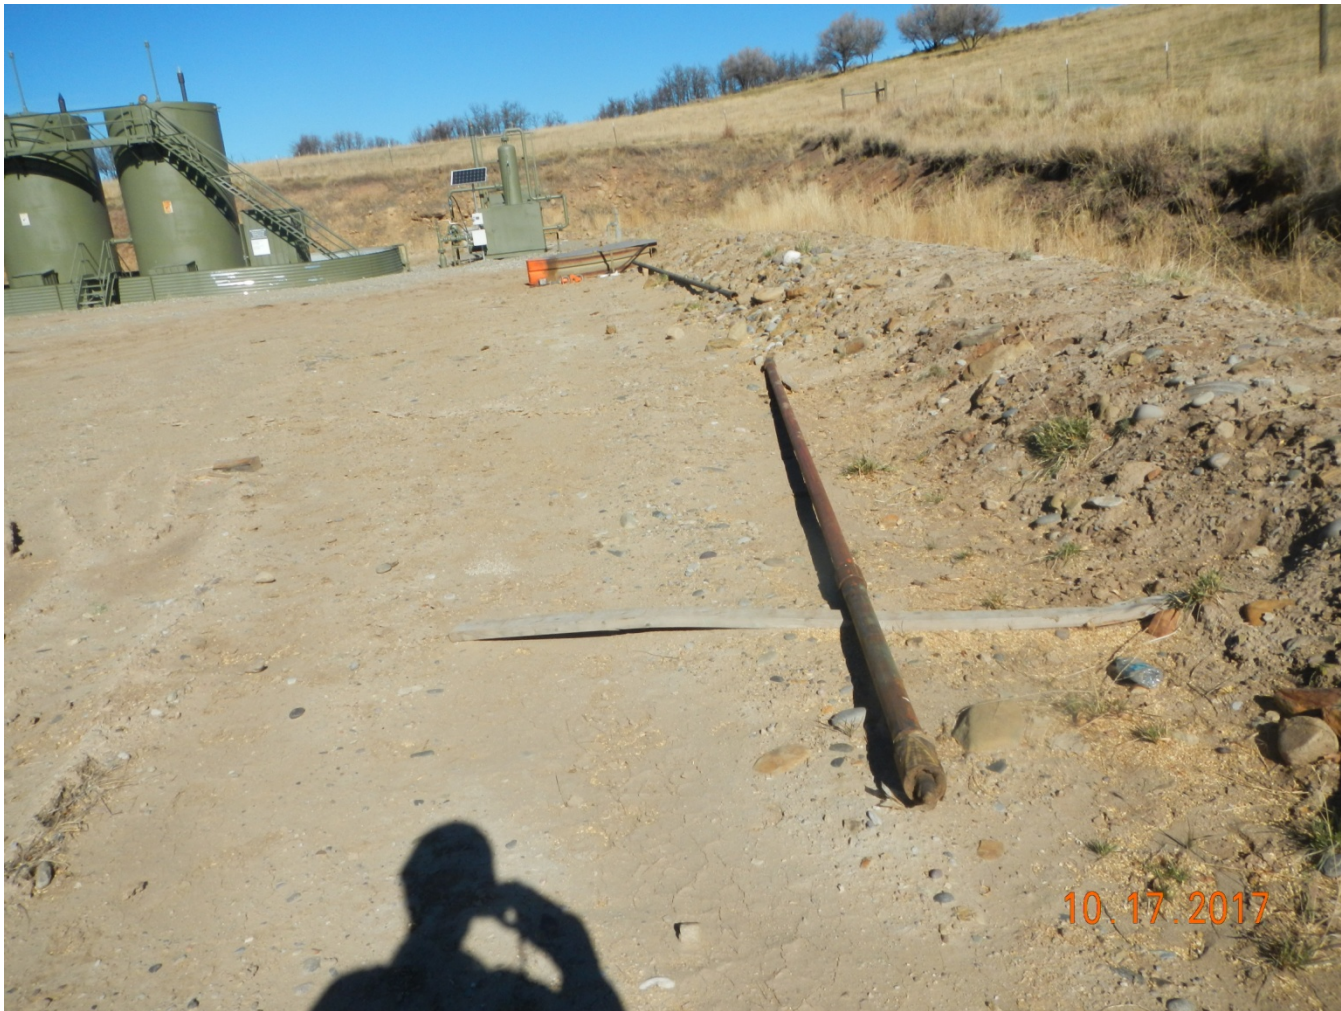
Photo 5. View of the eastern edge of the project area from the southeastern edge facing northward. Unused pipes and pump jack parts as well as small debris are present in this portion of the project area. These need to be removed.

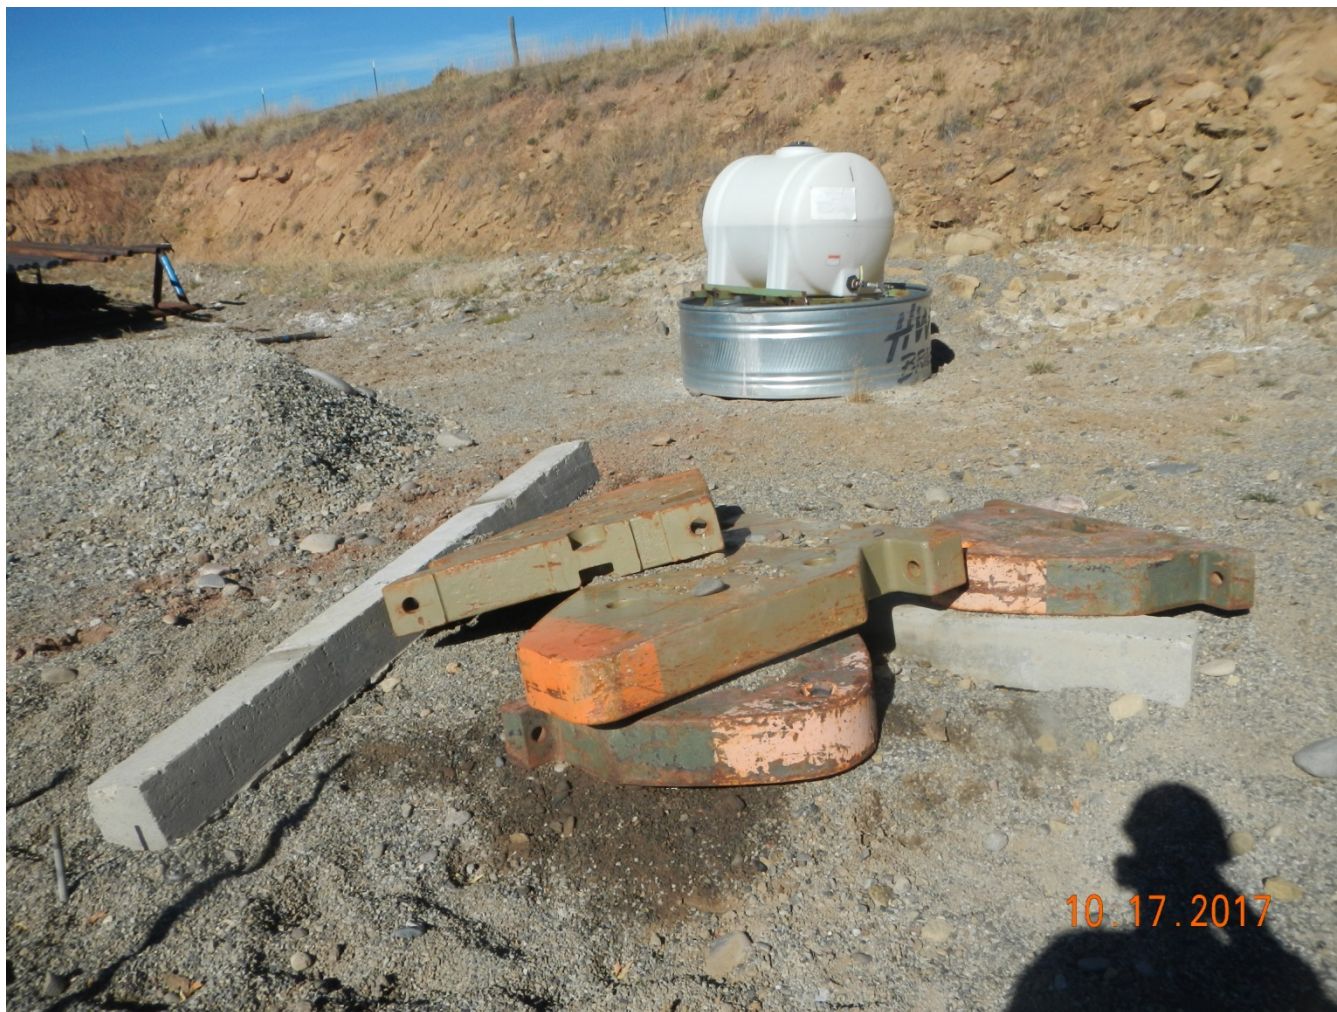
Photo 6. View of unused chemical tank, pump jack parts, cement debris, and what appears to be oil stained soils in the northern portion of the project area. These need to be removed, and stained soils remediated or properly disposed of.

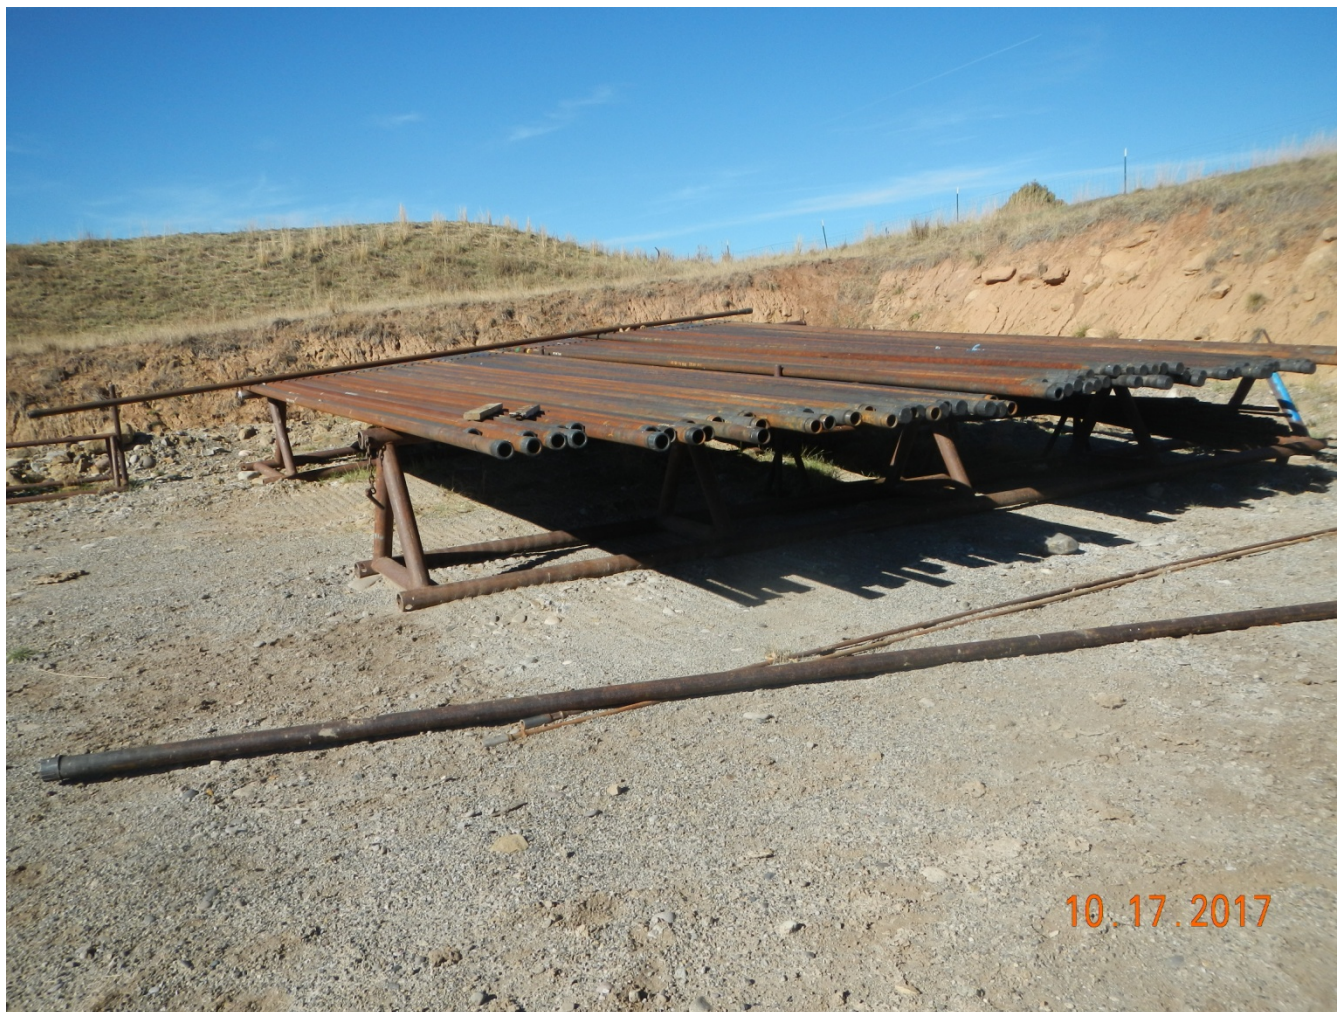
Photo 7. View of unused pipes stored in the northwestern portion of the project area. These need to be removed.
