## Inspection Photos

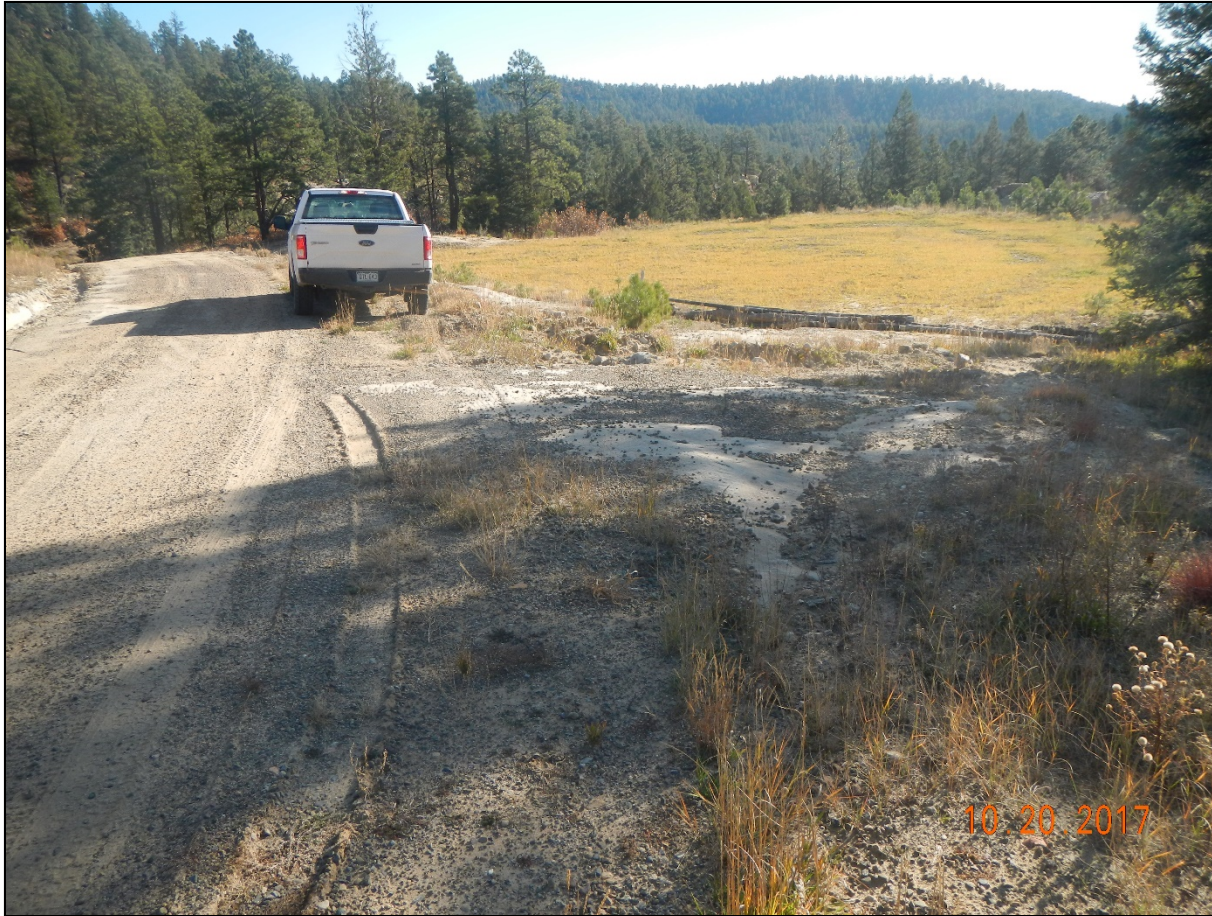
**Photo 1.** Facing northeast toward the location and main road that is used to access active well sites.

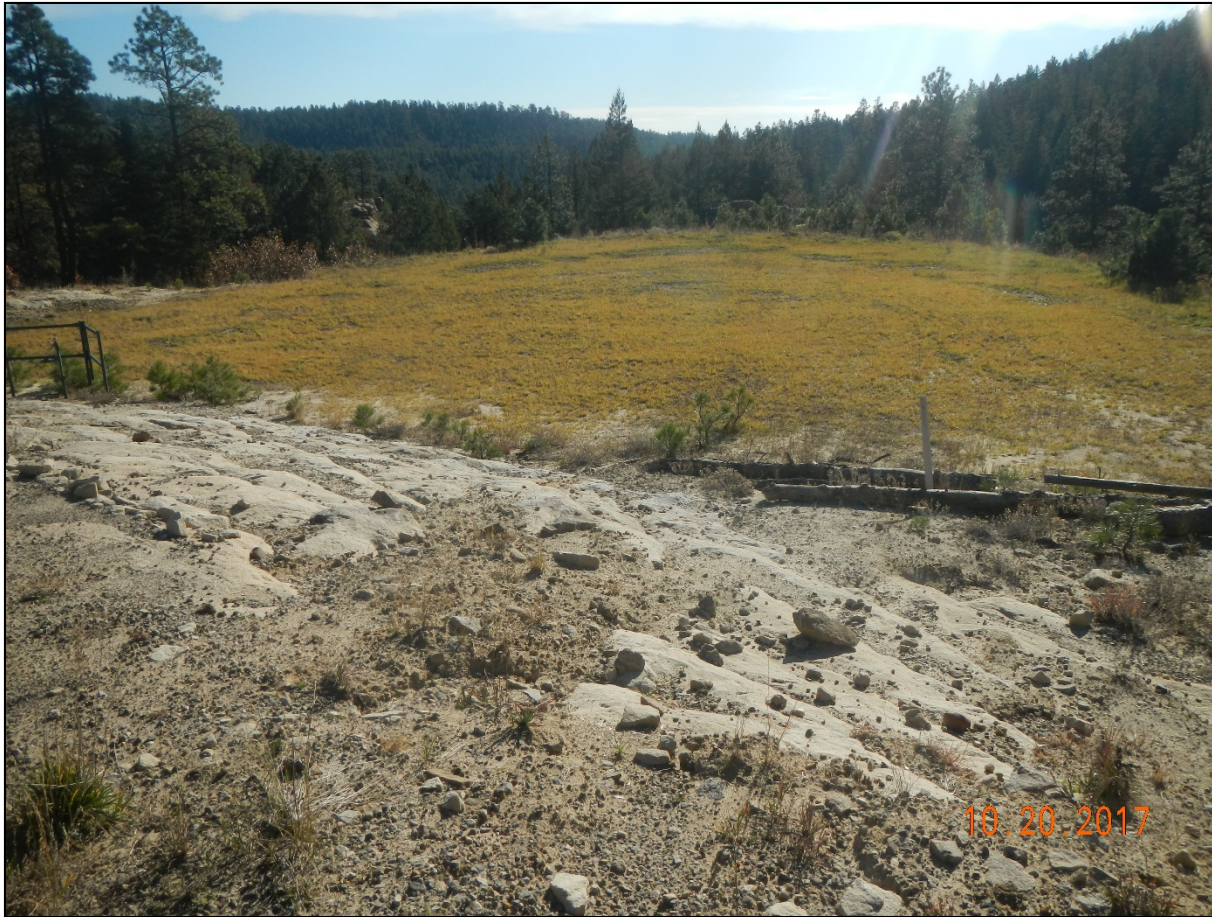
**Photo 2.** Facing east toward the location.

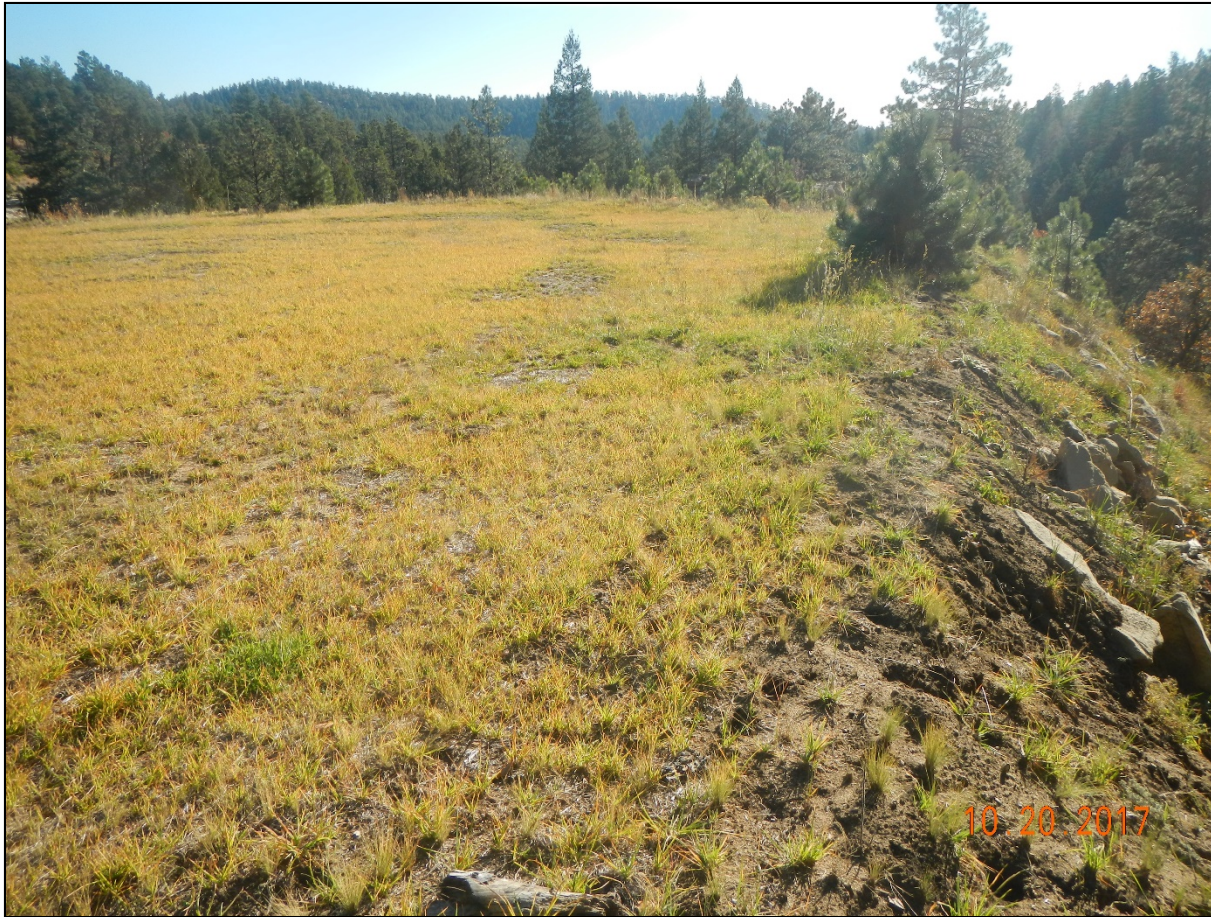
**Photo 3.** Facing east along the south fill slope.

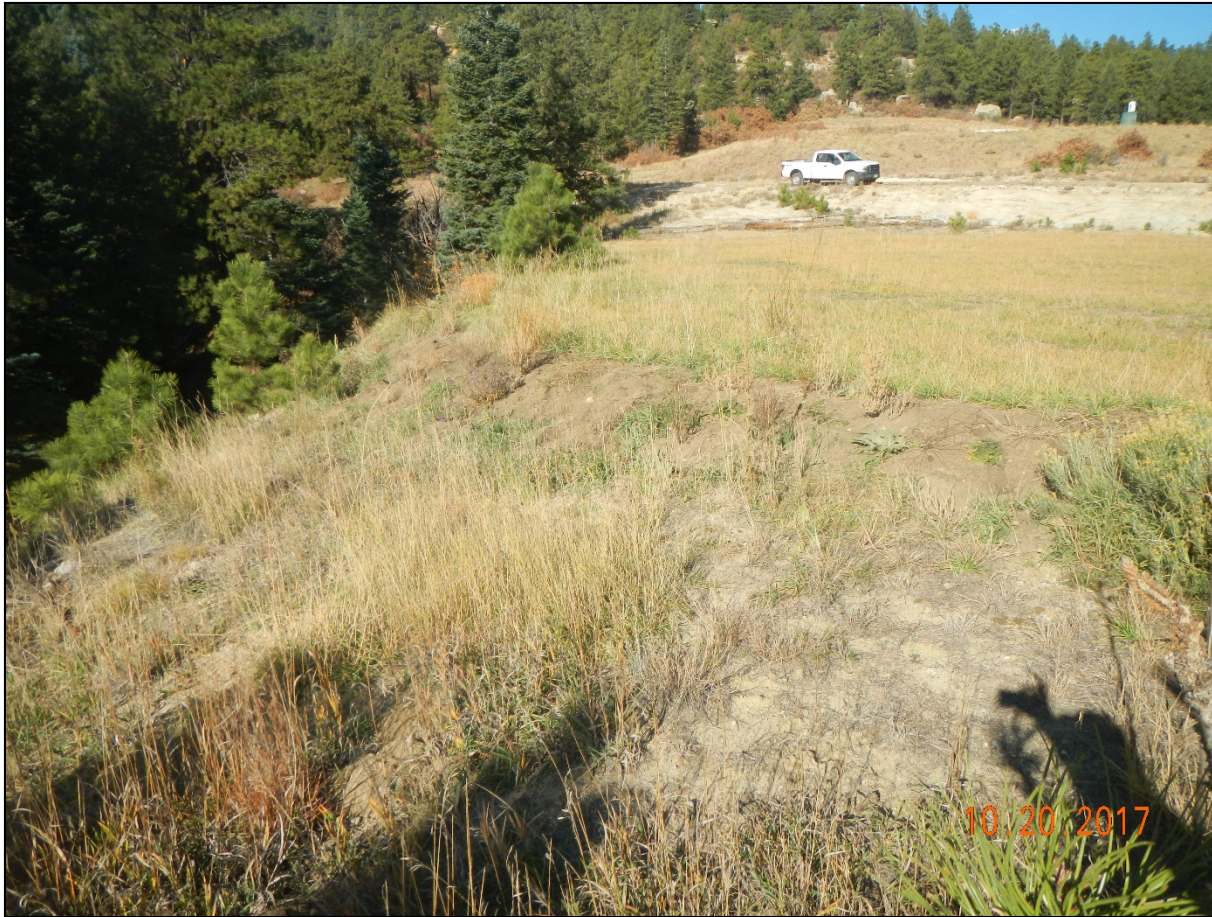
**Photo 4.** East side of the location facing west.

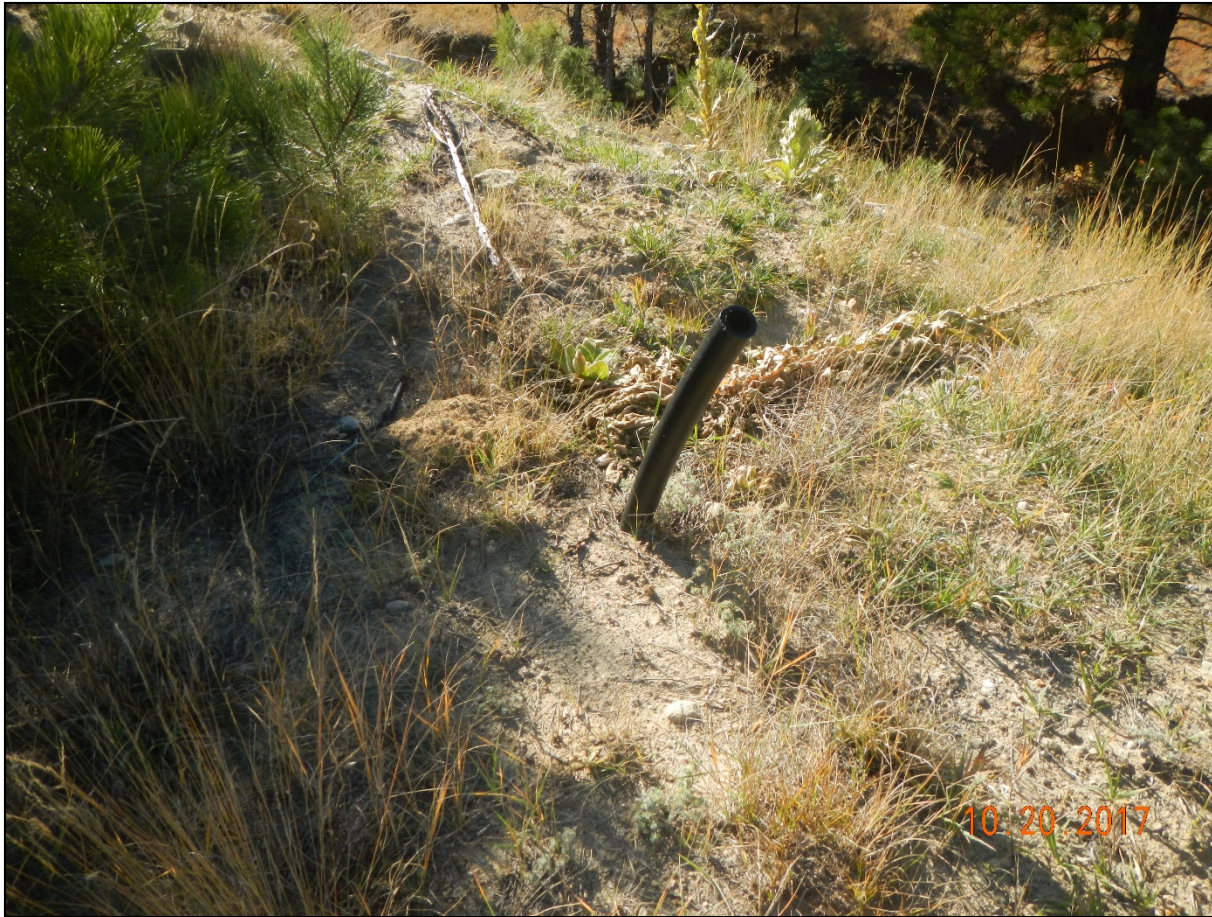
**Photo 5.** There is plastic pipe at the southeast corner of the location.

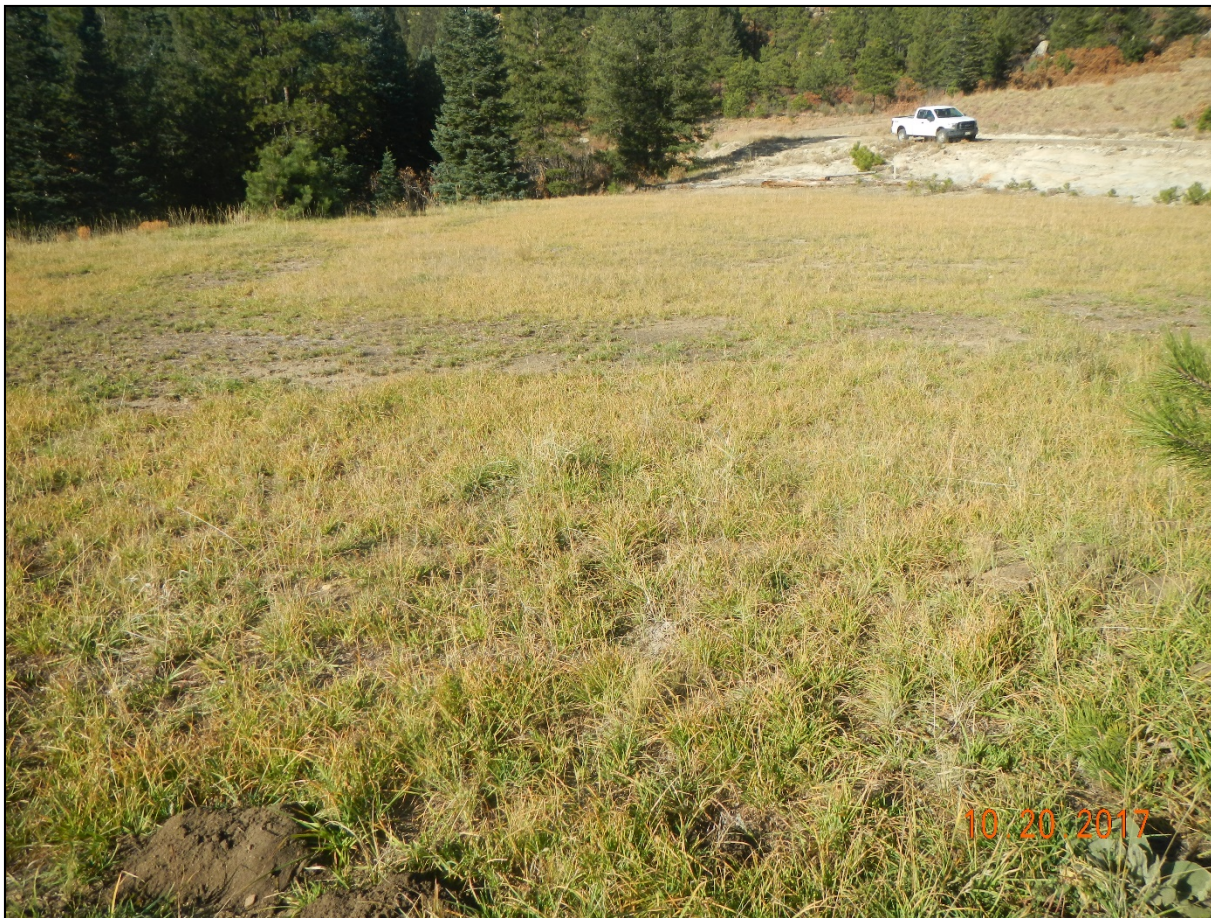
**Photo 6.** Facing southwest at the location.

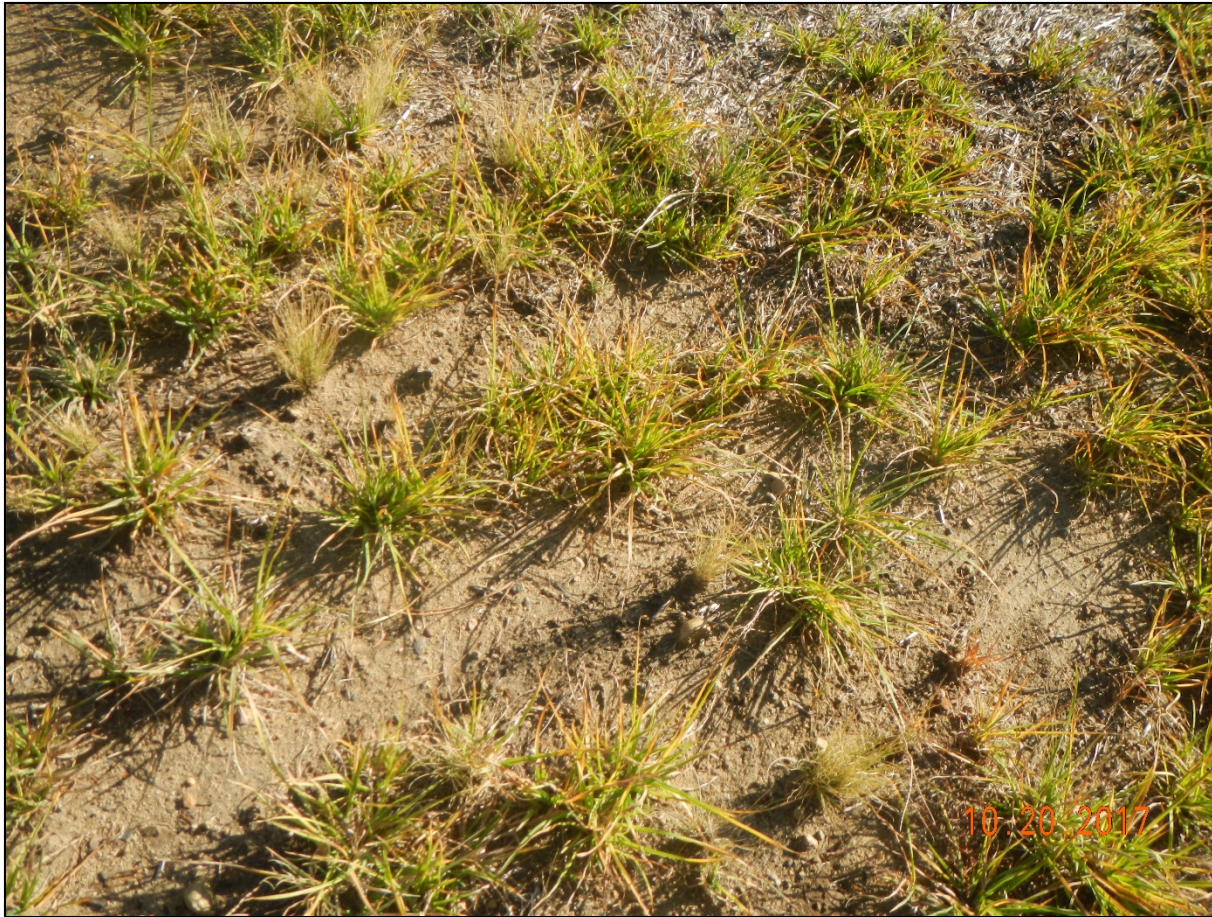
**Photo 7.** View of groundcover at the location. There was no gravel observed and vegetation appears to be establishing.

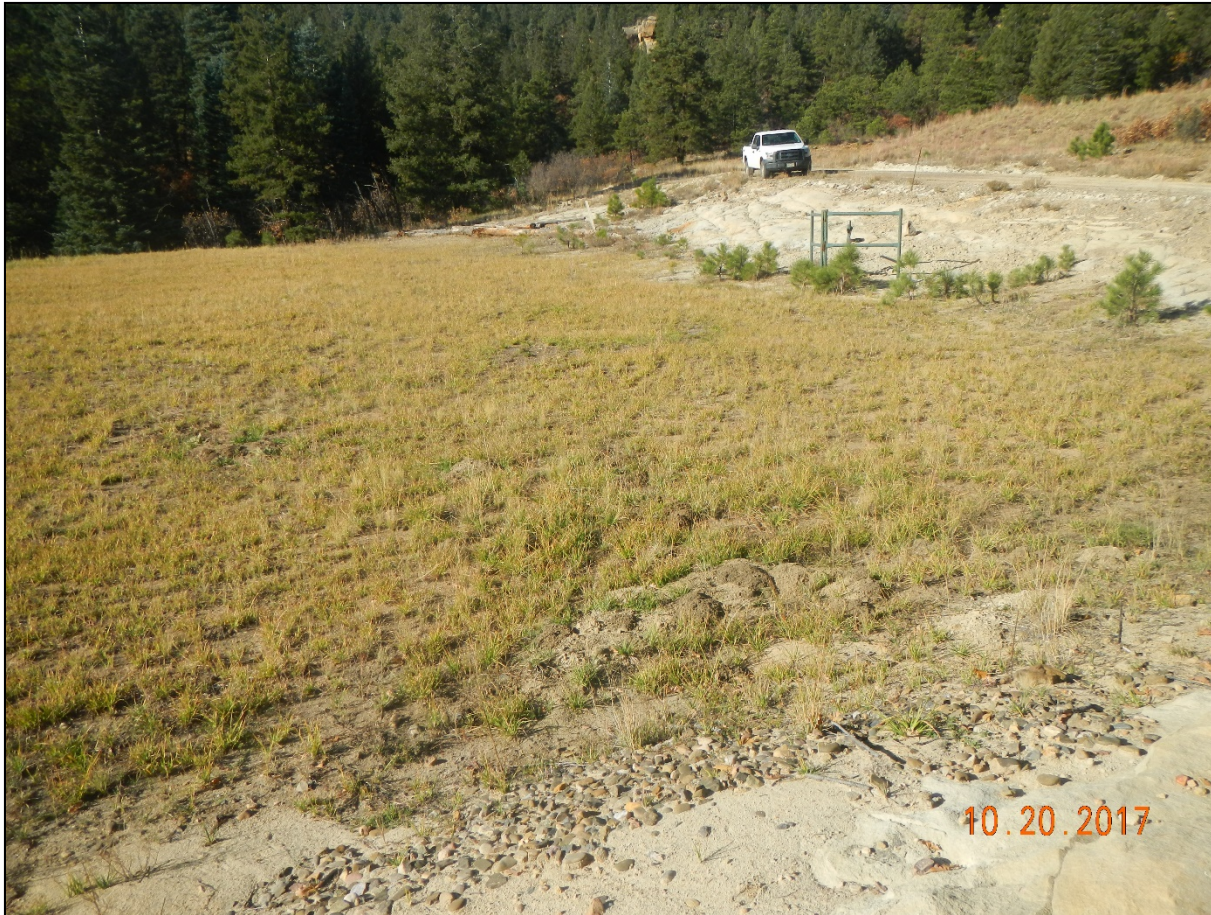
**Photo 8.** North side of the location facing southwest.

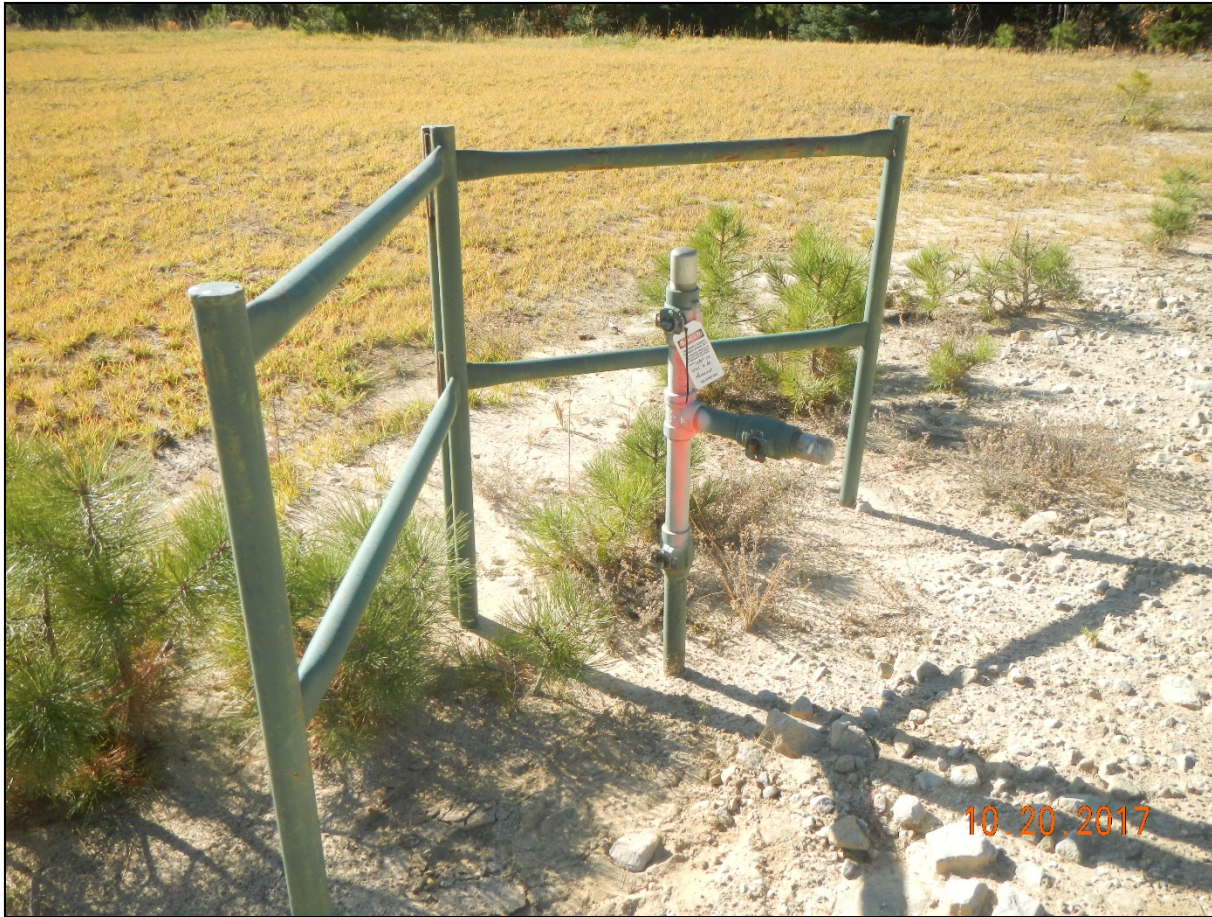
**Photo 9.** There is a pipe riser that remains at the east side of the location which appears to be marked for removal.

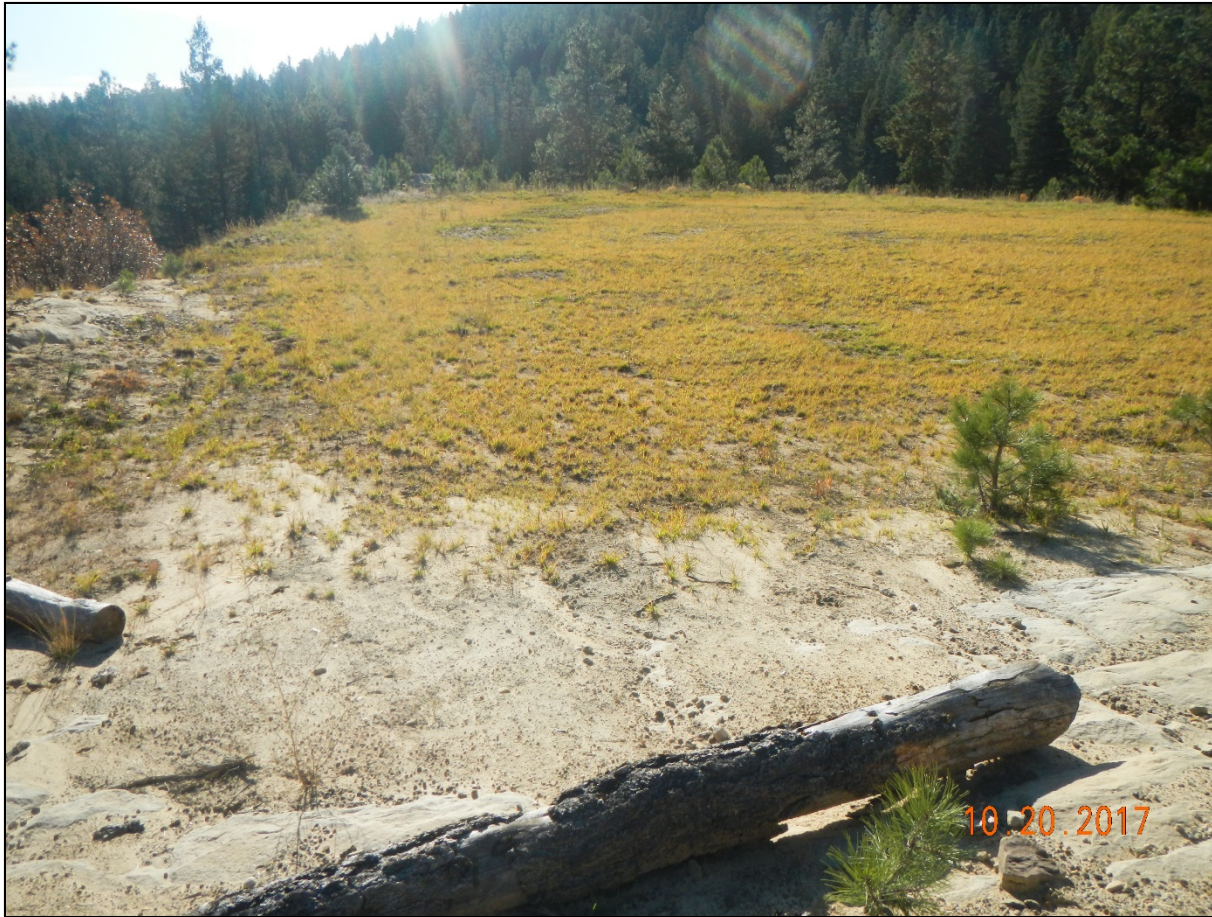
**Photo 10.** Facing southeast at the location.
