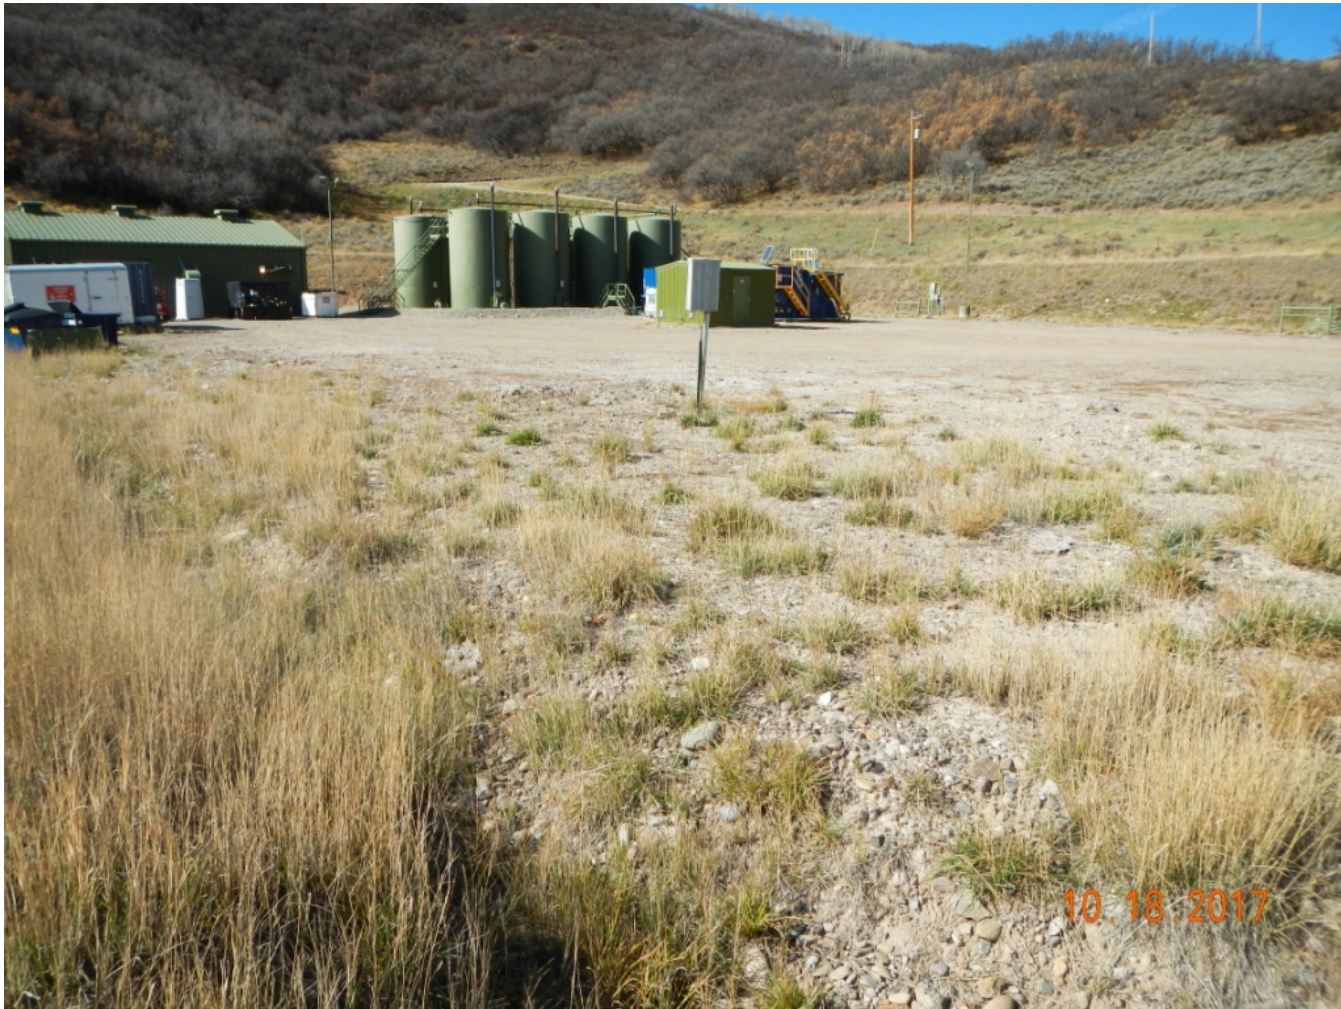
Photo 1. View of the project area from the southeastern corner of the working area facing center.

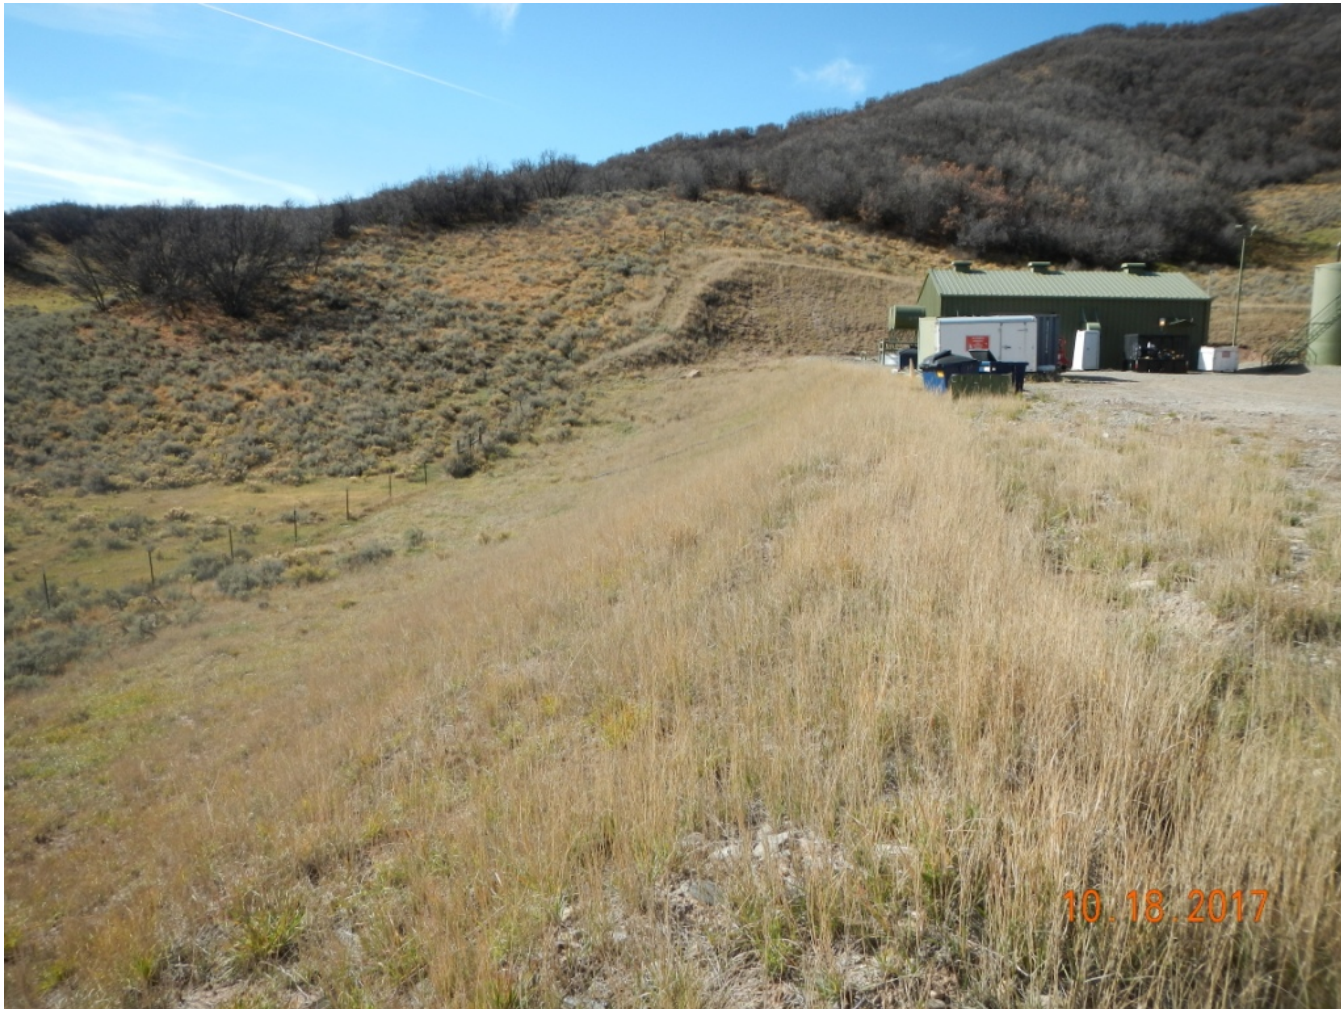
Photo 2. View of the southern portion of the project area from the southwestern corner of the working area facing southwestward. Revegetation is well established with grasses such as western wheatgrass (*Pascopyrum smithii*), and brome grass (*Bromus* sp.).

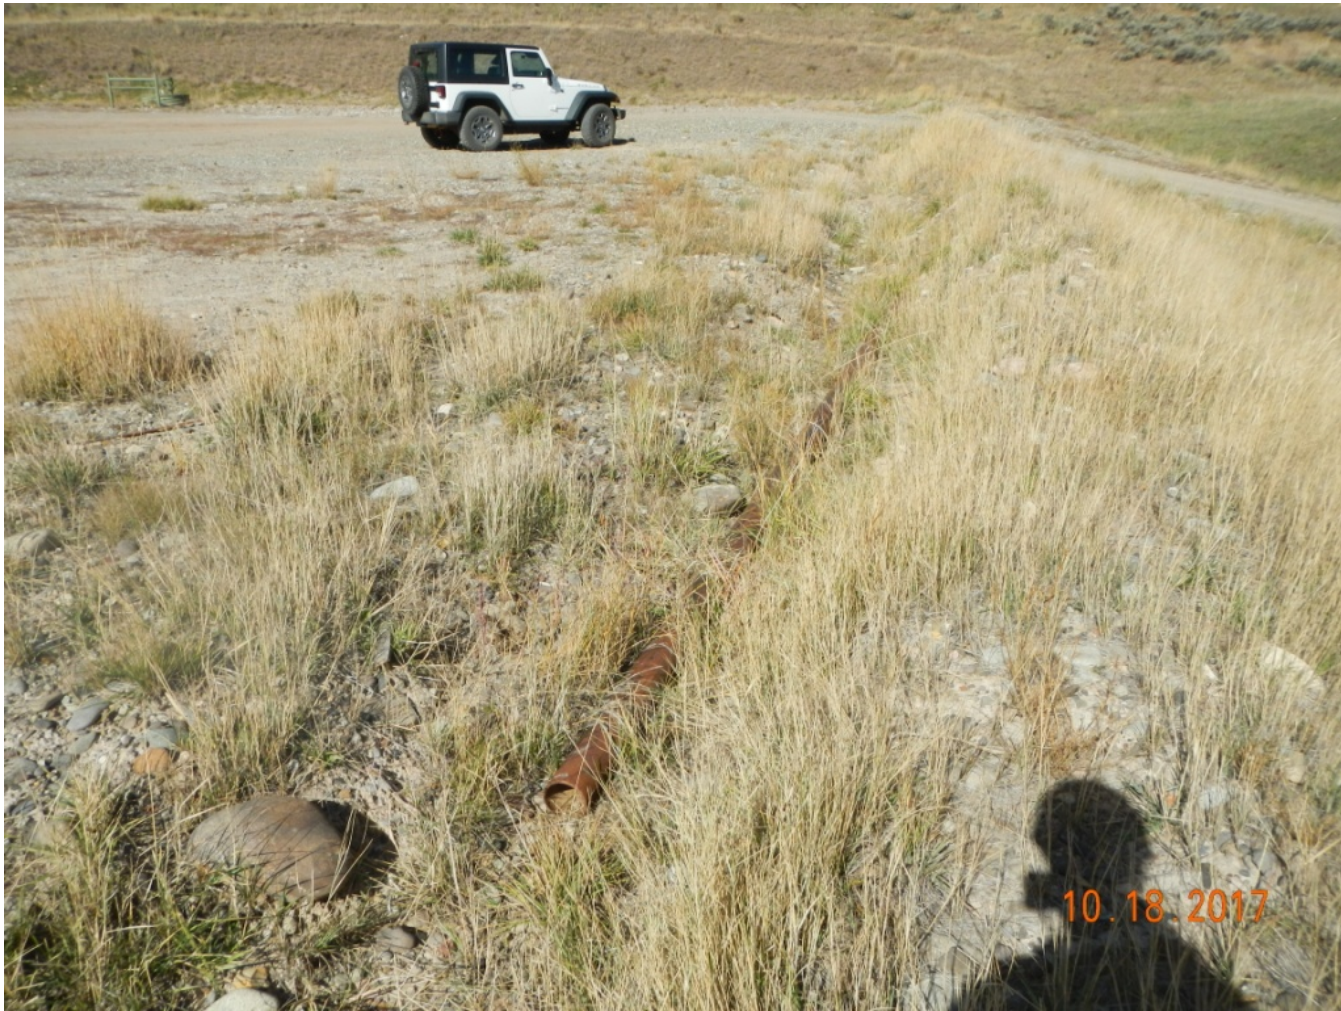
Photo 3. View of the eastern portion of the project area from the southeastern corner of the working area facing northward. Unused pipe needs to be removed and properly stored.

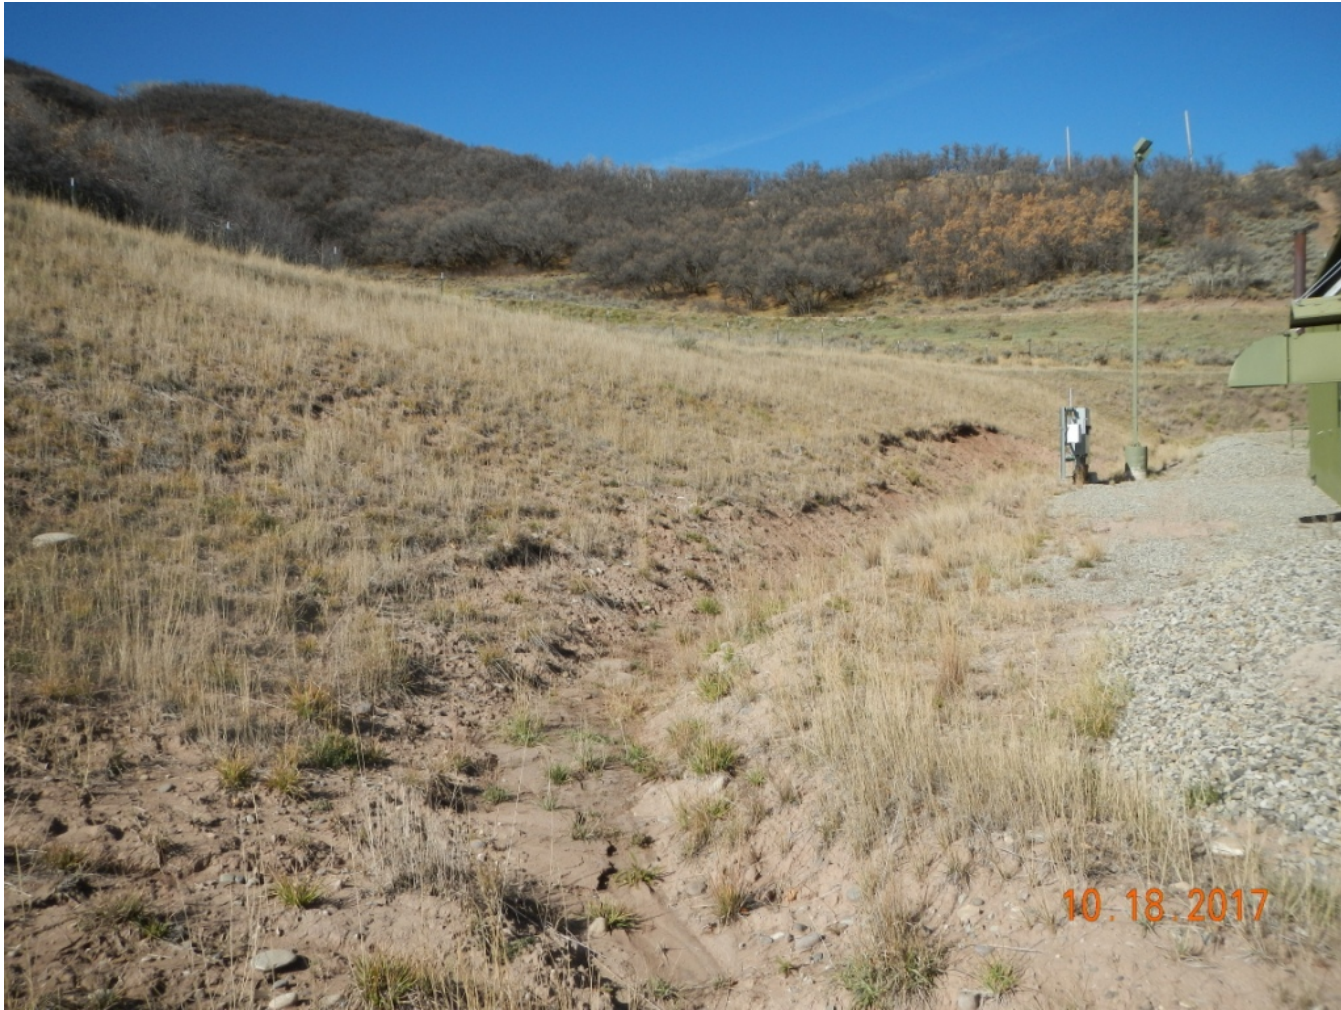
Photo 4. View of the western portion of the project area from the southwestern corner of the working area facing northward.

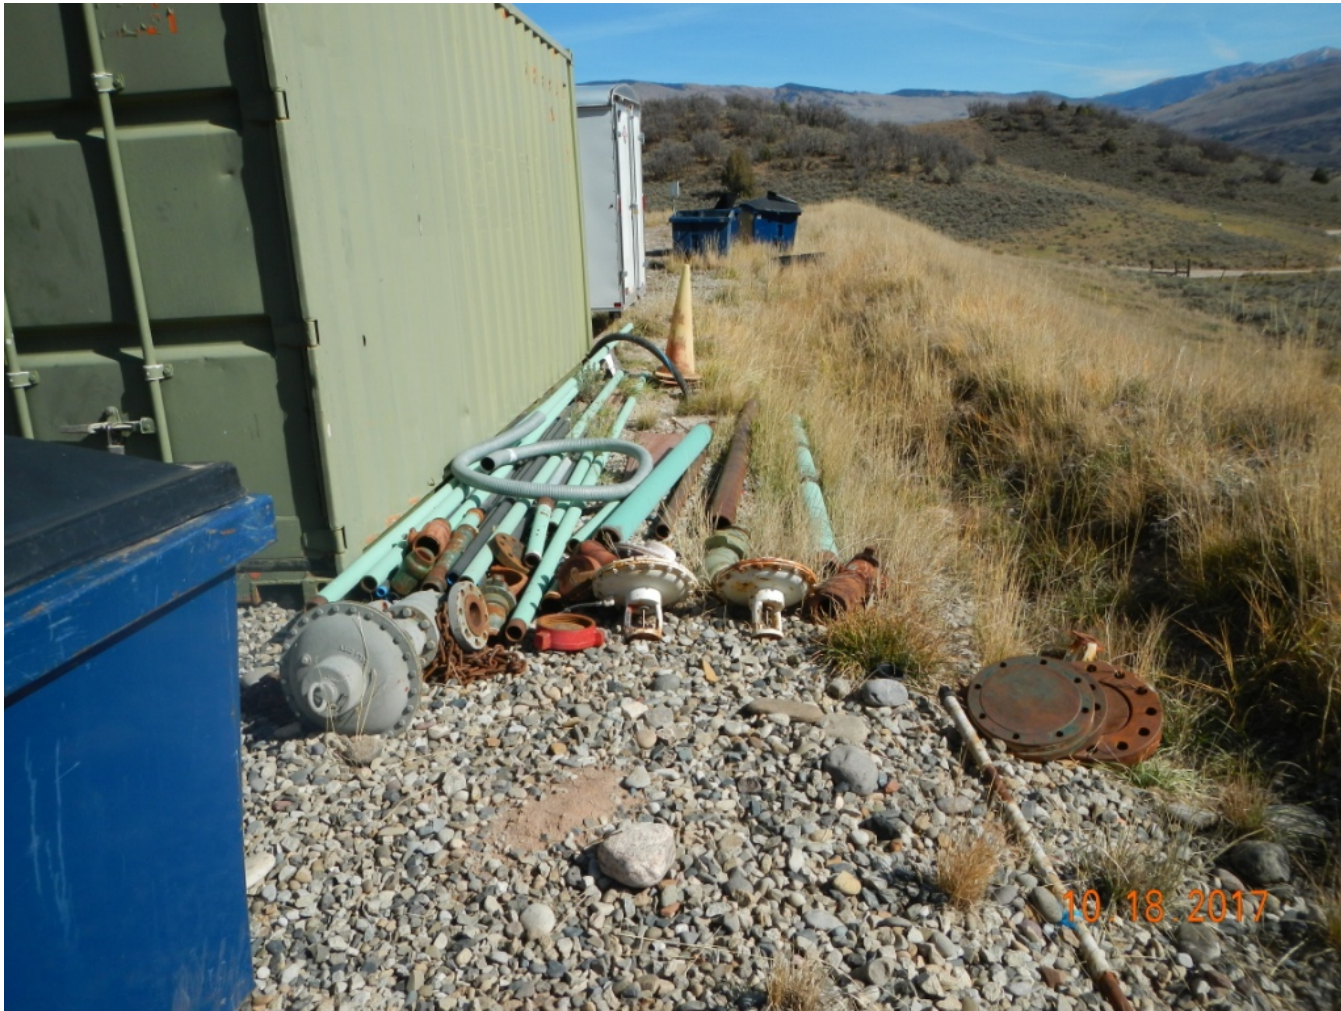
Photo 5. View of unused equipment stored in the southern portion of the project area.

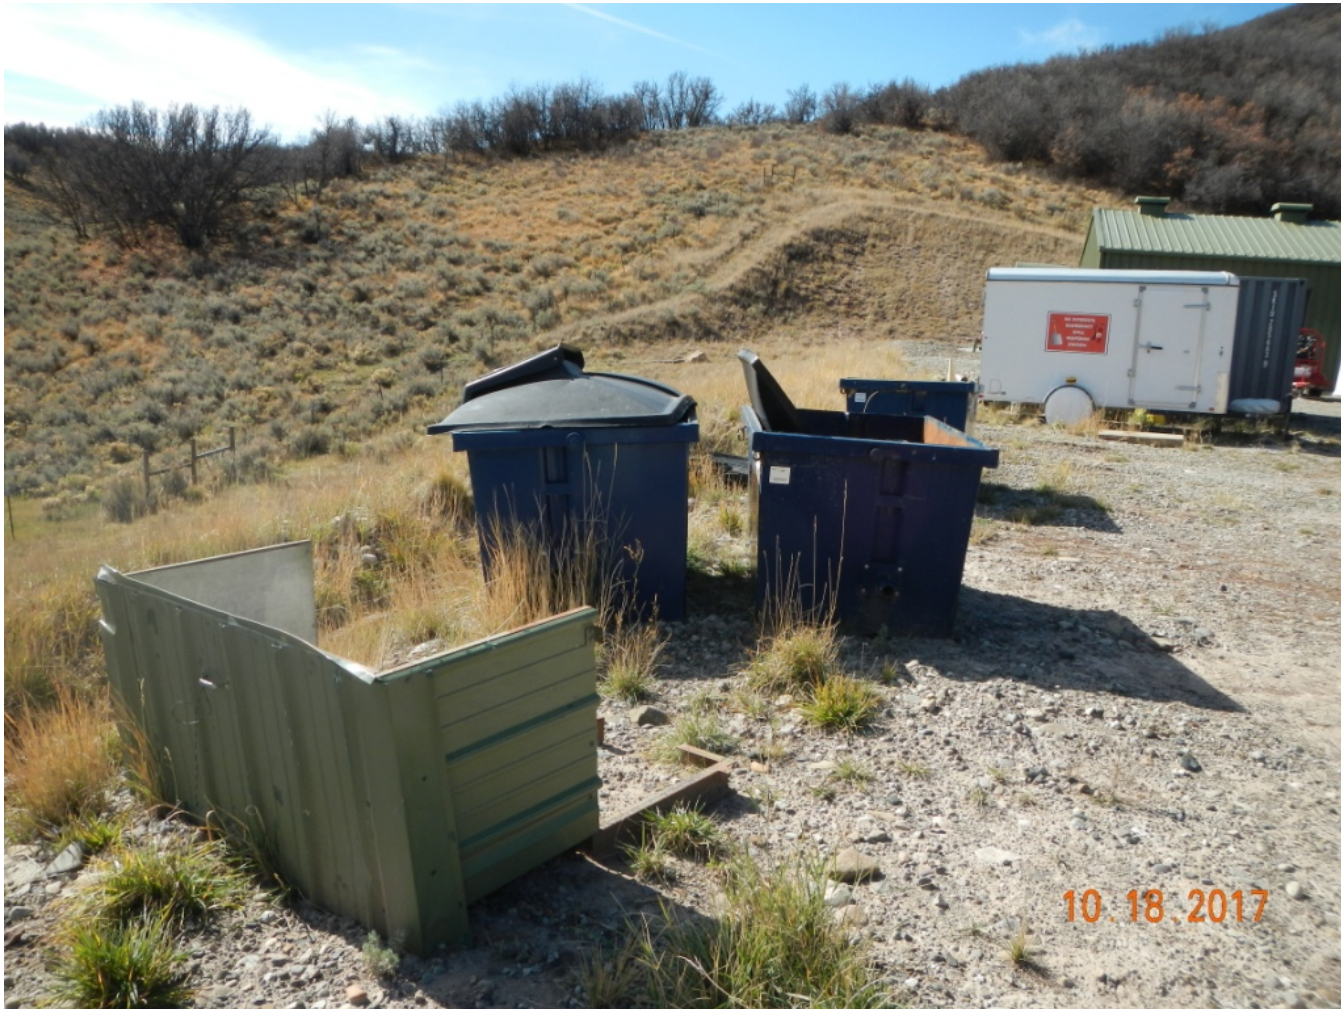
Photo 6. View of more unused equipment and debris in the southern portion of the project area.

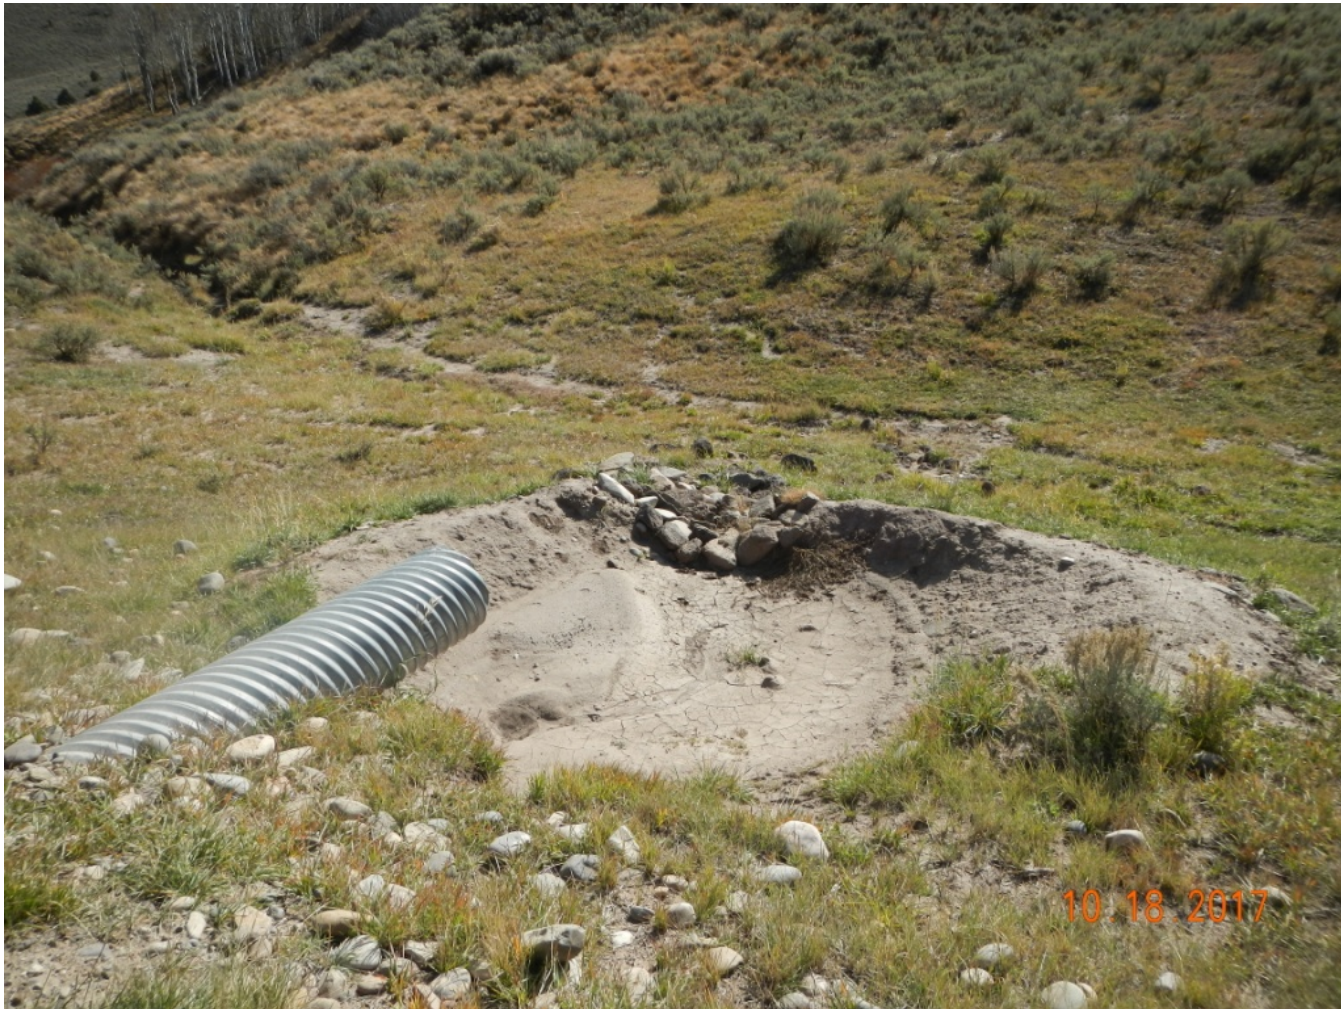
Photo 7. View of silt trap at culvert outlet along the access road.

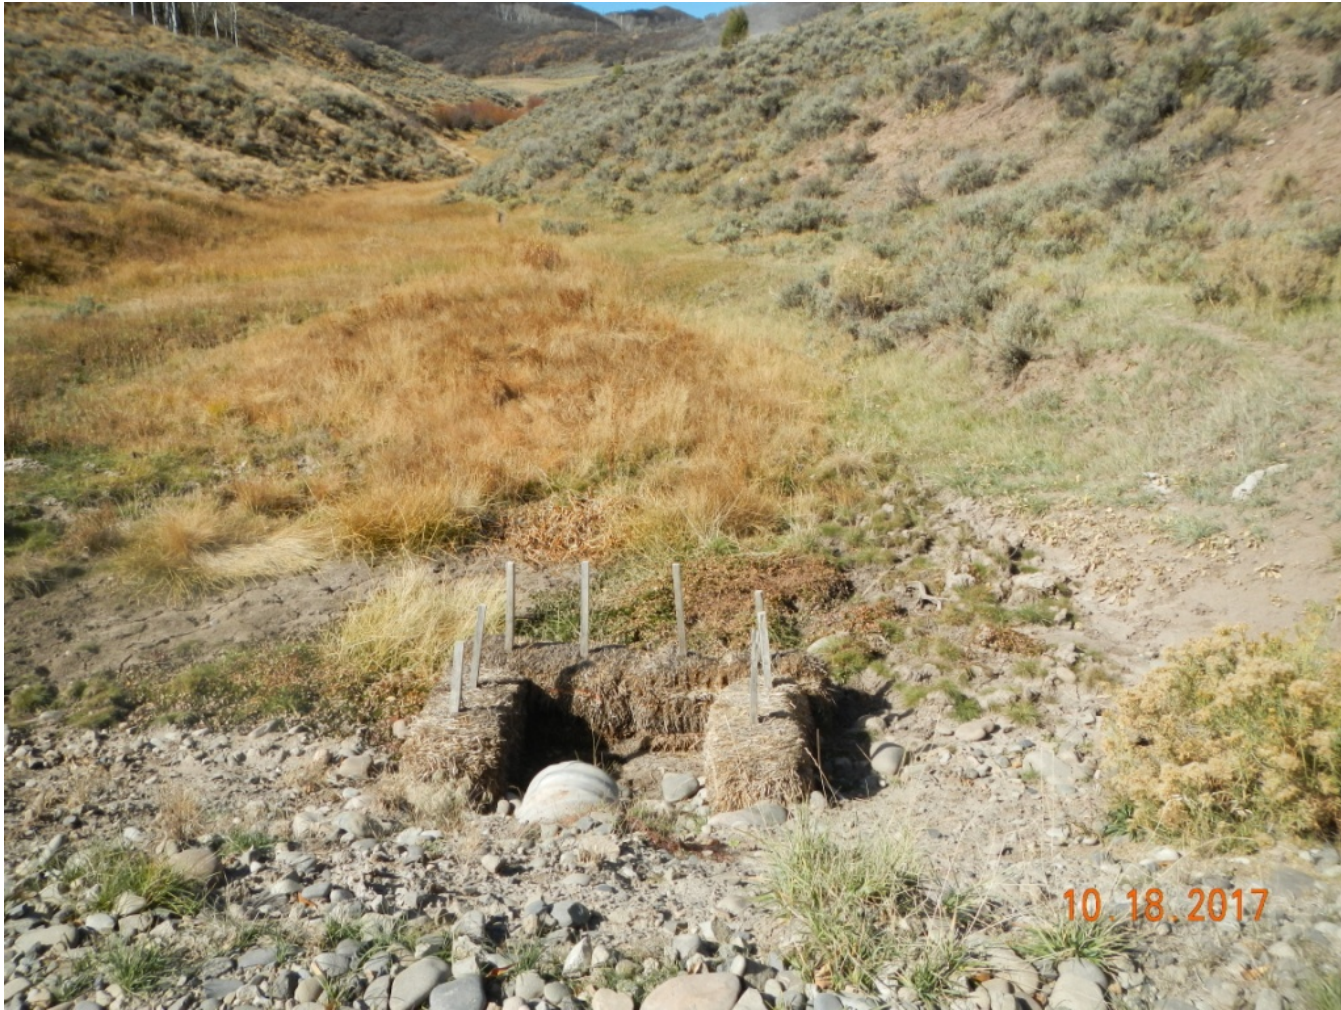
Photo 8. View of sediment controls at culvert at the lease road.
