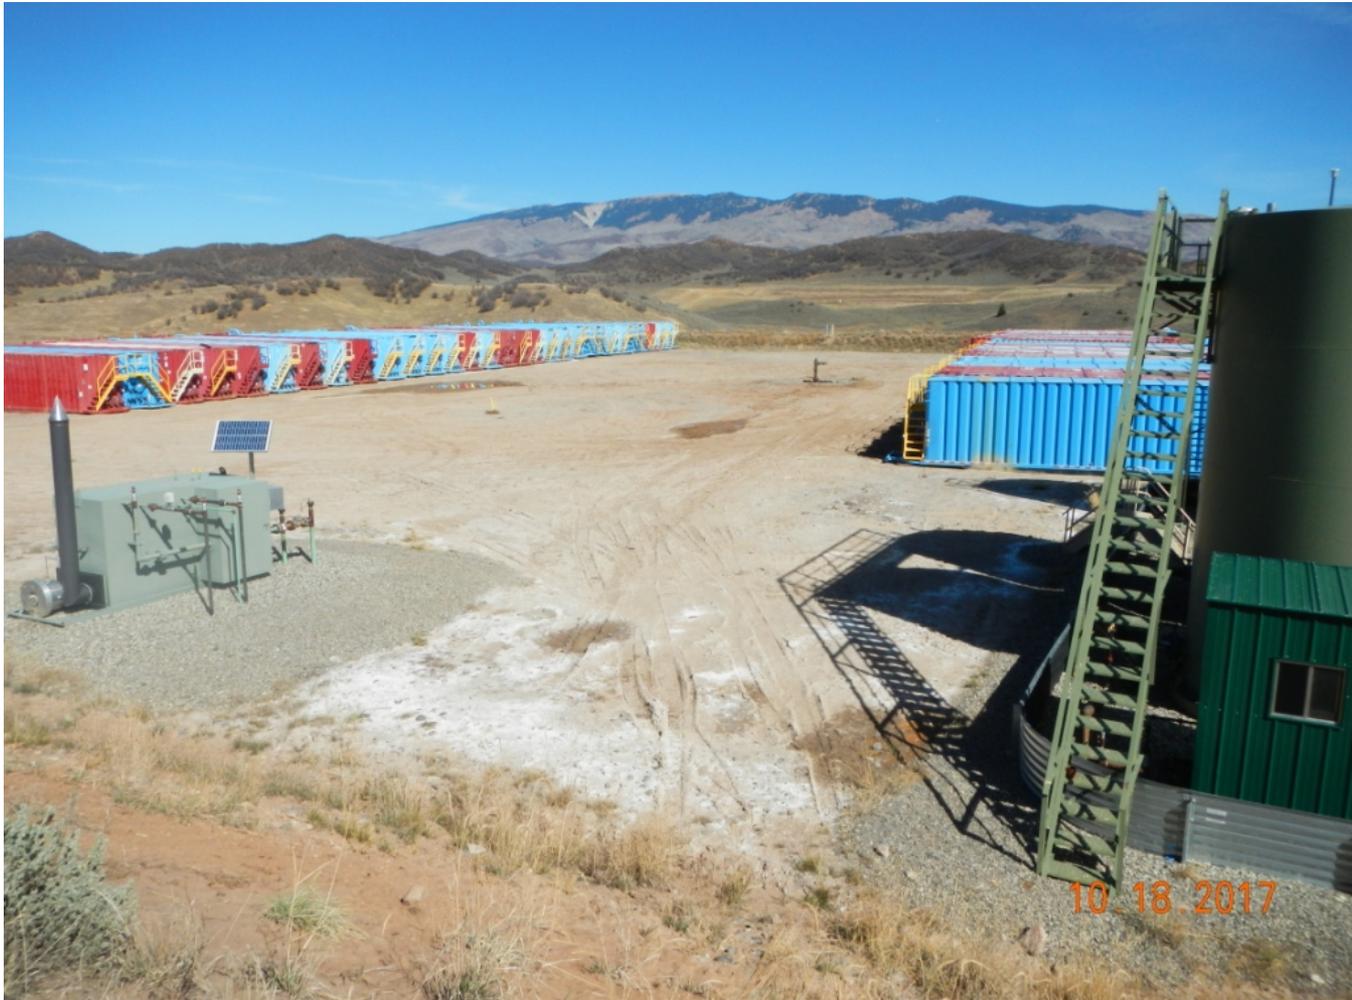
**Photo 1. View of the project area from the southern corner of the project area facing center. Frac tanks are stored on location.**

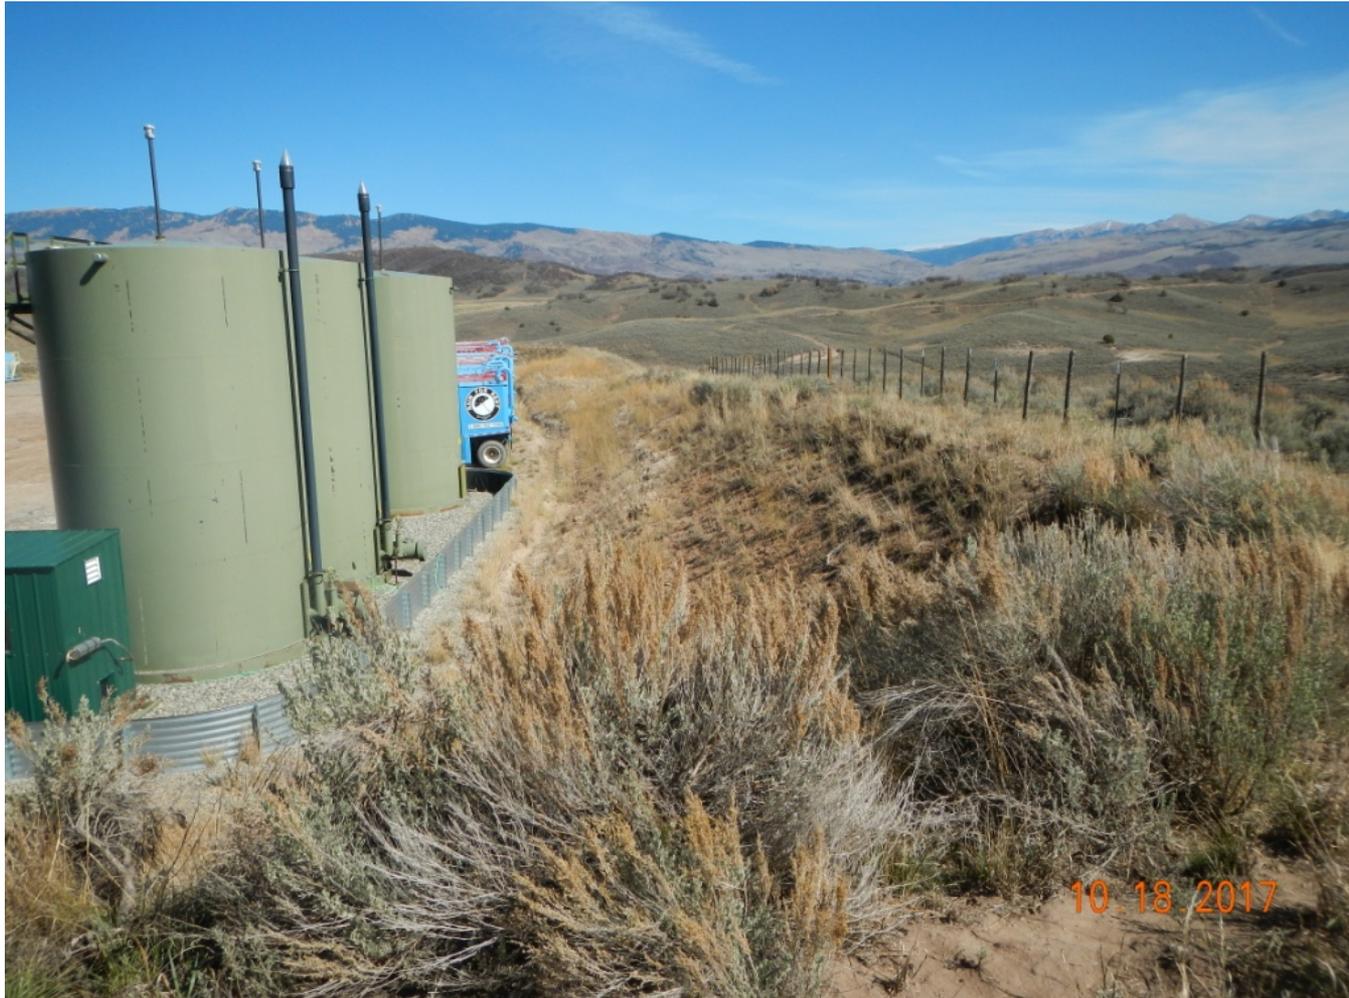
**Photo 2. View of the eastern portion of the project area from the southern corner facing northeastward. Revegetation in the outer portions of the project disturbance is well established with grasses and shrubs such as western wheatgrass (*Pascopyrum smithii*), giant squirreltail (*Elymus multisetus*), and big sagebrush (*Artemisia tridentata*).**

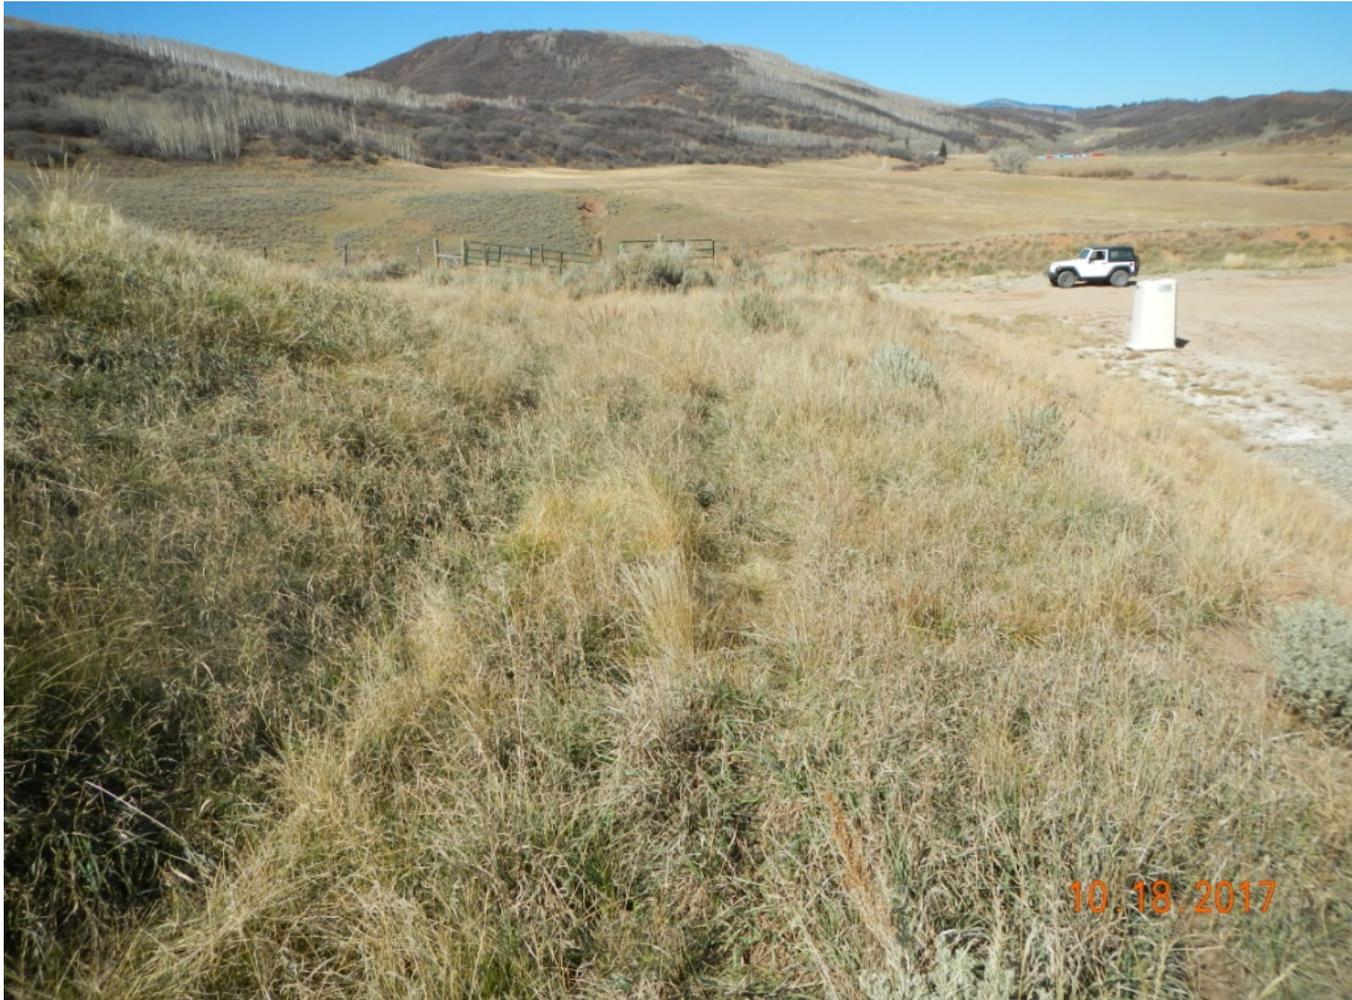
**Photo 3. View of the southern portion of the project area from the southern corner facing northwestward.**

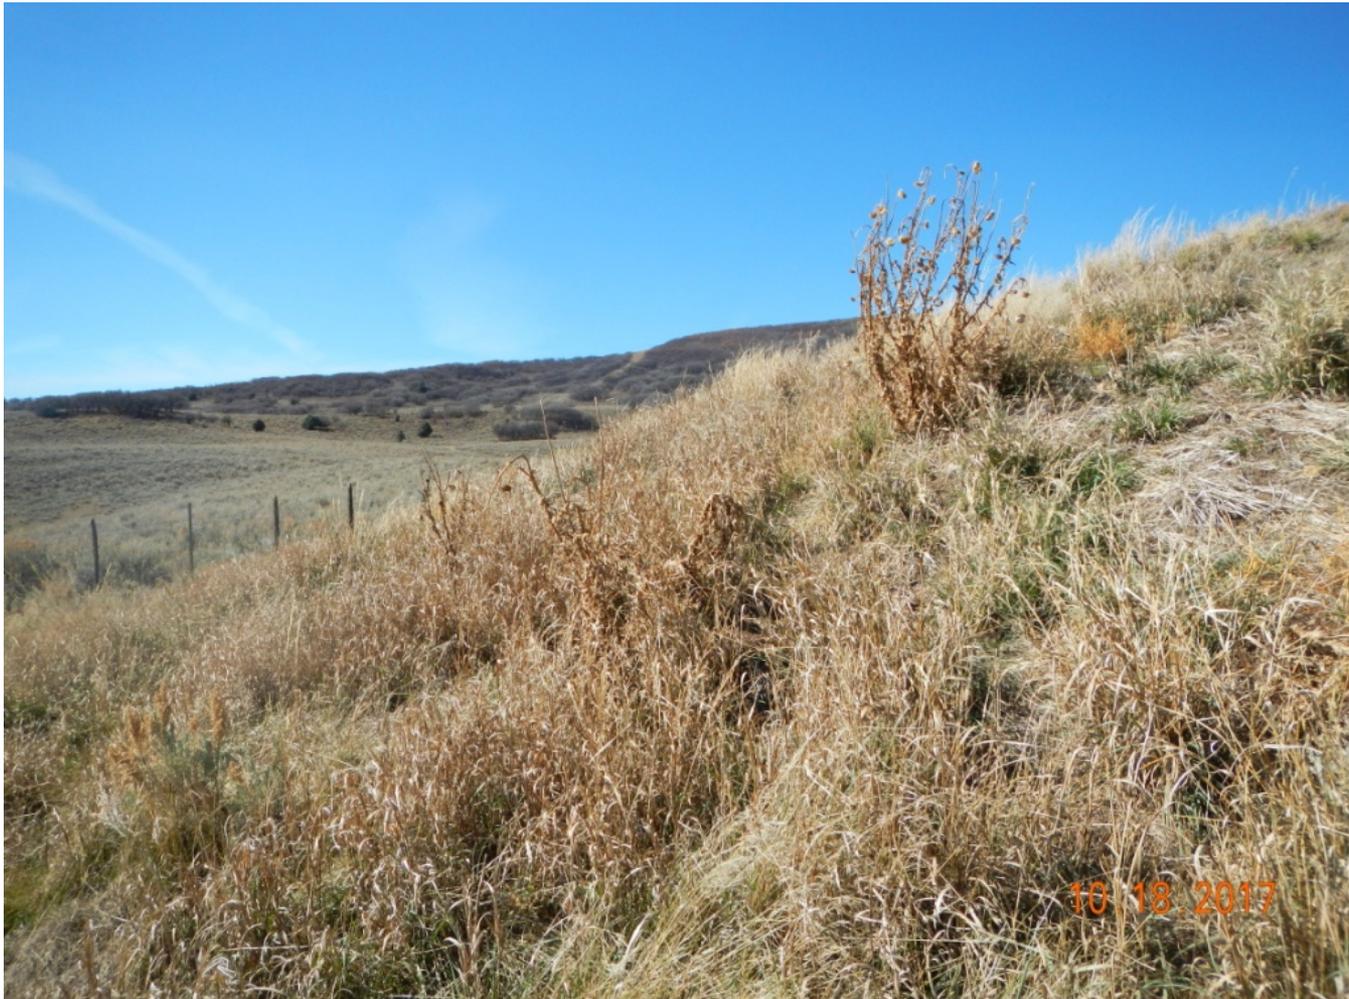
**Photo 4. View of musk thistles (*Carduus nutans*) that have flowered in the southern portion of the project area. Approximately 100 thistles were observed within the outer revegetation areas.**

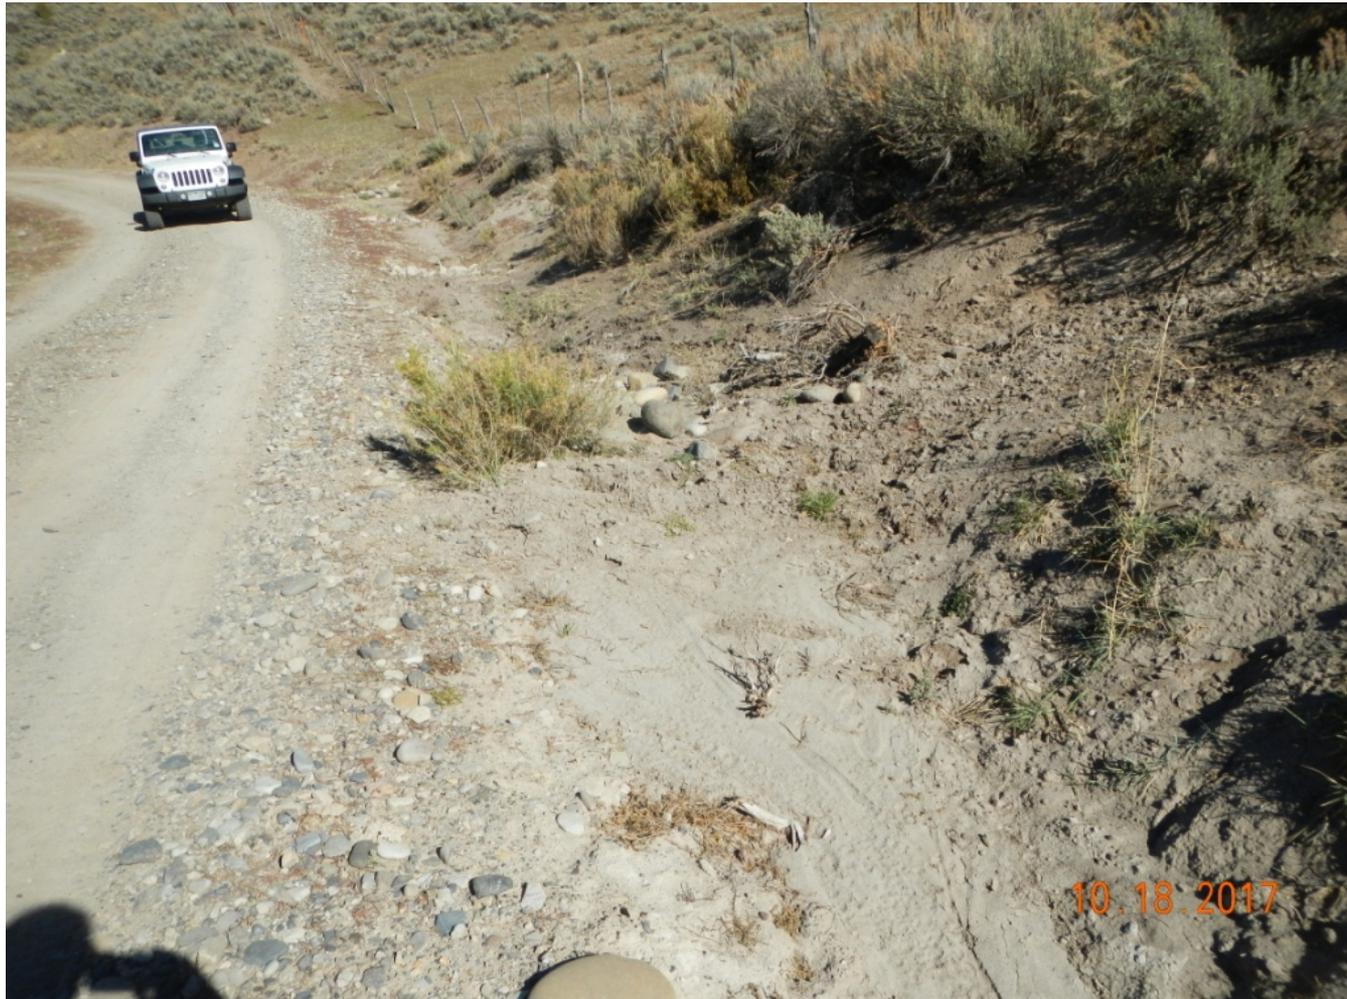
**Photo 5. View of rock check dams along the access road that are full of sediment and need maintenance.**

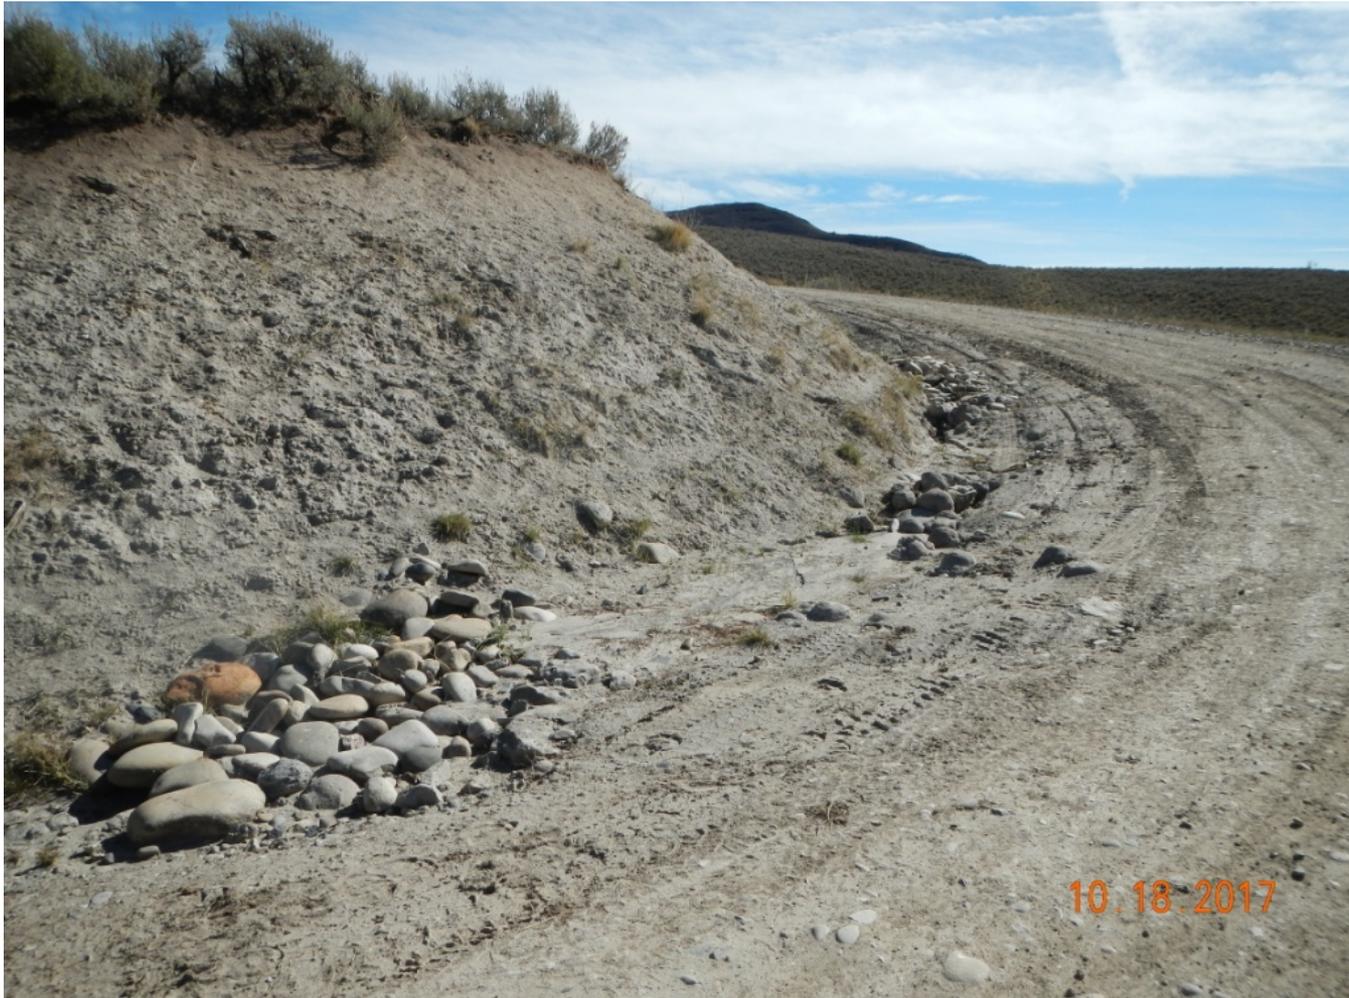
**Photo 6. Another view of sediment filled rock check dams along the access road.**

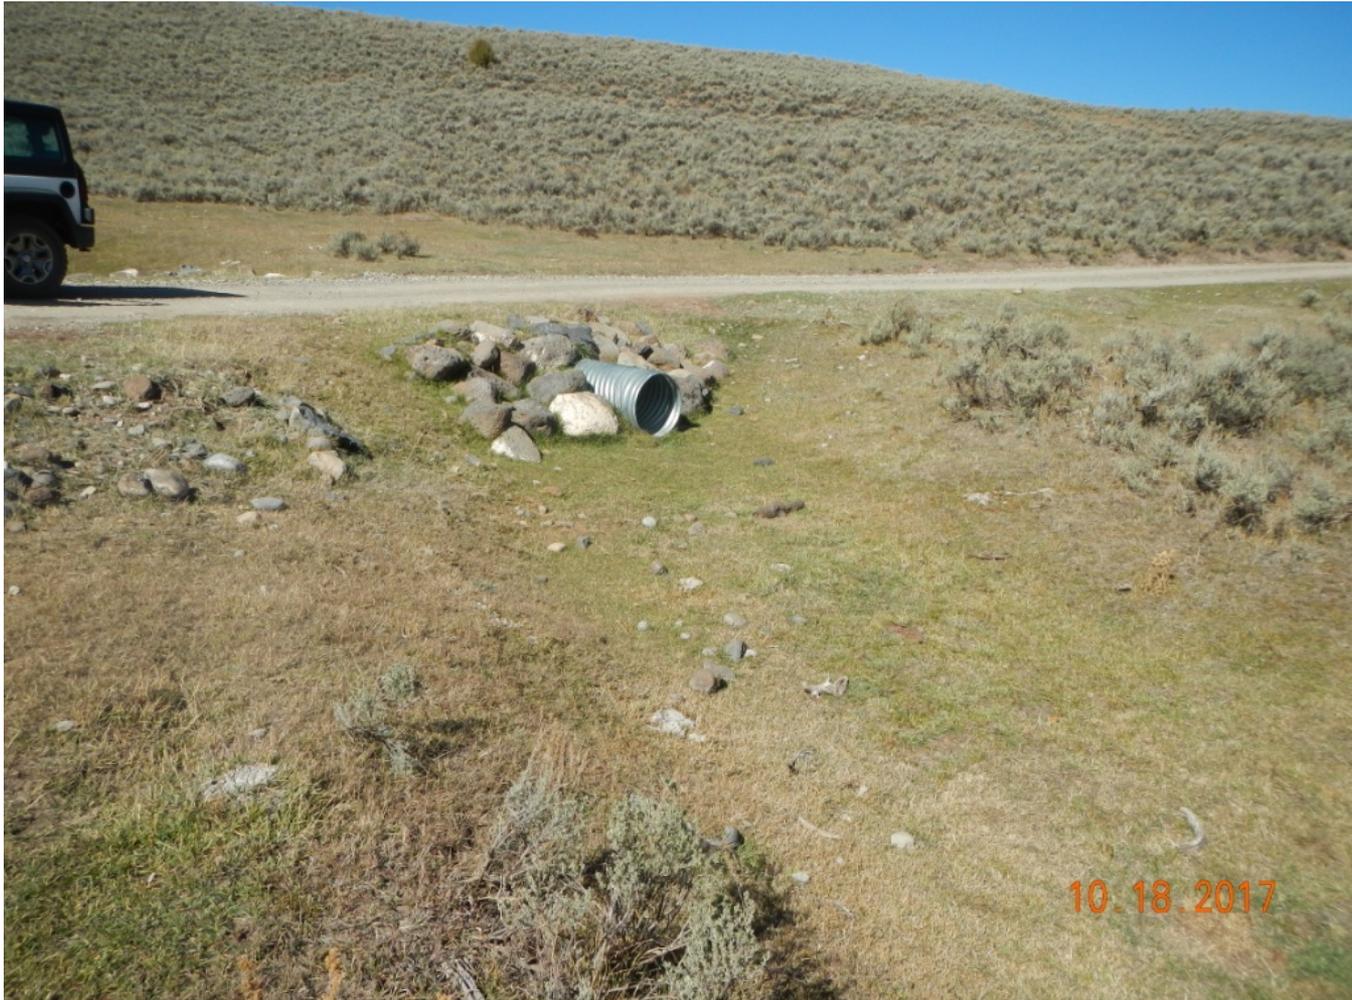
**Photo 7. View of culvert along the access road that is in good condition.**
