Inspection Photos
Location Name: Hendershot #1
API: 05-123-05210

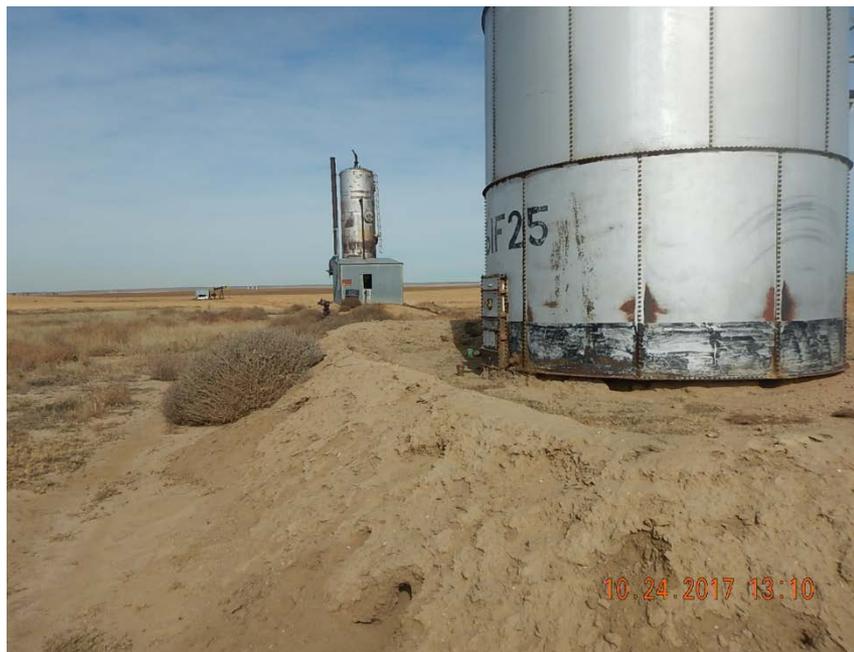
Photo 1: Location, looking N

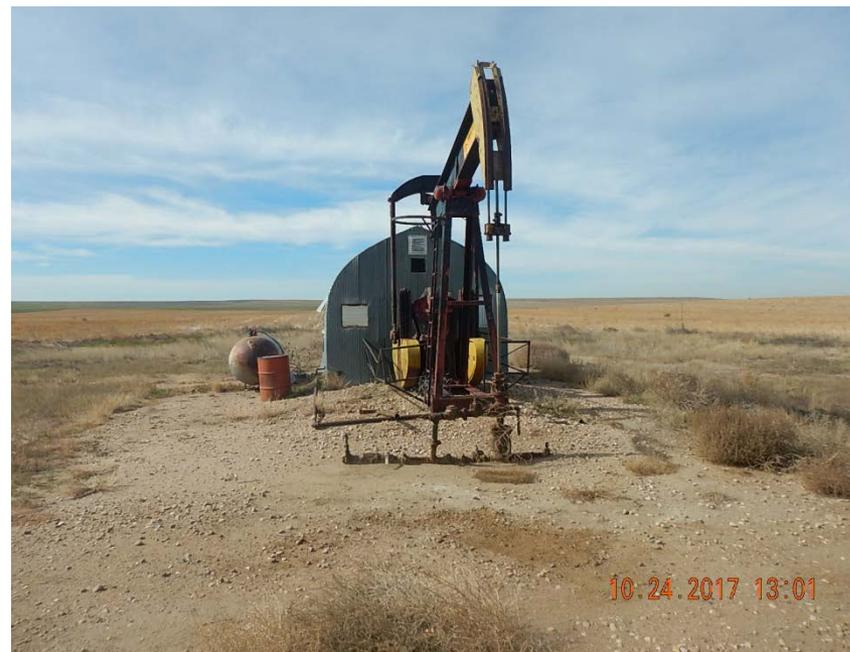
Photo 2: Wellhead, looking W

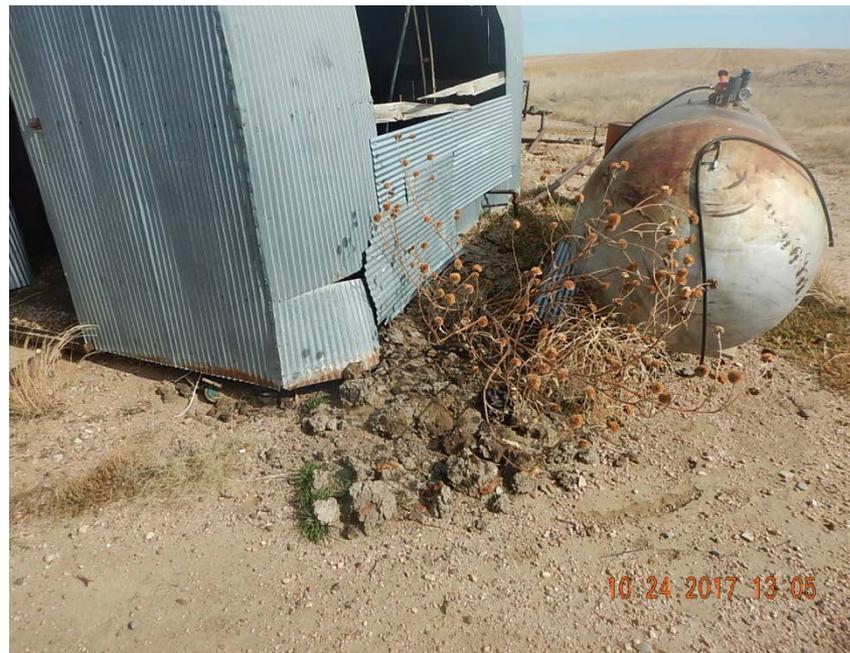
Photo 3: Stained soil worked

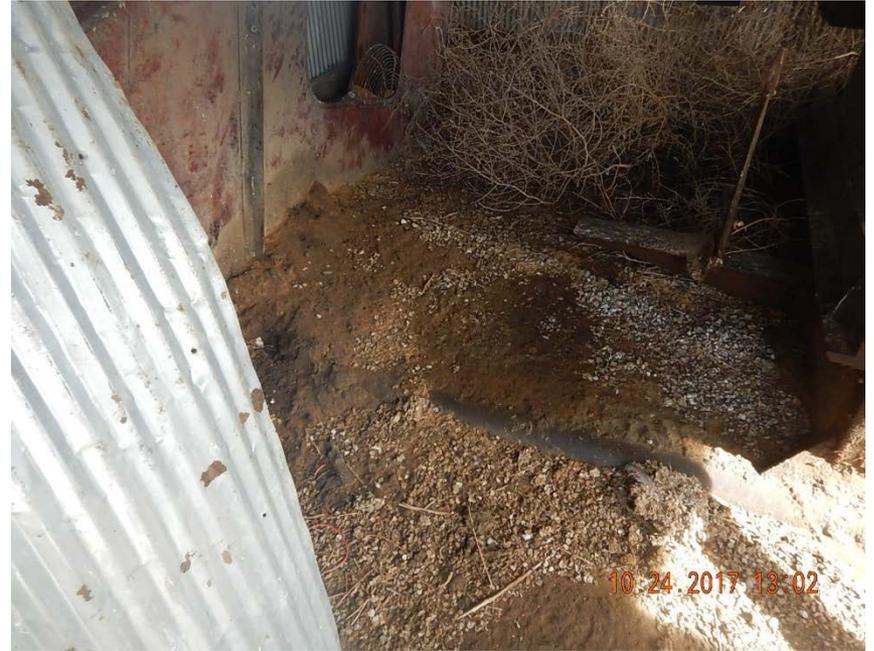
Photo 4: Stained soil in engine house

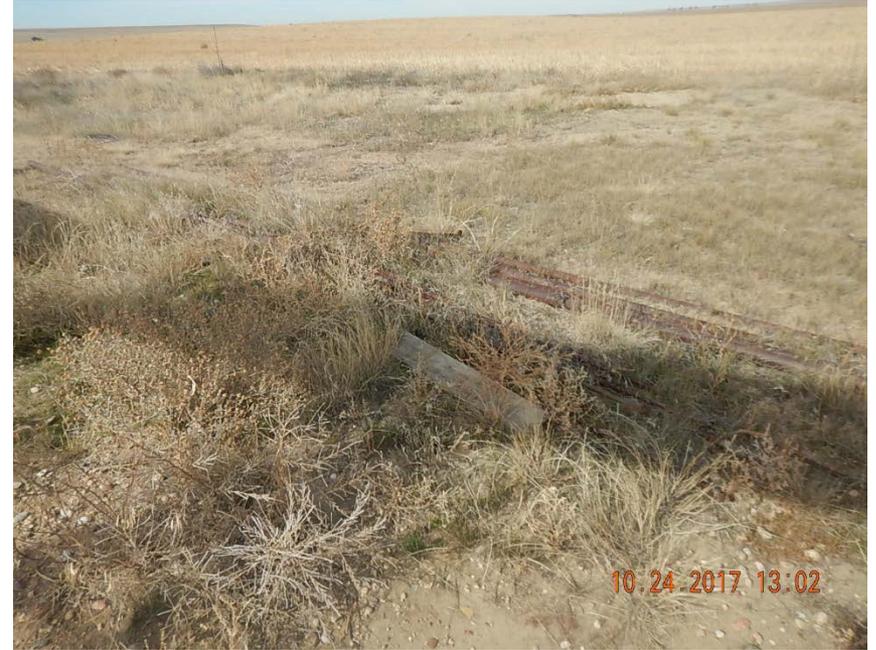
Photo 5: Unused pipe at wellhead

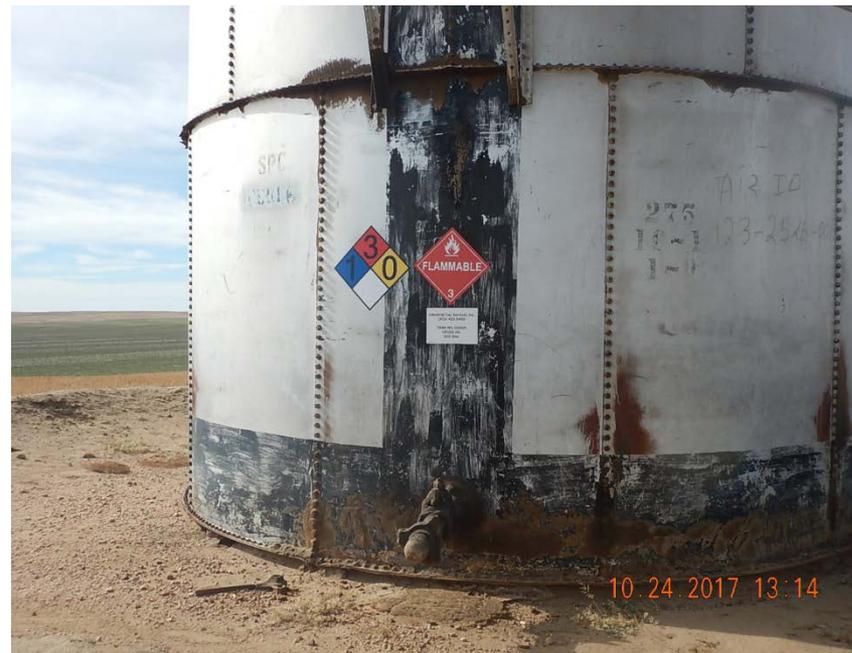
Photo 6: Berms built up, tanks labeled

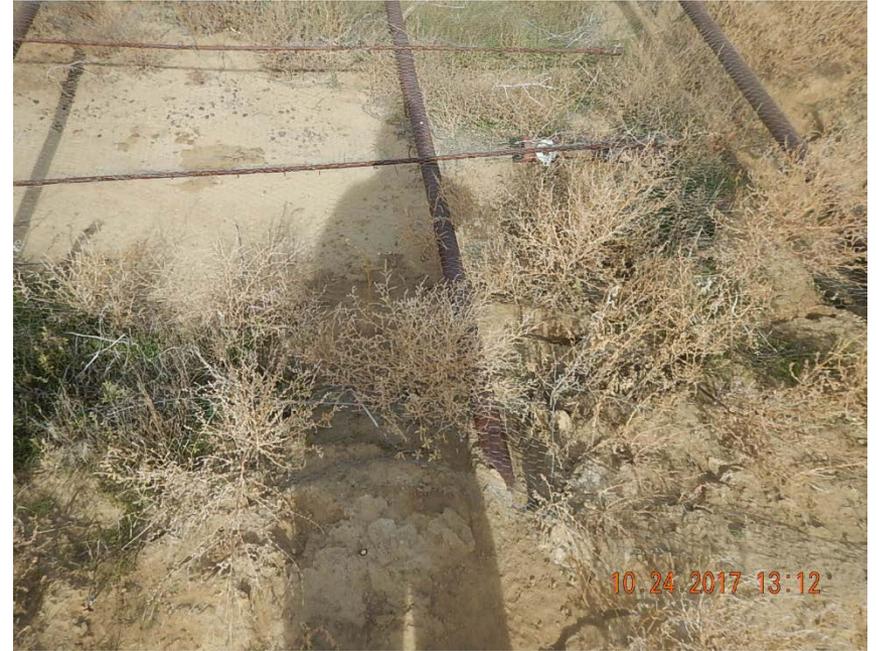
Photo 7: Gap under netting

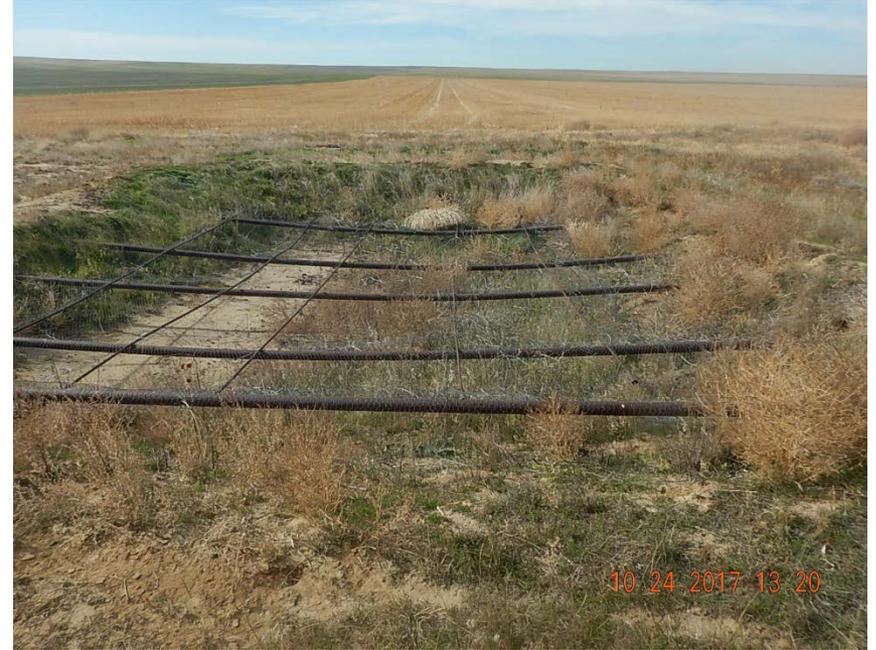
Photo 8: Weeds in pit

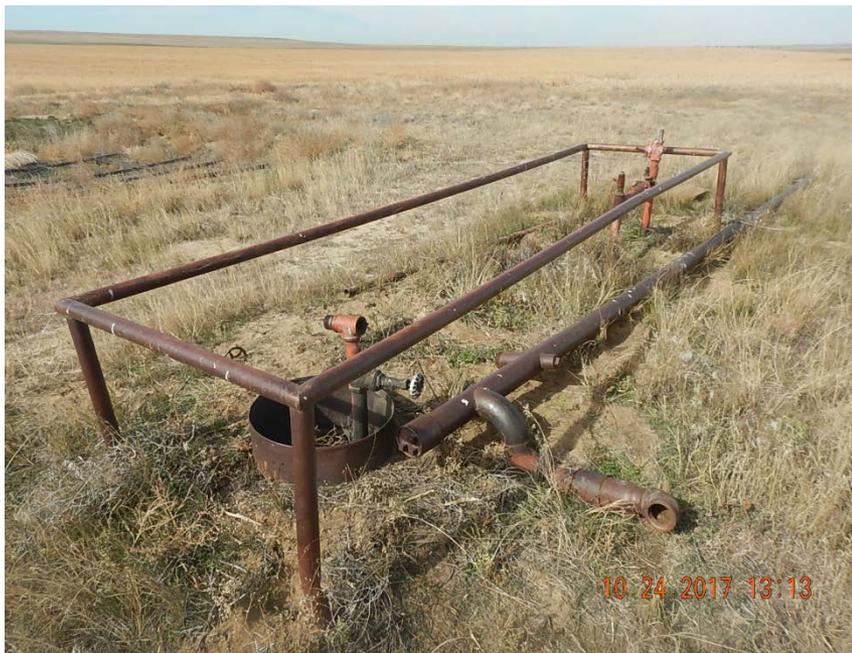
Photo 9: Unused equipment at manifold

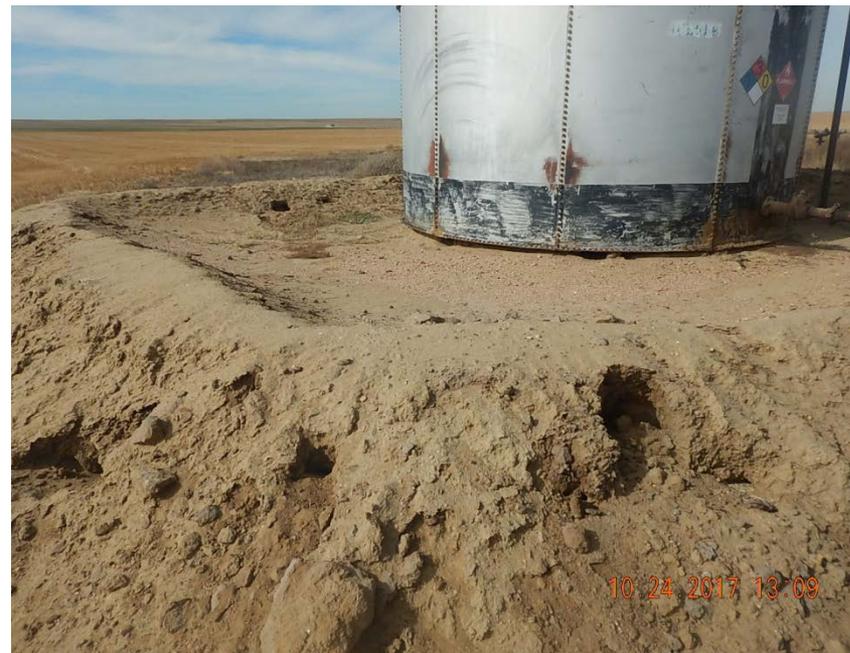
Photo 10: Burrows in berms

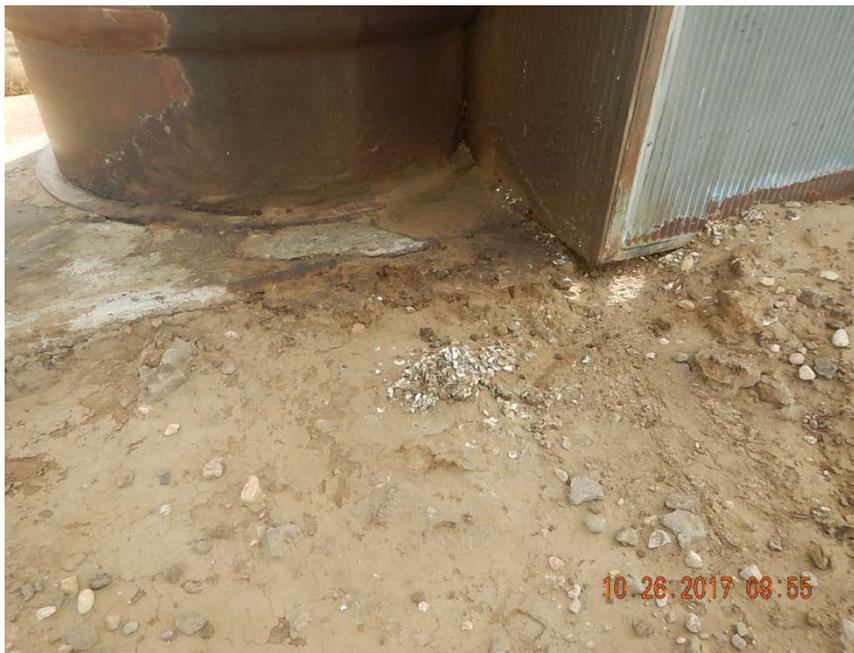
Photo 11: Stained soil at vessel

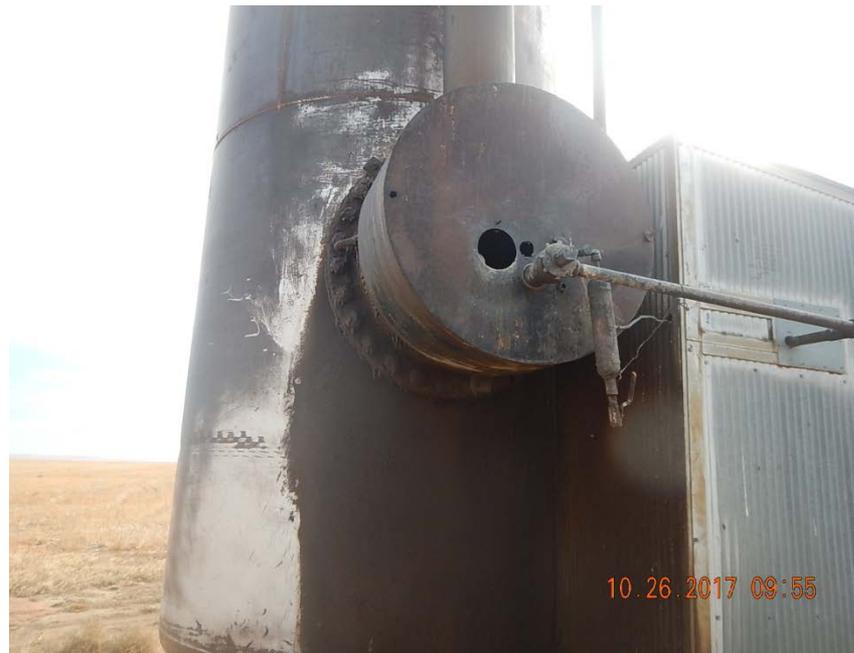
Photo 12: Wildlife egress
