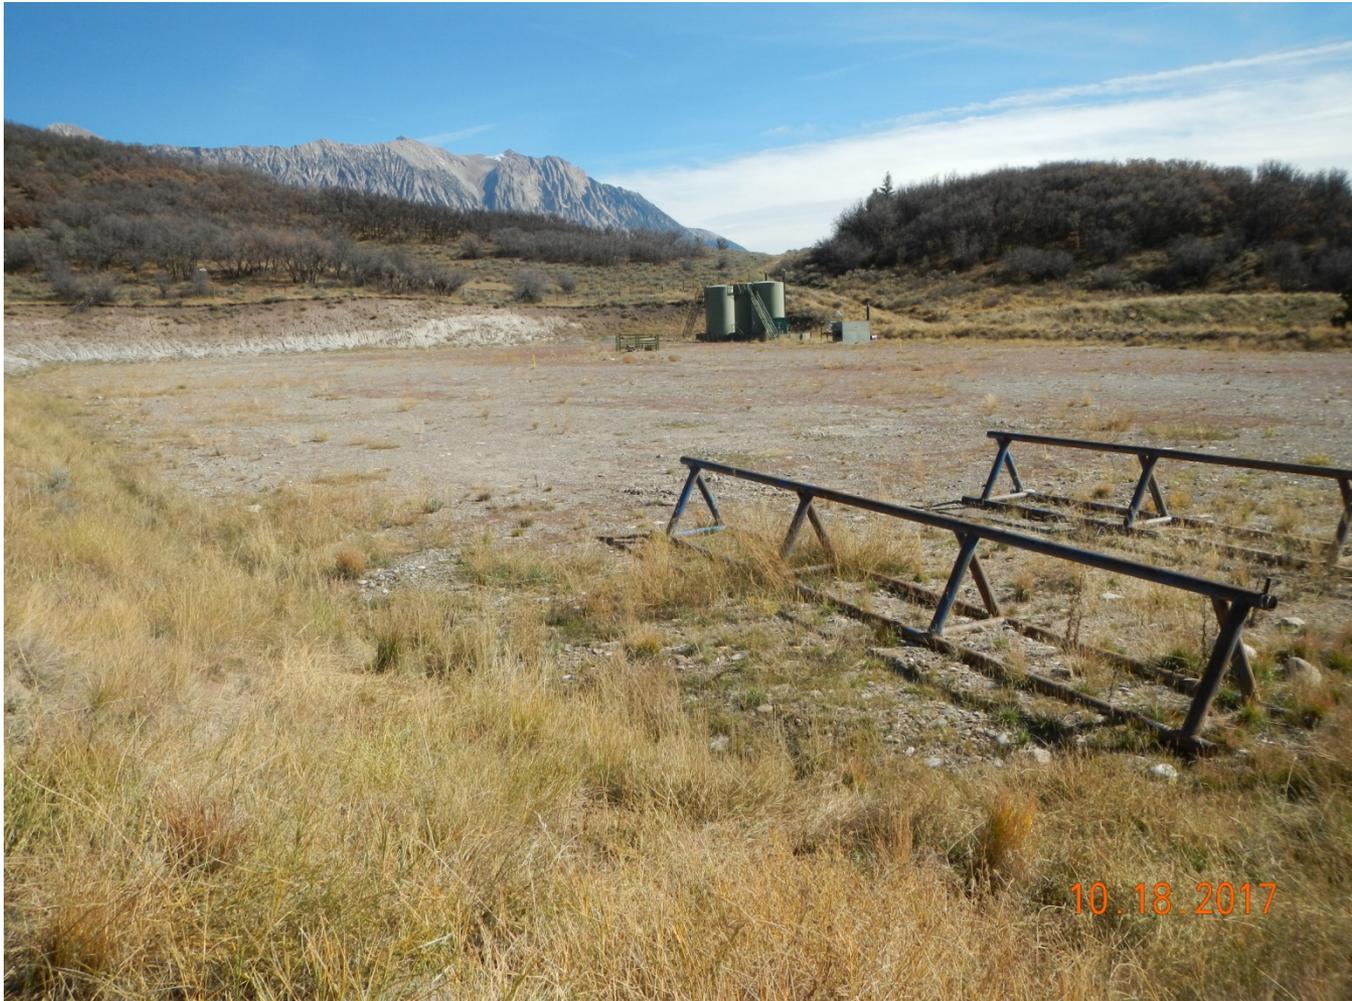
Photo 1. View from the northwestern corner of the project area facing center. Pipe rack in the foreground does not appear to be in use.

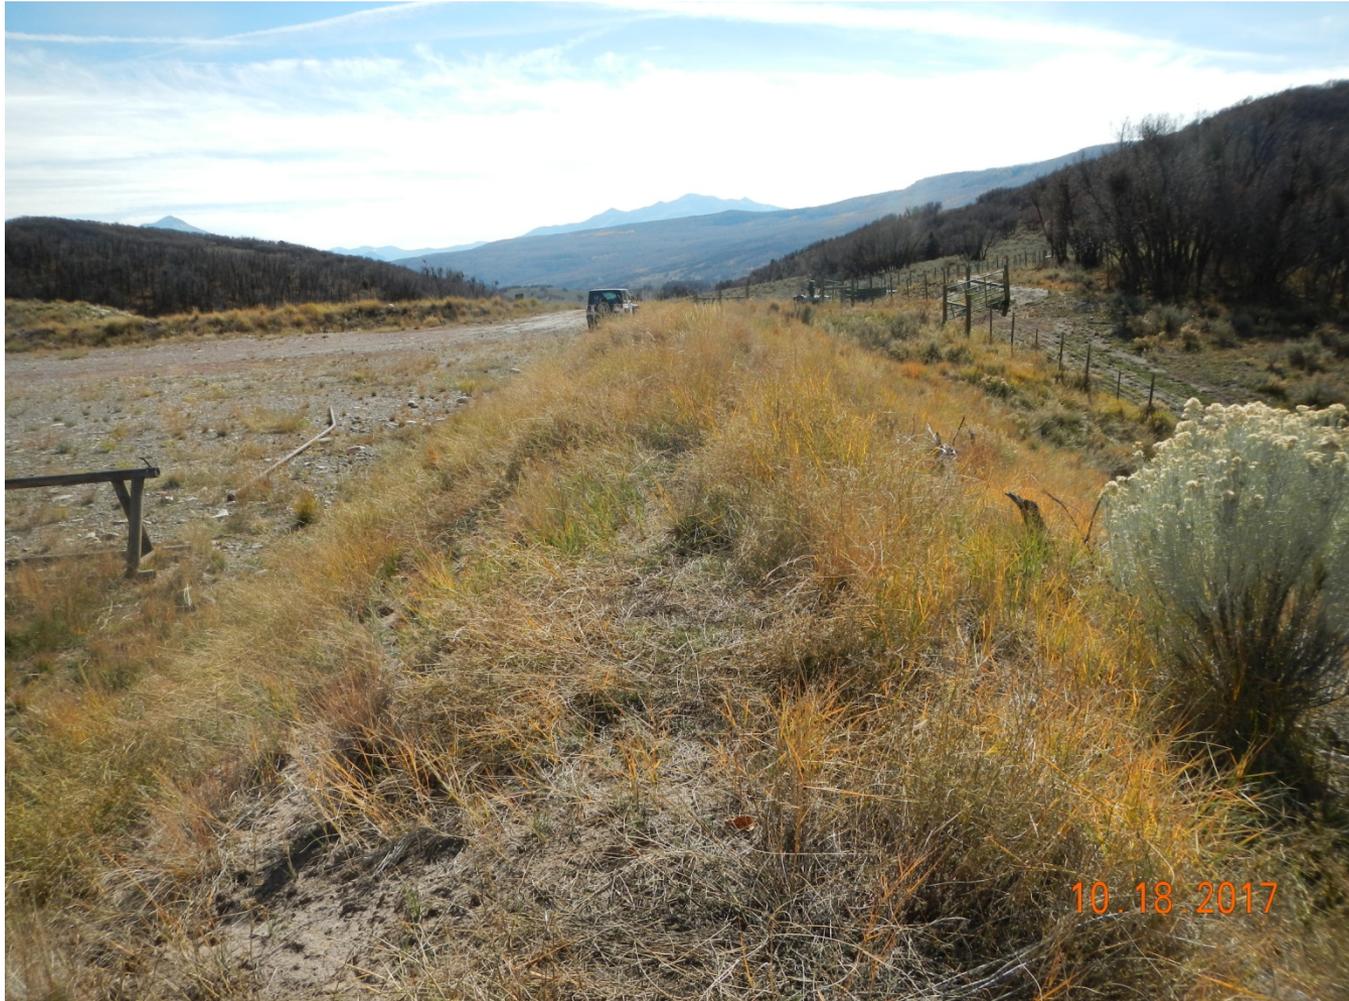
Photo 2. View of the western portion of the project area from the northwestern corner facing southward. Revegetation in the outer portions of the project disturbance is progressing with grasses such as western wheatgrass (*Pascopyrum smithii*) and brome grass (*Bromus* sp.).

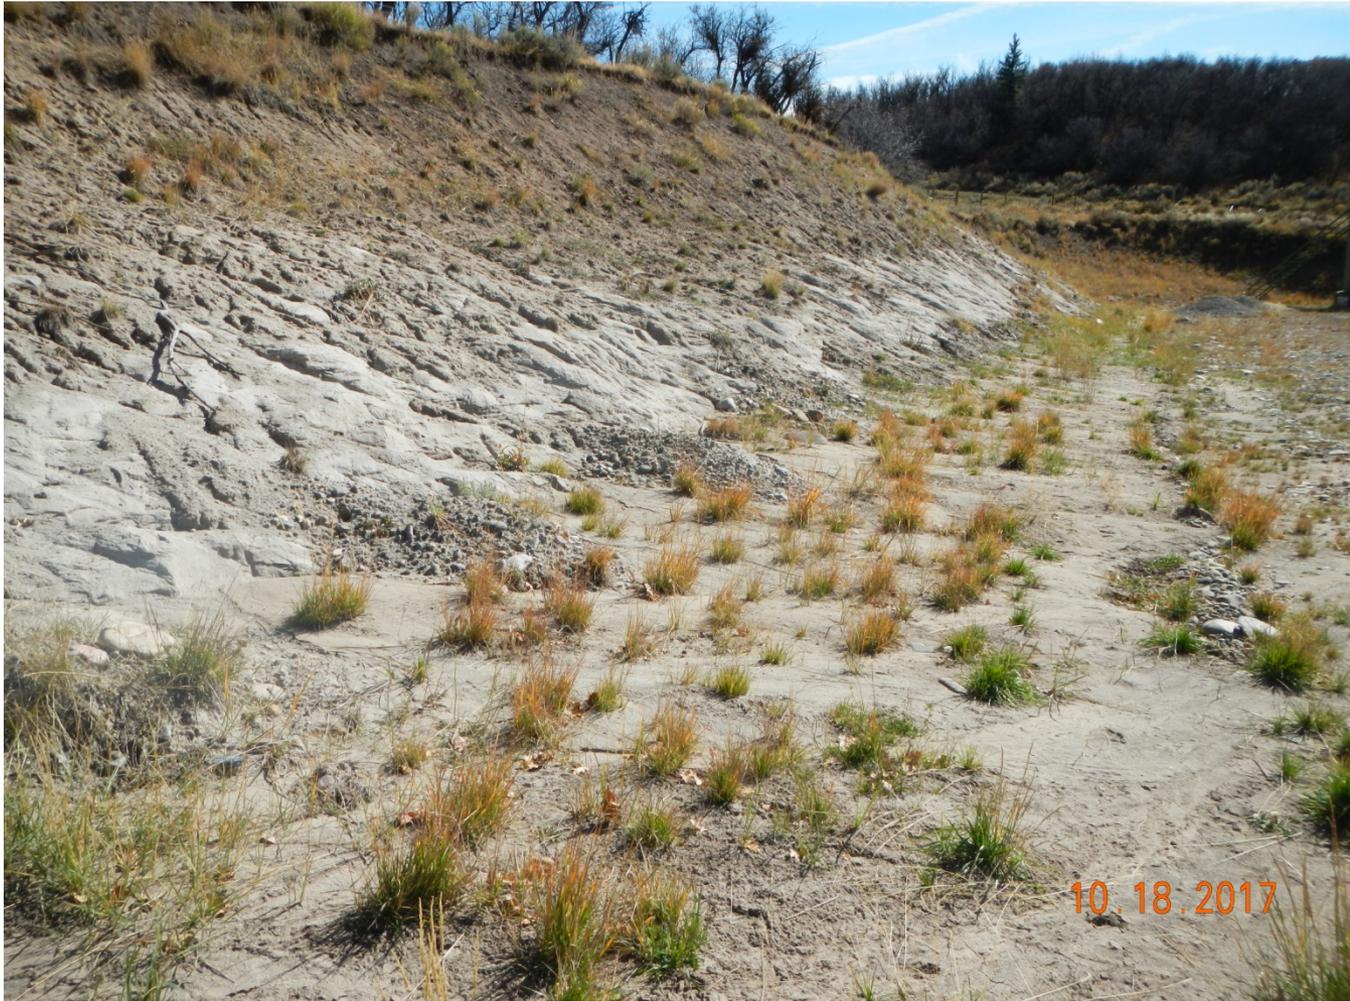
Photo 4. View of the eastern cut-slope from the northeastern corner facing southward. This slope is not stabilized as evidenced by the exposed roots at the top of the slope, erosional rilling within the slope, and sediment deposition at the toe of the slope.

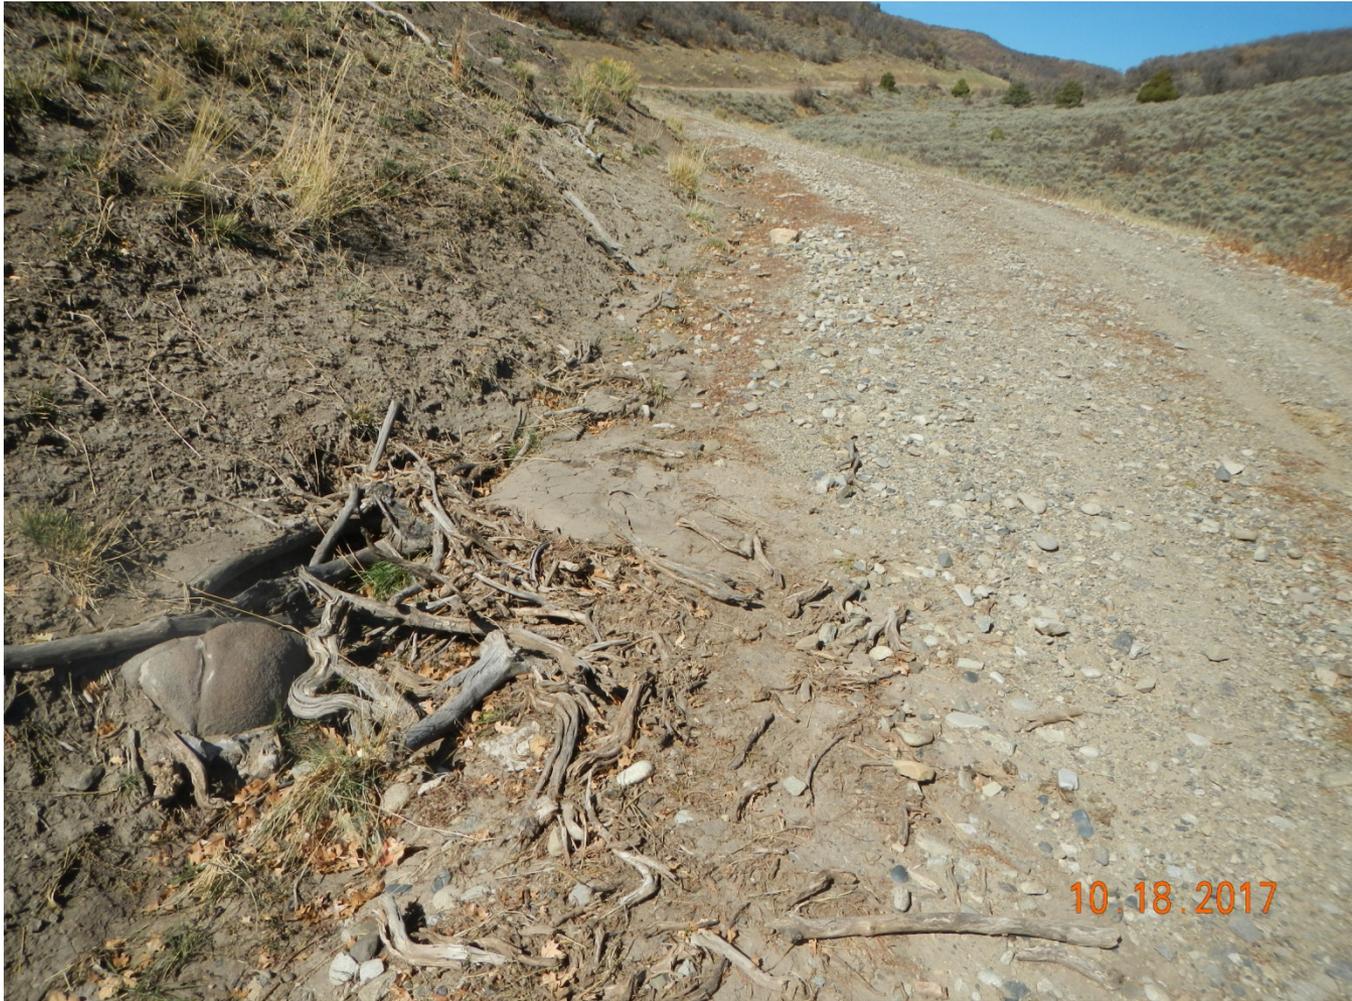
Photo 5. View of sediment deposition along the western edge of the access road, near the entrance to the access road facing northward.
