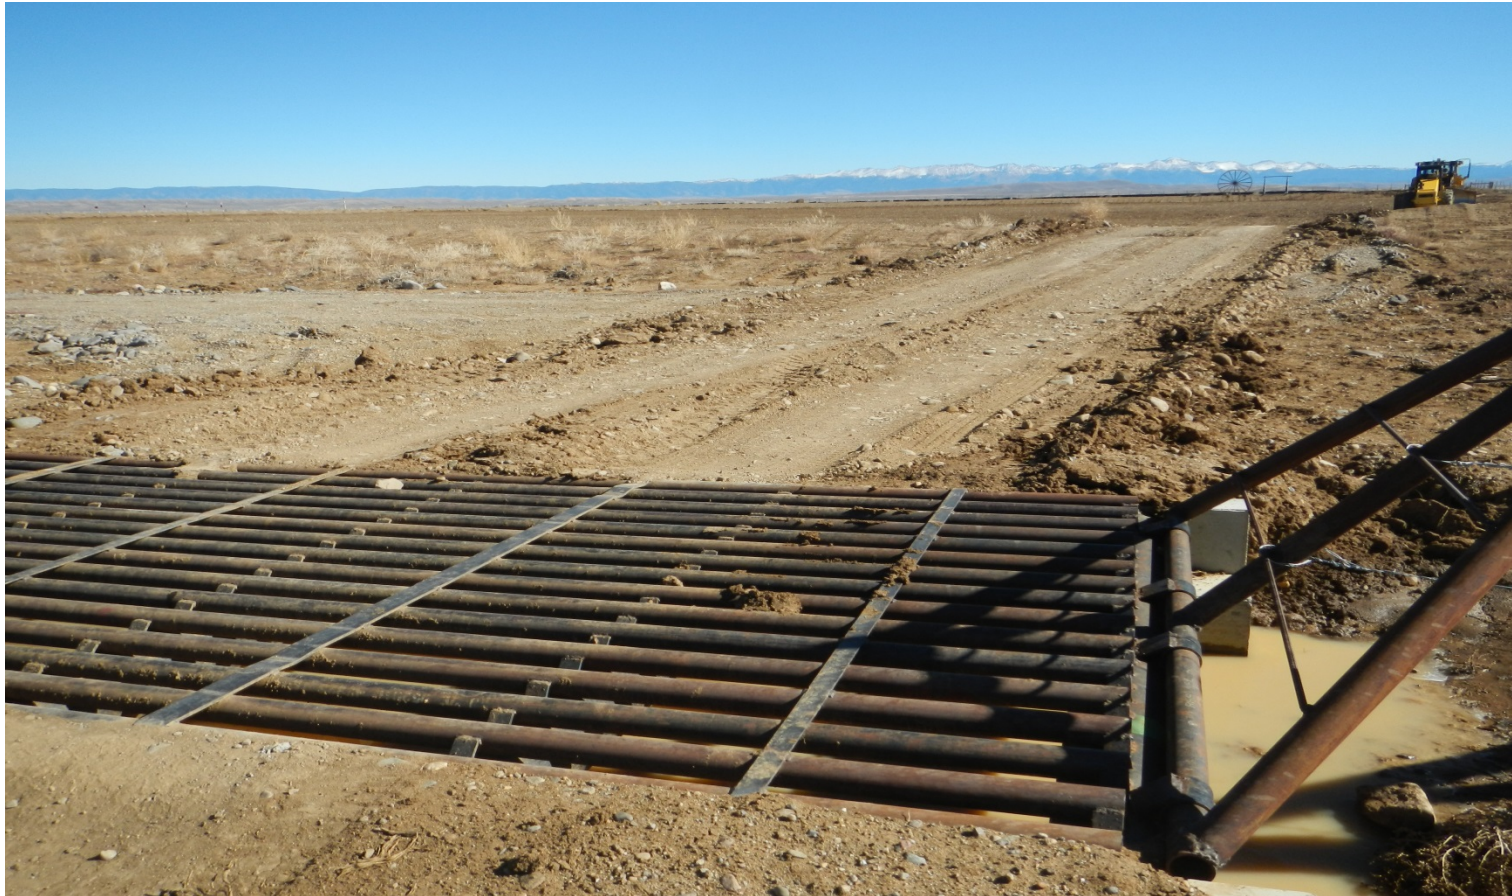
Photo#1:
Overview of Location from Entry at SW corner.

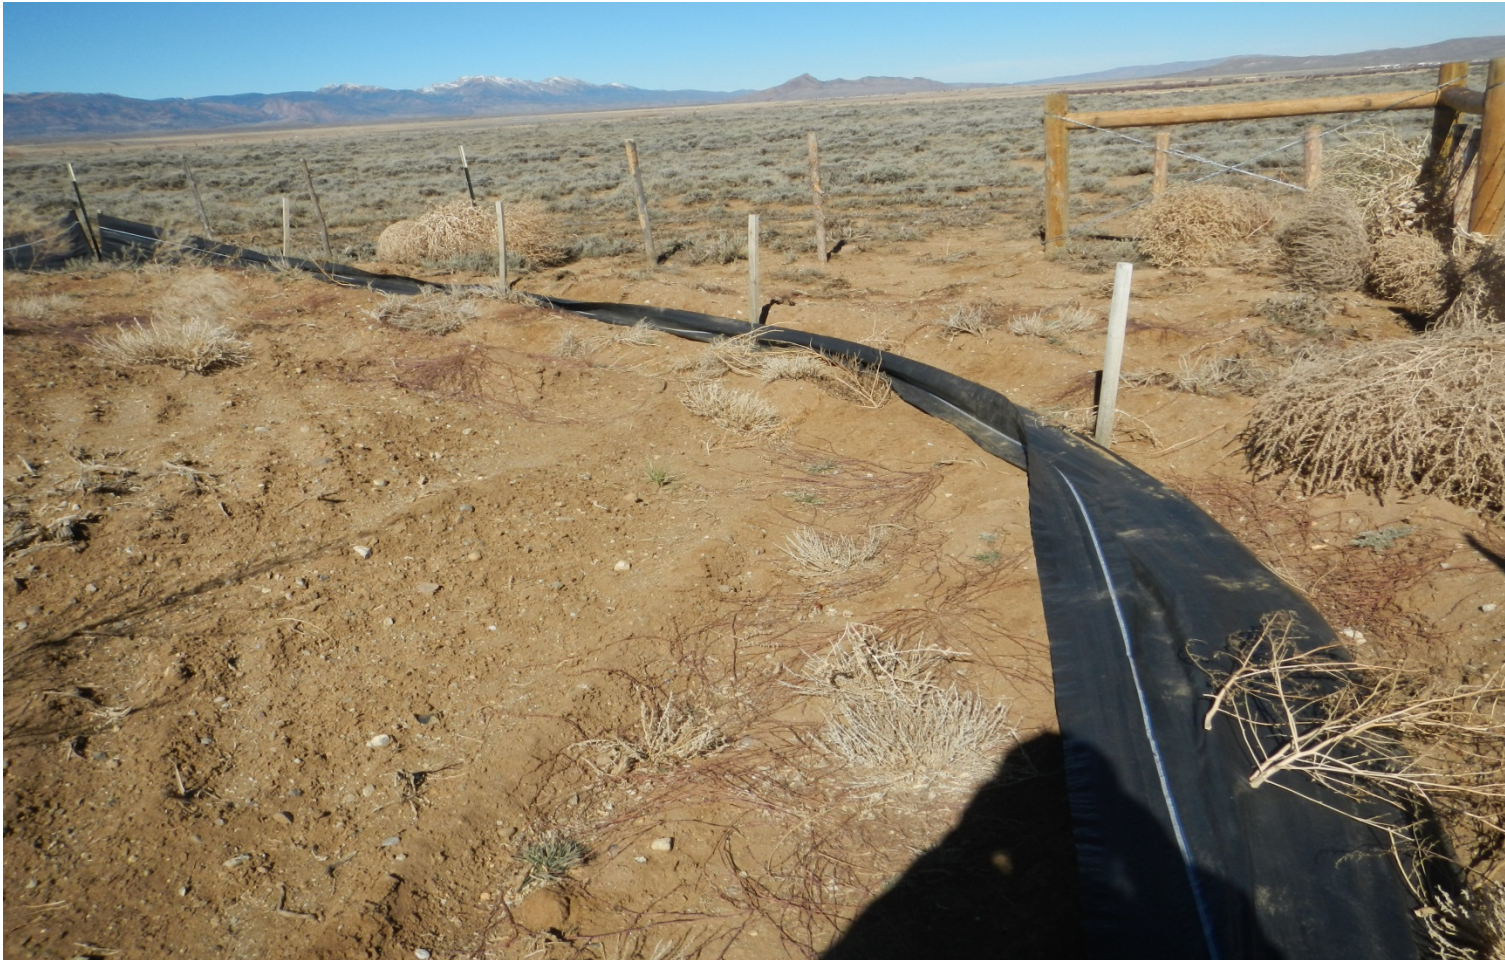
Photo#2:

NE Corner of Location: Portions of Silt Fence are in disrepair. Note Russian thistle plants that have senesced, broken off and become Debris.

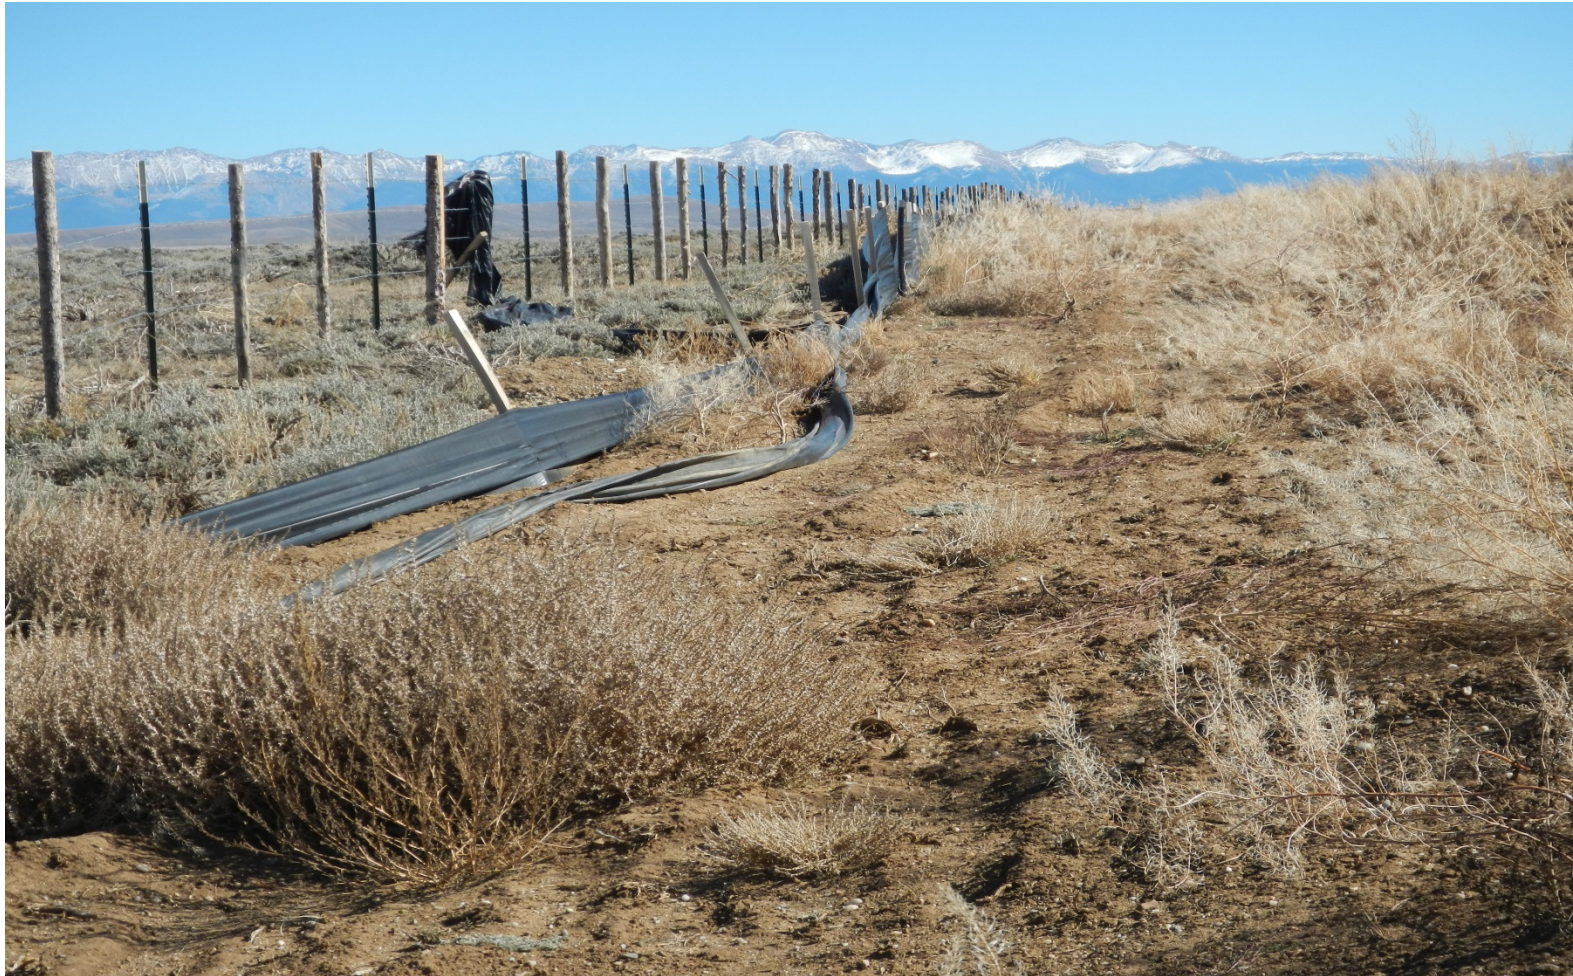
Photo#3:

North Fill slope area of Location : Portions of Silt Fence are in disrepair. Note Annual Weeds that have senesced , will break off , blow and become Debris.

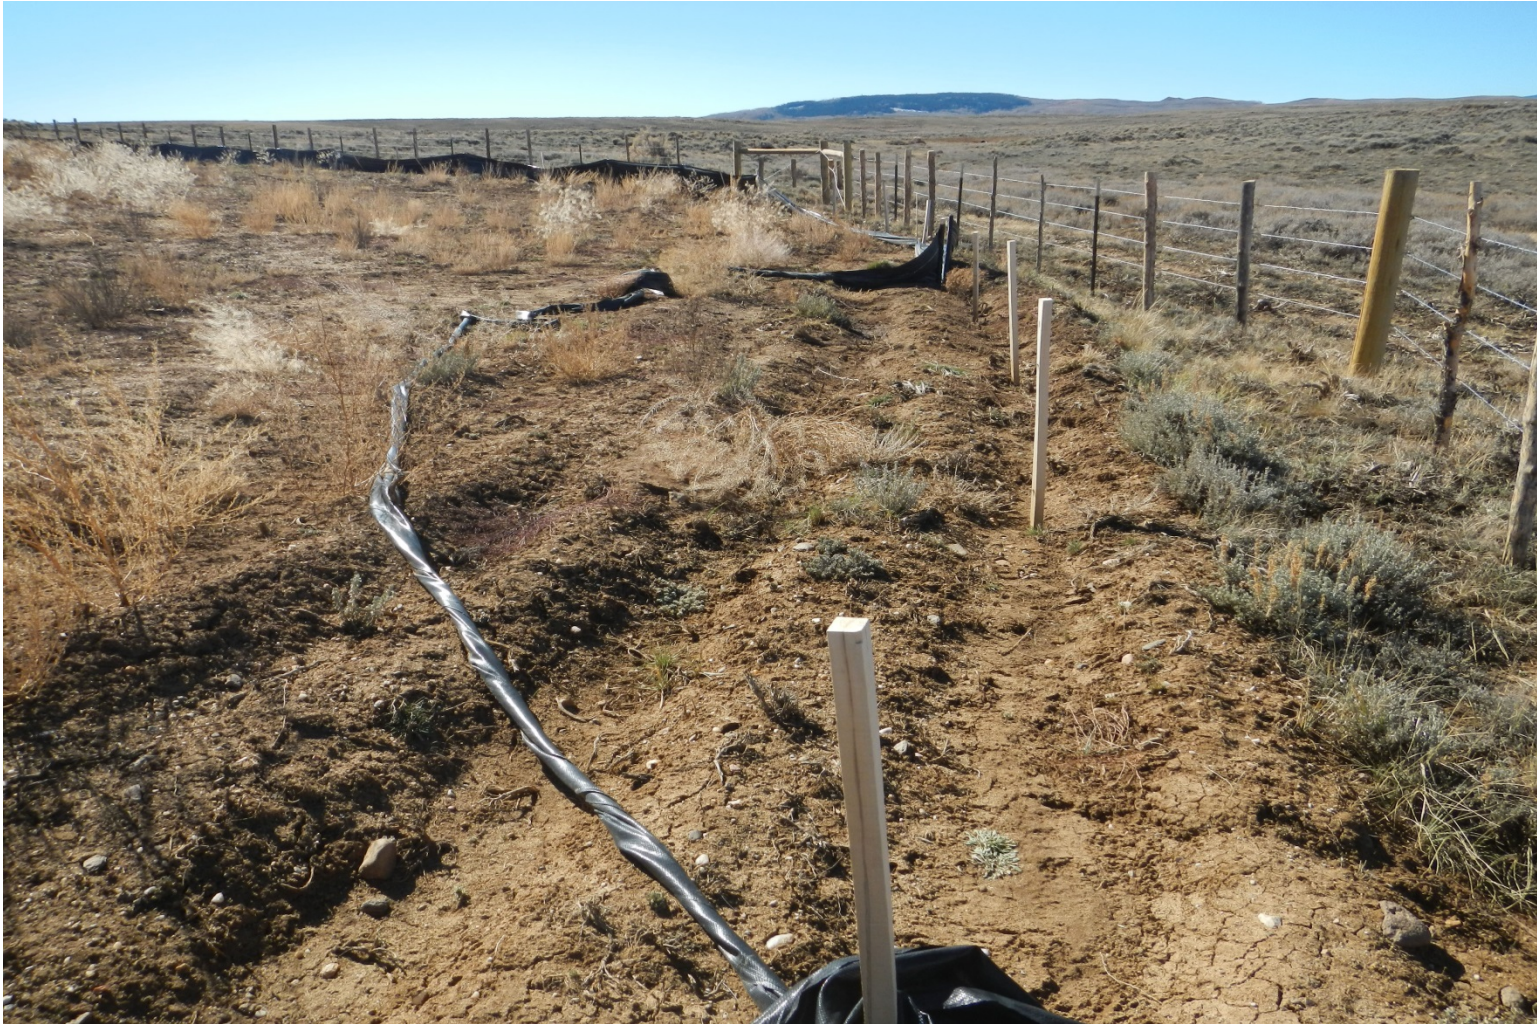
Photo#4:

Another area where Silt Fence has become Debris

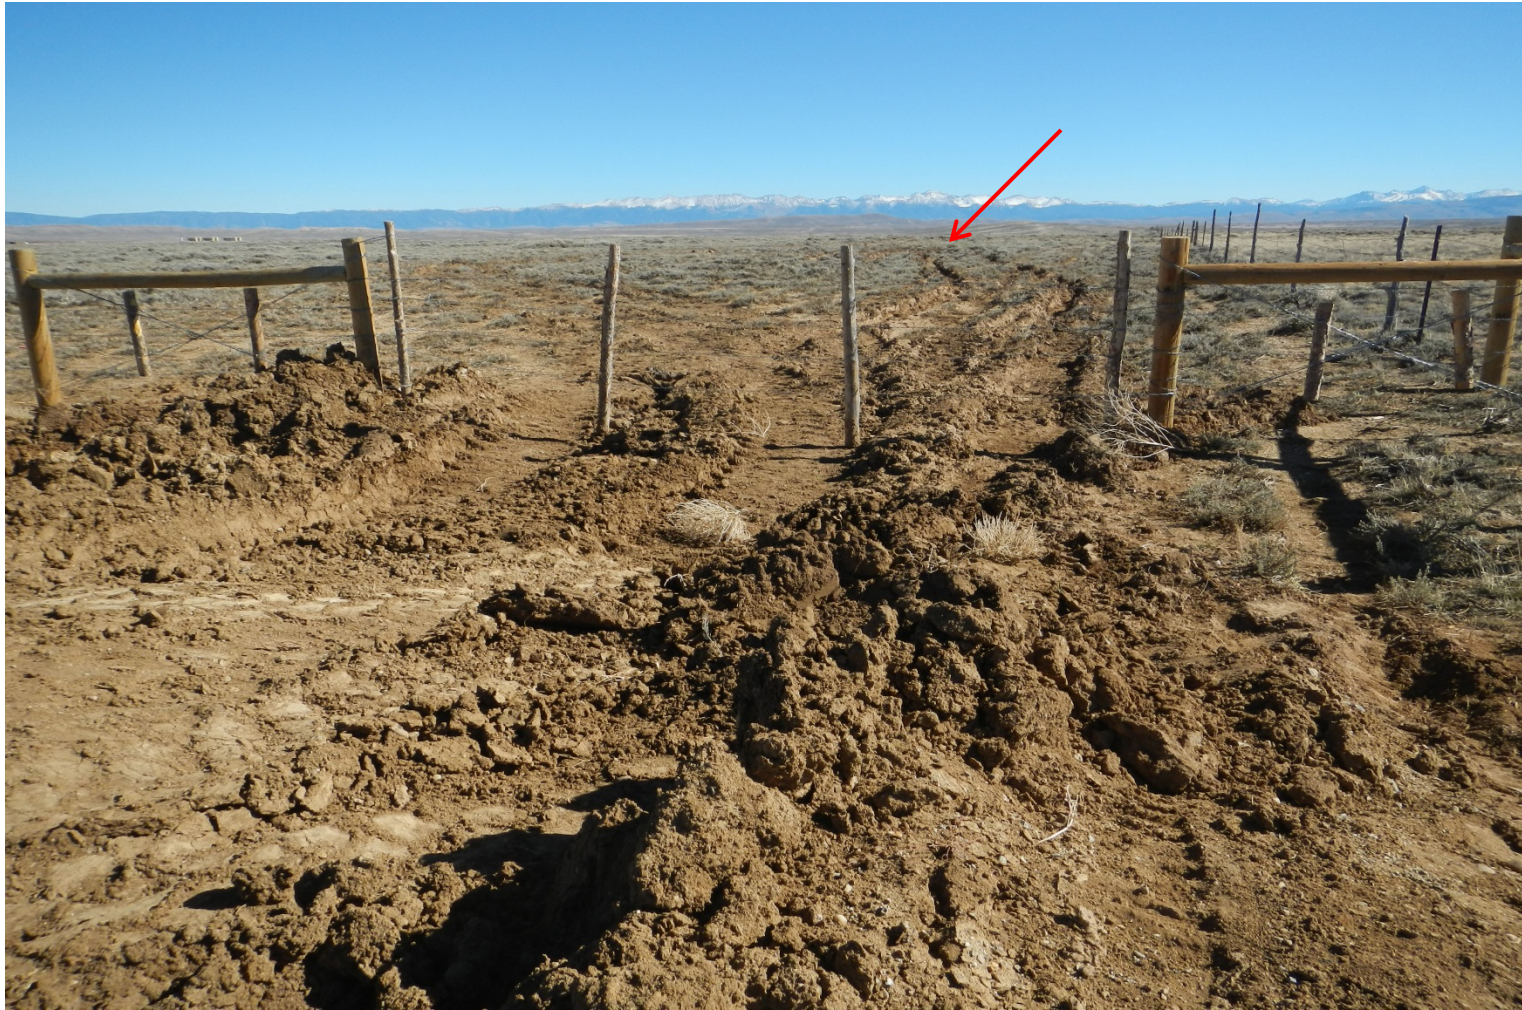
Photo#5:

Severe rutting / tracking and disturbance has occurred at SE corner of Location. Arrow indicates rutting leading out of Site to flagged area of future Pipeline / Road (?).

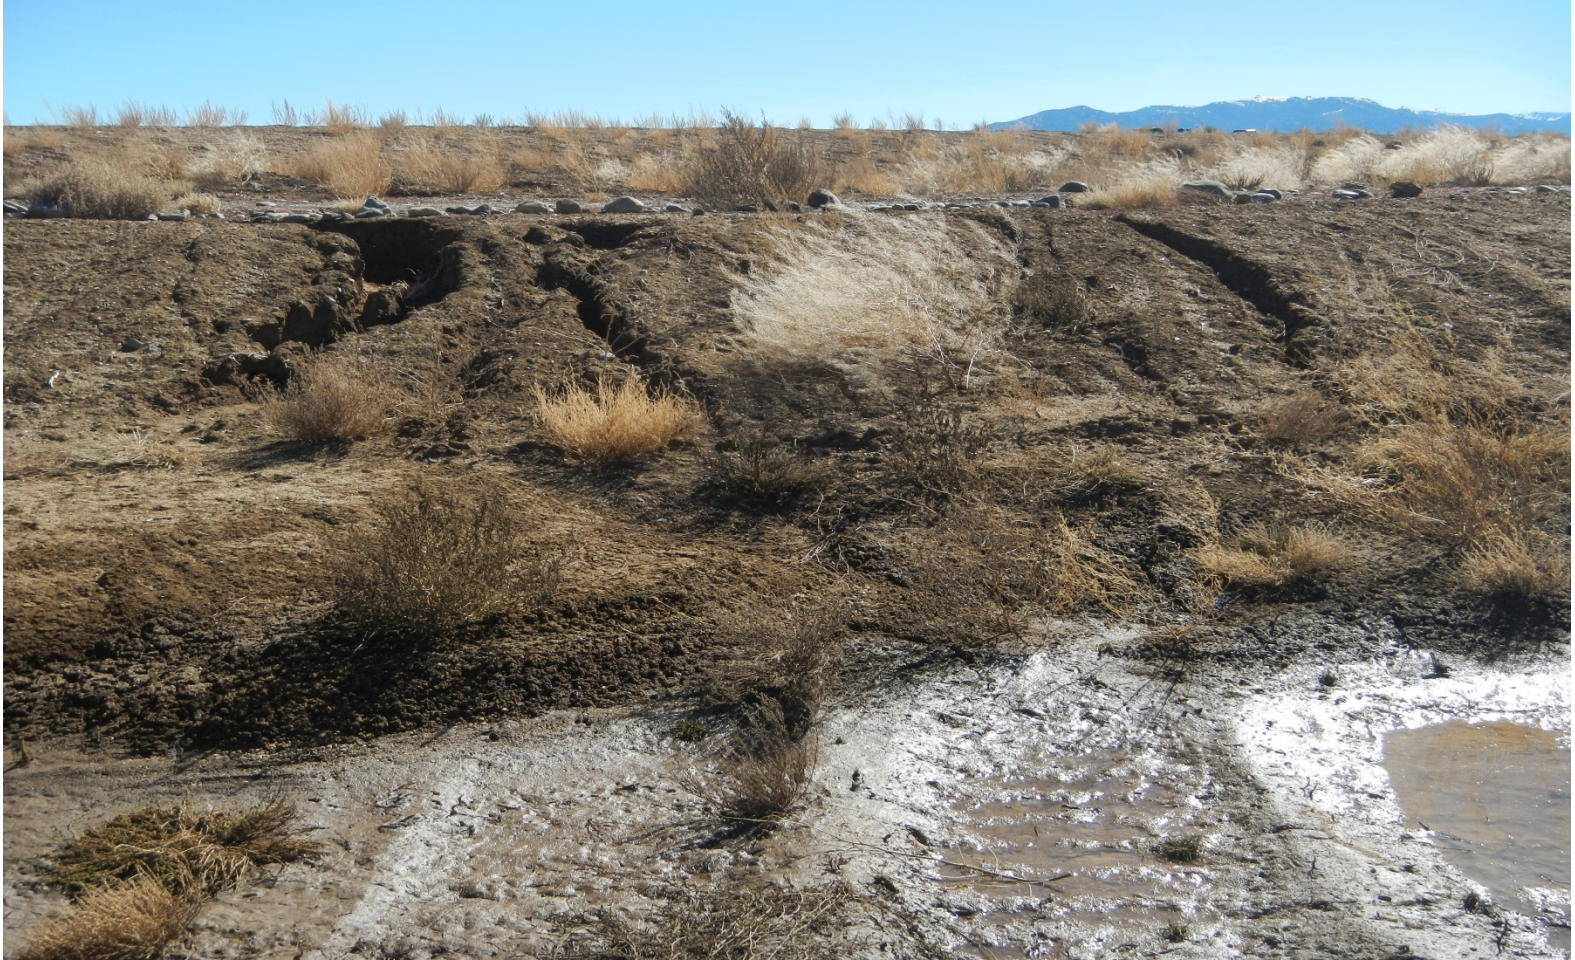
Photo#6:

View of Erosion along Secondary Access Road at NW corner of Location.

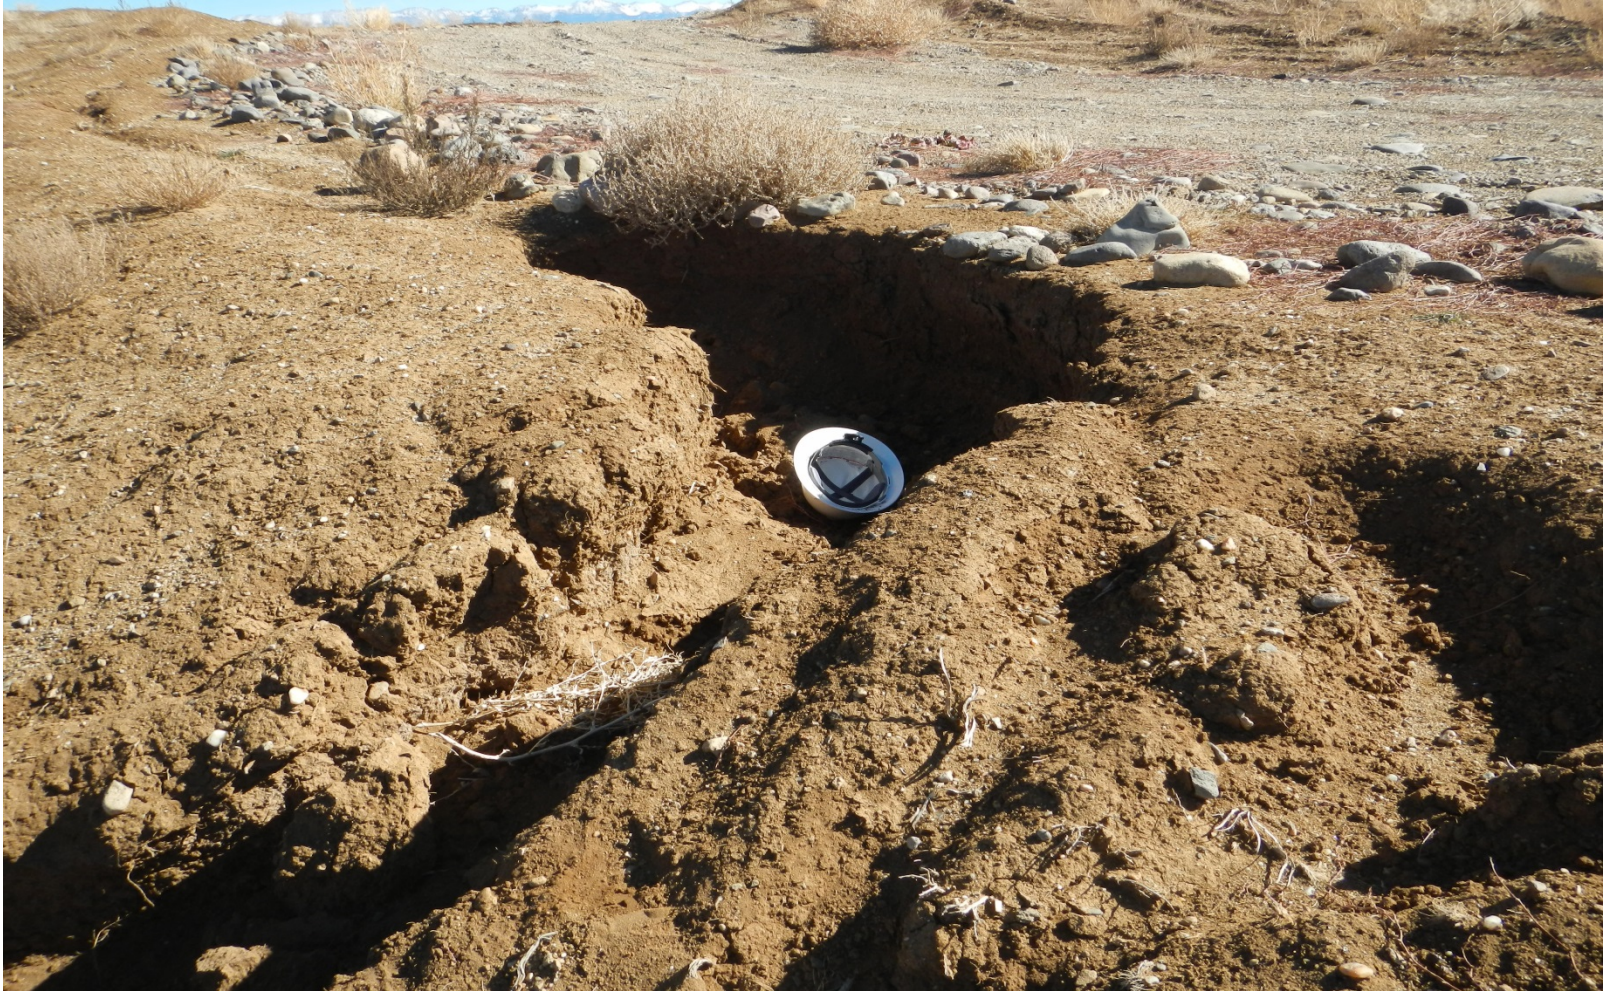
Photo#7:

Close up of Erosion along Secondary Access Road.
