RECLAMATION MONITORING REPORT

**ALOHA MULA #6
LINCOLN COUNTY, COLORADO**

OCTOBER 2017

**WIEPKING-FULLERTON ENERGY, L.L.C.
Denver, Colorado**

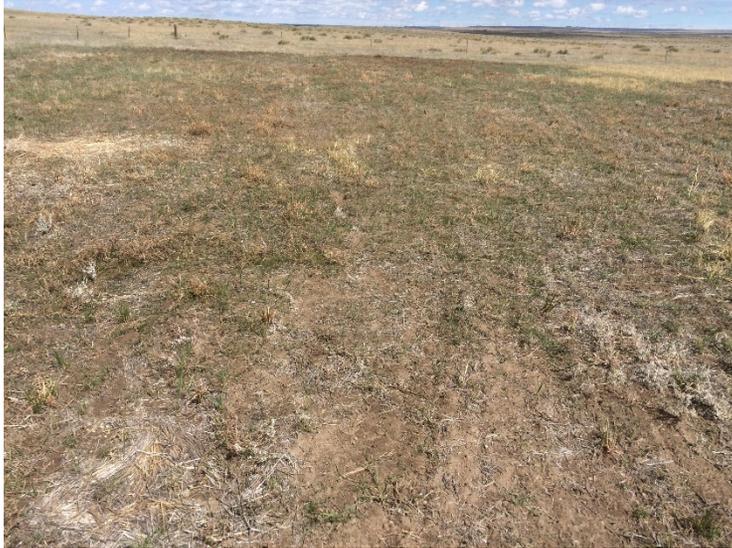
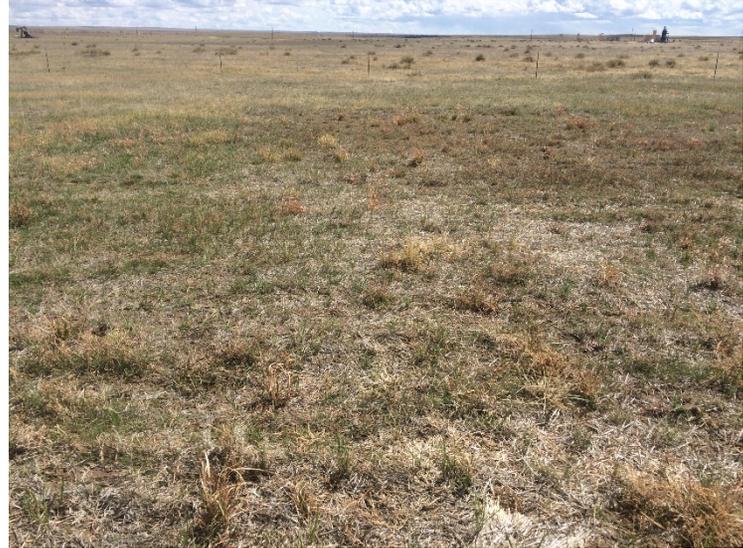
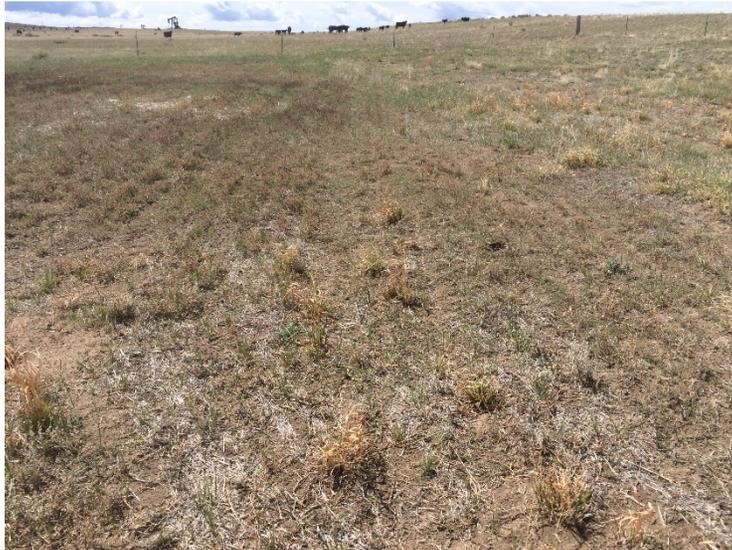
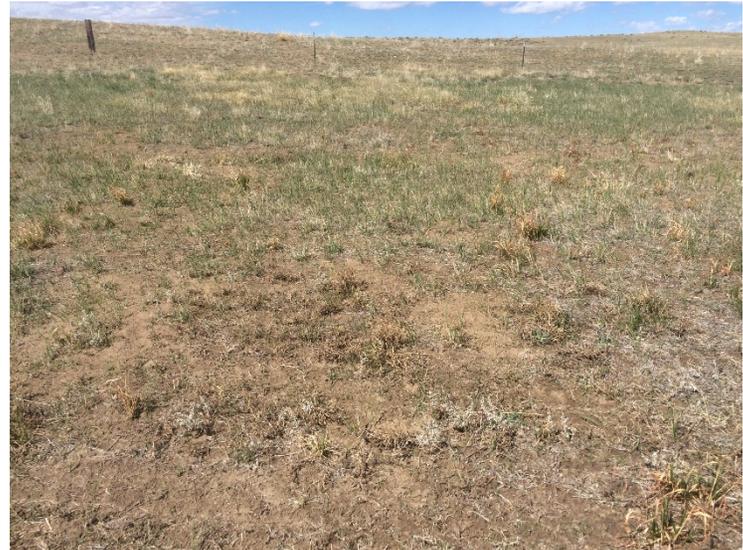
General Comments: Bare spots and abundant undesirable species. Grasses establishing well on north half of jetted area.

Weed mitigation and seeding in middle of site and along south side of site.

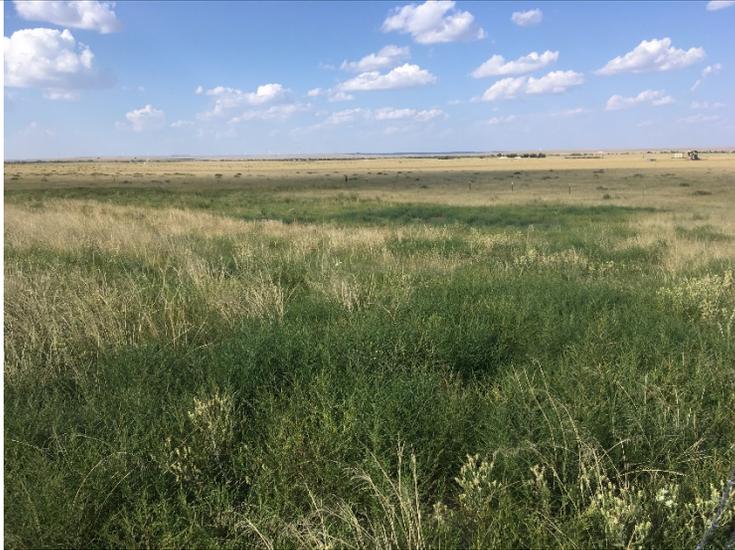
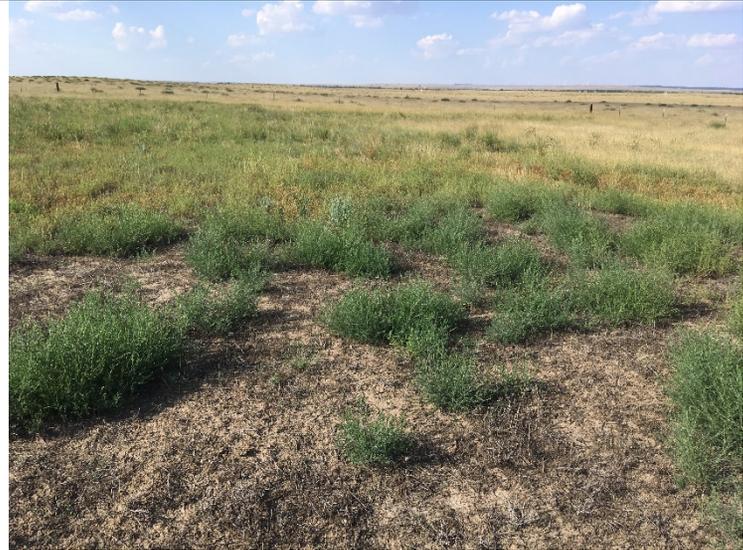
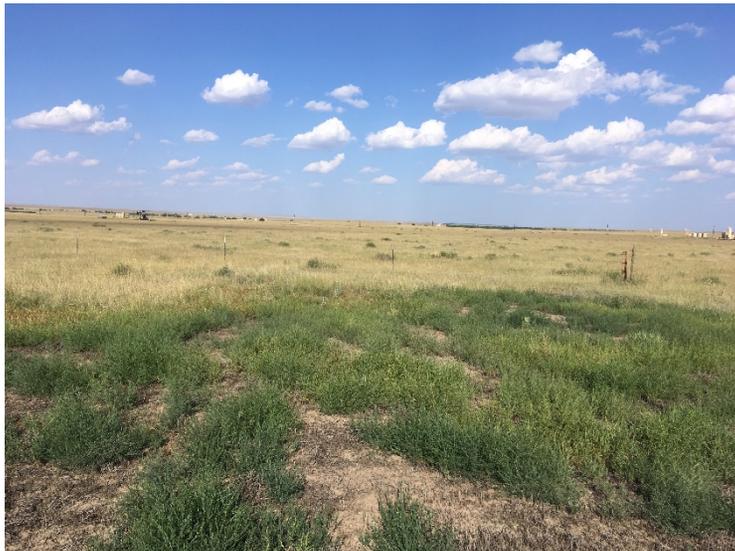
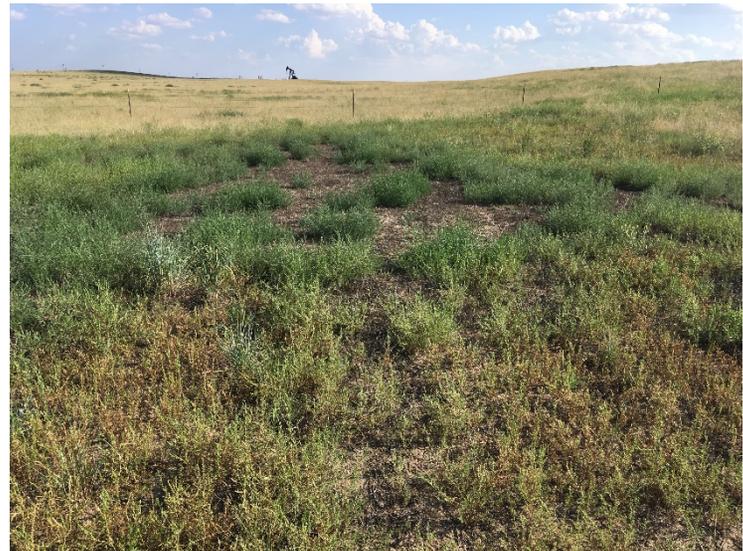
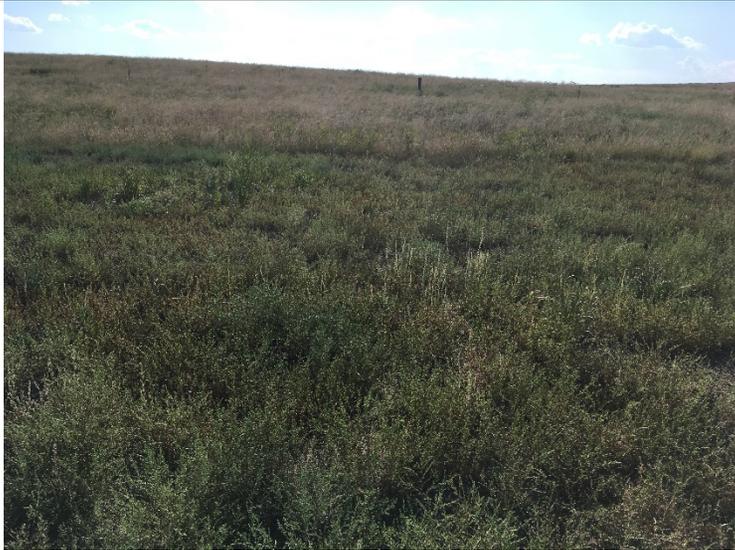
Noxious weeds observed onsite: None
Species observed onsite: SPCR, MENU, SATR12, BOCU, YUGL
General Comments: Bare spots and abundant kochia and Russian thistle. Grasses establishing well on north half of jetted area. Recent mowing has reduced canopy cover.

Spot seed bare areas, and mow Russian thistle and kochia before seedset to help grasses establish.
