Inspection Photos

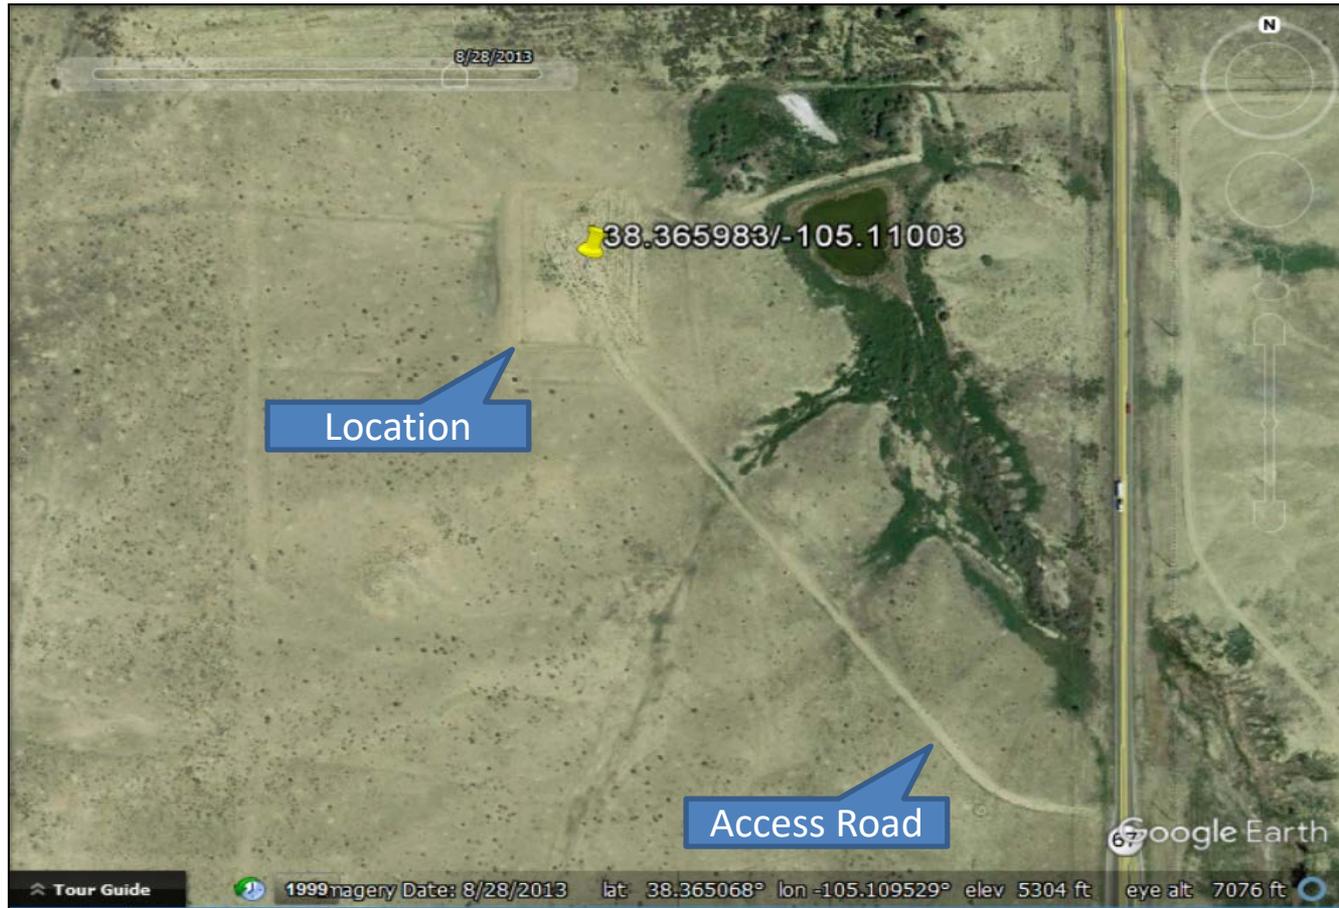
Photo 1. 2013 aerial photo shows disturbance area of the access road and the location.

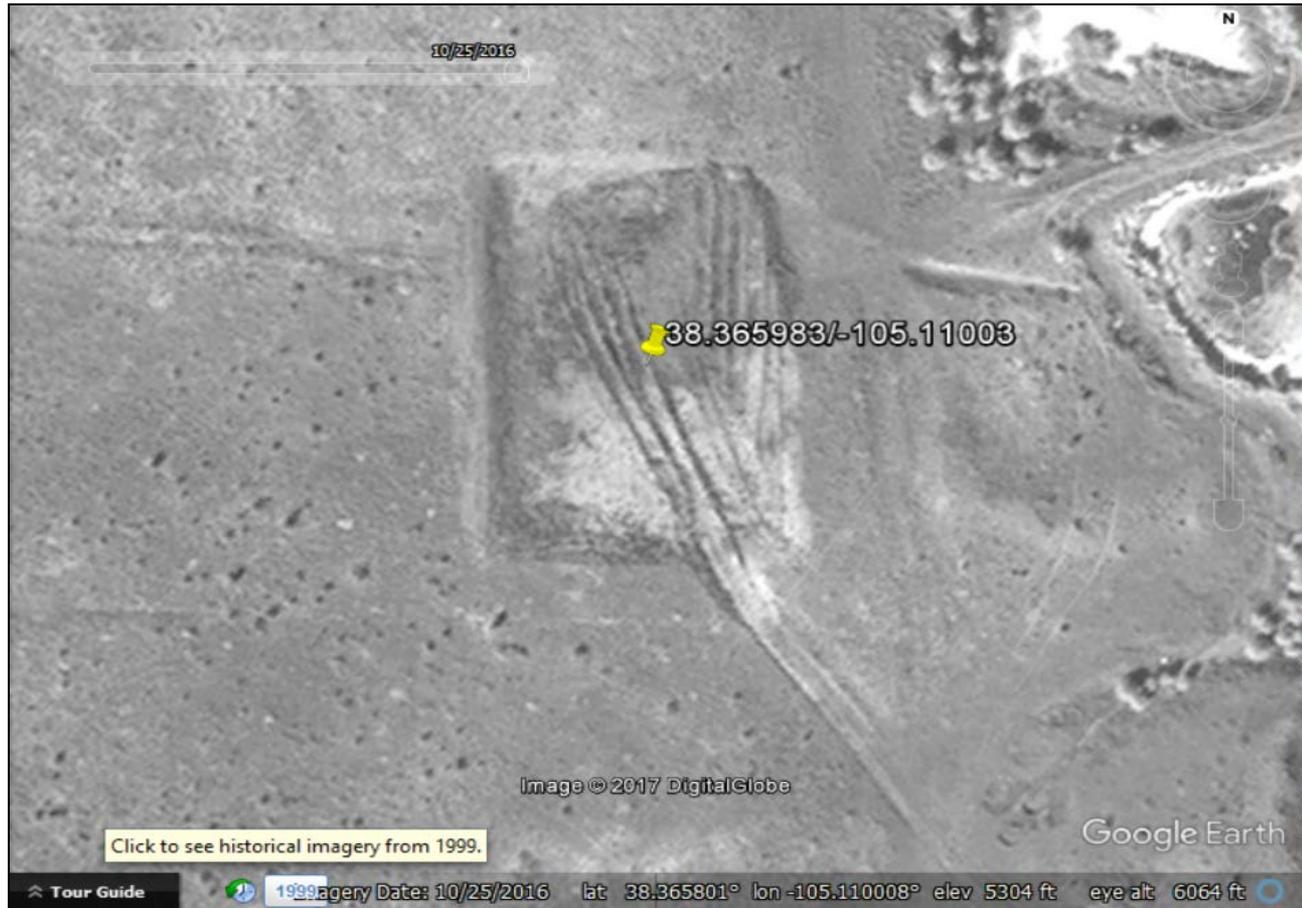
Photo 2. 2016 aerial photo shows disturbance area of the location.

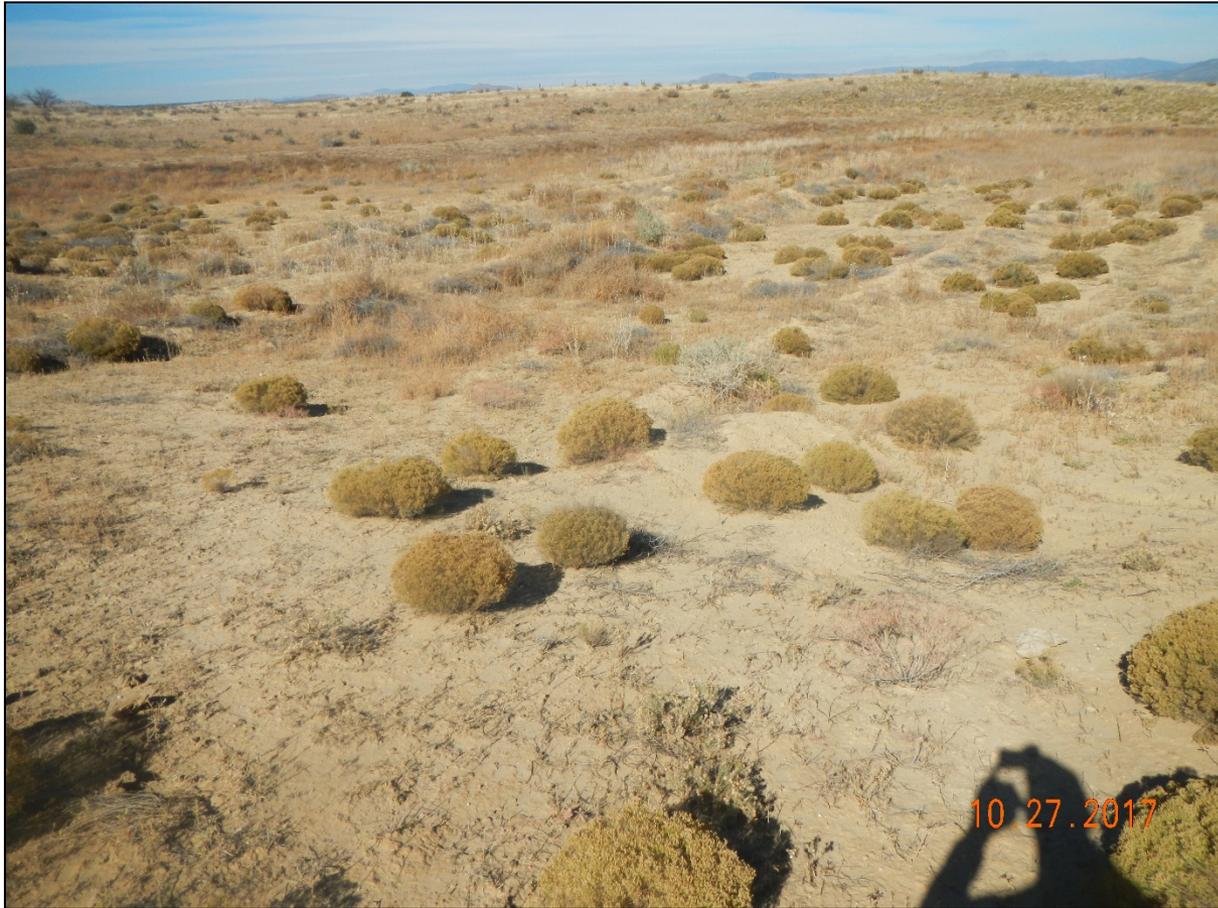
Photo 2. Facing northwest toward the location which has not been recontoured and reclaimed.

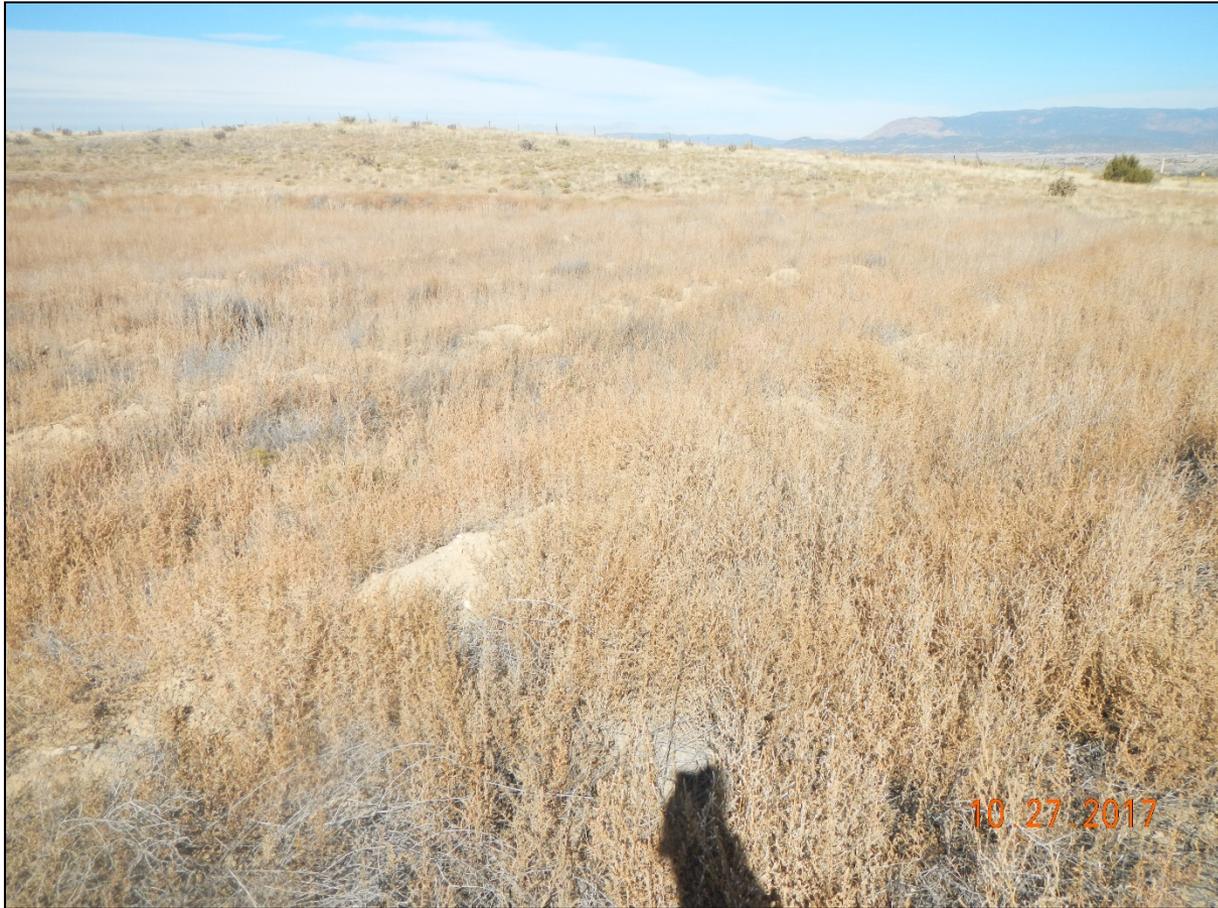
Photo 4. Facing northwest at the location. There is undesirable weed growth (Kochia sp.) throughout the location.

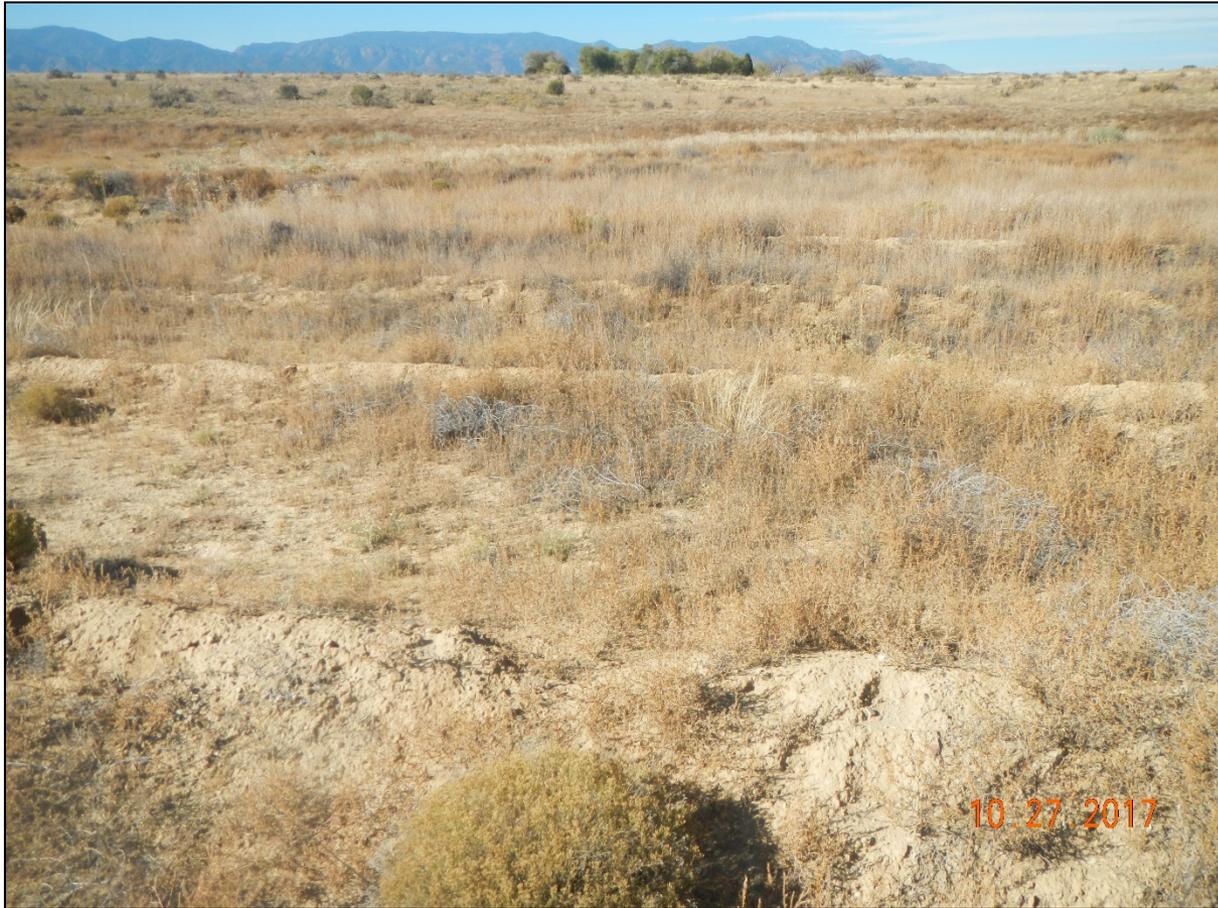
Photo 5. Facing west at the location. The location is not recontoured and there are rows of soil piled up on the surface.

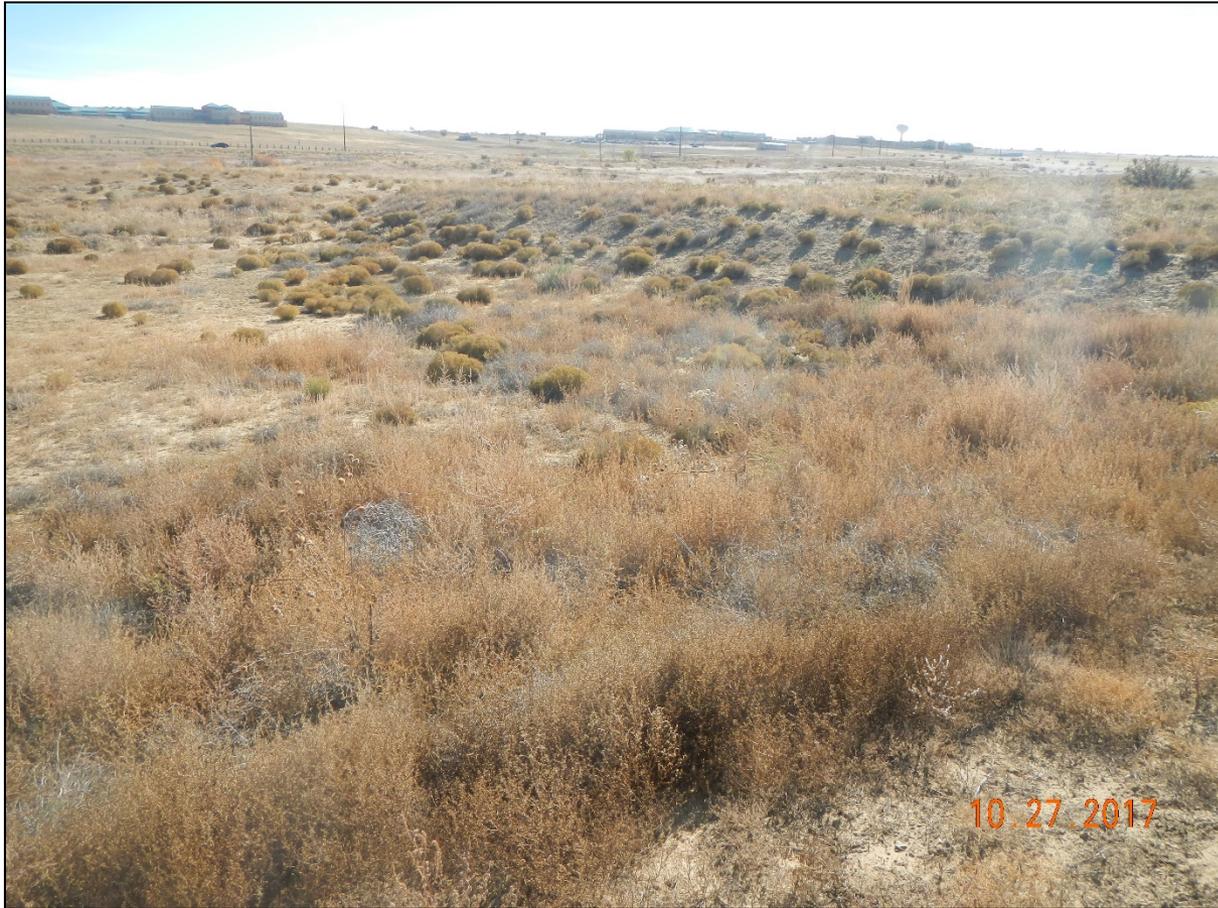
Photo 6. Facing southeast toward the cut slope.

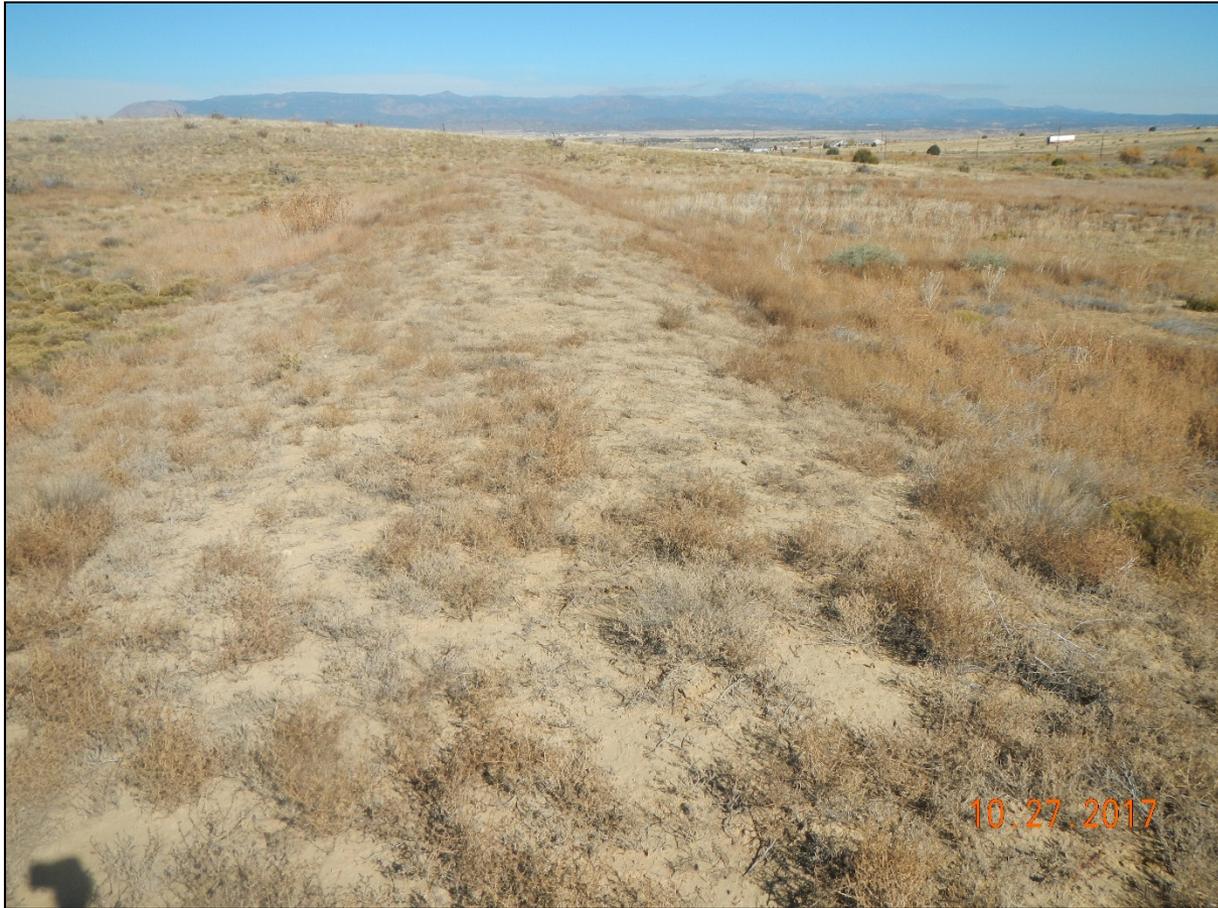
Photo 7. Facing north along the west side of the location. There is a soil berm along this side of the location.
