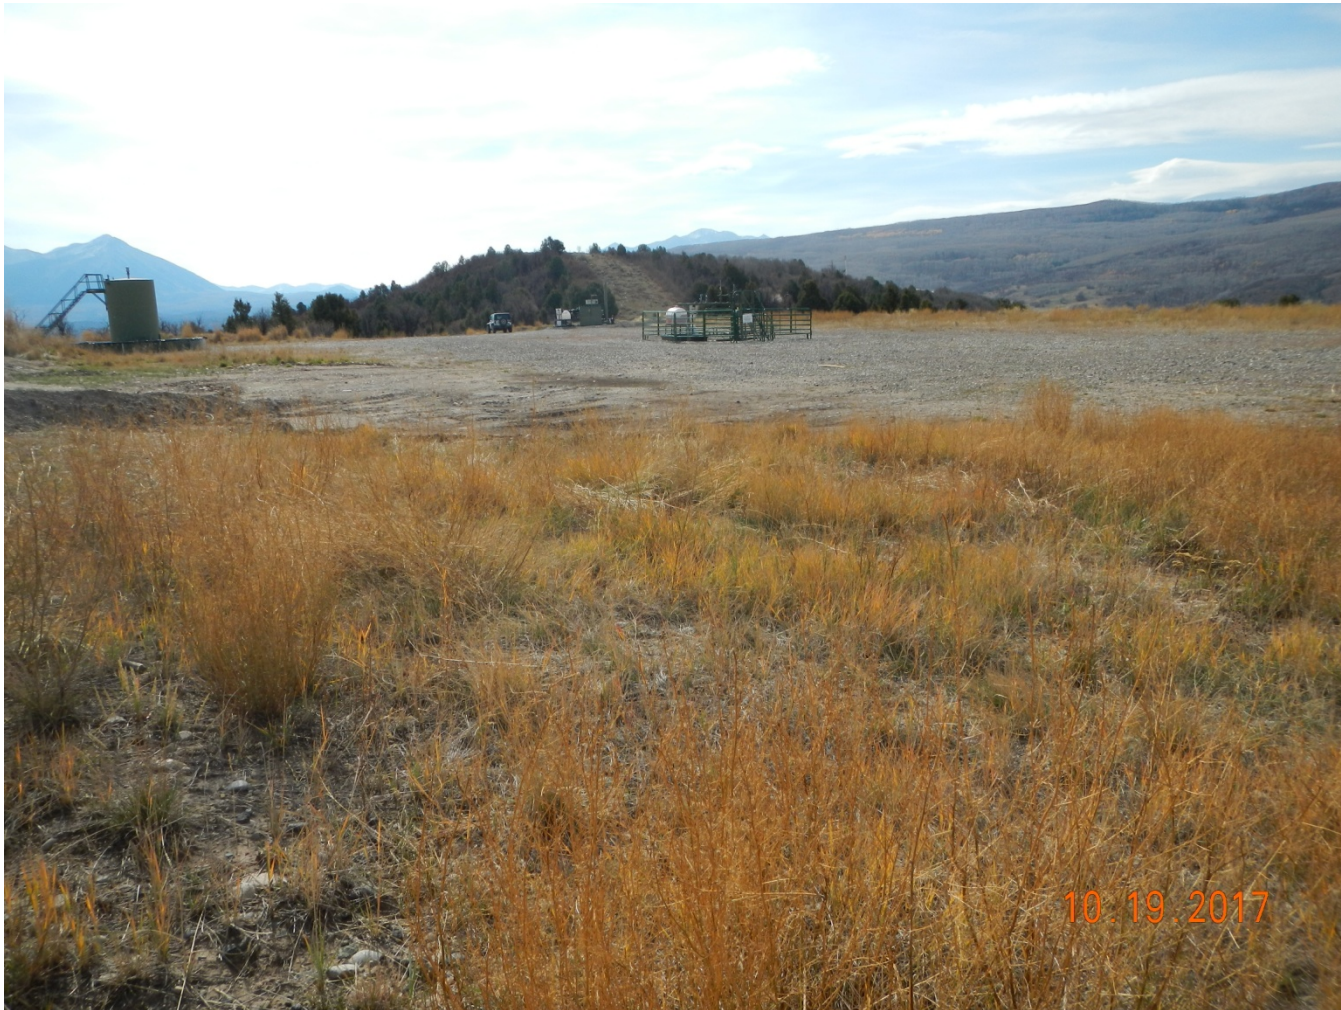
Photo 1. View from the northern corner of the project area facing center.

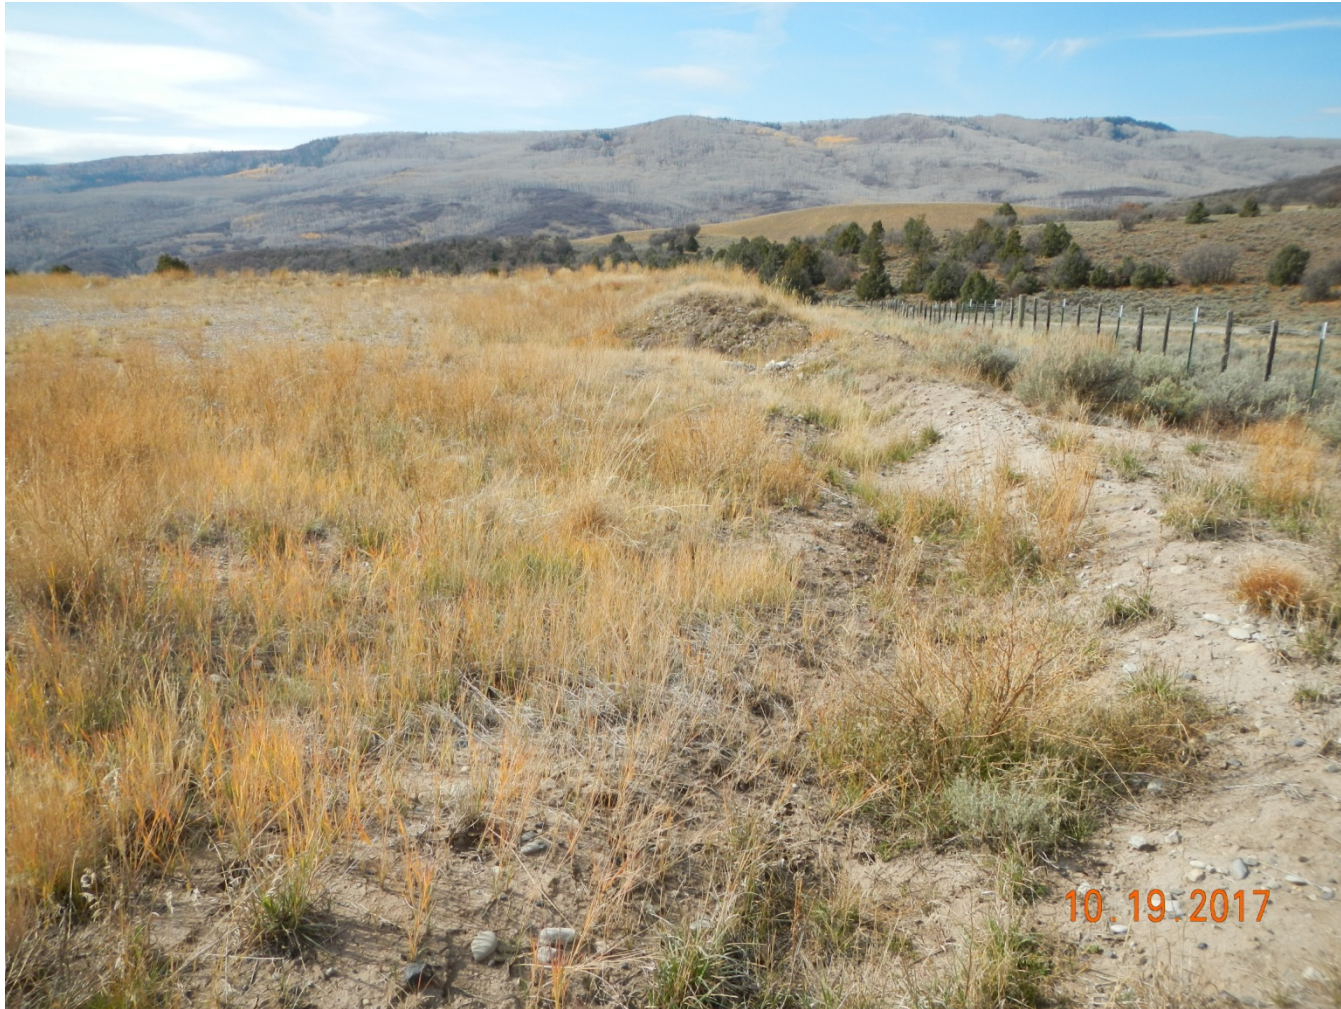
Photo 2. View of the northern portion of the project area from the northern corner facing southwestward. Revegetation is progressing within the outer revegetation areas with western wheatgrass (*Pascopyrum smithii*) and sleepy grass (*Achnatherum robustum*).

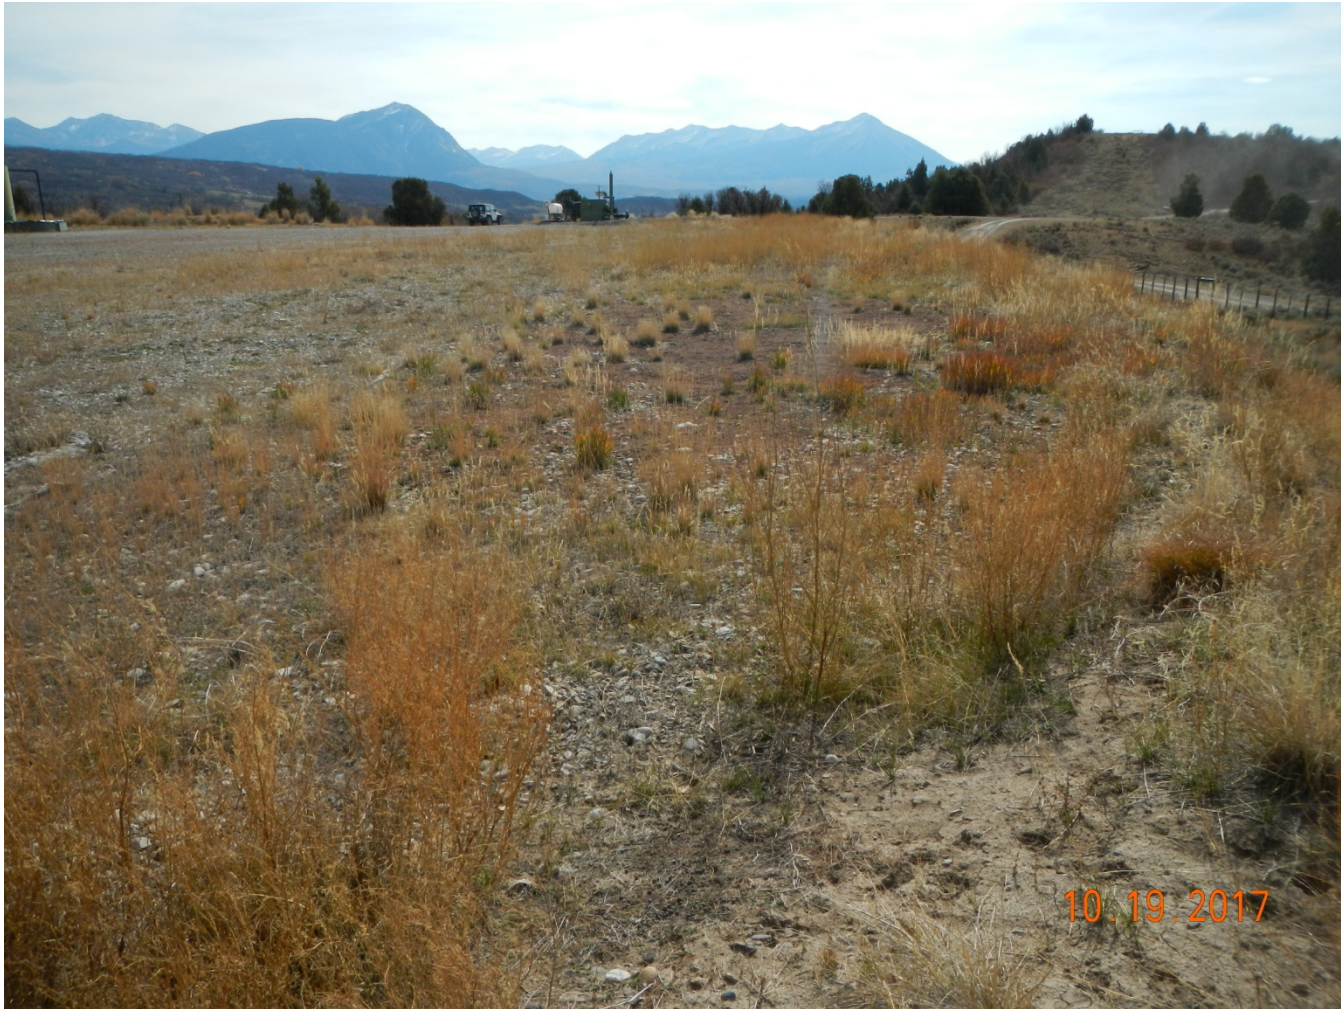
Photo 3. View of the western portion of the project area from the northwestern corner facing southward.

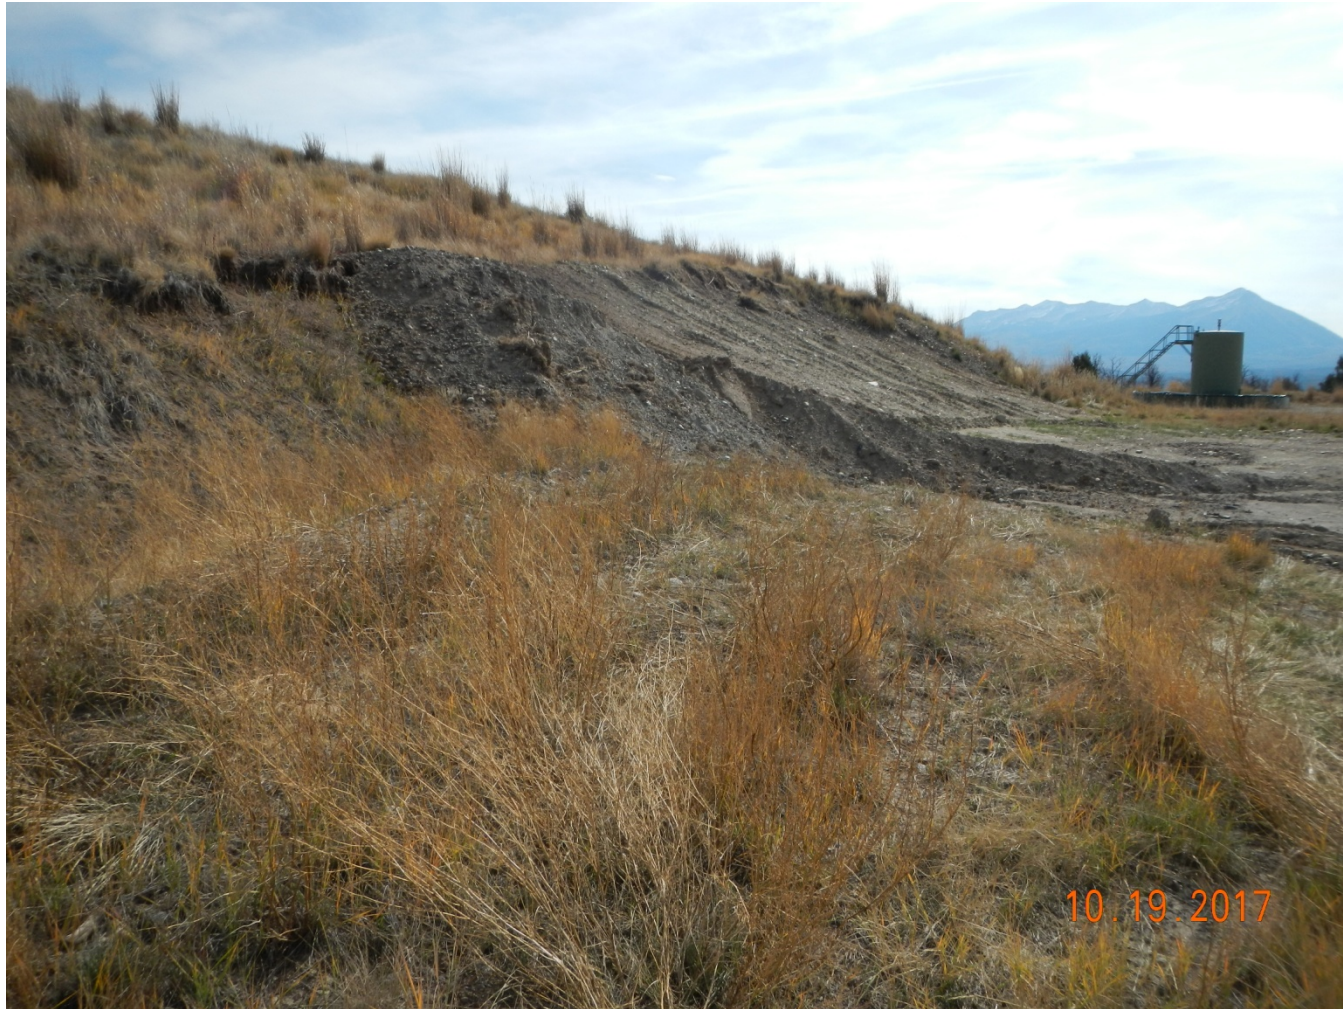
Photo 4. View of area in the eastern portion of the project area with disturbed soil. Per onsite discussion with Gunnison Energy representative, area of disturbed soil in the eastern project area is from fill material brought in from road maintenance activities with the intention to reduce the slope of the eastern cut slope.

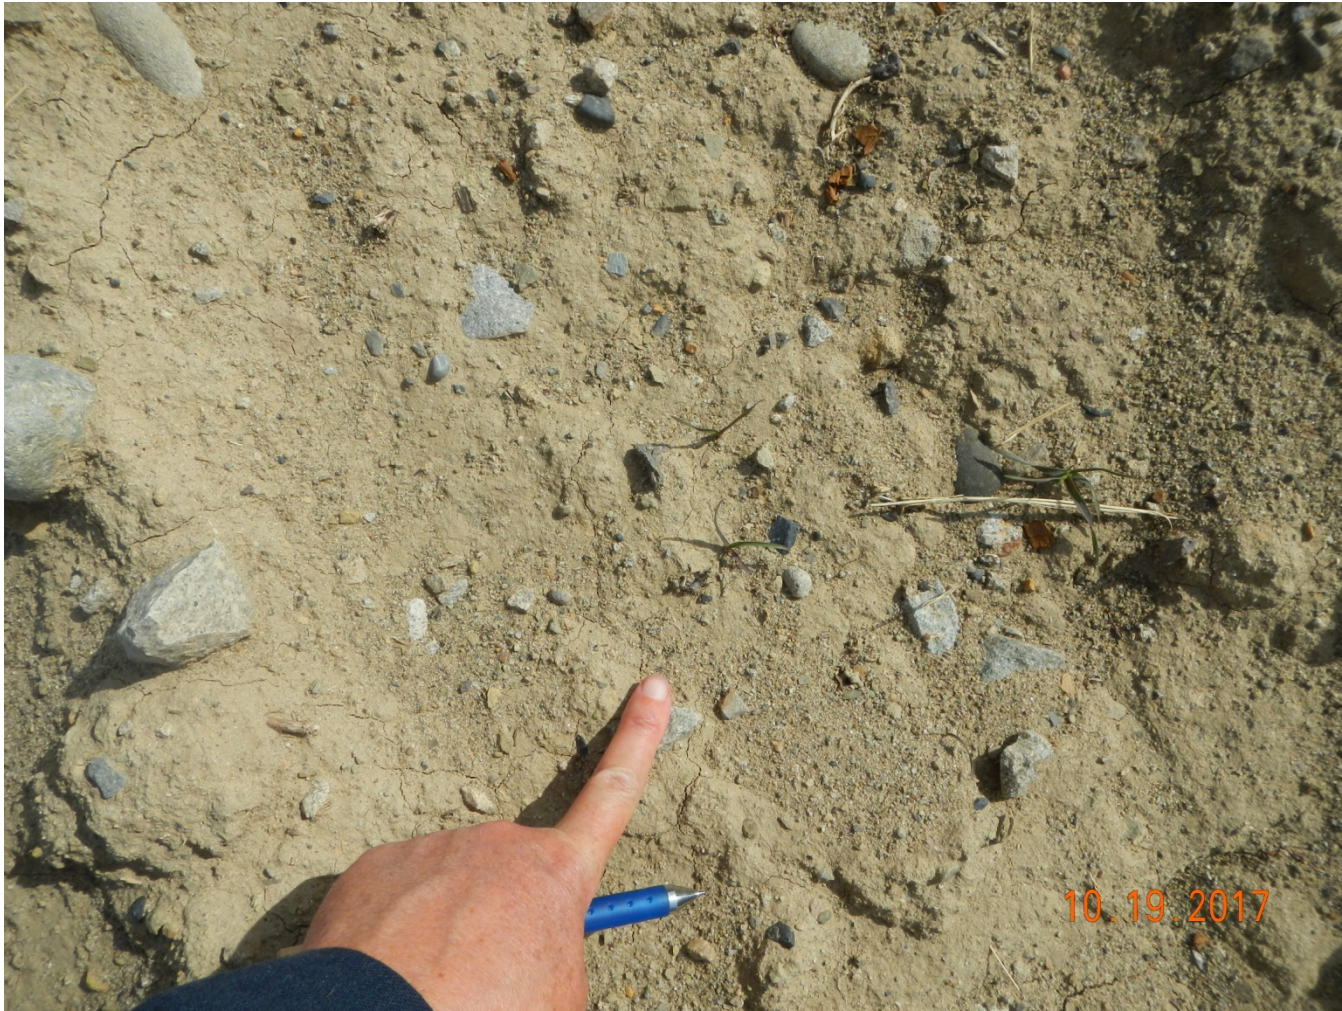
Photo 5. View of grass seedlings germinating in the eastern portion of the project area where there is recent soil disturbance.
