Inspection Photos
Location Name: UPRR 42 Pan Am N #3
API: 05-123-09102

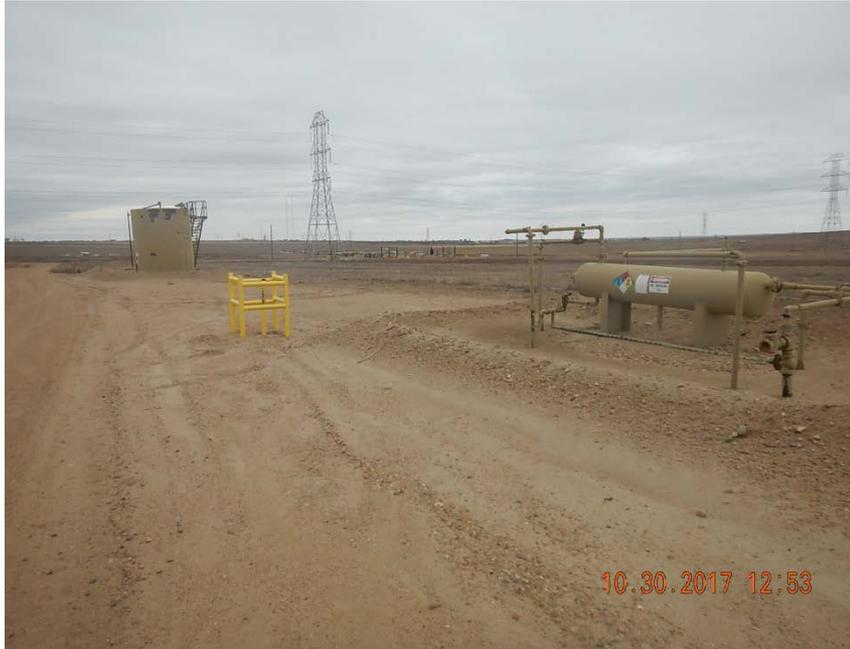
Photo 1: Location, looking NE

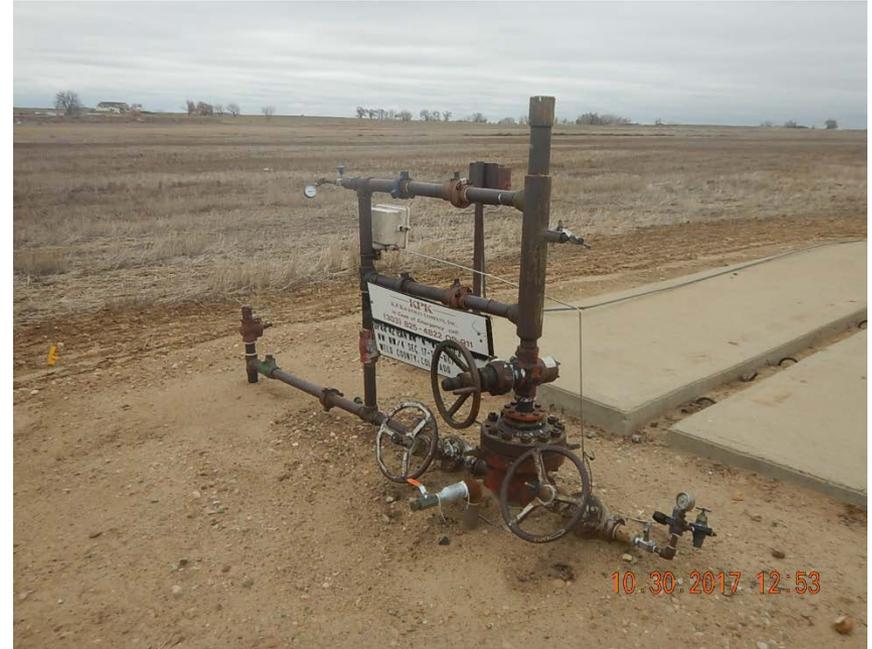
Photo 2: Wellhead, looking SE

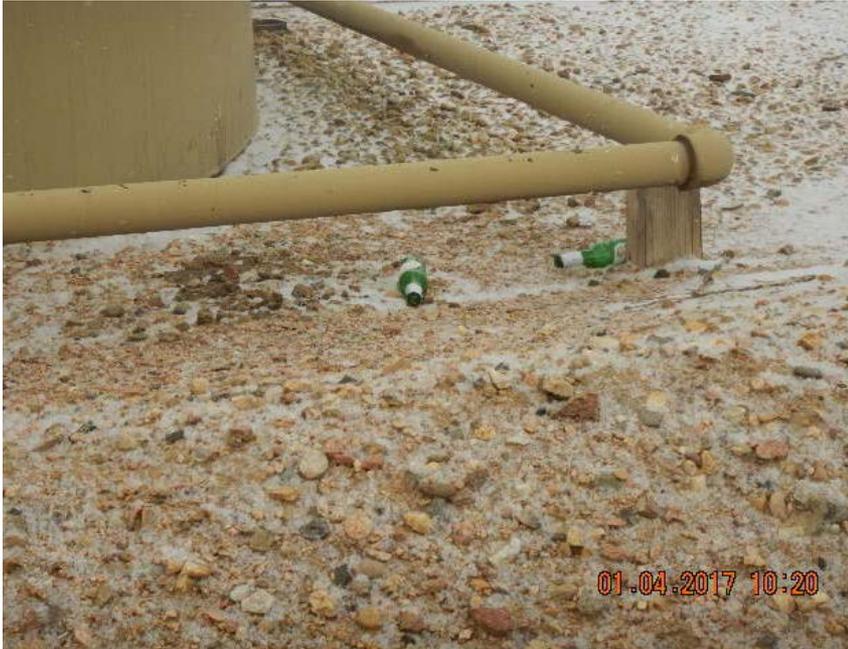
Photo from prior inspection for comparison

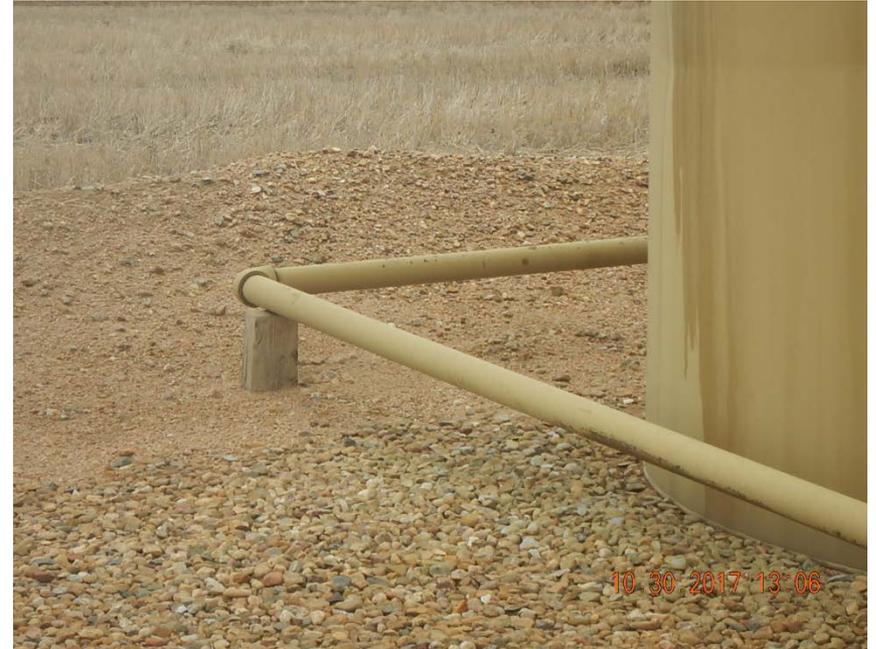
Photo 3: Trash removed

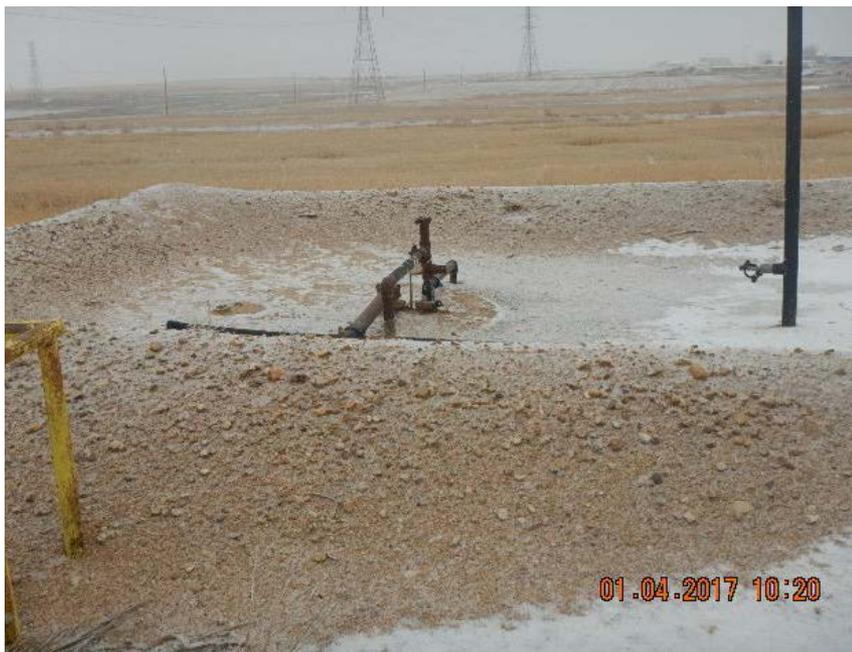
Photo from prior inspection for comparison

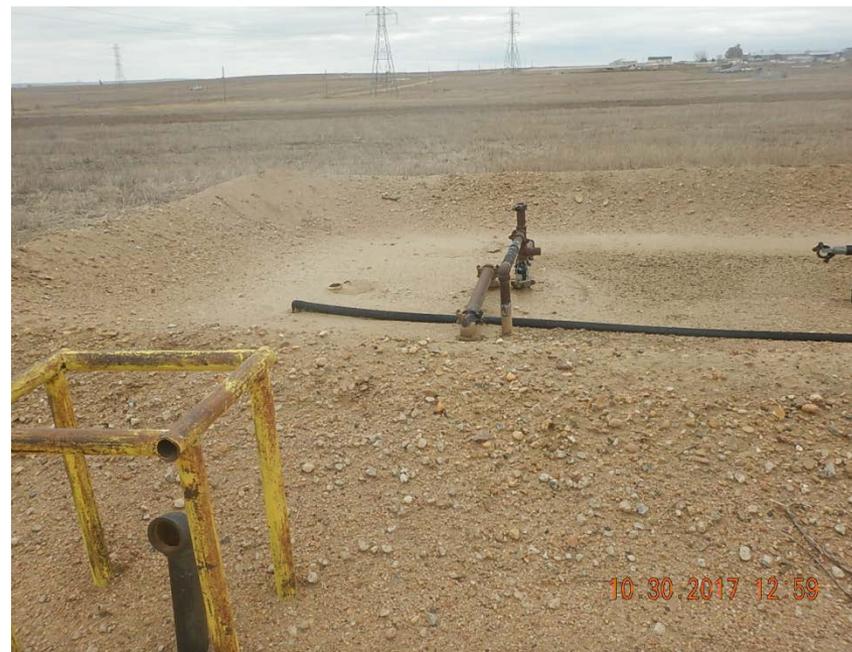
Photo 4: Produced water vault has no contents, capacities, safety labeling

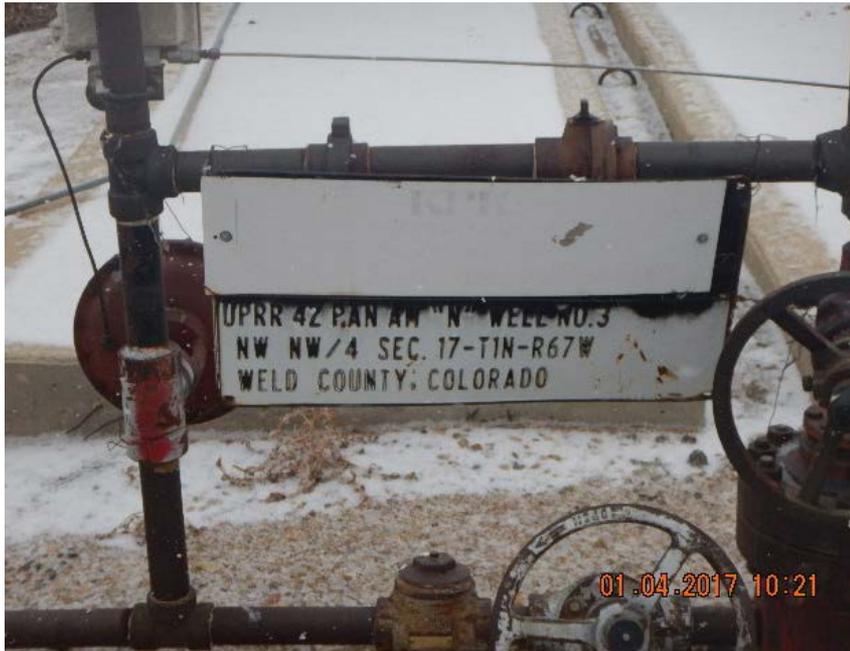
Photo from prior inspection for comparison

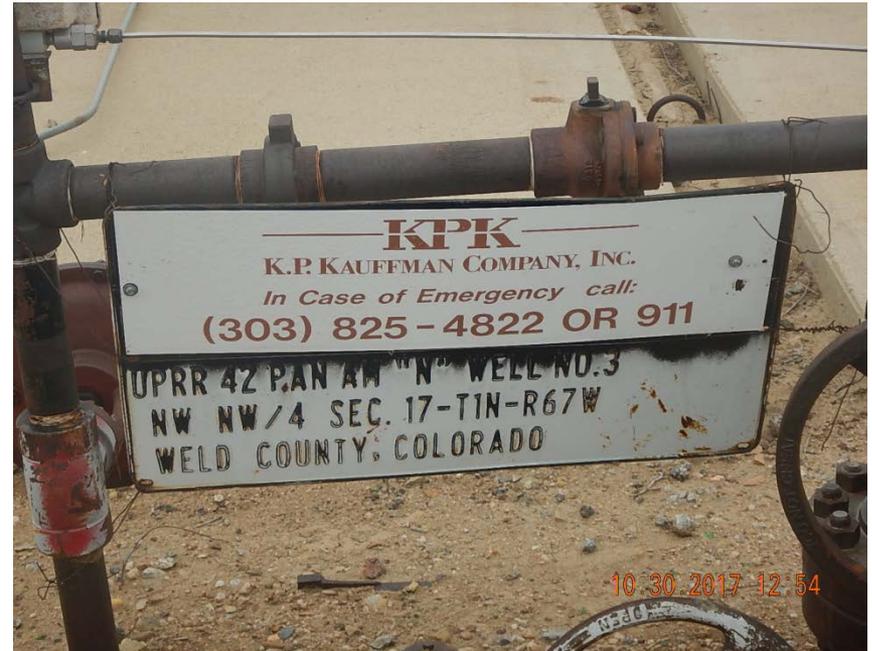
Photo 5: Decal replaced

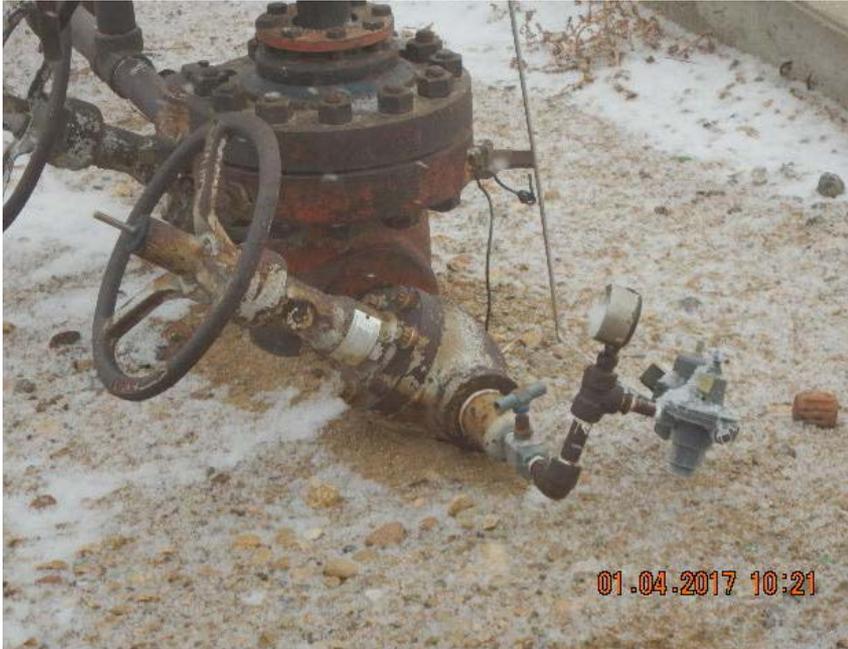
Photo from prior inspection for comparison

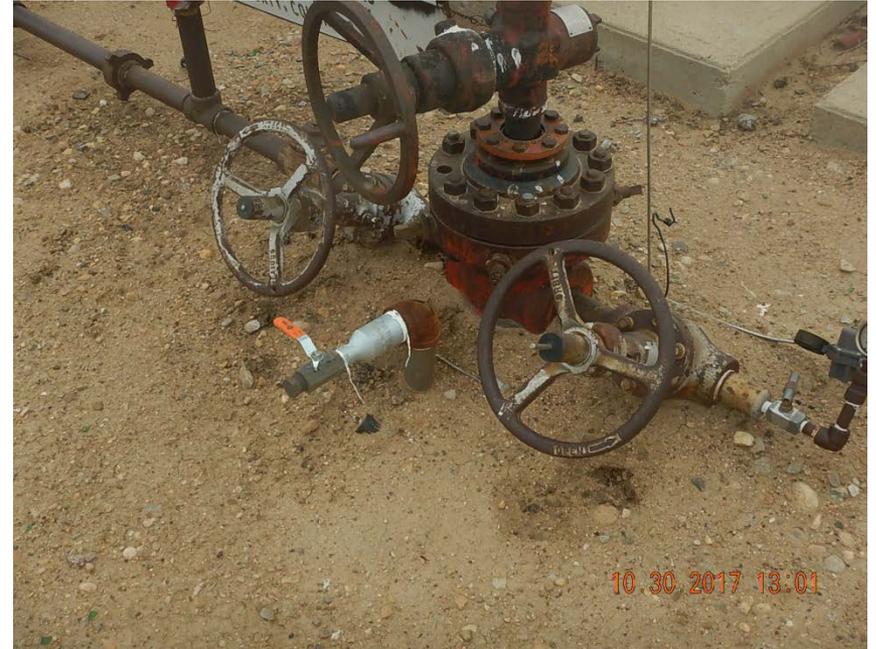
Photo 6: Bradenhead plumbed to surface.

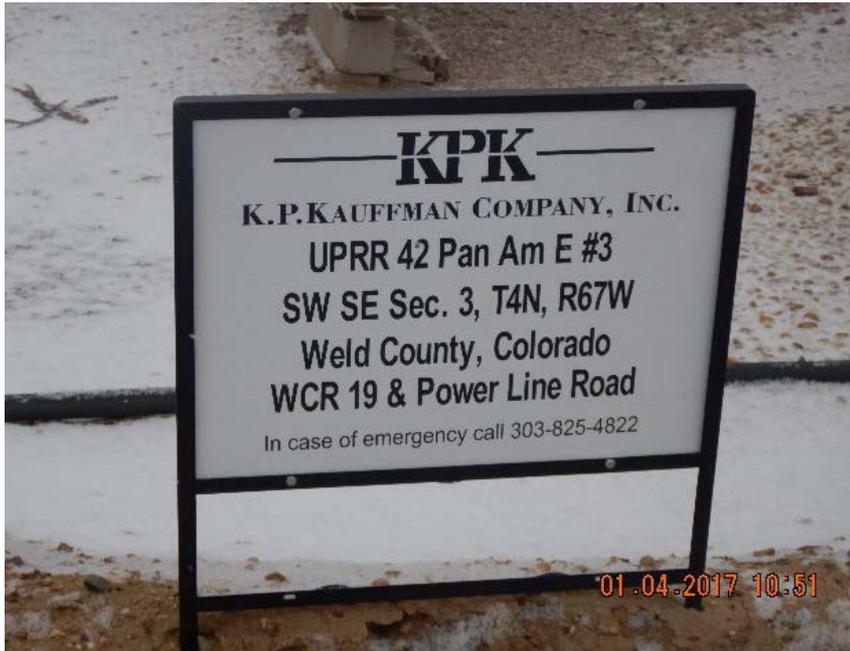
Photo from prior inspection for comparison

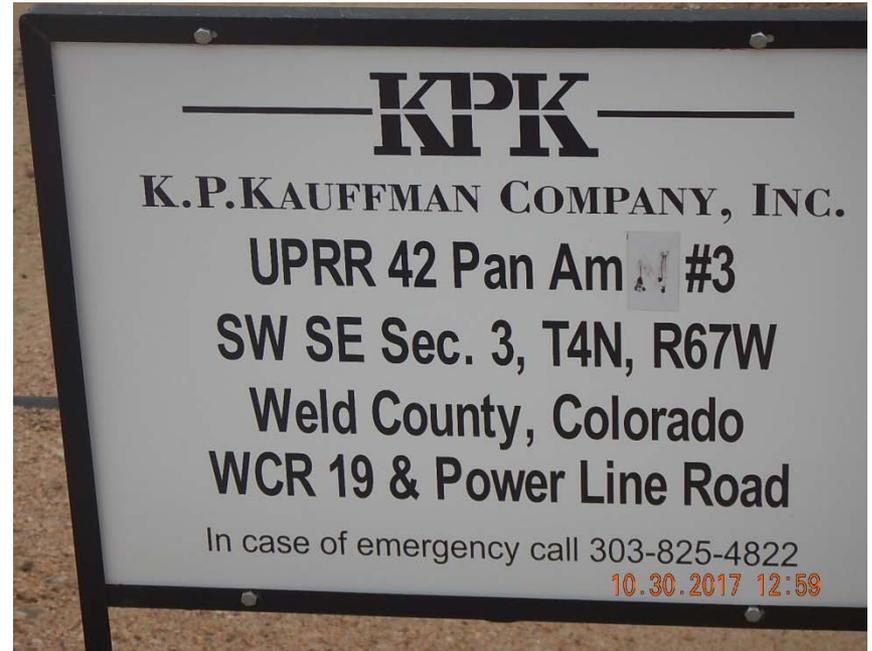
Photo 7: Battery sign corrected.

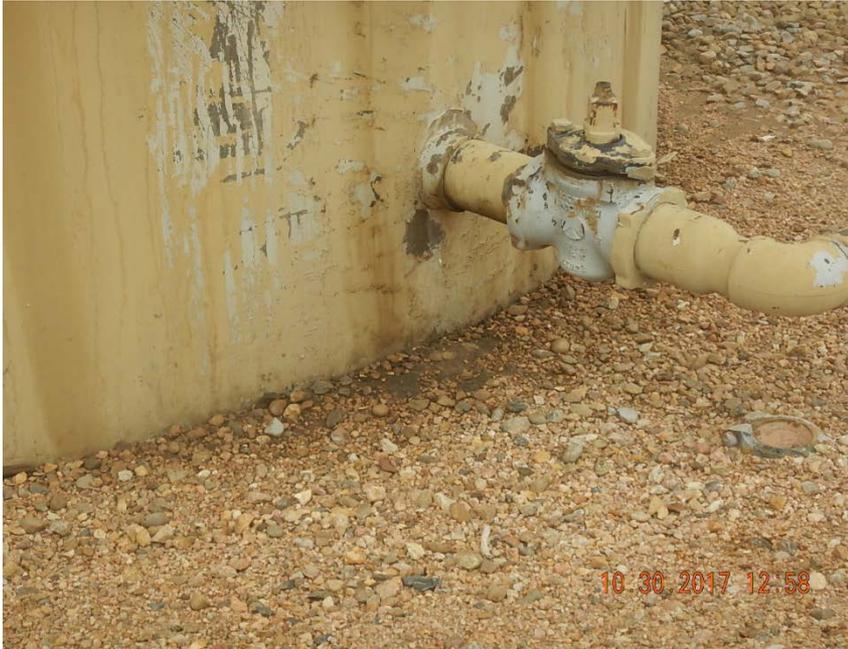
Photo 8: Stained soil at oil tank

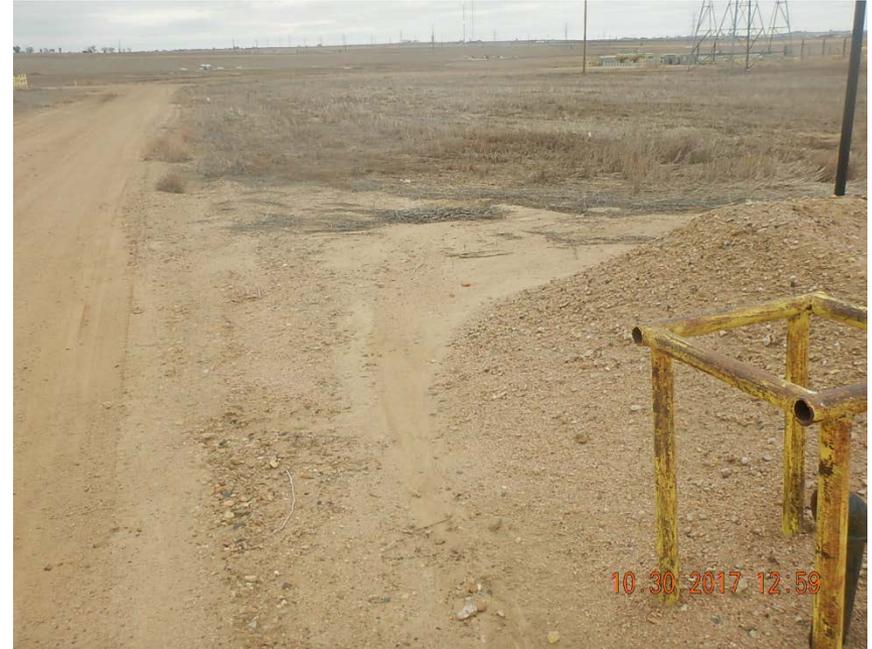
Photo 9: Stormwater erosion NW of battery
