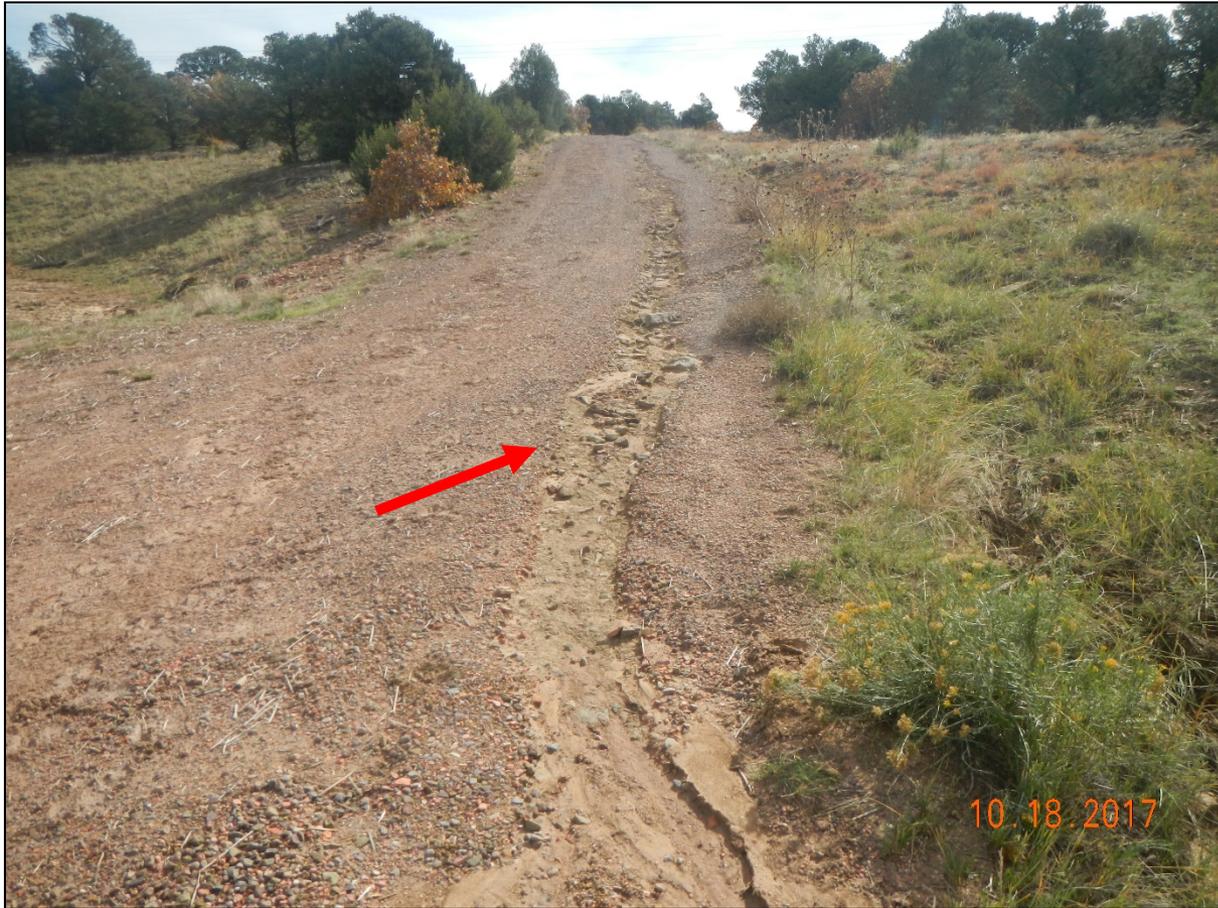
**Photo 1.** Facing southeast along the access road. There are signs of erosion occurring down the road.

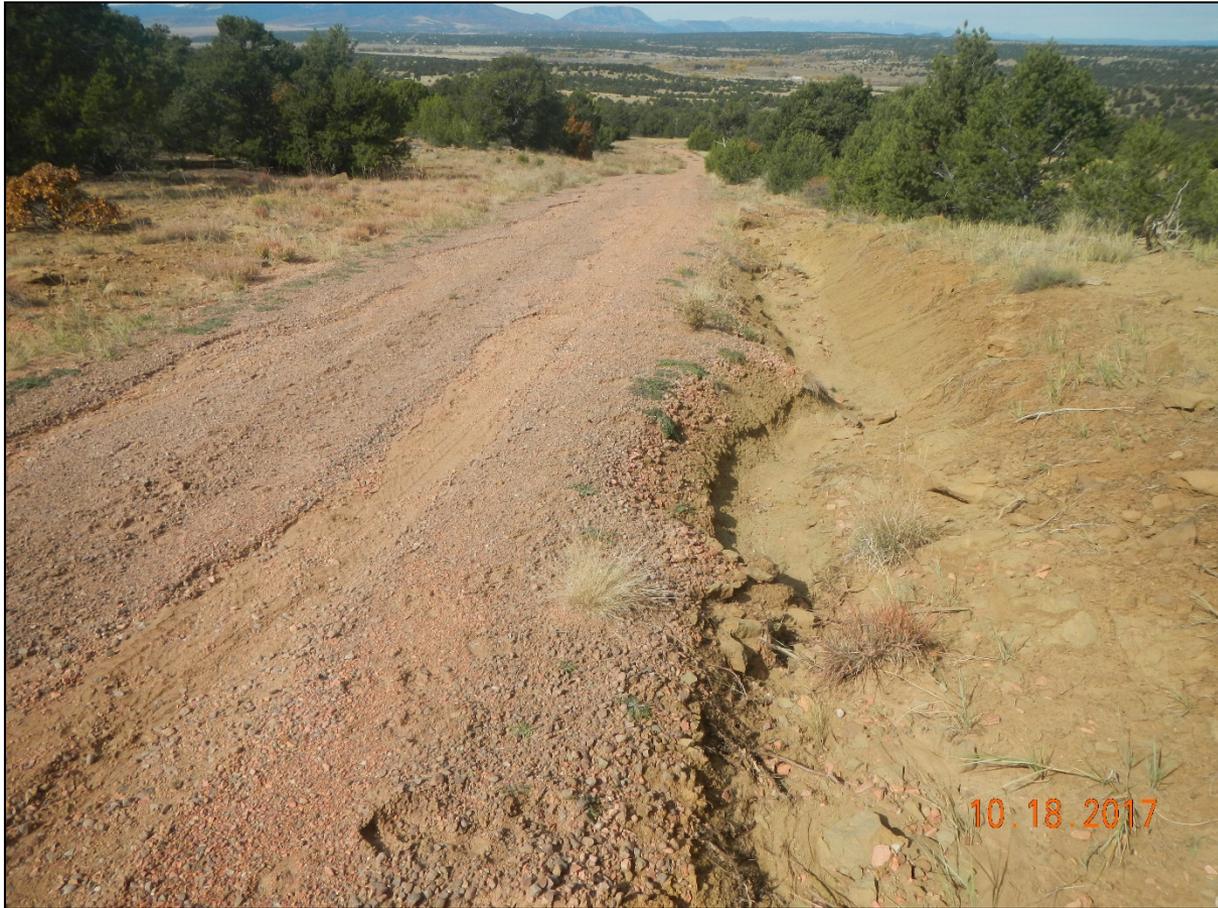
**Photo 2.** Facing back northwest along the access road. There is stormwater erosion occurring along the side of the road and no BMP's are installed.

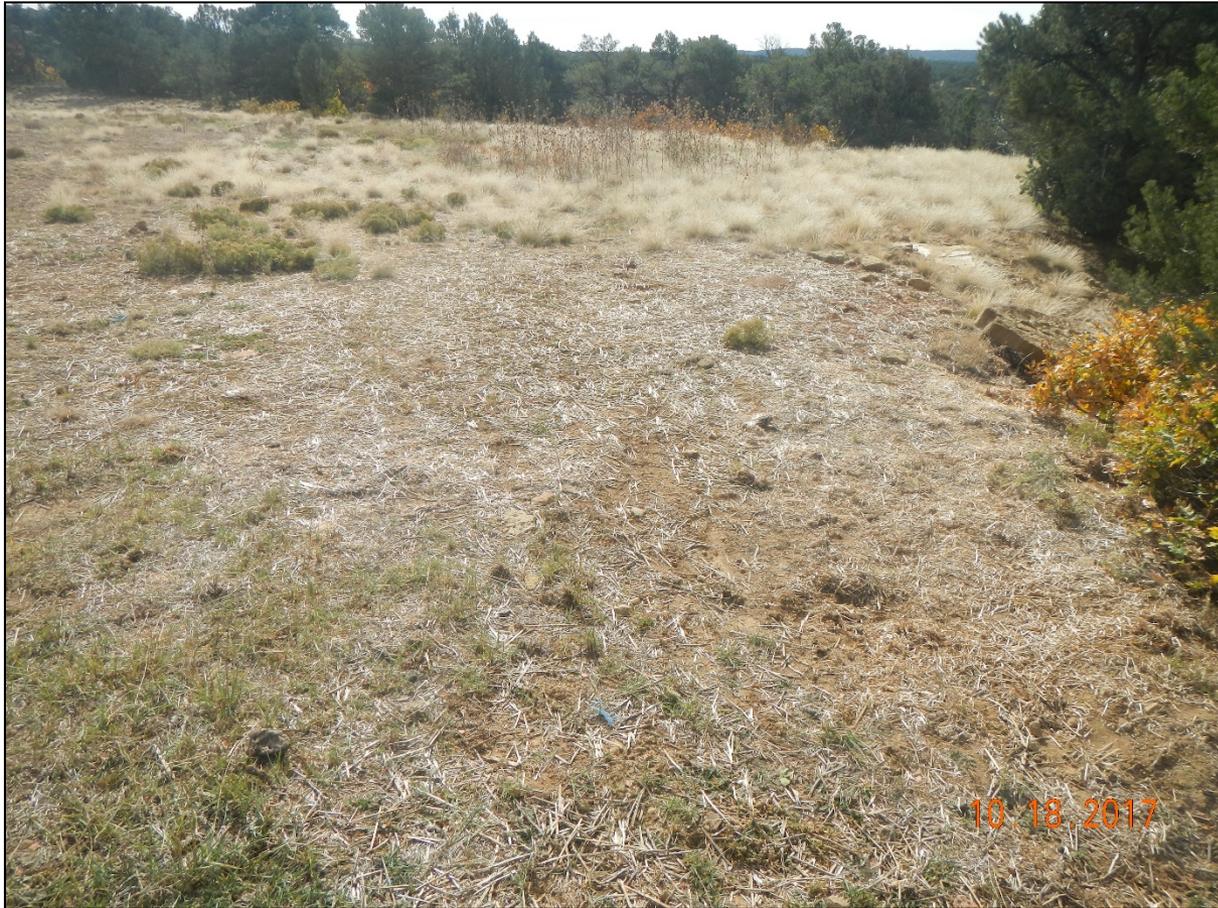
**Photo 4.** Facing southeast toward the south side of the location. Wood straw mulch has been applied to bare soil areas.

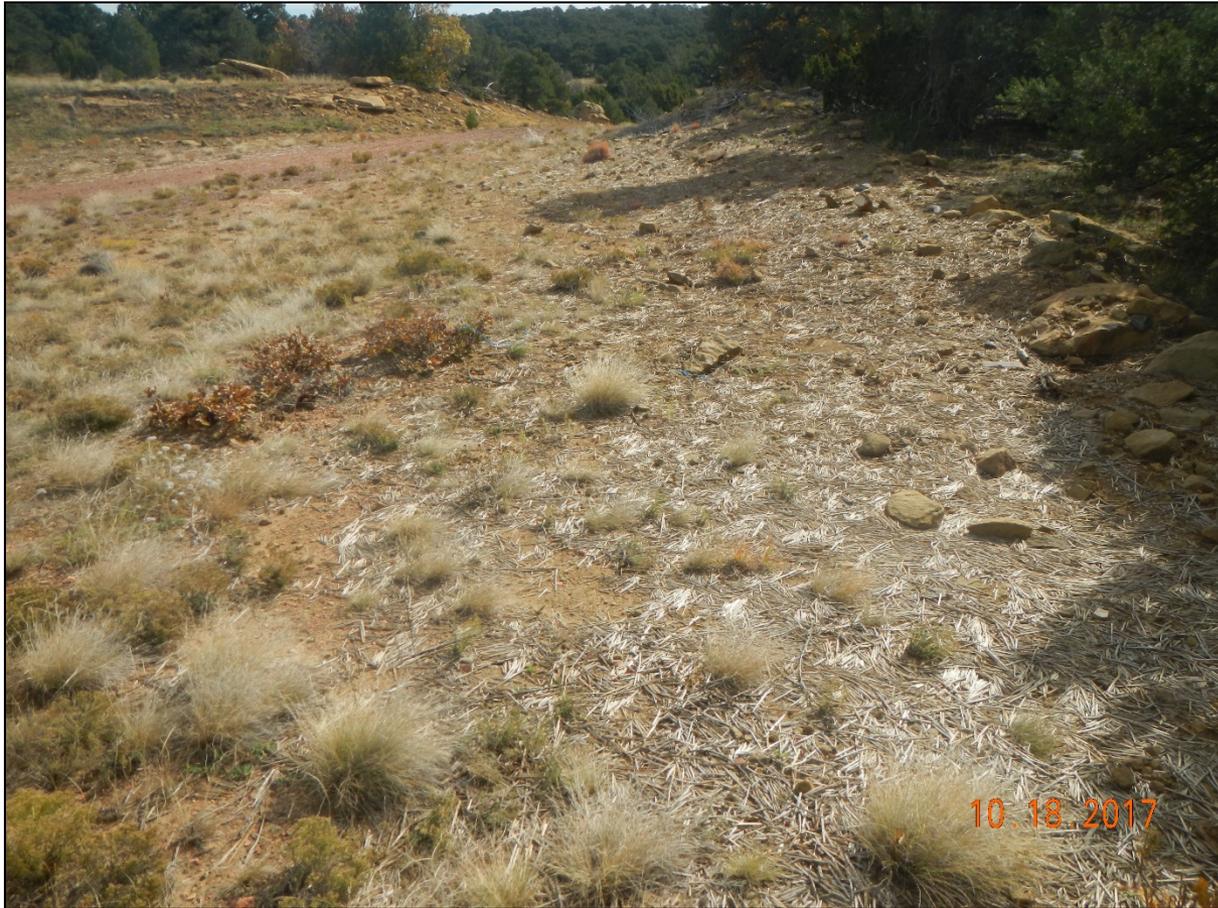
**Photo 5.** Facing east toward the south side of the location. Wood straw mulch has been applied to bare soil areas.

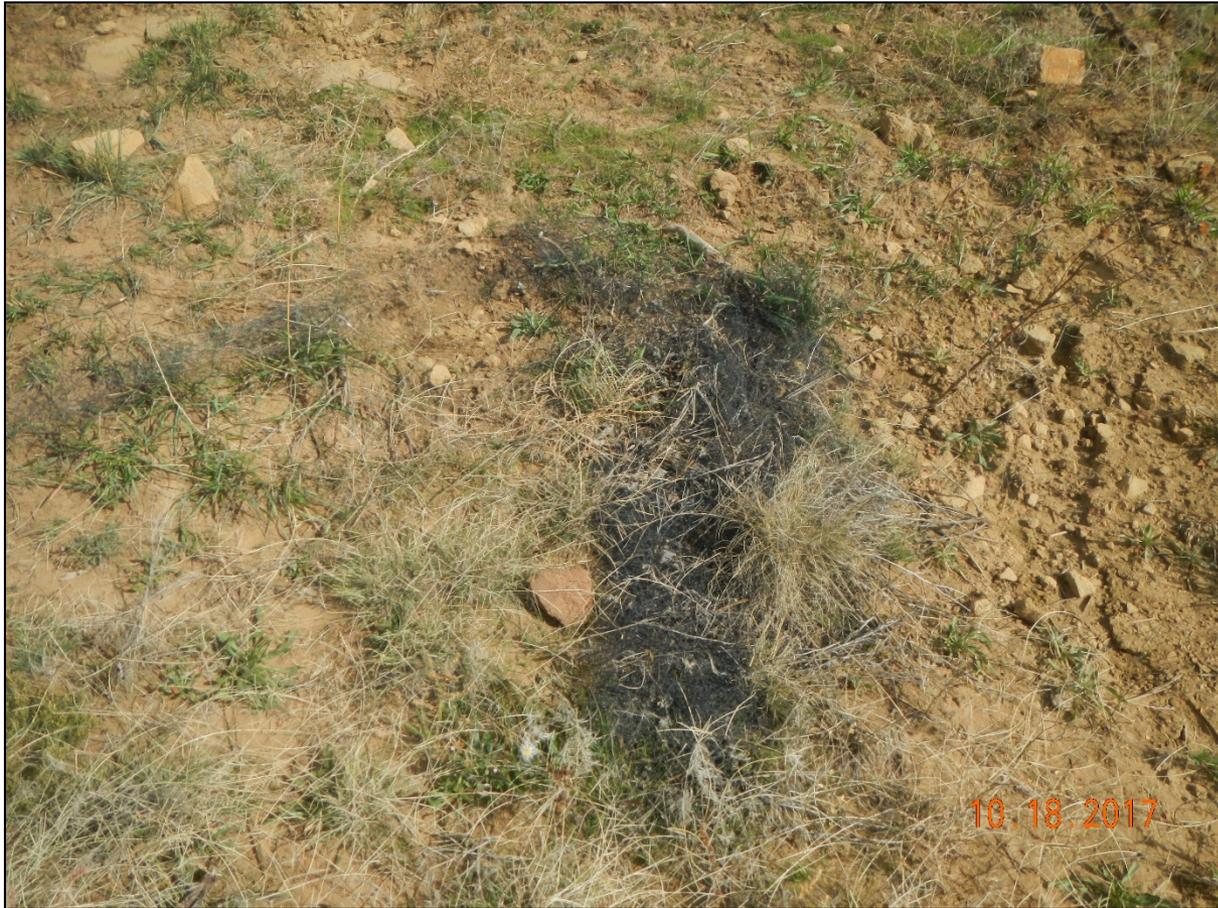
**Photo 7.** There is still some plastic debris along the southeast cut slope.
