Inspection Photos  
Location Name: Aries 34-12  
API: 05-081-07088

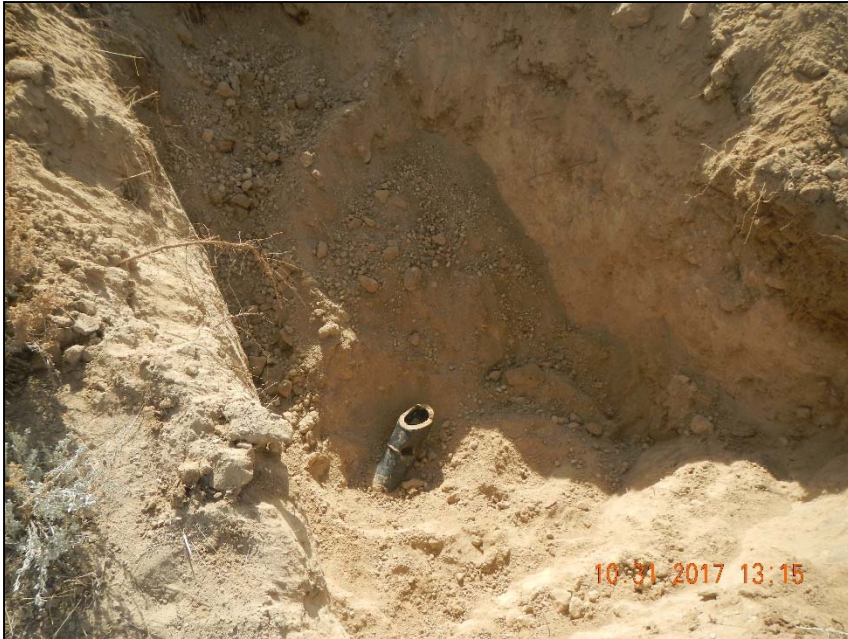
**Photo 1. Excavation of flowlines.**

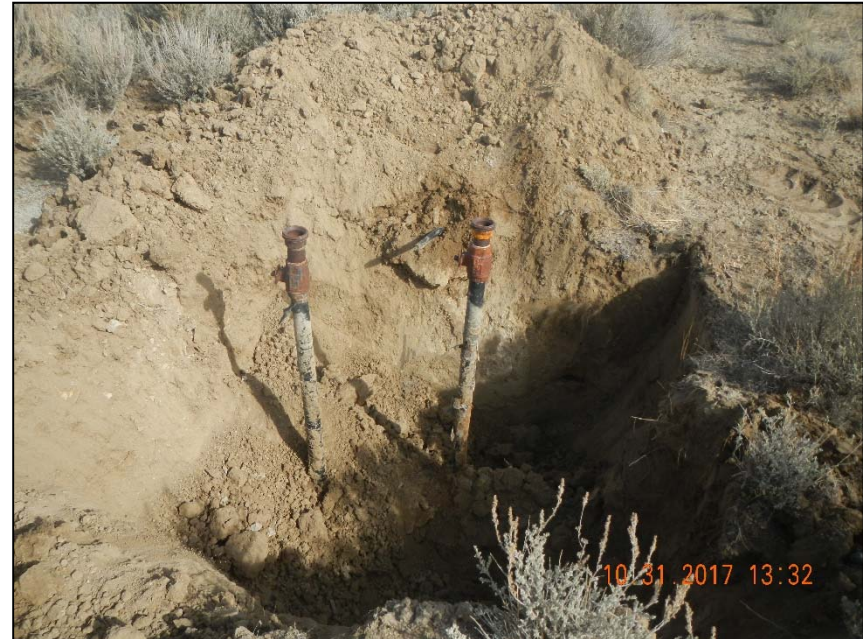
**Photo 2. Excavation of flowlines.**

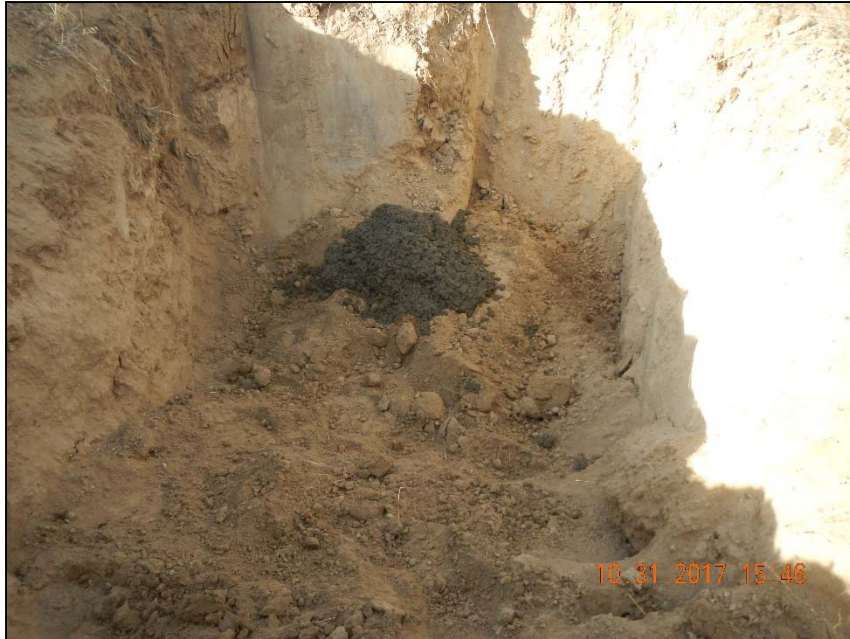
**Photo 3. Surface of cement plug.**

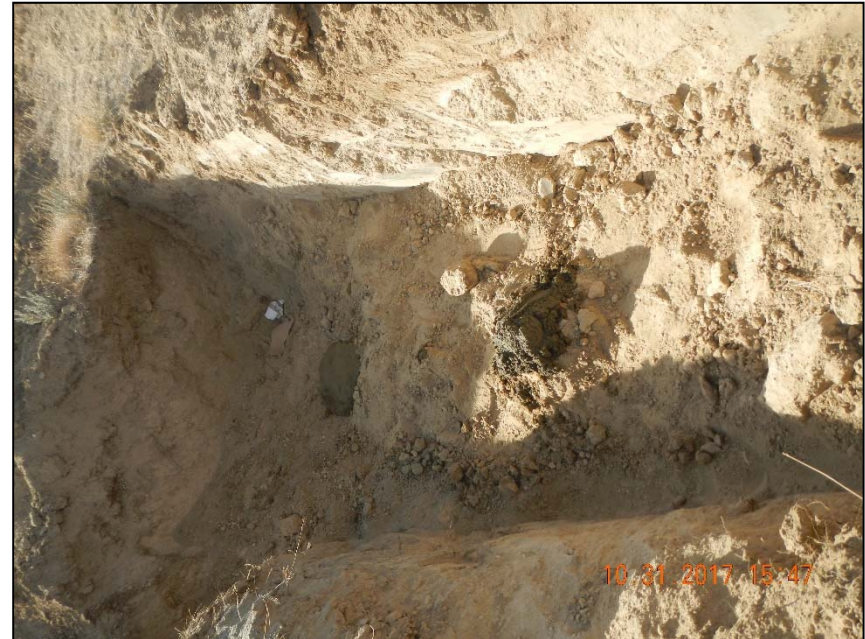
**Photo 4. Surface of cement plugs.**

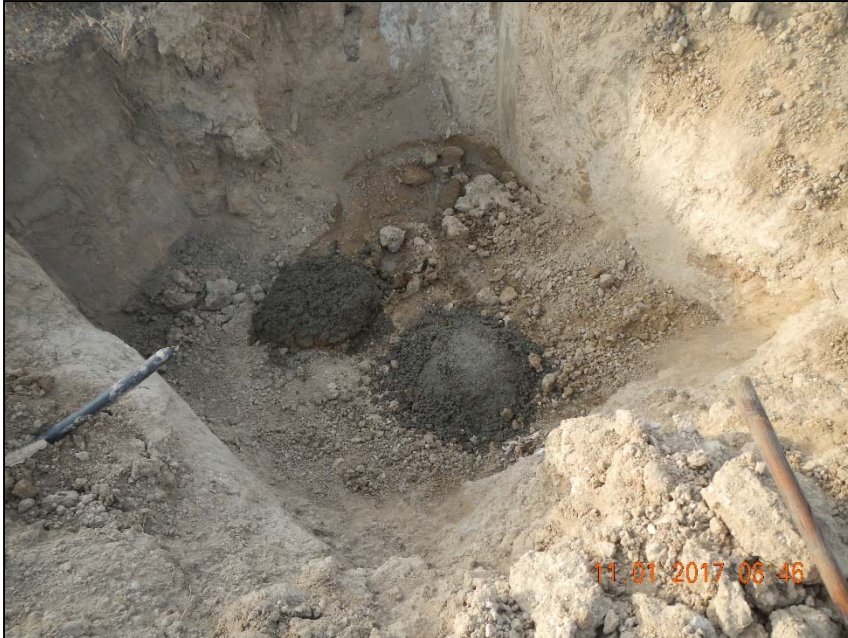
**Photo 5. Surface of cement plugs.**

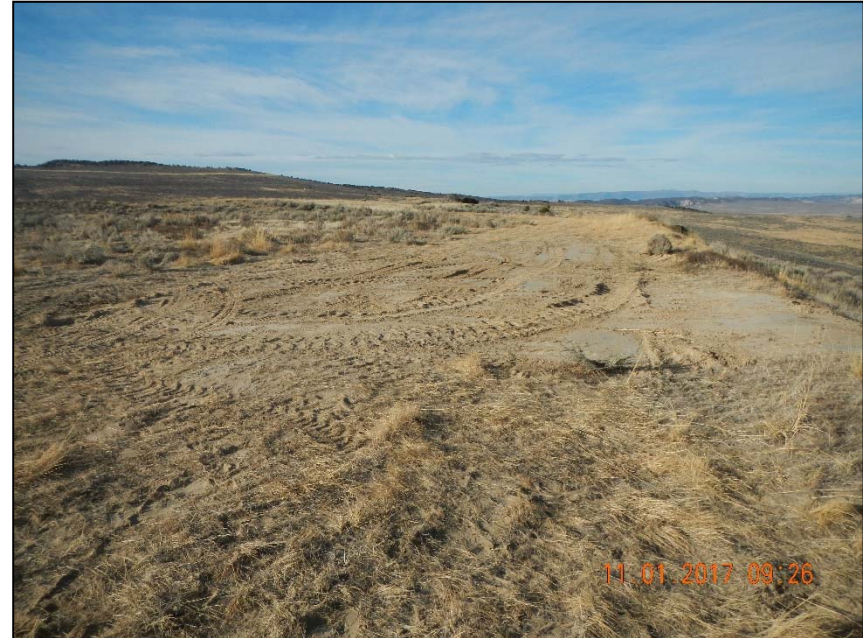
**Photo 6. Backfilled area over abandoned flowlines.**

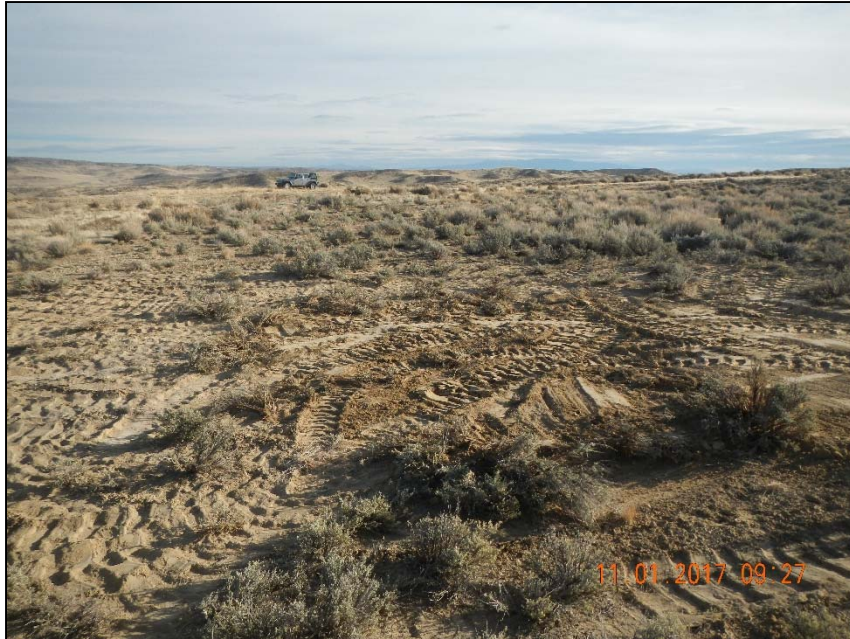
**Photo 7. Overview of location taken from southwest corner facing northeast.**

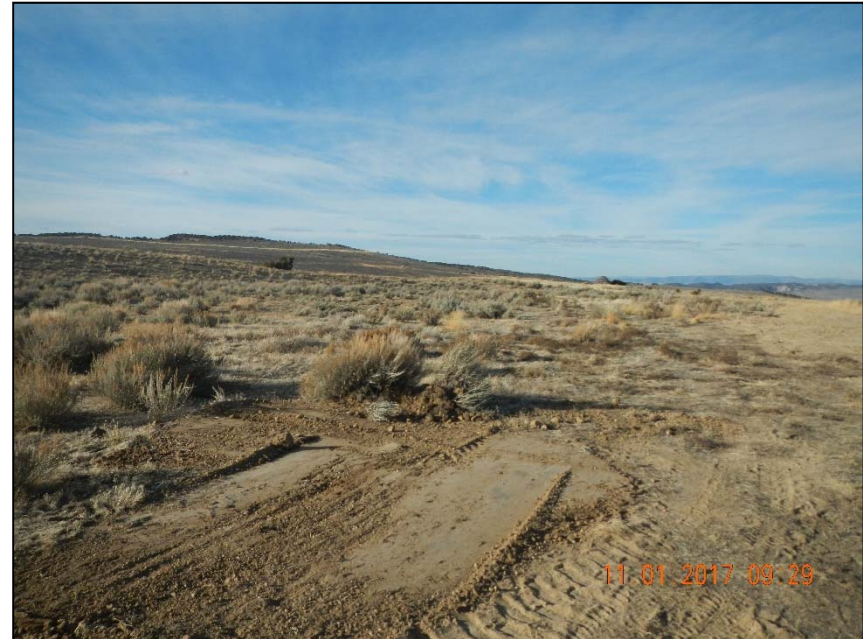
**Photo 8. Overview of location taken at entrance facing west.**
