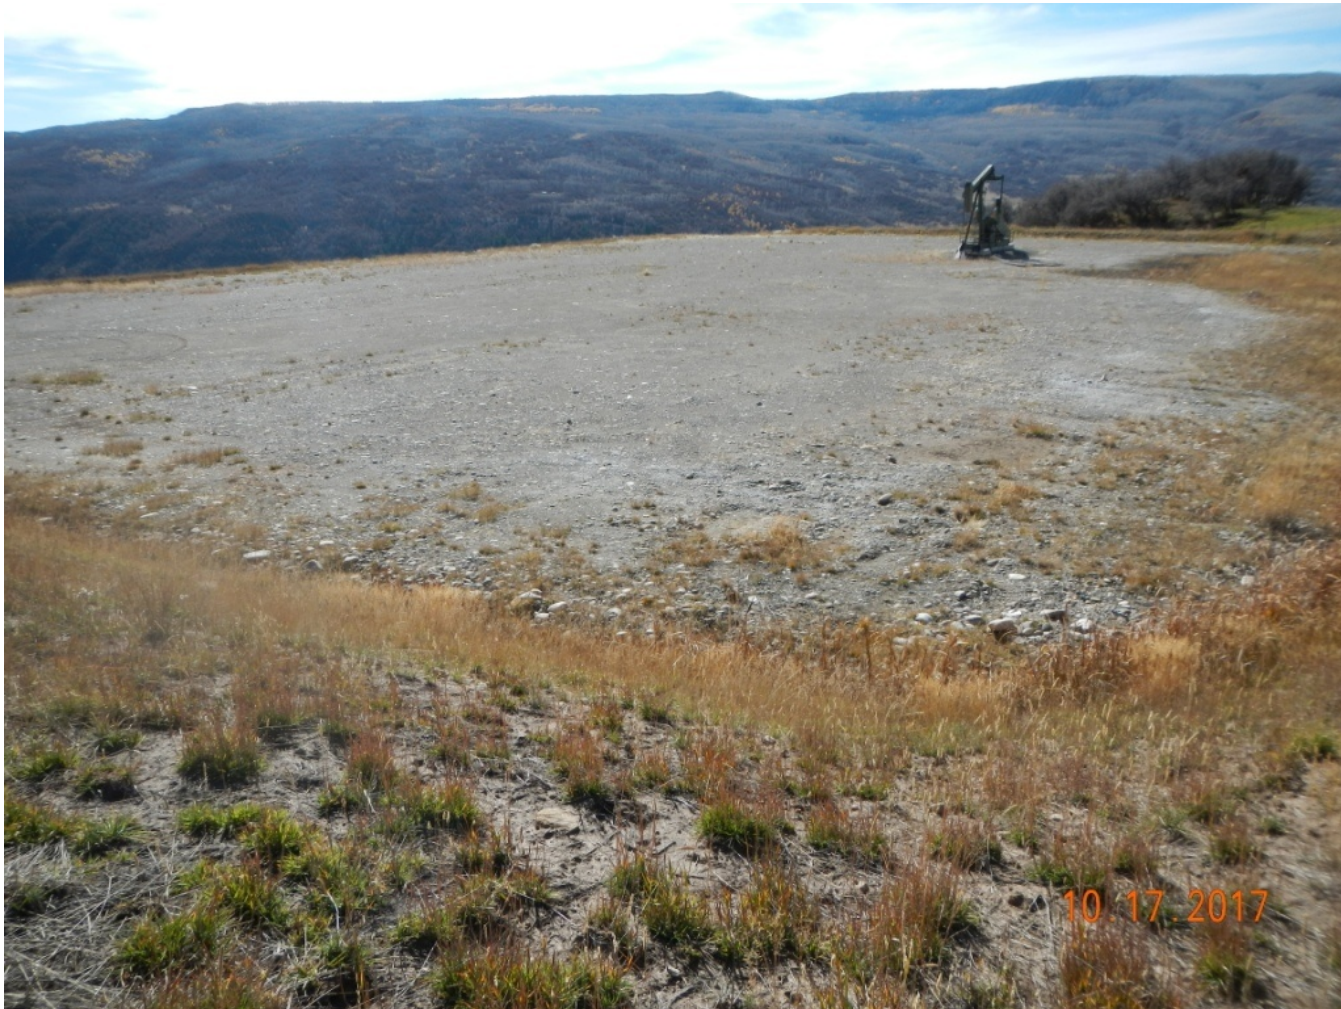
Photo 1. View from the northeastern corner of the project area facing center.

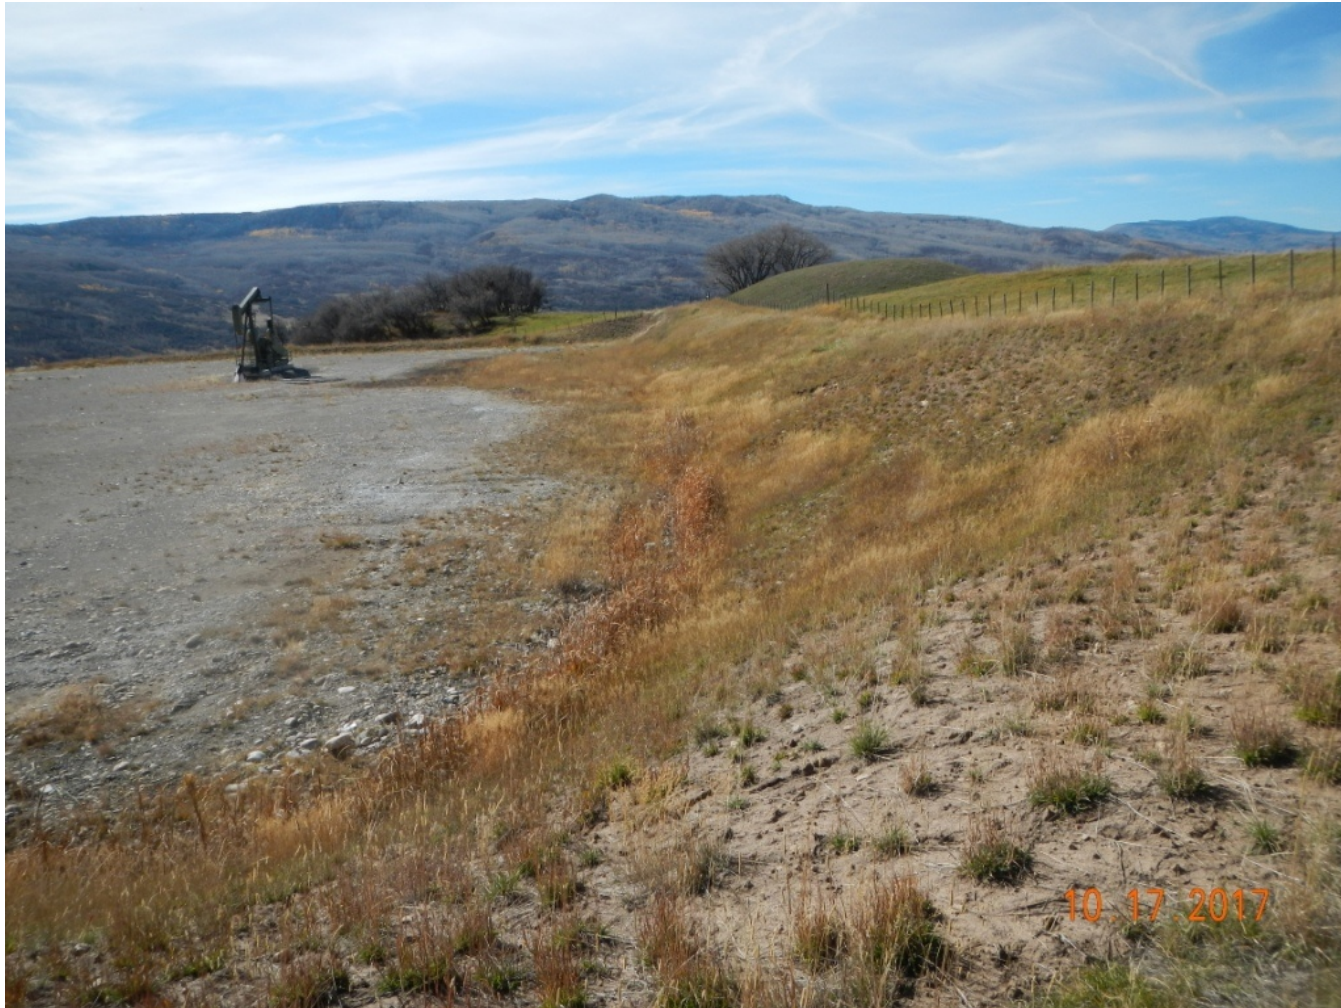
Photo 2. View of the northern portion of the project area from the northeastern corner facing westward. Revegetation in the outer portions of the project disturbance is progressing with grasses such as western wheatgrass (*Pascopyrum smithii*) and brome grass (*Bromus* sp.).

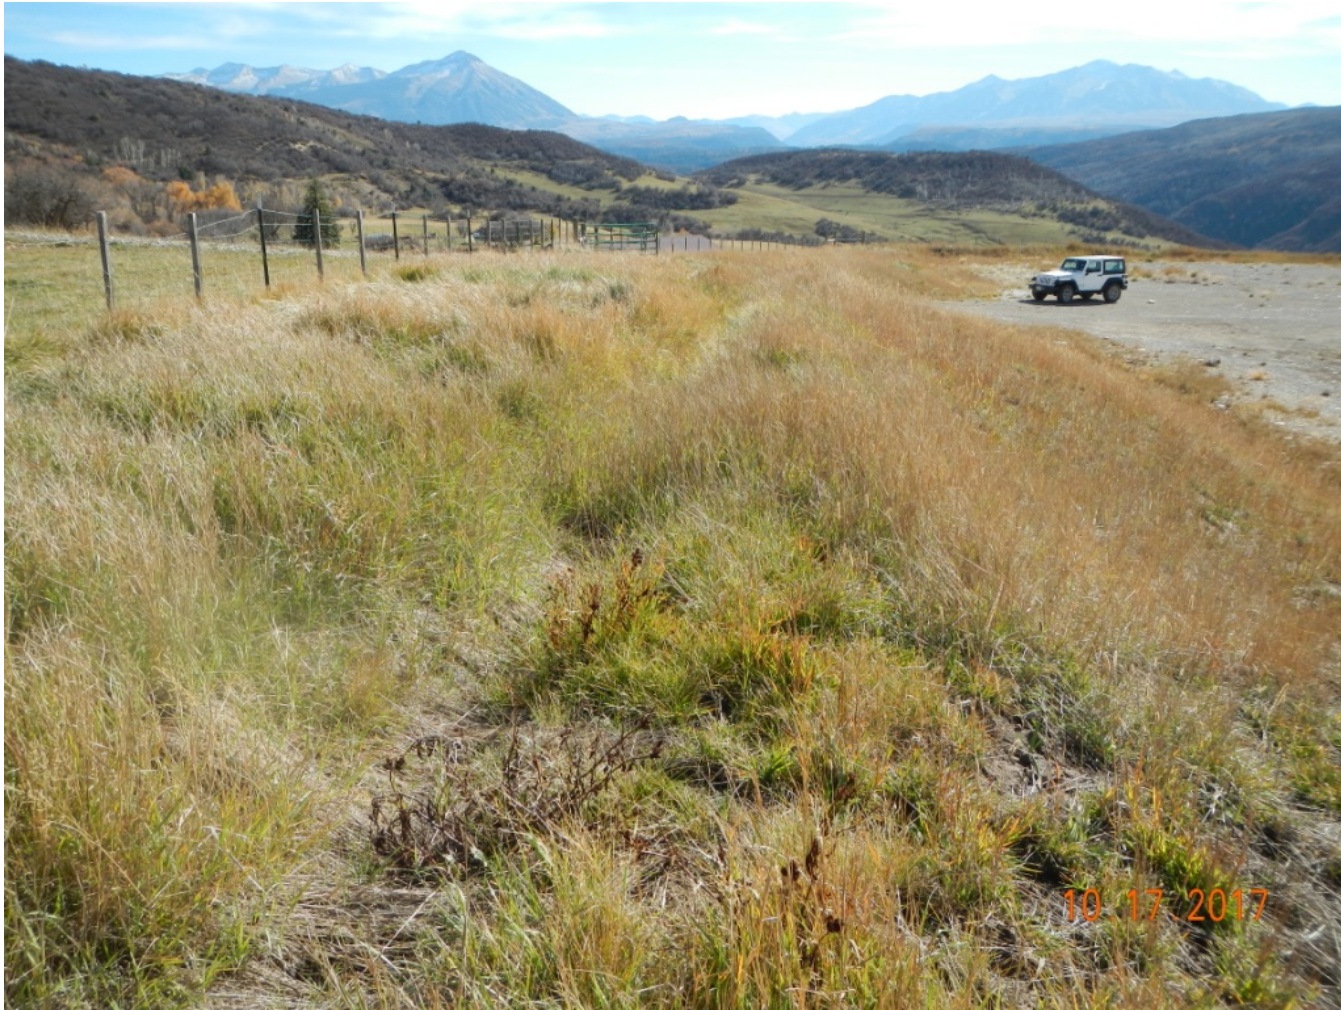
Photo 3. View of the eastern portion of the project area from the northeastern corner facing southward.

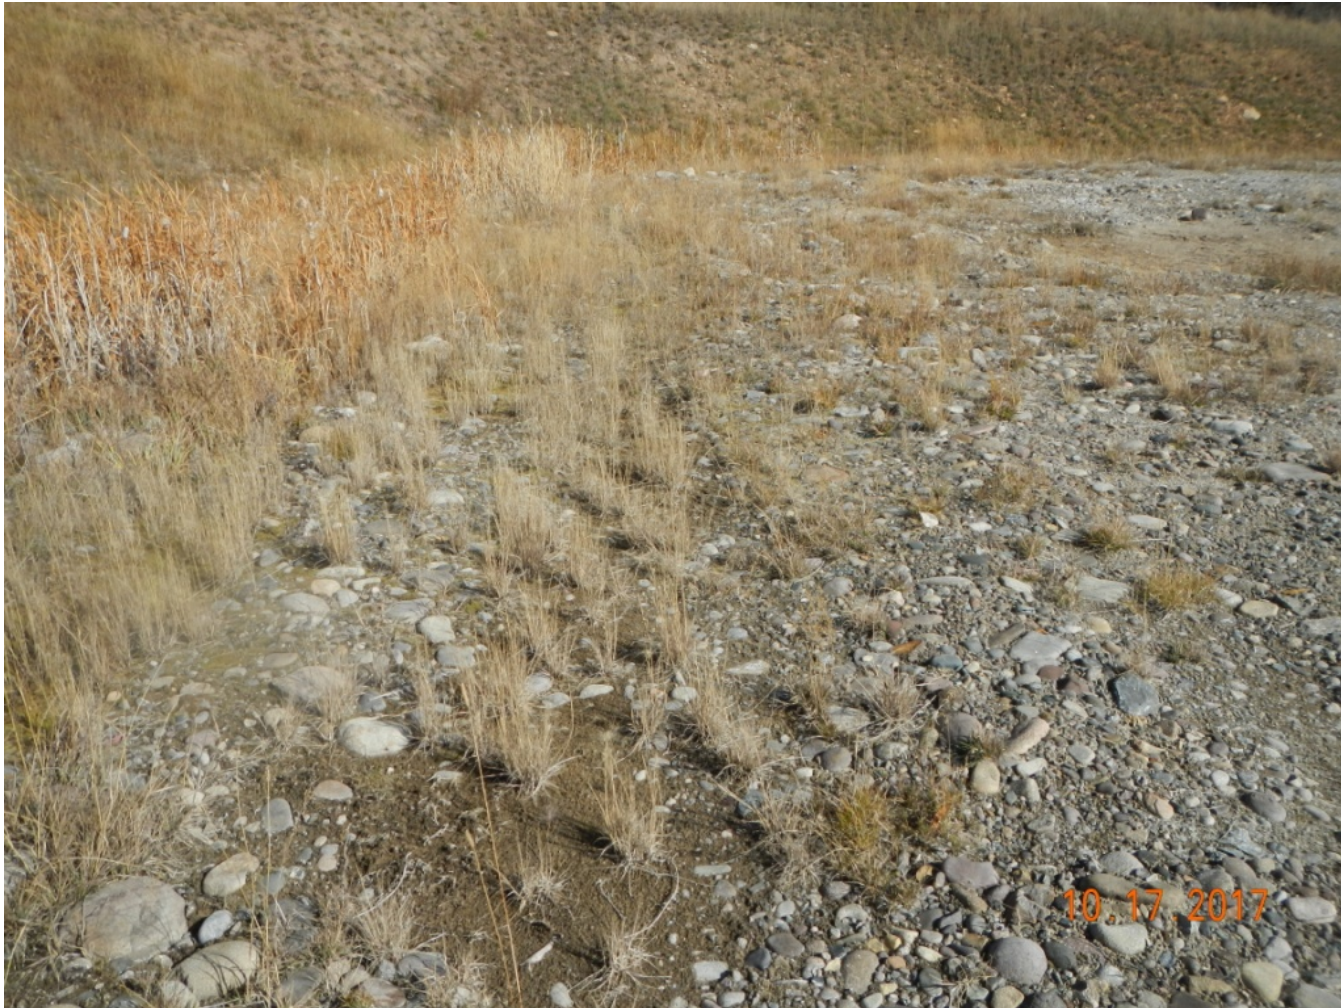
Photo 4. View of area in the northeastern portion of the working area, where tamarisk was observed in 2016 inspection. It does not appear to be present at this time.

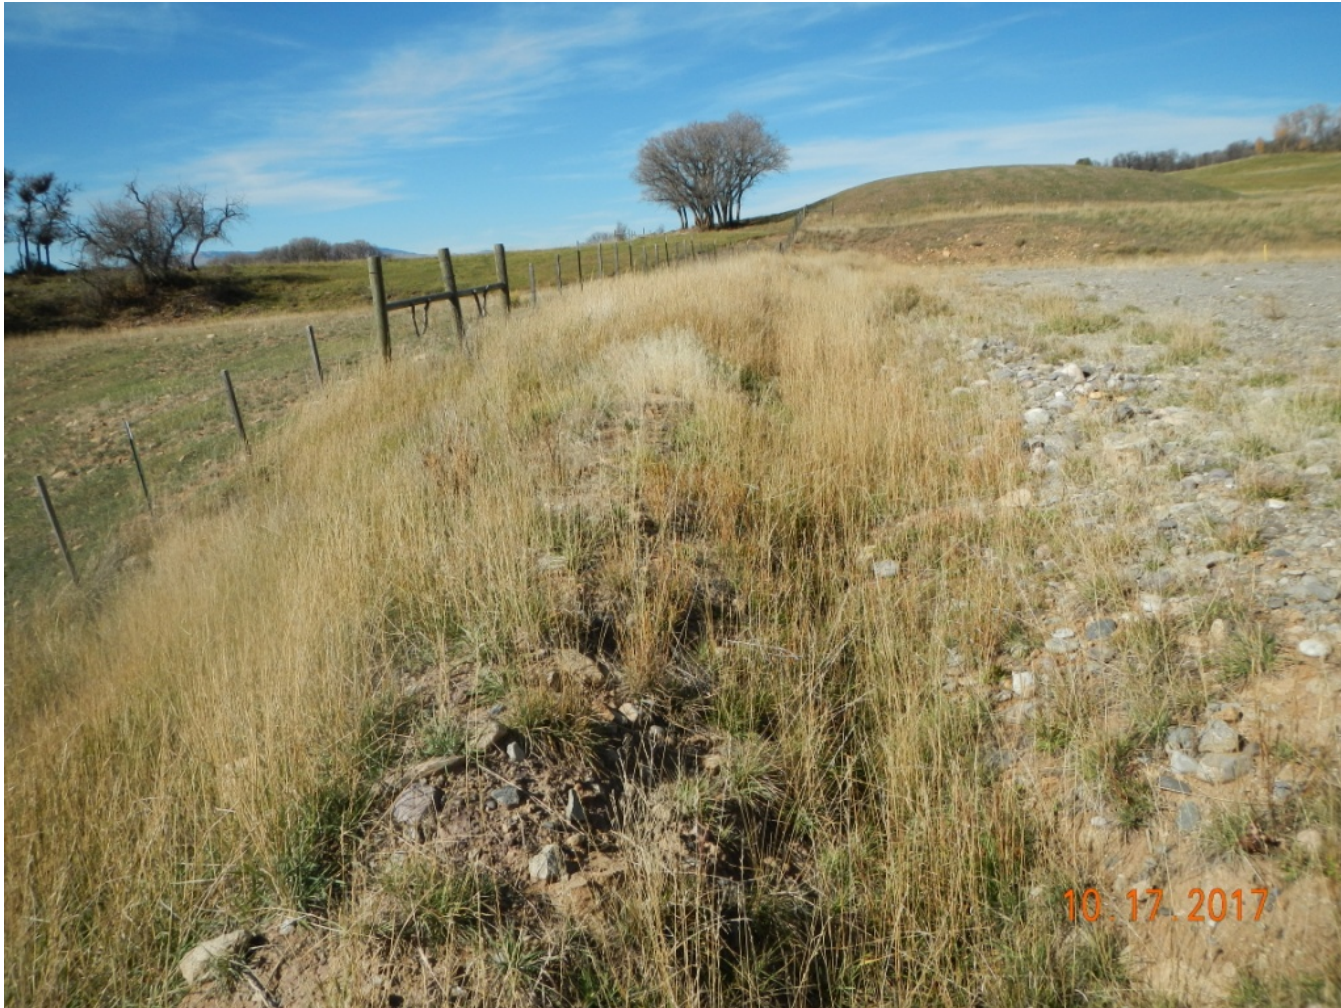
Photo 5. View of the western portion of the project area from the southwestern corner facing northward. Stormwater diversions appear to be functioning at this time.
