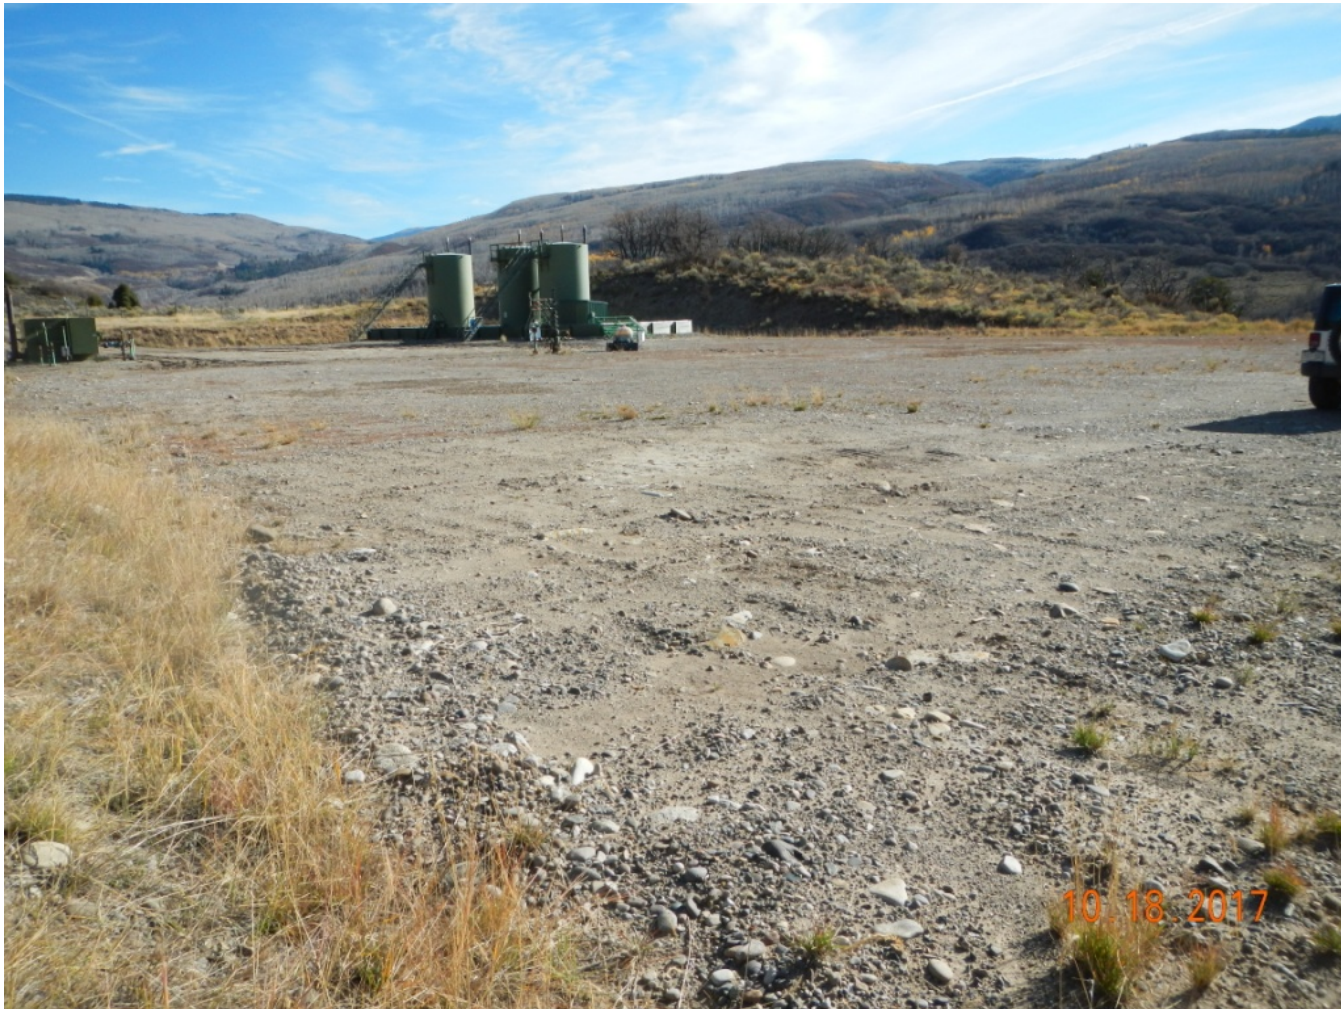
**Photo 1. View of the project area from the western corner of the working area facing center.**

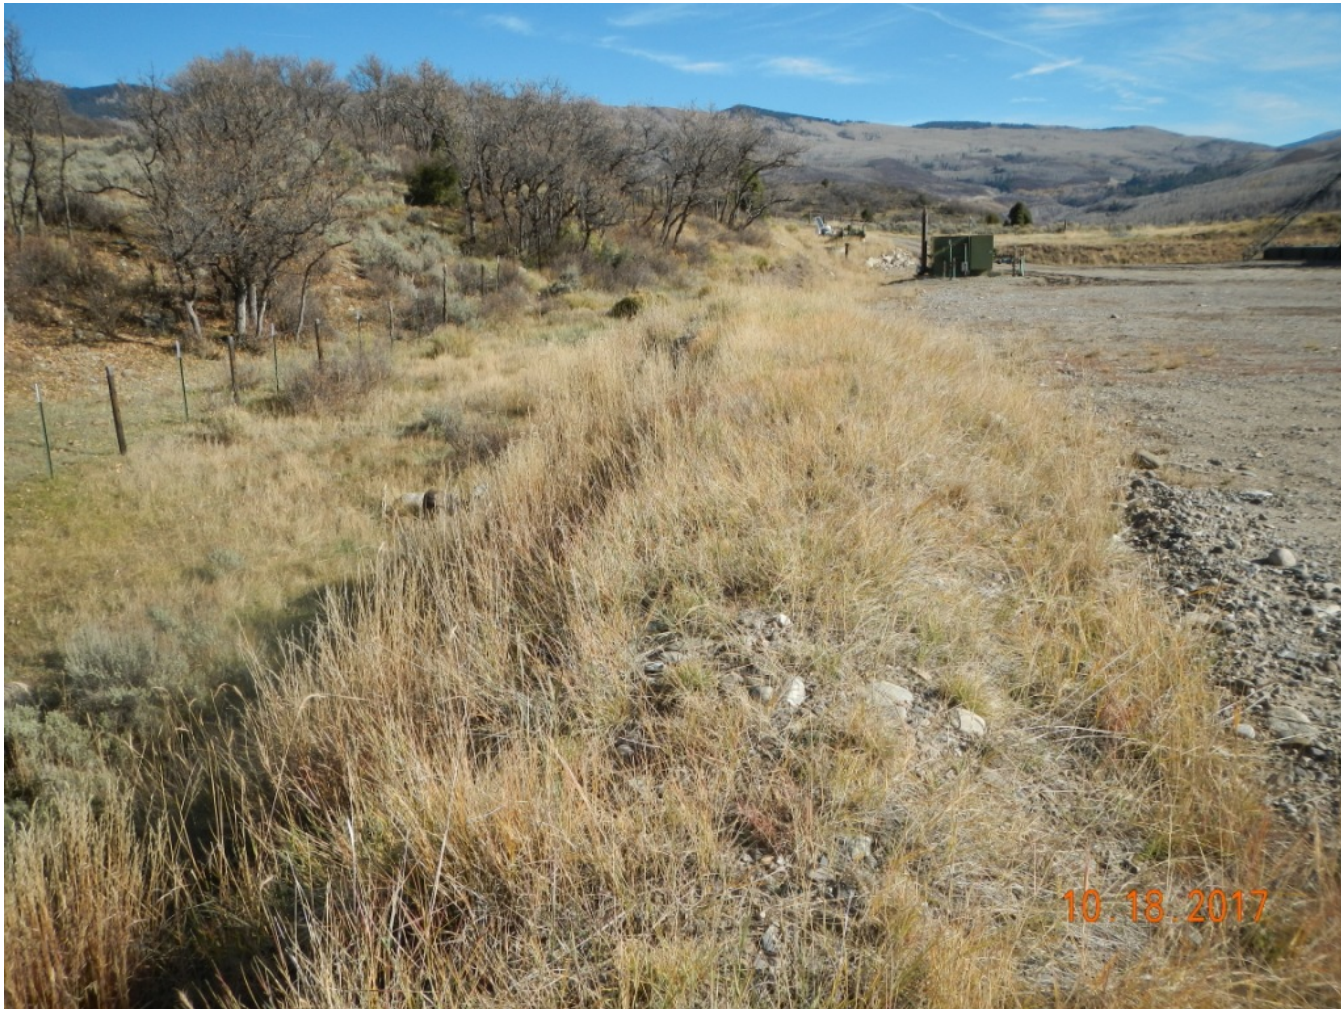
**Photo 2. View of the northwestern portion of the project area from the western corner facing northeastward.**

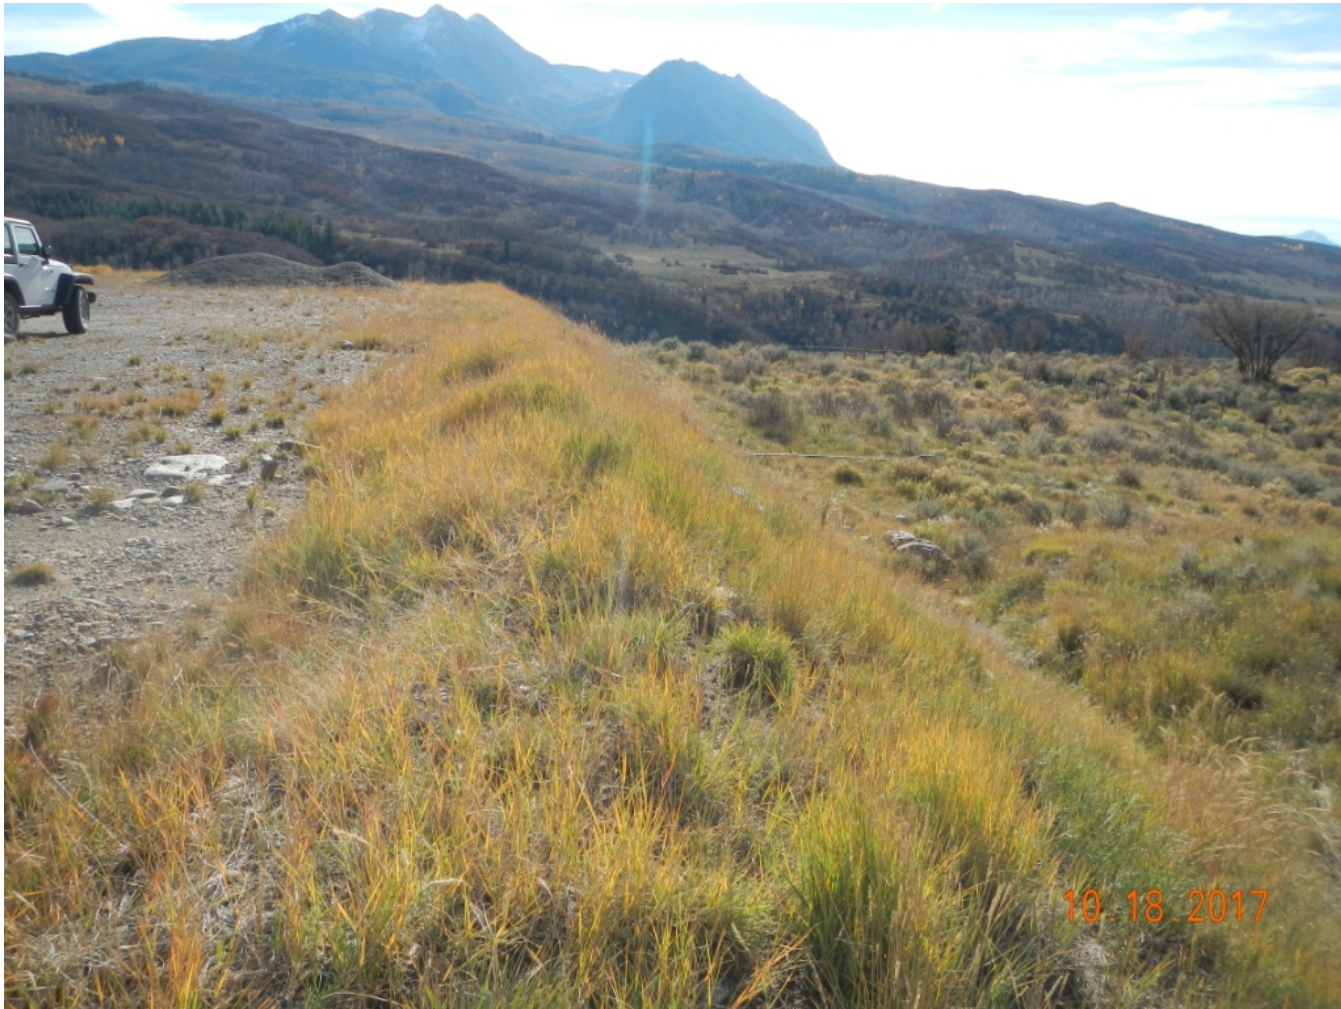
**Photo 3. View of the southern portion of the project area from the western corner of the working area facing southeastwestward. Vegetation is becoming established within the outer reclamation areas, and largely comprised of western wheatgrass (*Pascopyrum smithii*), big sagebrush (*Artemisia tridentata*) and big squirreltail (*Elymus multisetus*).**

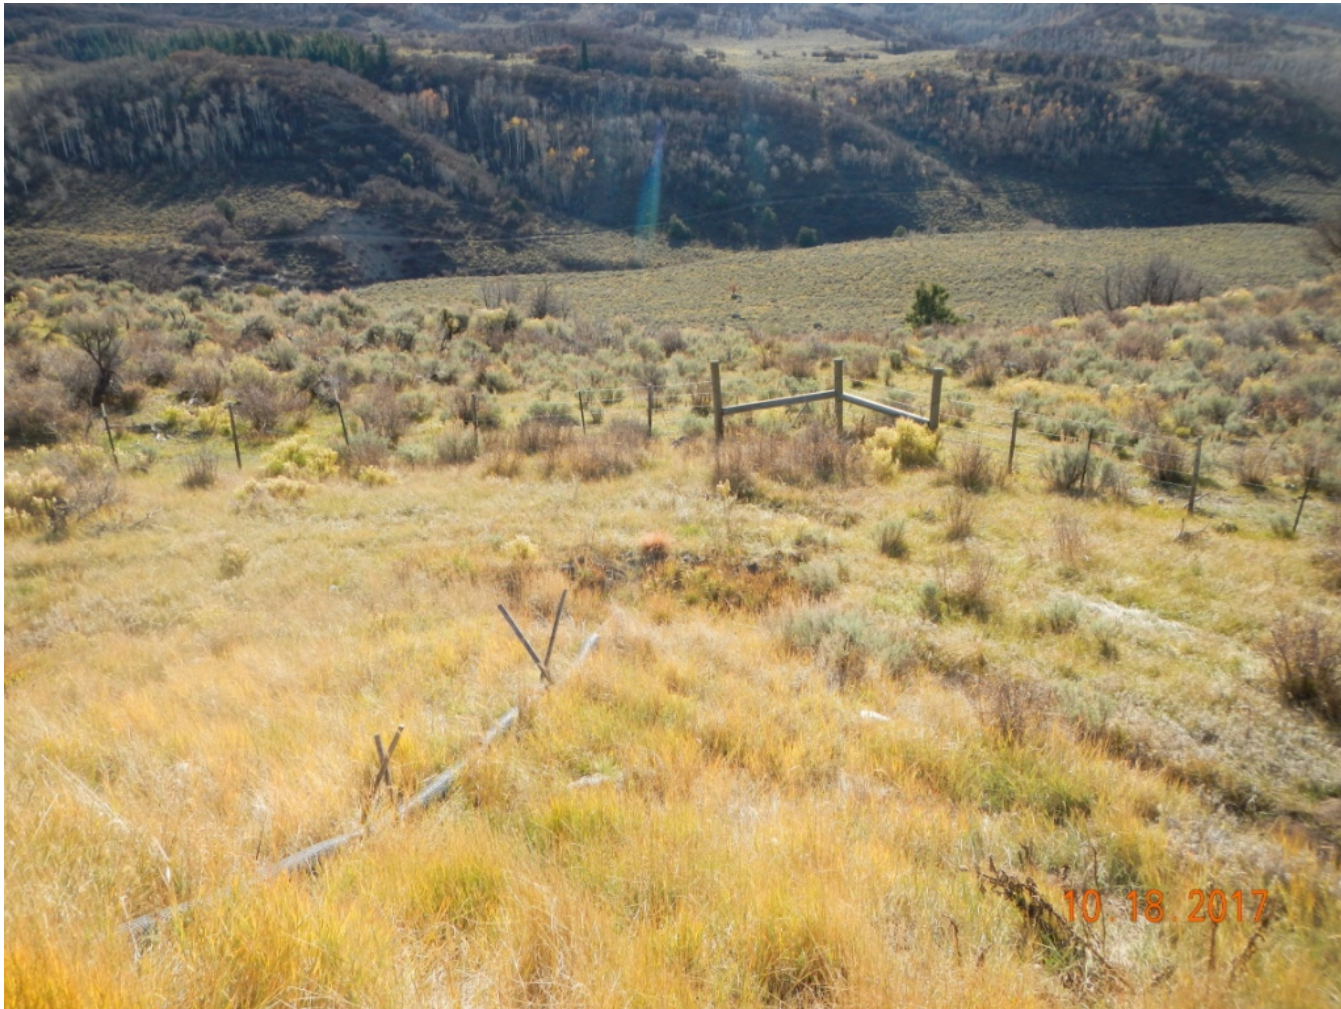
**Photo 4. View of stormwater controls in the southern portion of the project area that appear to be functioning.**

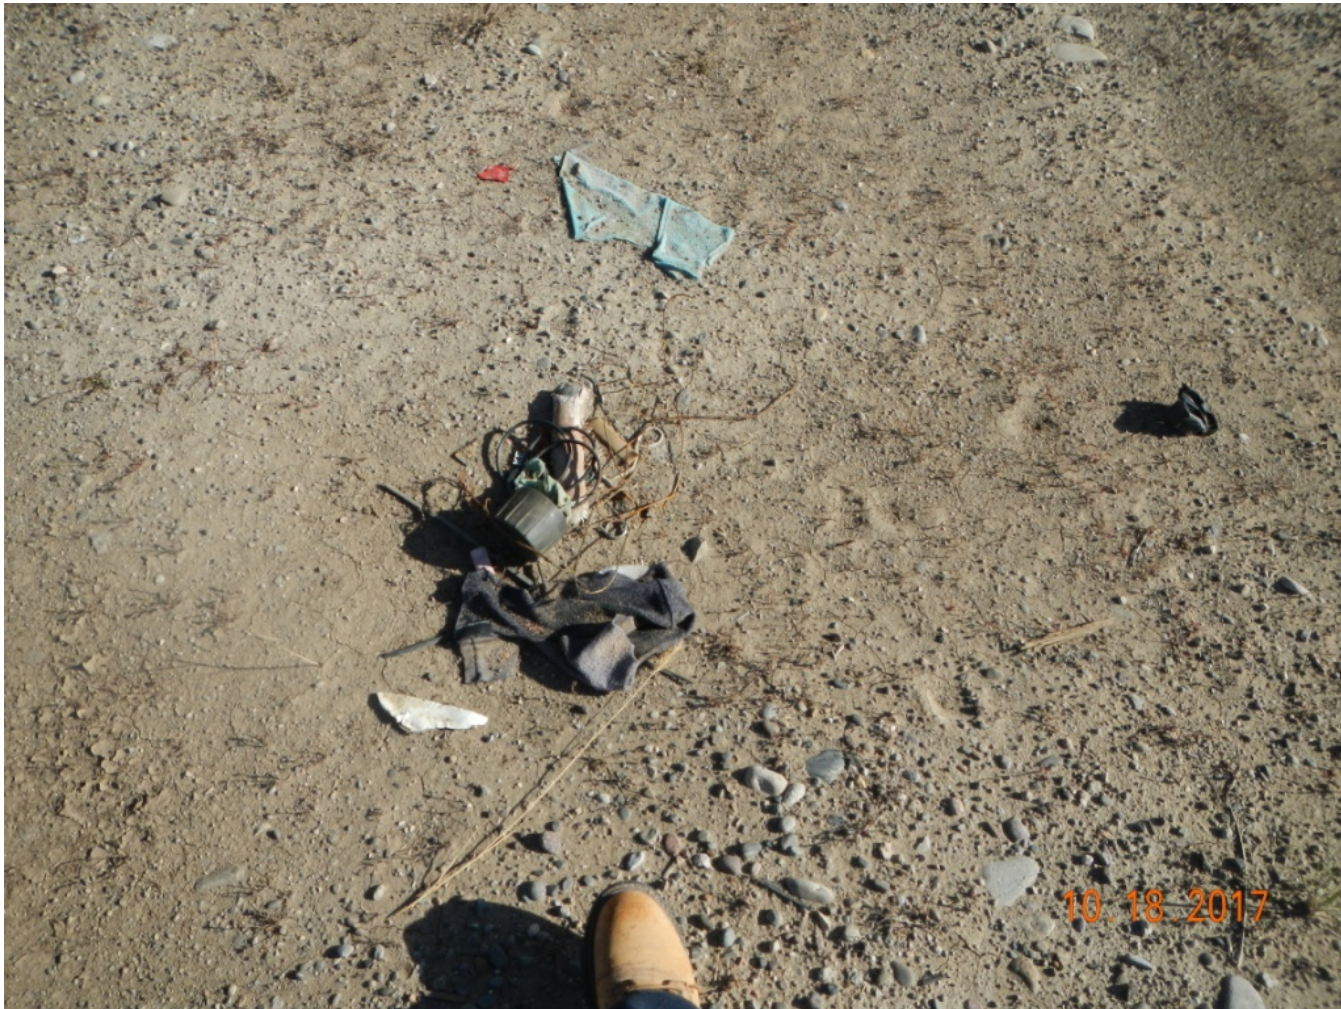
**Photo 5. View of junk on the well pad.**

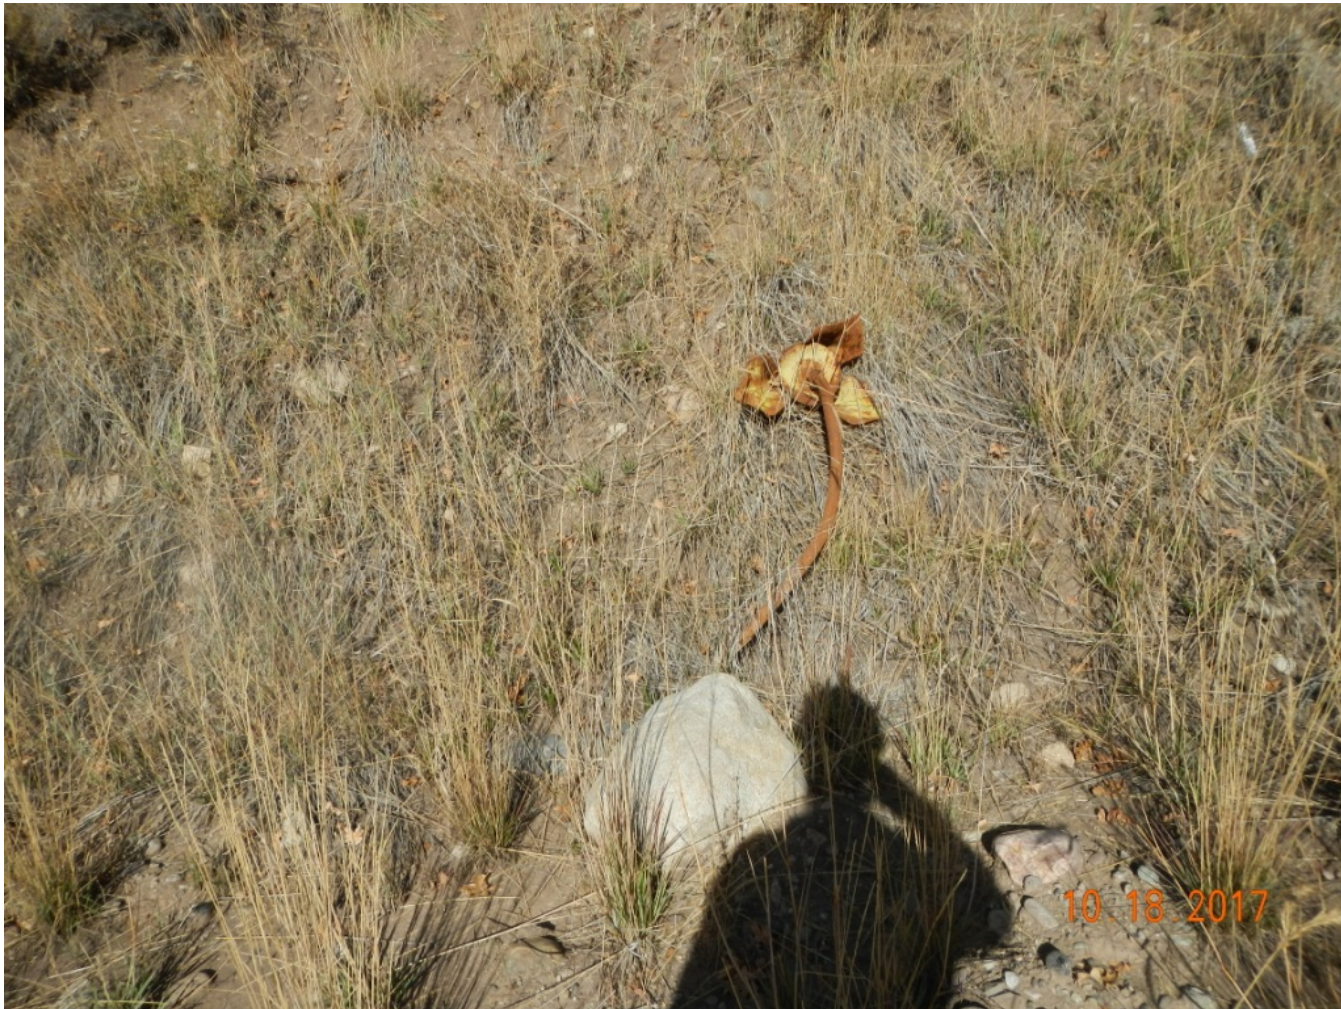
**Photo 6. View of unknown junk near the well pad entrance.**

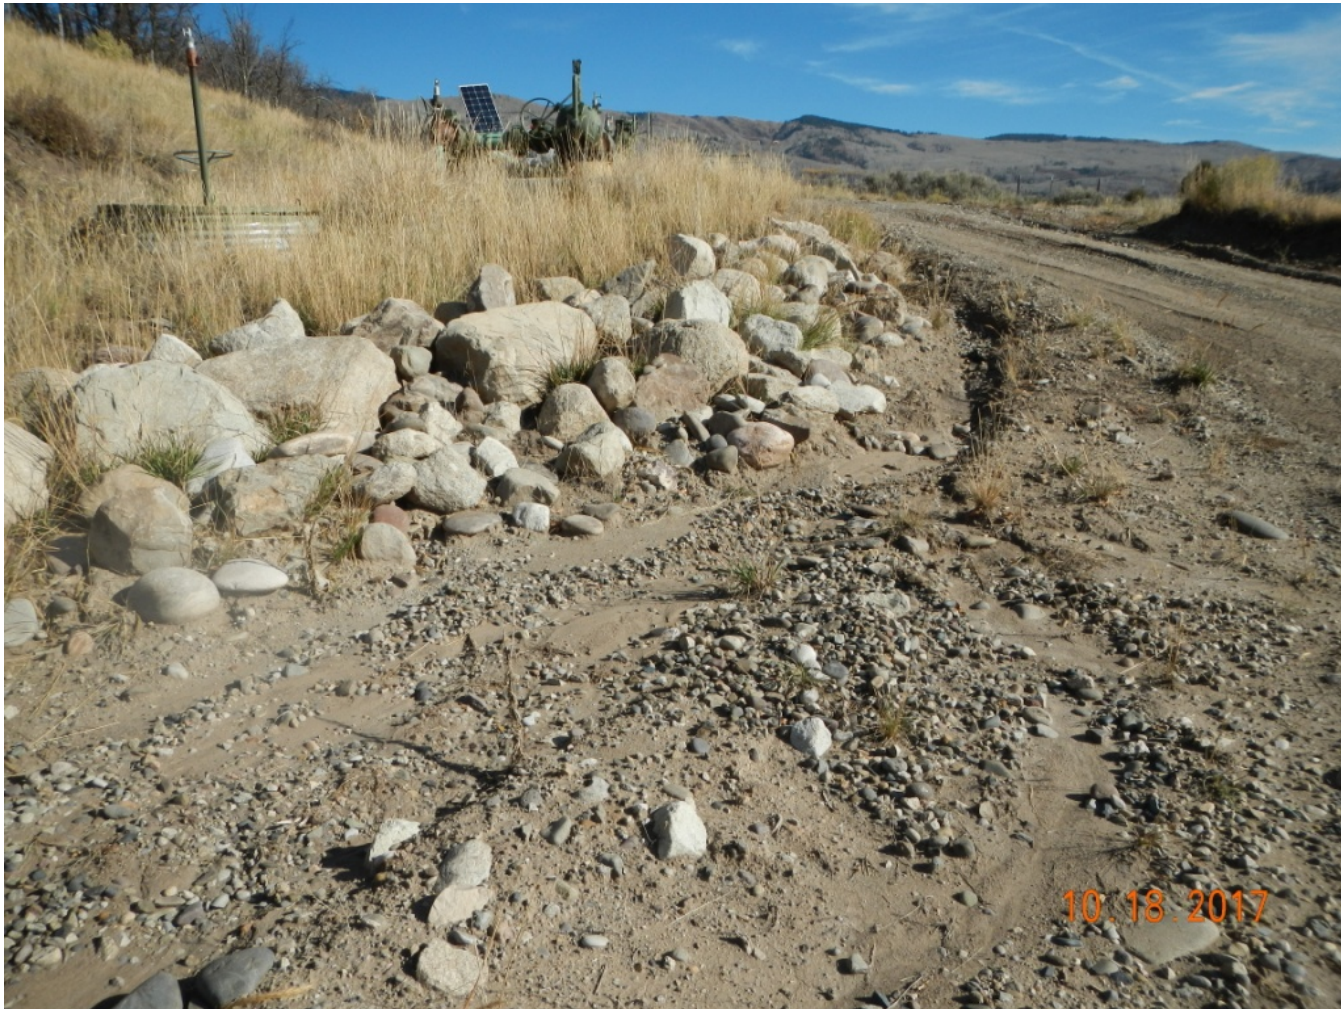
**Photo 7. View of erosion occurring where stormwater runoff along the access road is eroding at the well pad entrance.**
