Inspection Photos

11/1/2017

Operator: ST CROIX OPERATING INC - 81490

Location ID: 452312

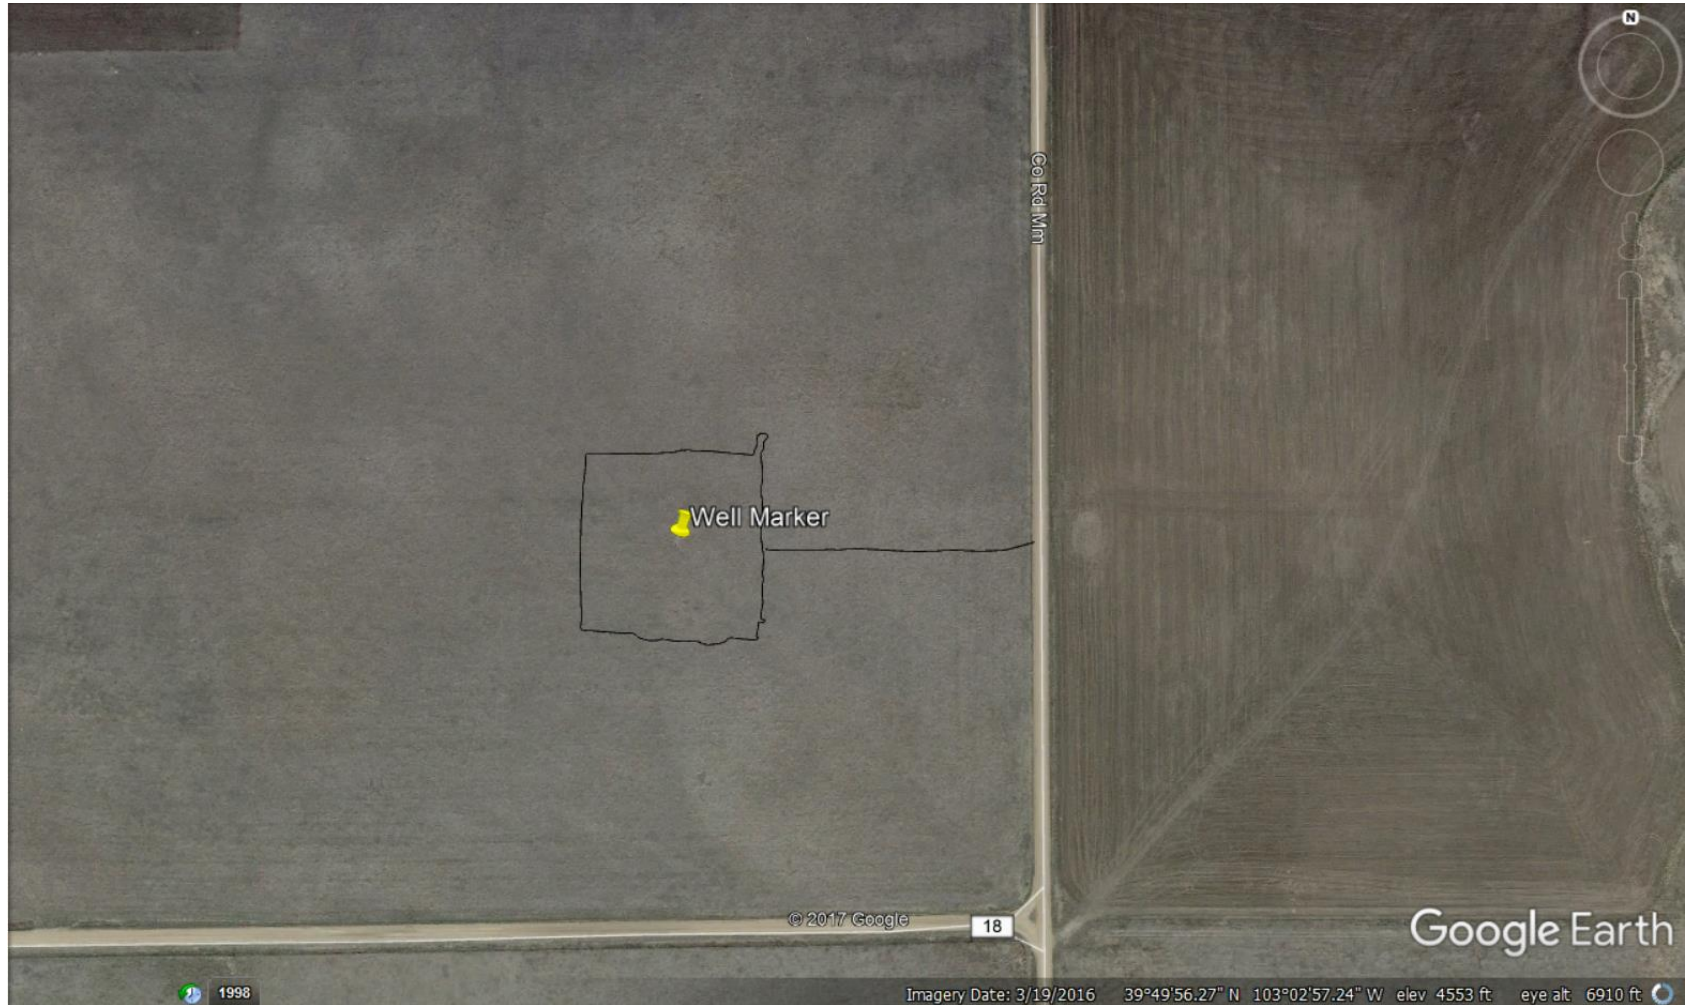
Photo 1: Aerial imagery showing current area of the construction site and disturbance. Current size of disturbance is ~2 acres

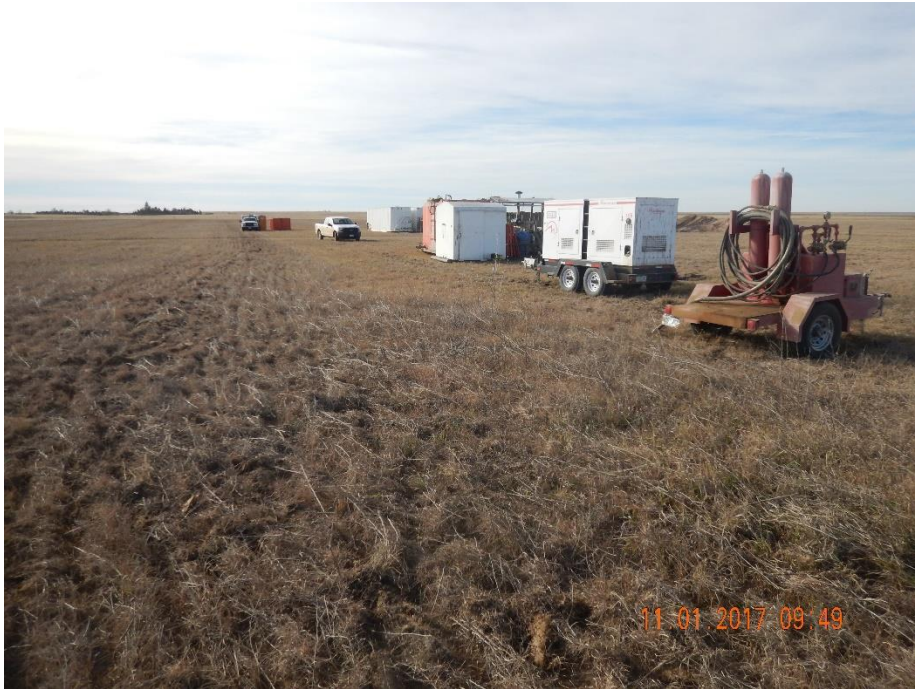
Photo 2: Photo taken from the northeast area of the location, facing south. Photo shows equipment has been brought onto the location. Photo shows that, with exception to a pit on the south end, no topsoil salvage on the location has occurred. All equipment and materials have been placed directly on the surface of the soil.

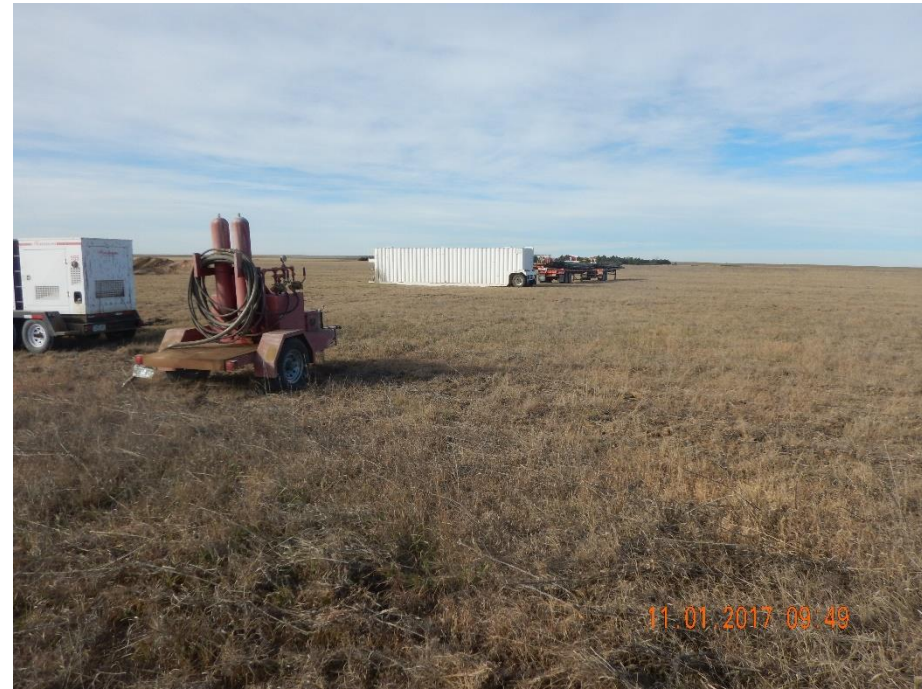
Photo 3: Photo taken from the northeast area of the location, facing west. See comments under photo 2.

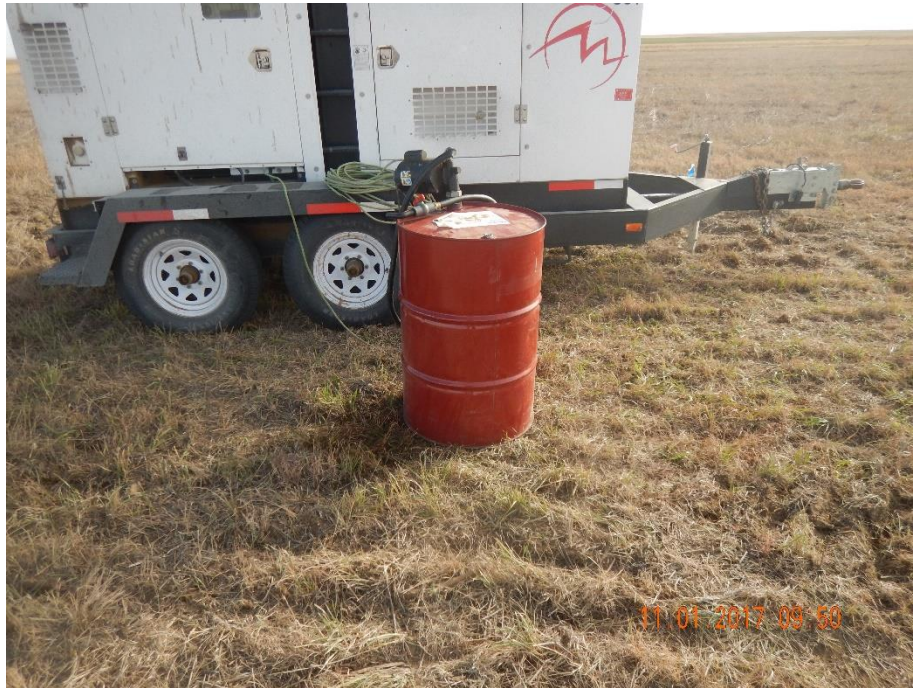
Photo 4: Photo taken from the northeast area of the location. Photo shows barrel placed directly upon topsoil. This is poor good-housekeeping and materials management.

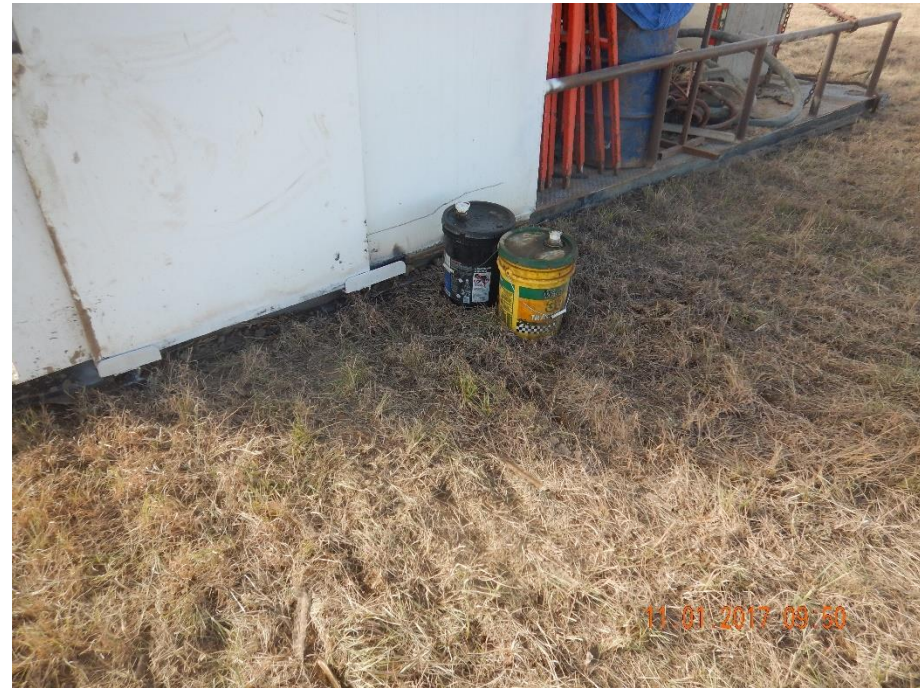
Photo 5: Photo taken from the northeast area of the location. Photo shows buckets placed directly upon topsoil. This is poor good-housekeeping and materials management.

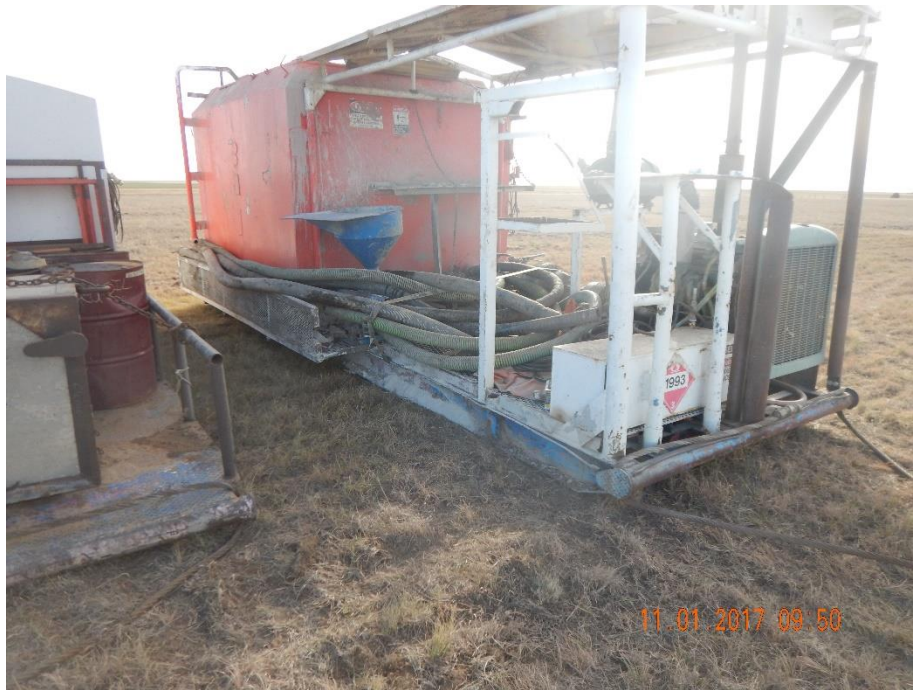
Photo 6: Photo taken from the east end of the location. Photo shows equipment has been brought onto the location. Photo shows that, with exception to a pit on the south end, no topsoil salvage on the location has occurred. All equipment and materials have been placed directly on the surface of the soil.

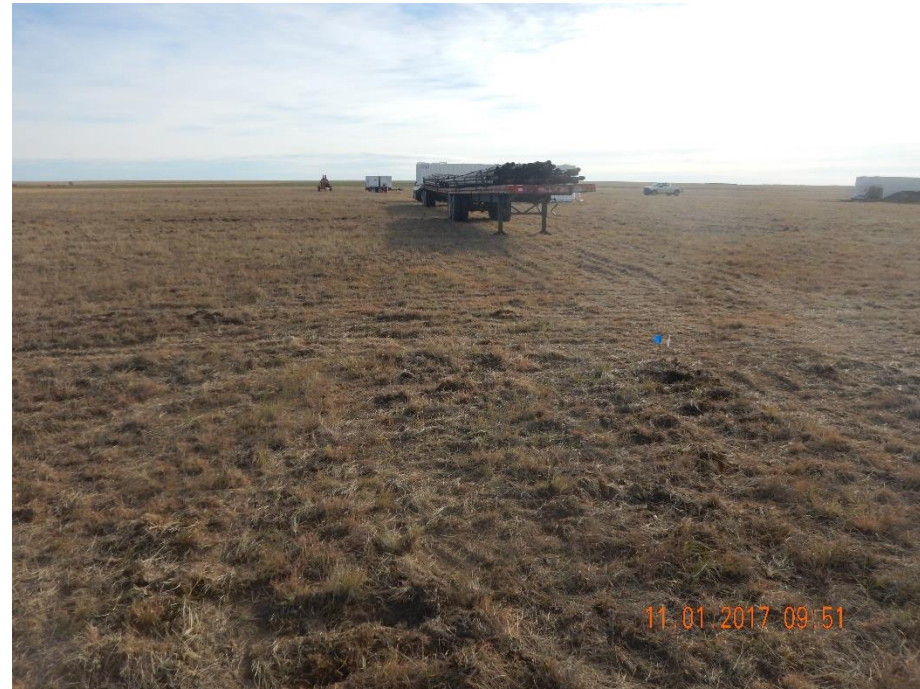
Photo 7: Photo taken from the northwest end of the location, facing east. See comments under photo 6.

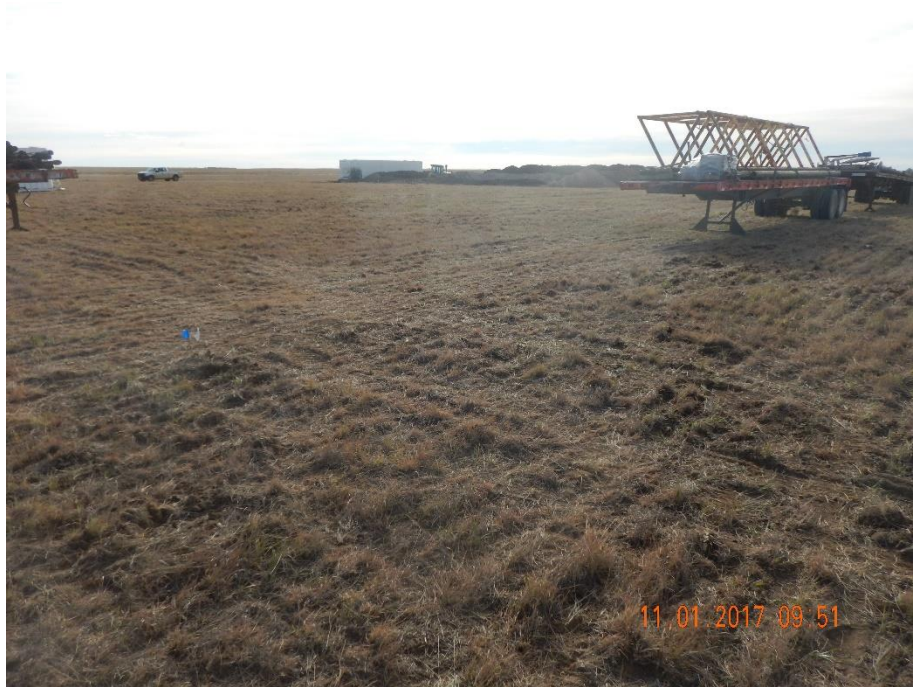
Photo 8: Photo taken from the northwest end of the location, facing southeast. See comments under photo 6.

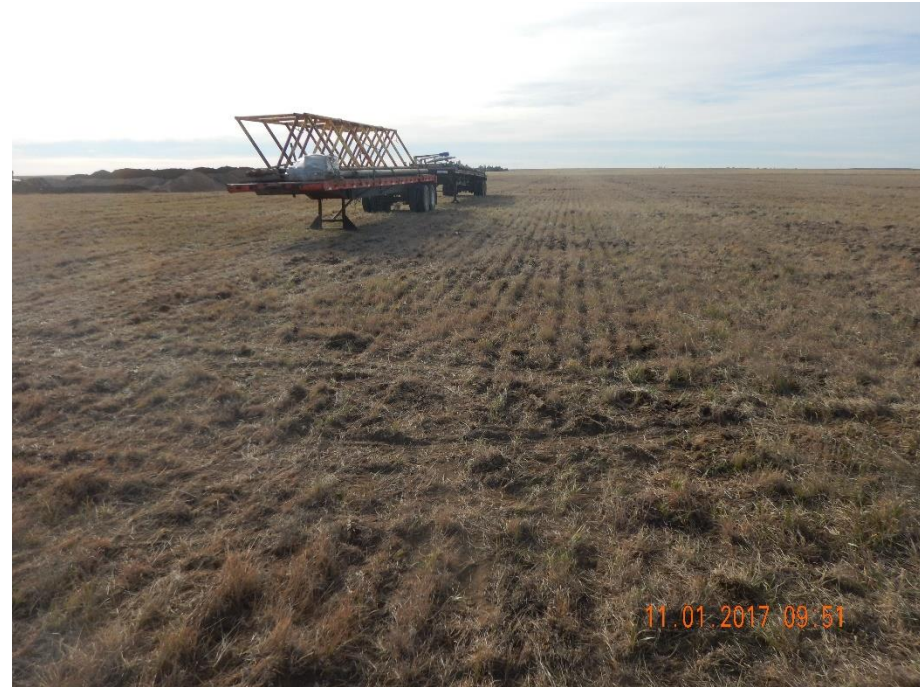
Photo 9: Photo taken from the northwest end of the location, facing south. See comments under photo 6.

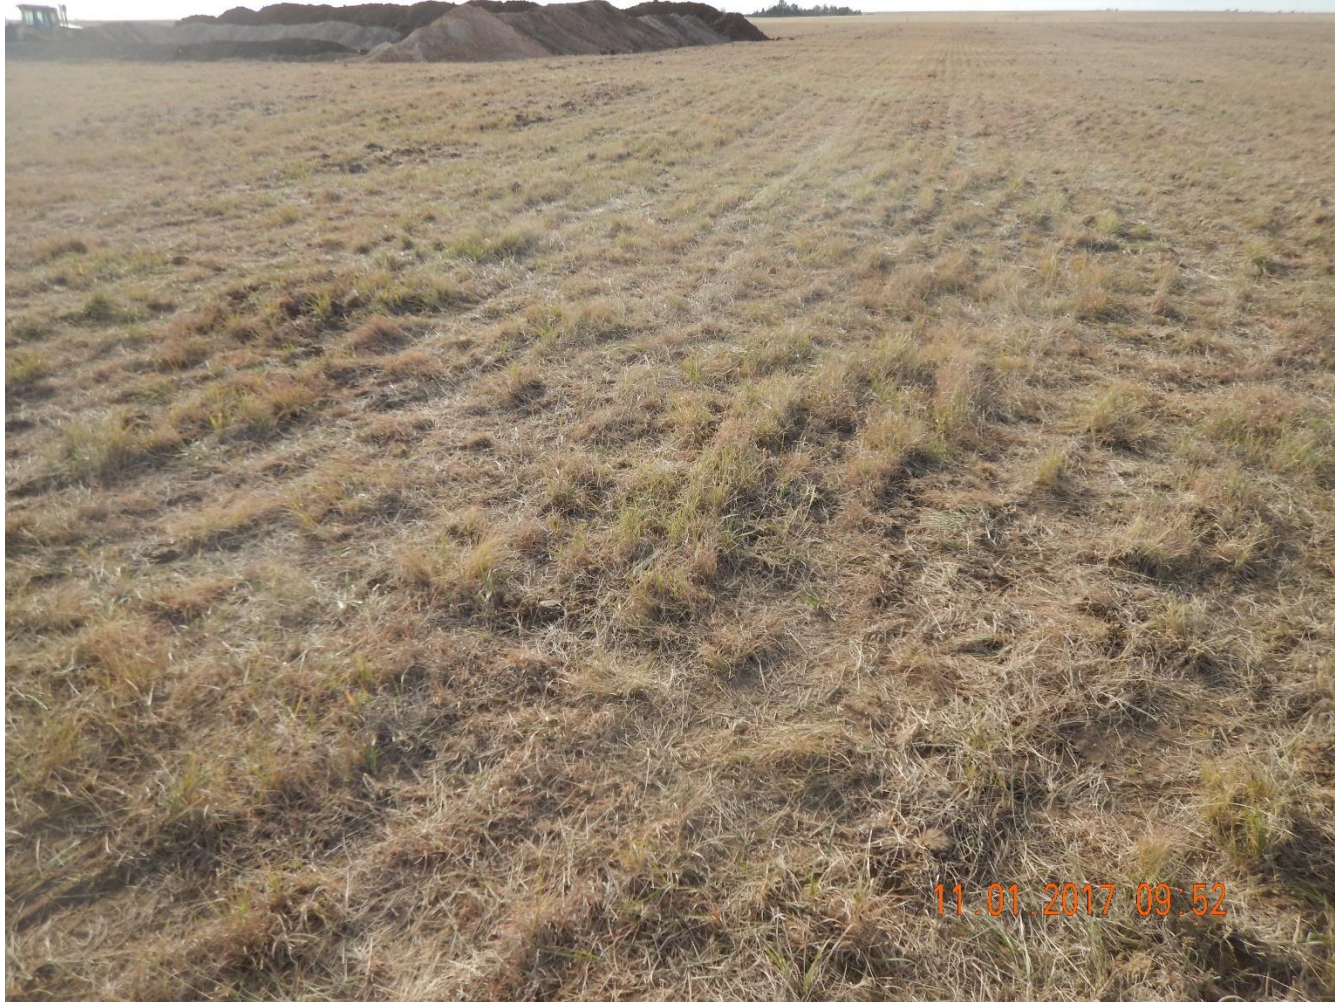
Photo 10: Photo taken from the center of the current location. Photo shows vegetation is a rangeland composed of Blue and Sideoats Grama, Western Wheat, Sand Dropseed, etc... Photo also shows that, with exception to a pit on the south end, no topsoil salvage on the location has occurred.

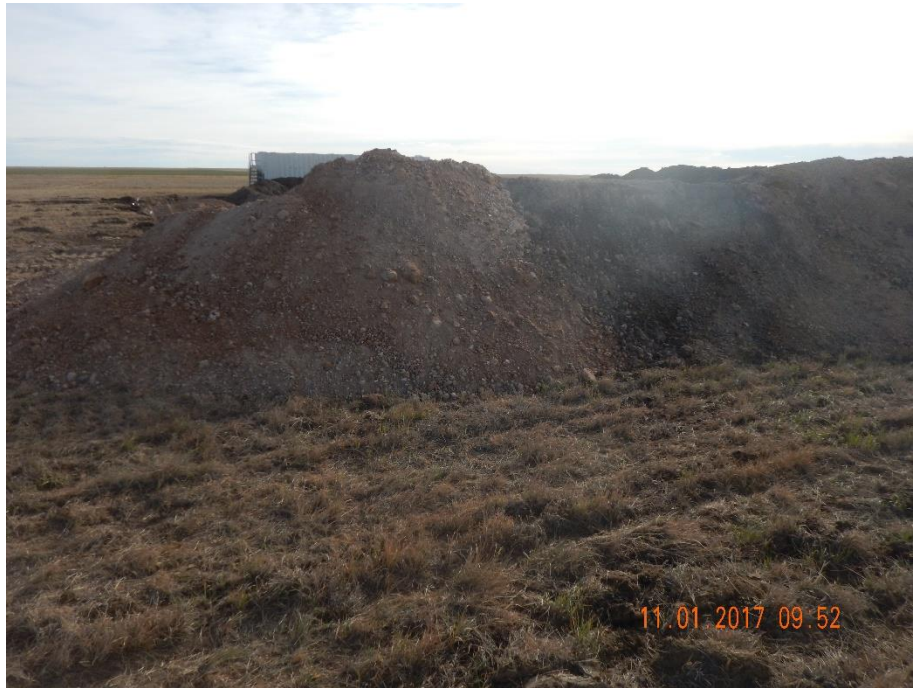
Photo 11: Photo taken from the west end of the pit, facing east. Photo shows topsoil pile has not been stabilized with good engineering practices. This is not protective of soils in accordance to 1002.c. Photo also shows that surface roughening appears to have been implemented throughout the site. Surface roughening is a temporary BMP that should be used in conjunction with other BMPs. Additional BMPs will be required.

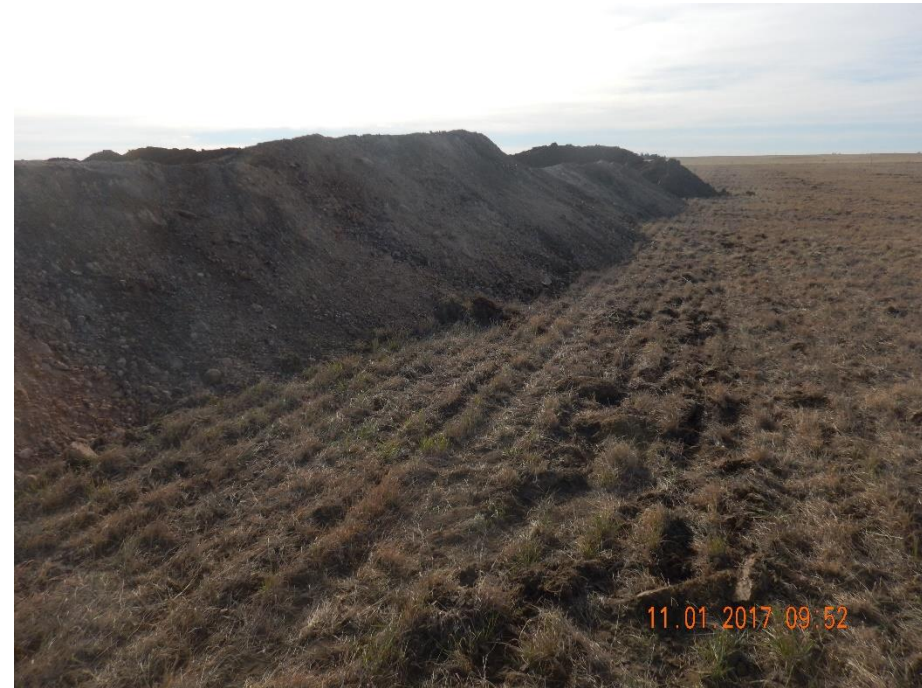
Photo 12: Photo taken from the west end of the pit, facing south. See comments under photo 11.

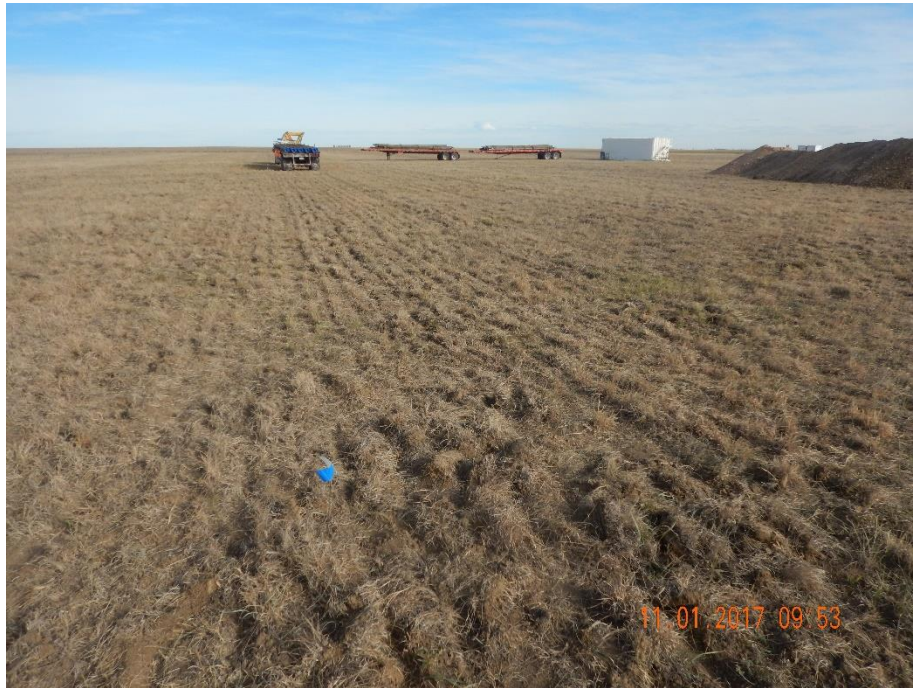
Photo 13: Photo taken from the southwest area of the location, facing north. Photo shows equipment has been brought onto the location. Photo shows that, with exception to a pit on the south end, no topsoil salvage on the location has occurred. All equipment and materials have been placed directly on the surface of the soil.

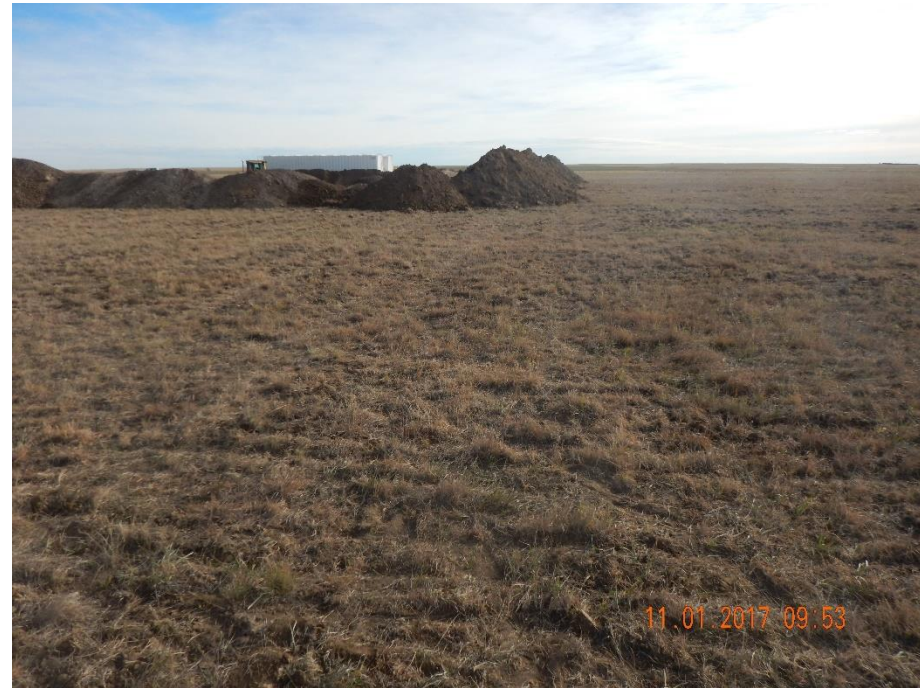
Photo 14: Photo taken from the southwest area of the location, facing east. See comments under photo 13.

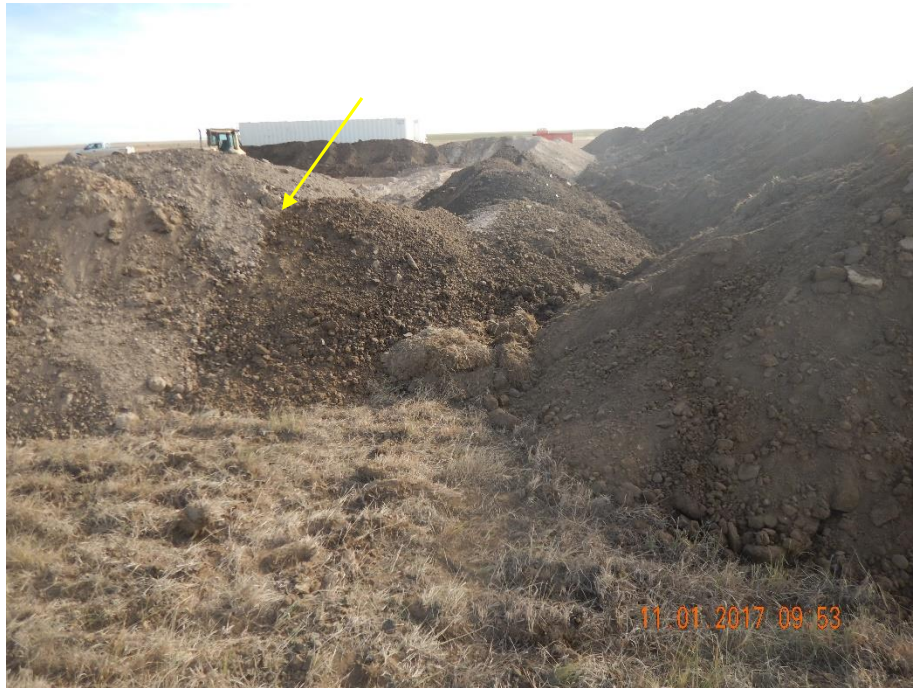
Photo 15: Photo taken from the west end of the pit. Photo shows soil horizons do not appear to be stored separately from one another per 1002.b.

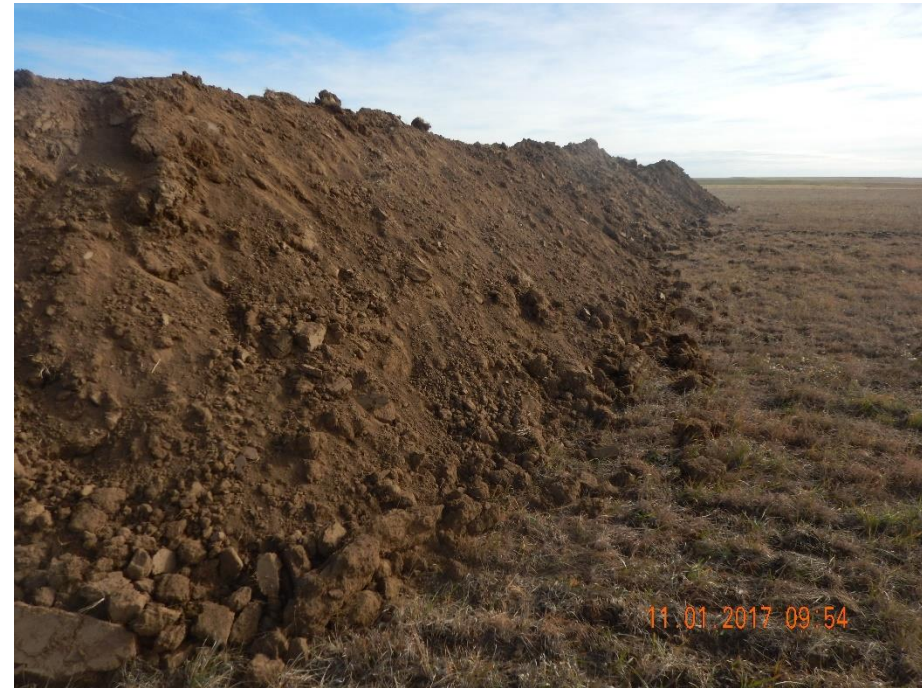
Photo 16: Photo taken from the south end of the pit, facing east. Photo shows topsoil pile has not been stabilized with good engineering practices. Photo also shows that surface roughening appears to have been implemented throughout the site. Surface roughening is a temporary BMP that should be used in conjunction with other BMPs. Additional BMPs will be required.

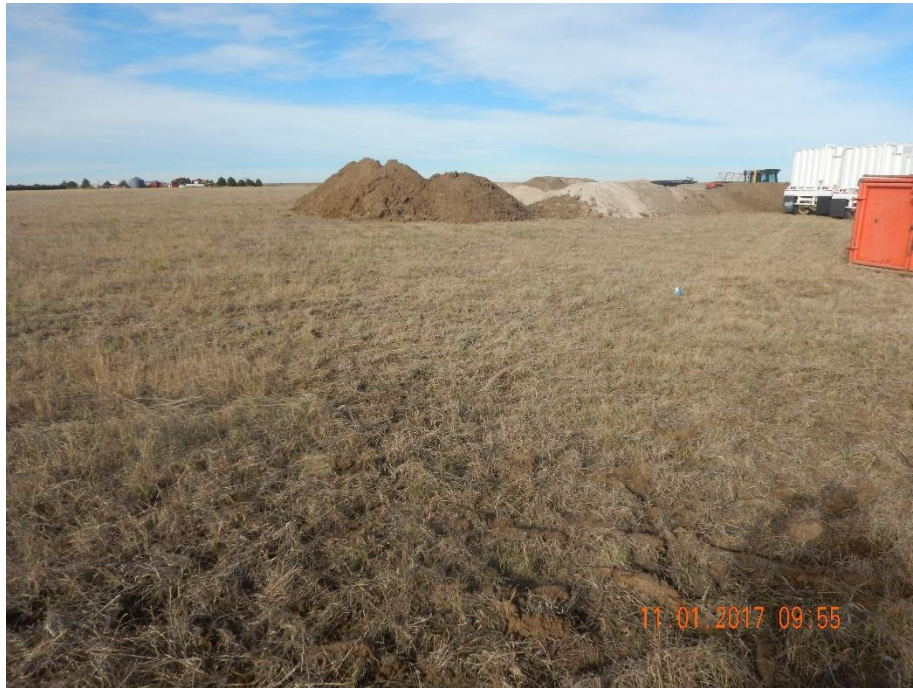
Photo 17: Photo taken from the southeast area of the location, facing west. Photo shows equipment has been brought onto the location. Photo shows that, with exception to a pit on the south end, no topsoil salvage on the location has occurred. All equipment and materials have been placed directly on the surface of the soil.

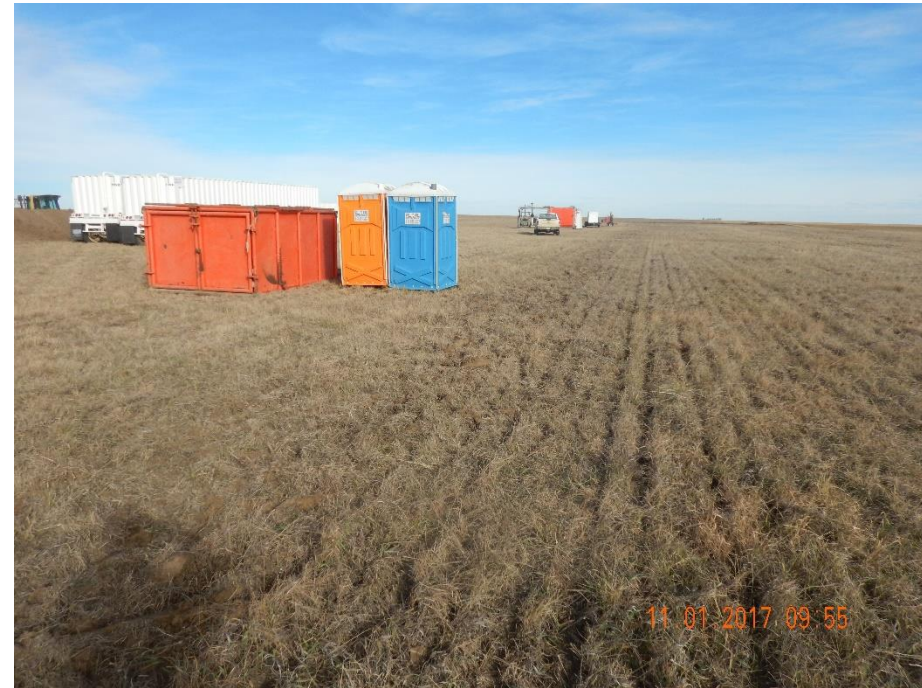
Photo 18: Photo taken from the southeast area of the location, facing north. See comments under photo 17.

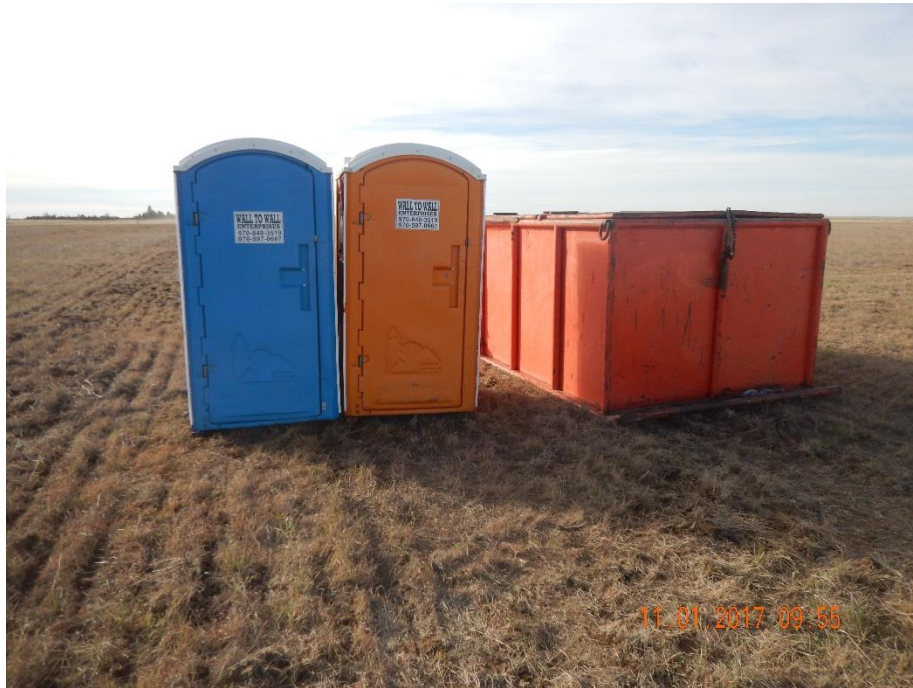
Photo 19: Photo taken from the southeast end of the location, facing south. Photo shows equipment and porta-johns on site. Portable toilets do not appear to have been anchored down per good engineering practices.

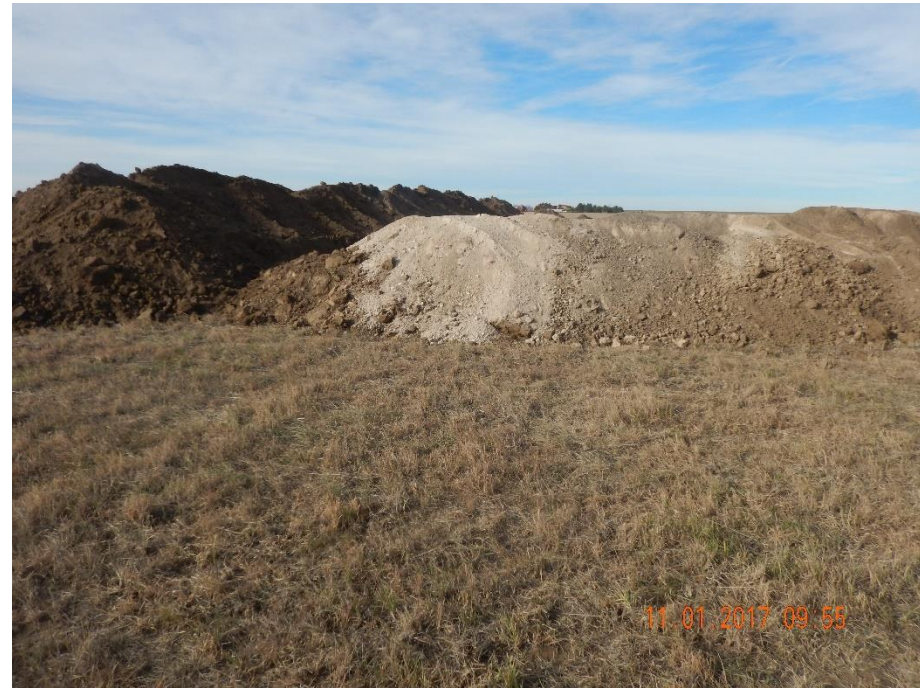
Photo 20: Photo taken from the east end of the pit. Photo shows soil horizons to not appear to be stored separately from one another per 1002.b.

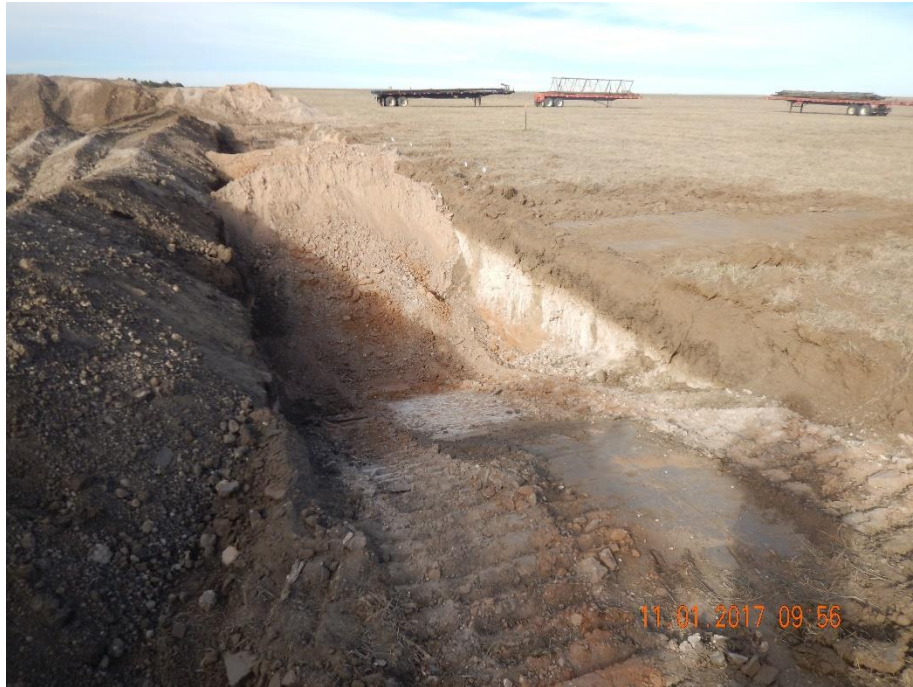
Photo 21: Photo taken from the north end of the location, facing west. Photo shows pit that has been constructed.

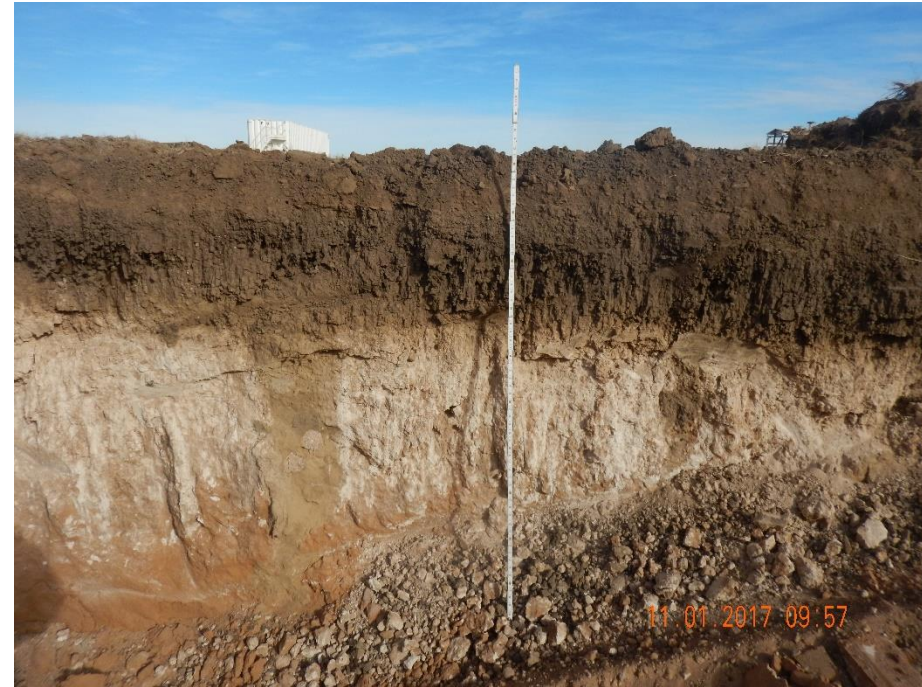
Photo 22: Photo taken from within pit seen in photo 21. Photo shows topsoil and soil horizons at the location. 6 foot measuring stick for reference.

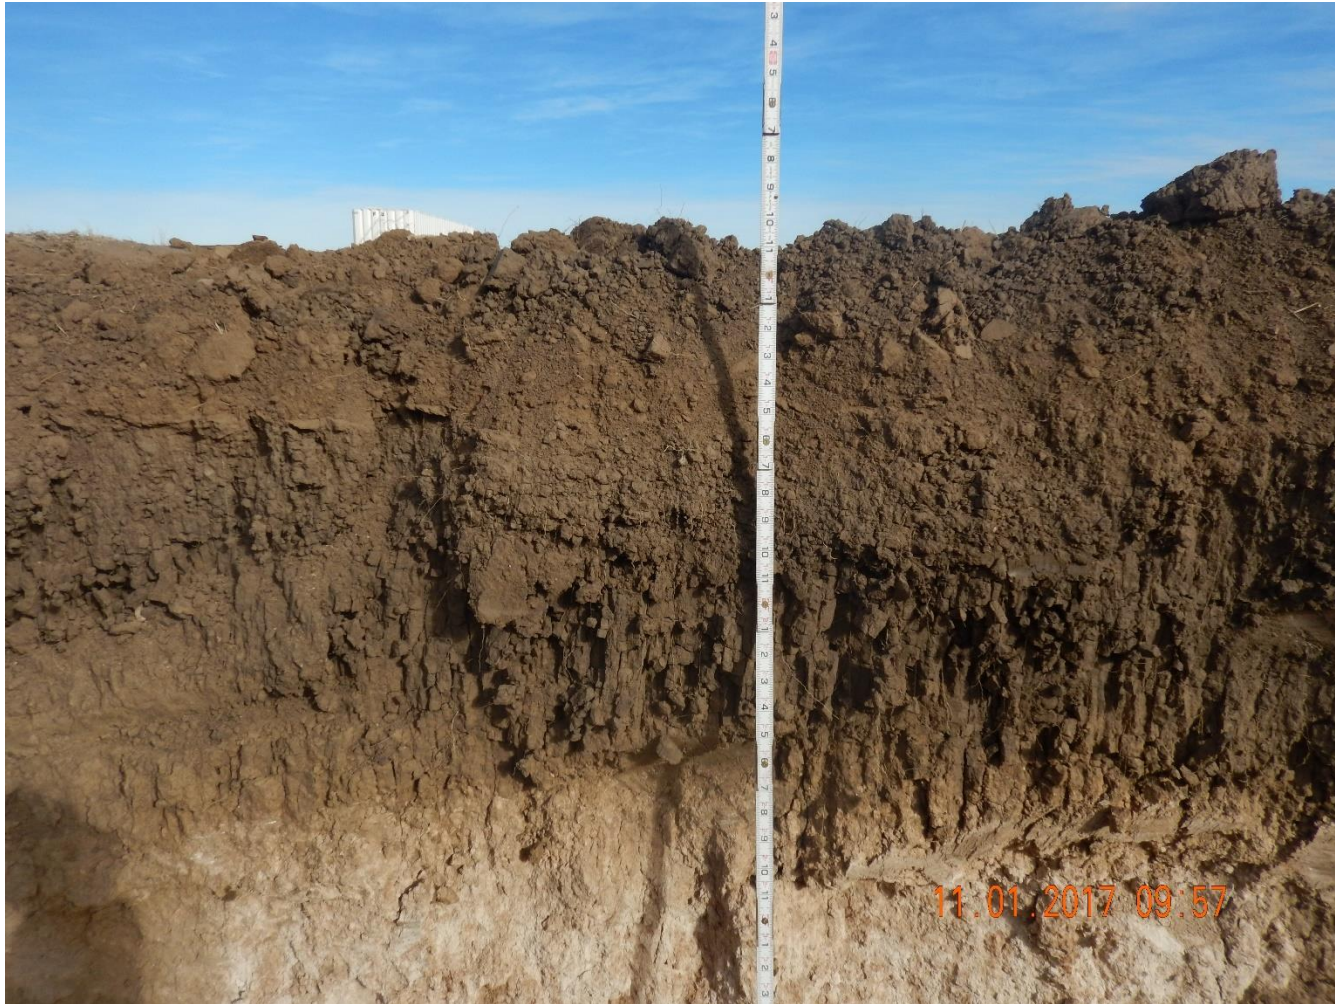
Photo 23: Photo taken from within pit seen in photo 21. Photo shows topsoil layer. Topsoil appears to be ~ 2 feet in depth.

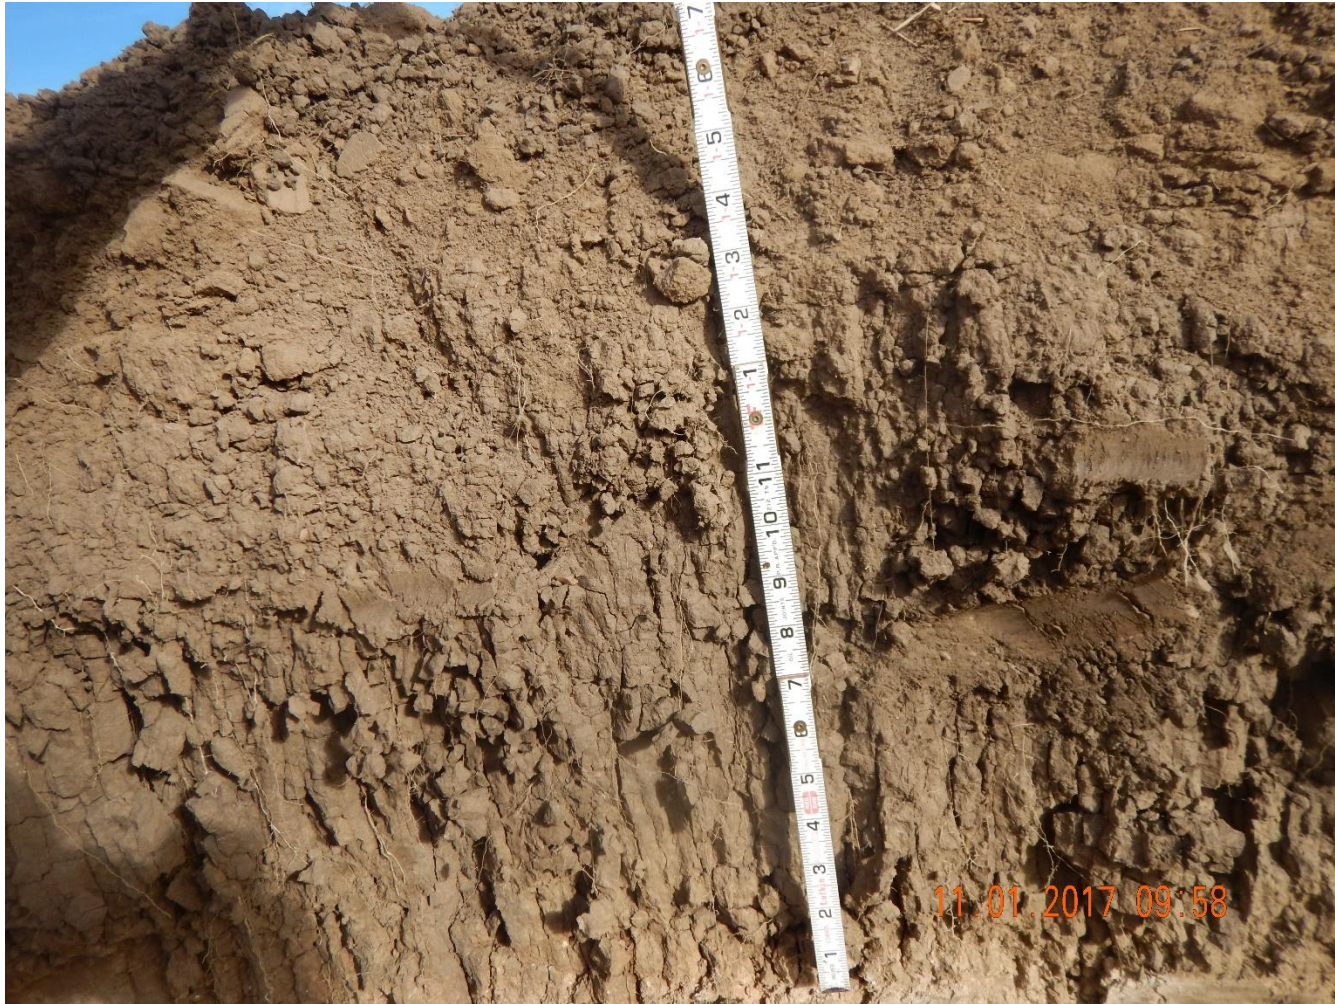
Photo 24: Photo taken from within pit seen in photo 21. Photo shows topsoil layer. Topsoil appears to be ~ 2 feet in depth.

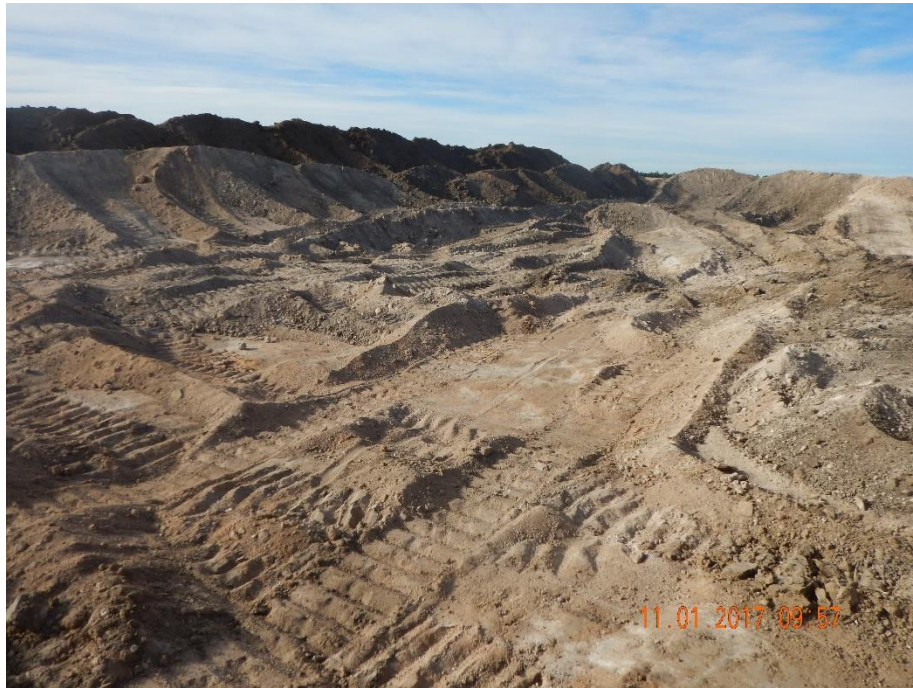
Photo 25: Photo taken from the within the pit, facing west. Photo shows soil horizons to not appear to be stored separately from one another per 1002.b.

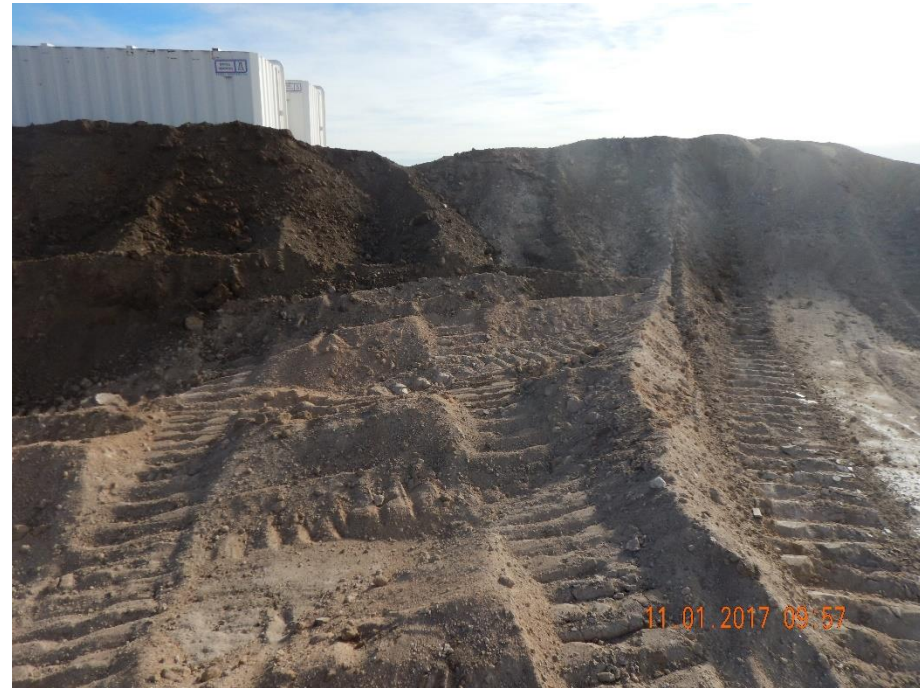
Photo 26: Photo taken from the within the pit, facing east. Photo shows soil horizons to not appear to be stored separately from one another per 1002.b.

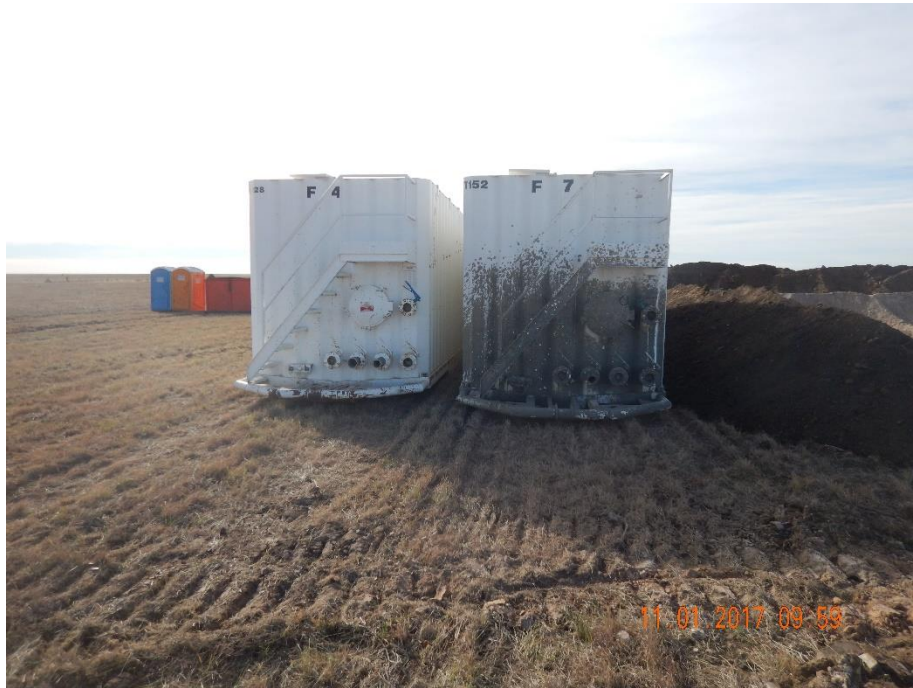
Photo 27: Photo taken from the east end of the location, facing south. Photo shows equipment has been brought onto the location. Photo shows that, with exception to a pit on the south end, no topsoil salvage on the location has occurred. All equipment and materials have been placed directly on the surface of the soil.

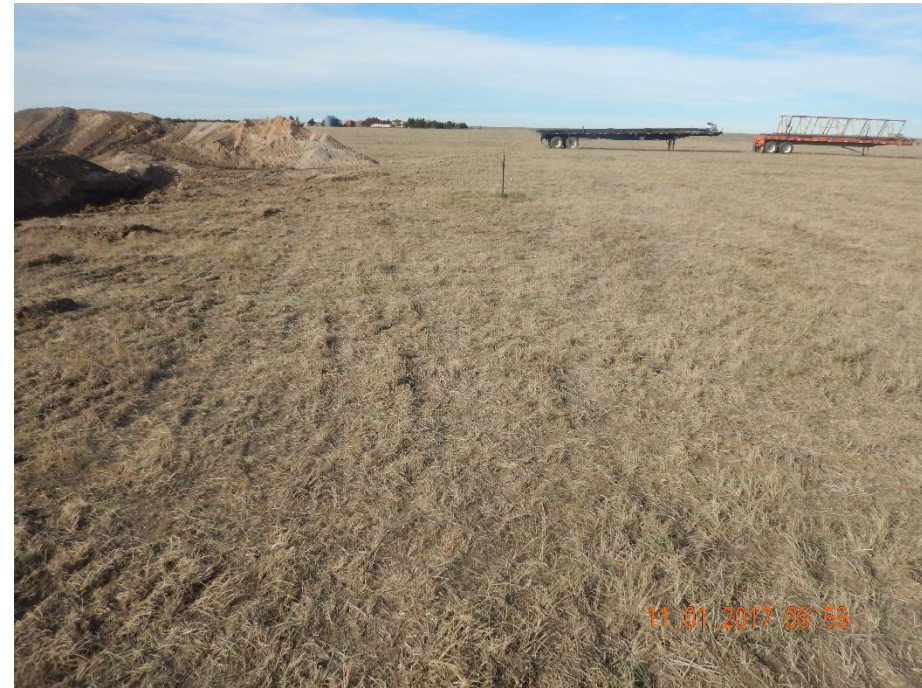
Photo 28: Photo taken from the location, facing west. Photo shows well marker. Photo also shows that no topsoil salvage has occurred at the well marker.

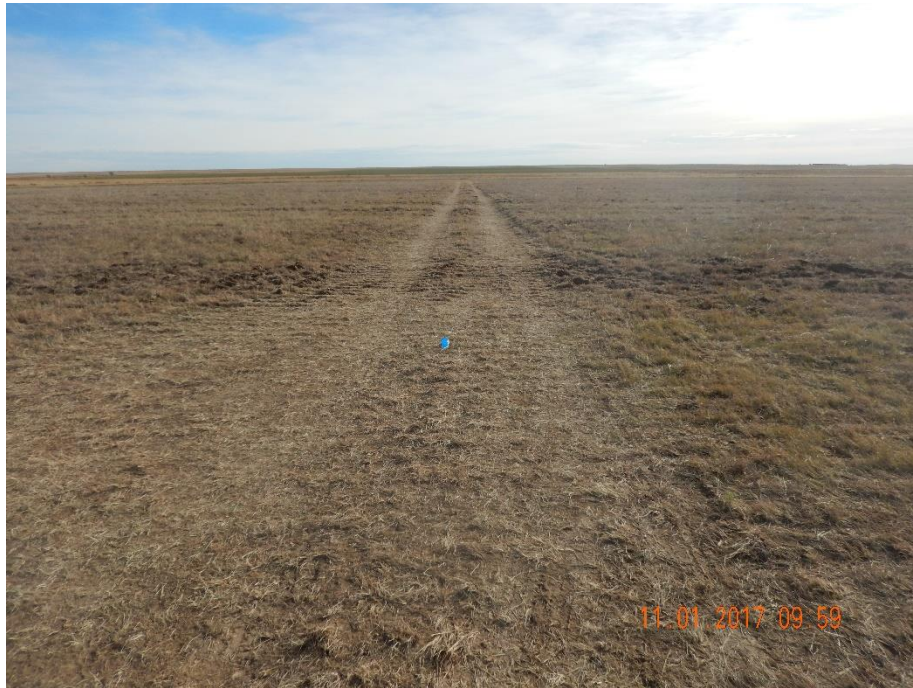
Photo 29: Photo taken from the east end of the location, facing east. Photo shows access road leading to the location. Photo shows no topsoil has been salvaged from the access road. Operator appears to have traveled over the surface to access location.
