Inspection Photos

11/1/2017

Operator: ST CROIX OPERATING INC - 81490

Location ID: 452312

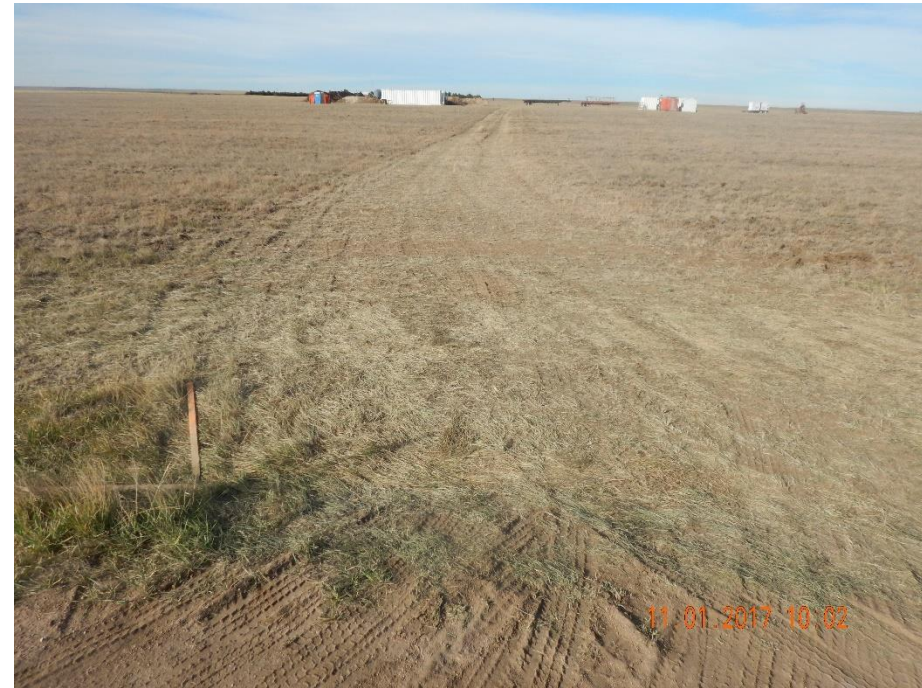
Photo 30: Photo taken from the country road, east of the location, facing west. Photo shows access road leading to the location. Photo shows no topsoil has been salvaged from the access road. Operator appears to have traveled over the surface to access location.
