COGCC conducted an inspection of the Lilli Unit 2-8 location (Location ID 326772) on September 26, 2017 (Document 684904467). During that inspection, COGCC made the following observations:

Name: Lilli Unit 2-8  
Location ID: 326772

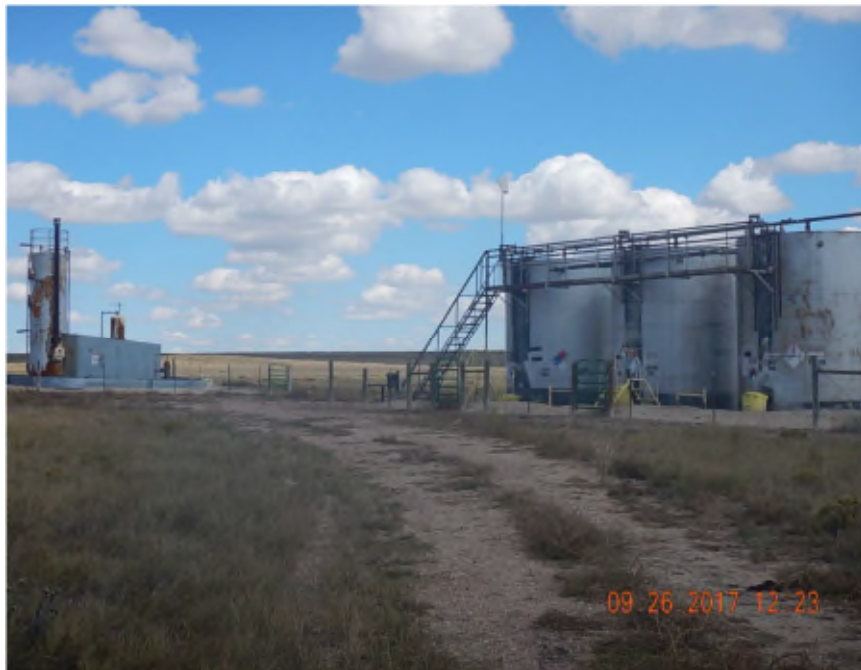
Tanks and Berms: Berms – Berms are low in places. Repair or install berms or other secondary containment devices per Rule 605.a.(4).

Stormwater: Stormwater erosion in center of site, eroding to the east. Install or repair required BMPs per Rule 1002.f.

Photo 1: Location, looking NE

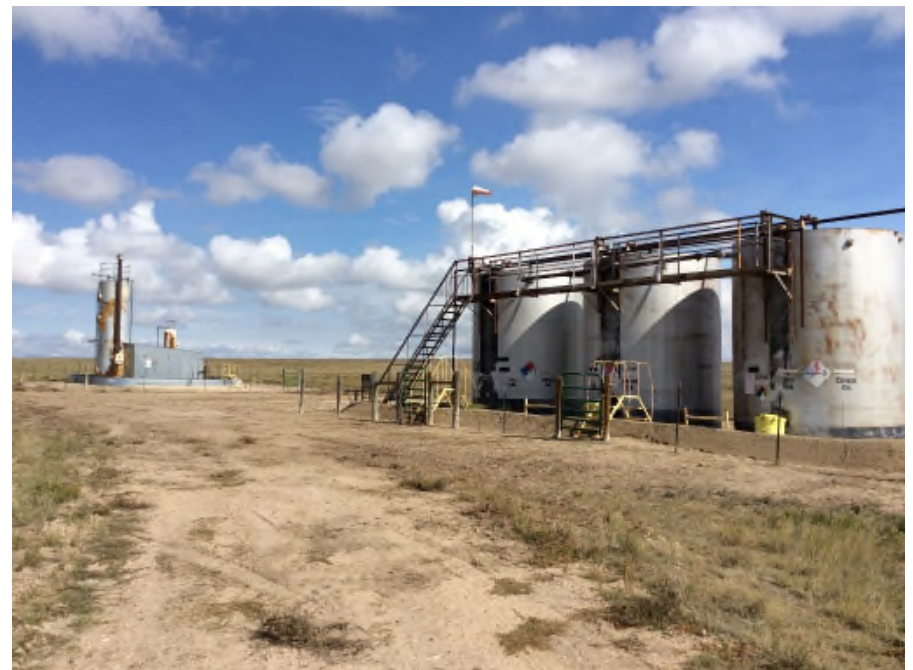
Photo NBL1. Erosion and berms have been repaired

Response: Noble has repaired the berms and erosion on-site.

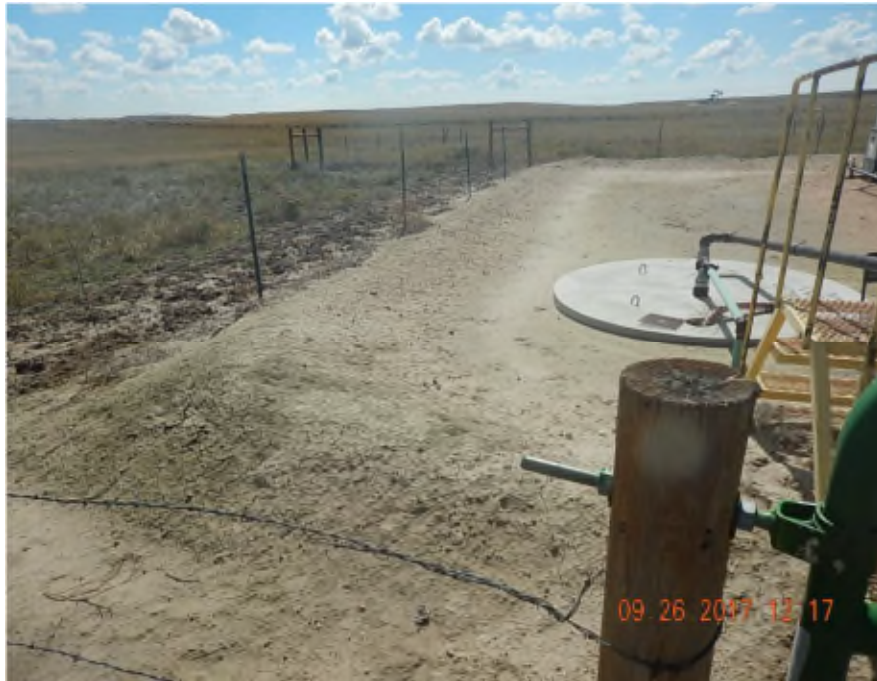
Tanks and Berms: Berms – Berms are low in places. Repair or install berms or other secondary containment devices per Rule 605.a.(4).

Photo 3: Low berms at tank battery

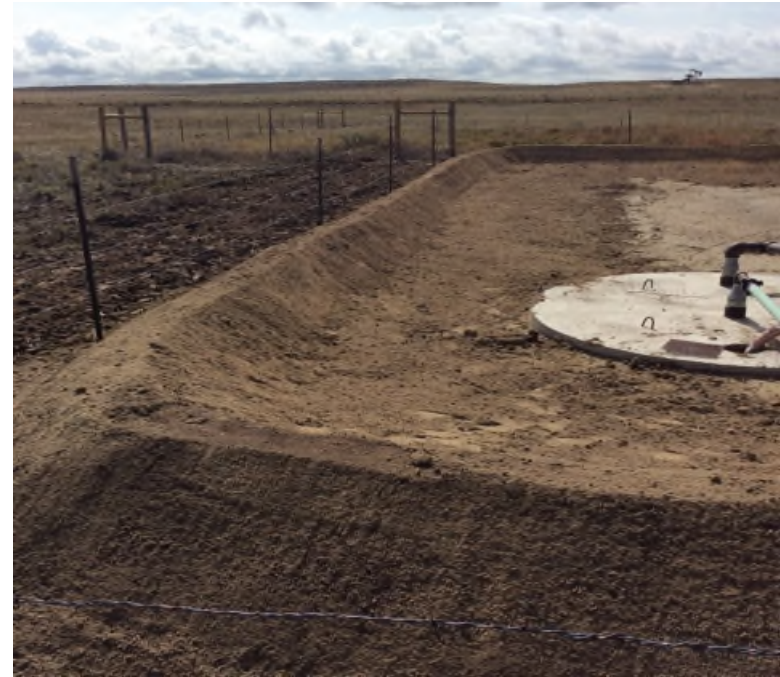
Photo NBL2. The berms of the containment have been enlarged and compacted.

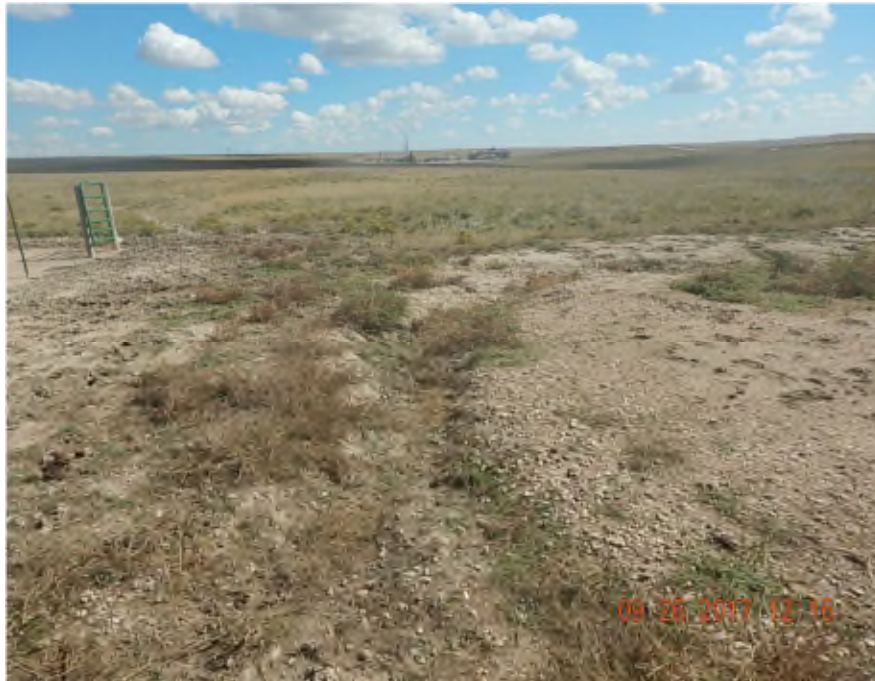
Stormwater: Stormwater erosion in center of site, eroding to the east. Install or repair required BMPs per Rule 1002.f.

Photo 5: Stormwater erosion at location, between treater and battery.

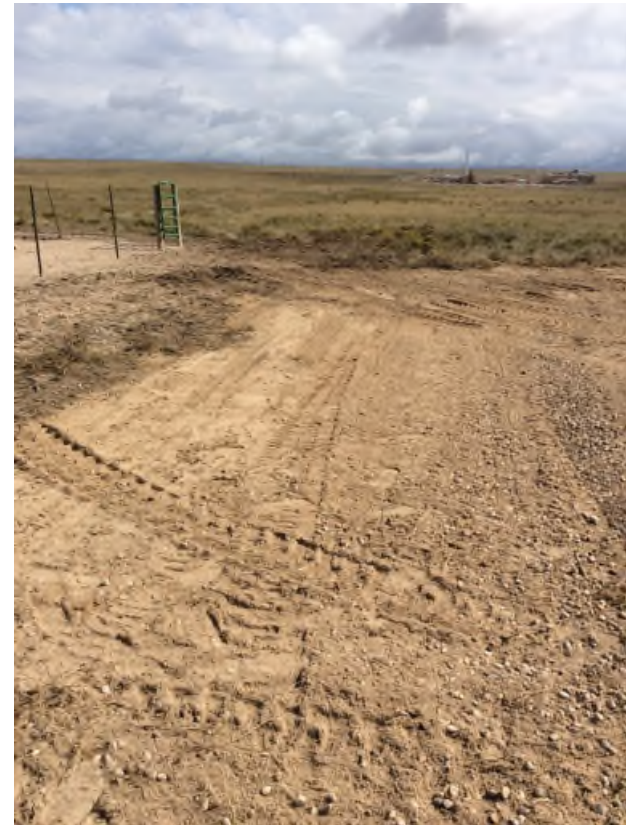
Photo NBL3. The erosion has been repaired by filling and grading.
