Inspection Photos
Location Name: URSA Operating LLC/Mclin B
API: 05-045-19375

Location Name: URSA Operating LLC/Mclin B

API: 05-045-19375

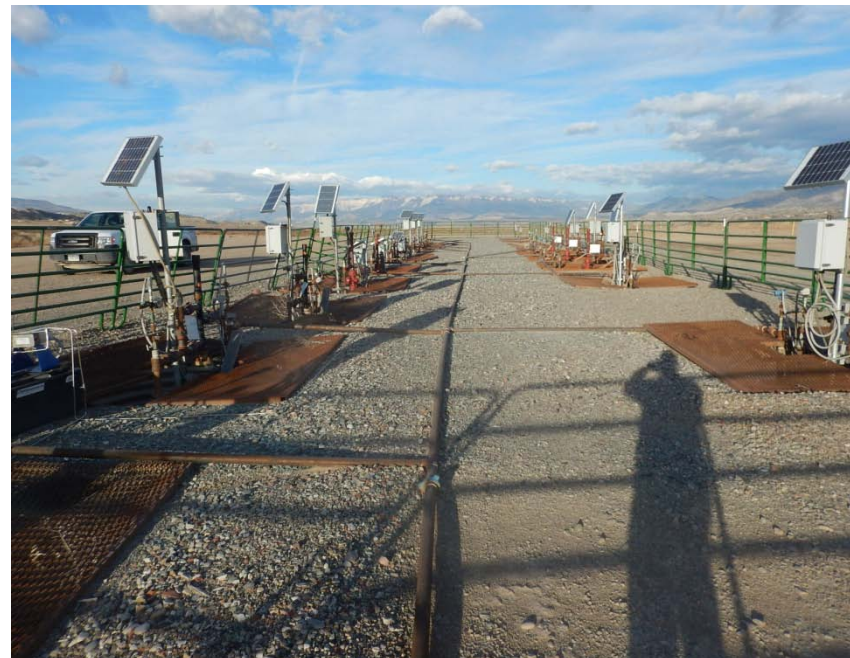
Wellheads with 2" pipe manifold connecting Bradenheads

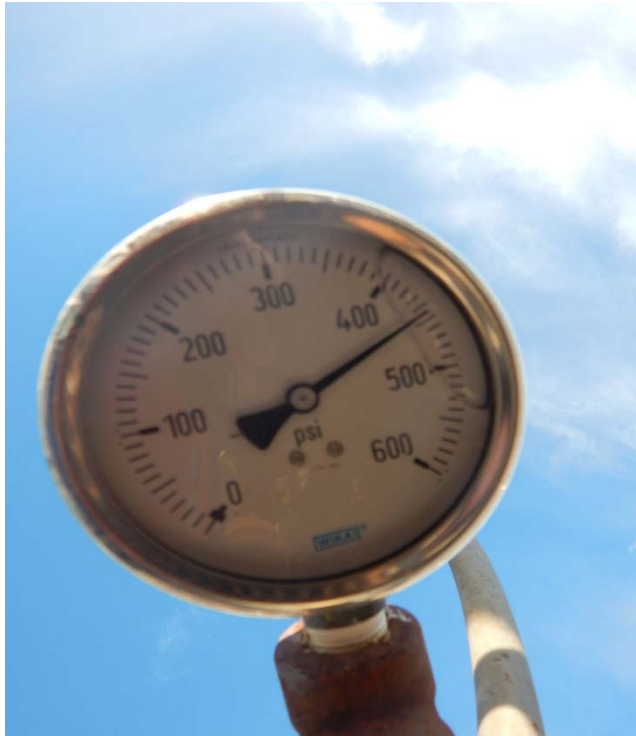
Gage on well B9

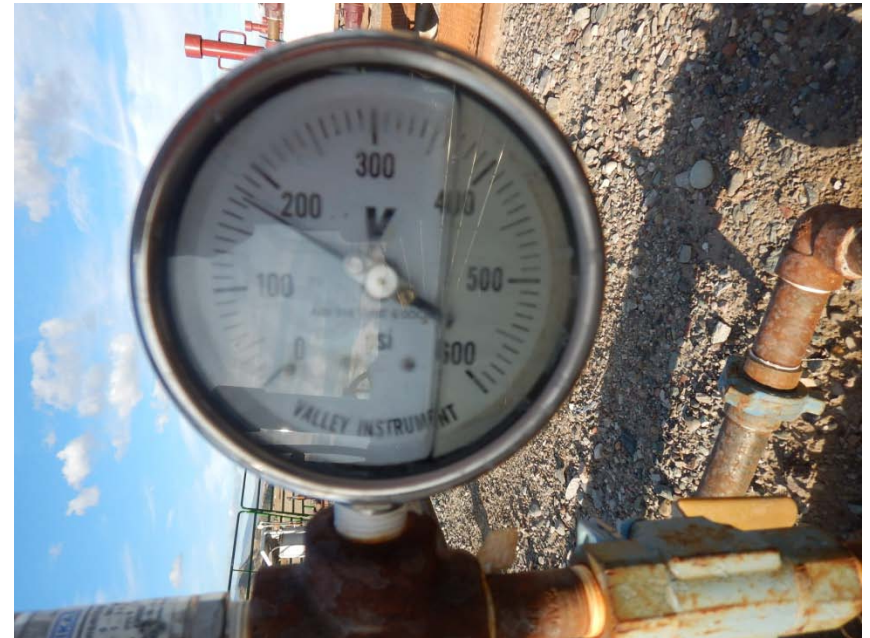
Gage on bradenhead manifold

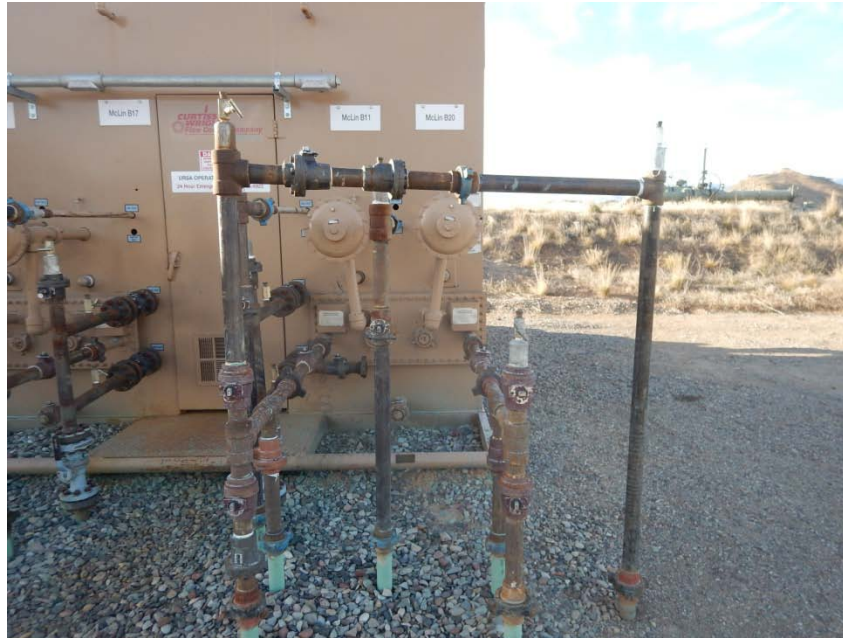
2" inlet pipe on right side of picture, coming from bradenhead manifold. Gas pass thru check valve then to gate valve into separator
