Inspection Photos
Location Name: State #1 (13-36)
API: 05-123-09934

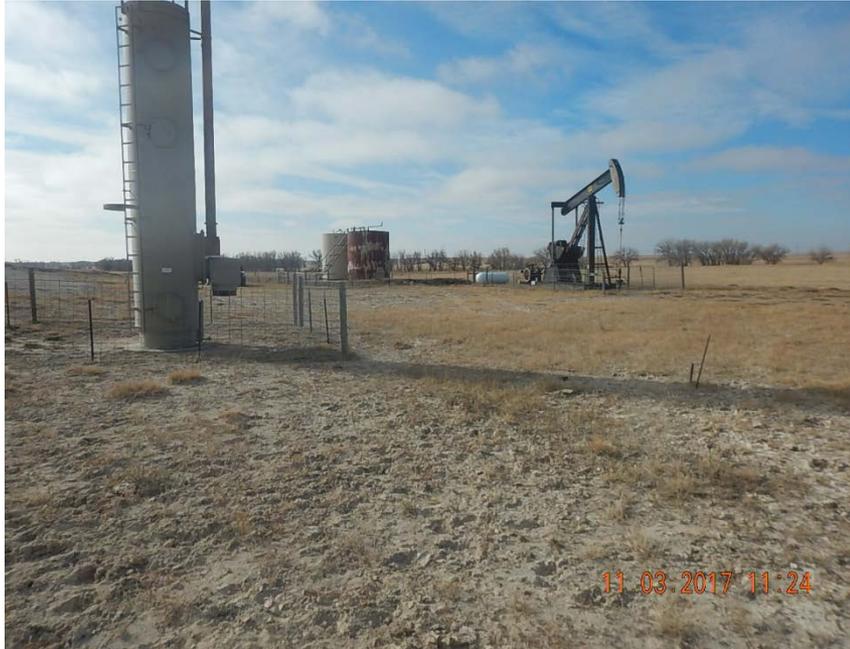
Photo 1: Location, looking NW

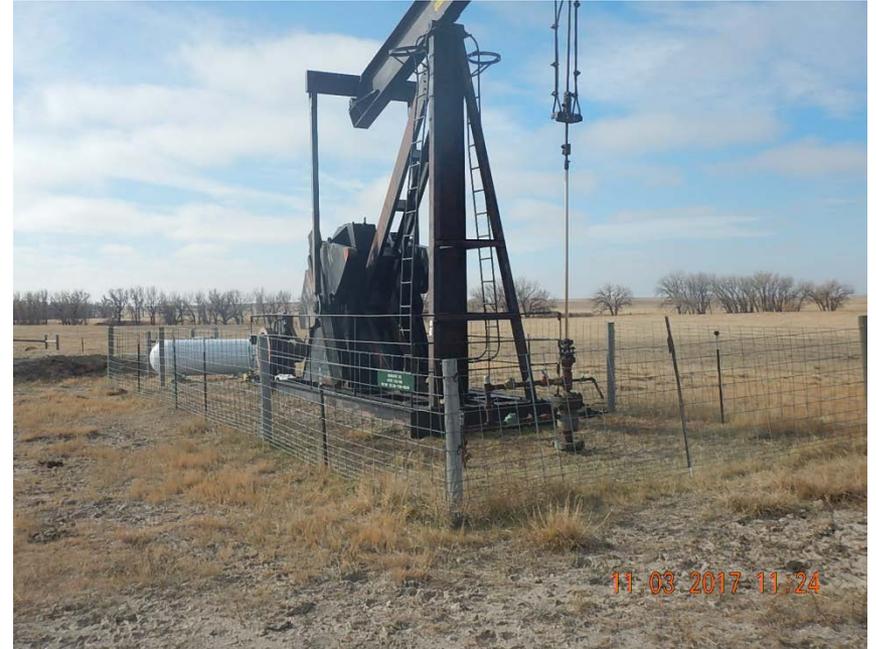
Photo 2: Wellhead, looking NW

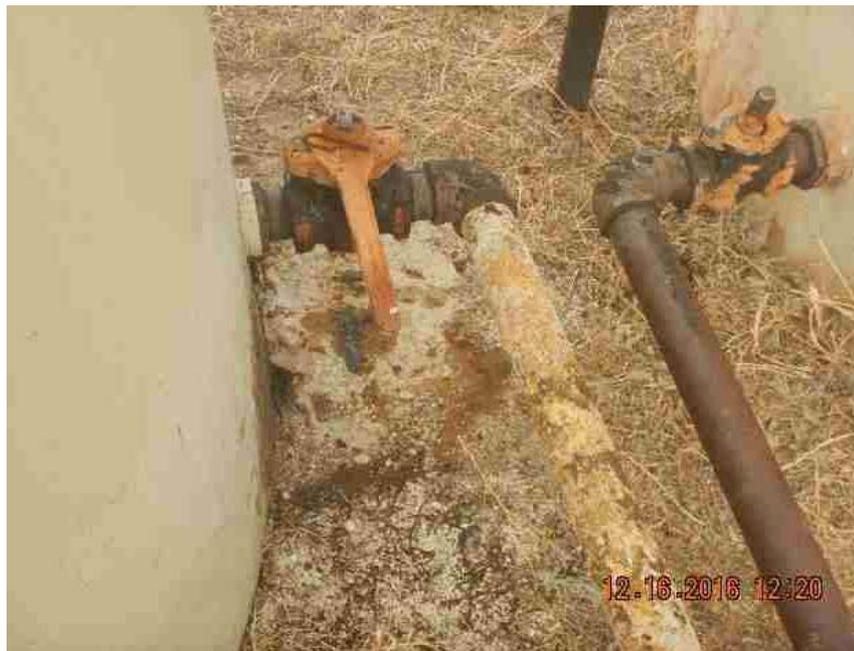
Photo from prior inspection for comparison

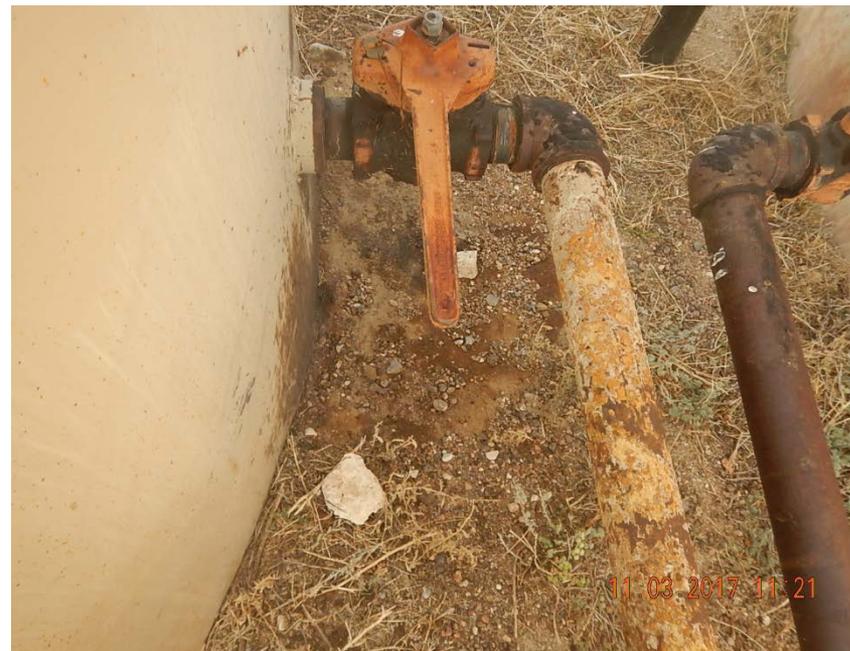
Photo 3: Stained soil at loadout

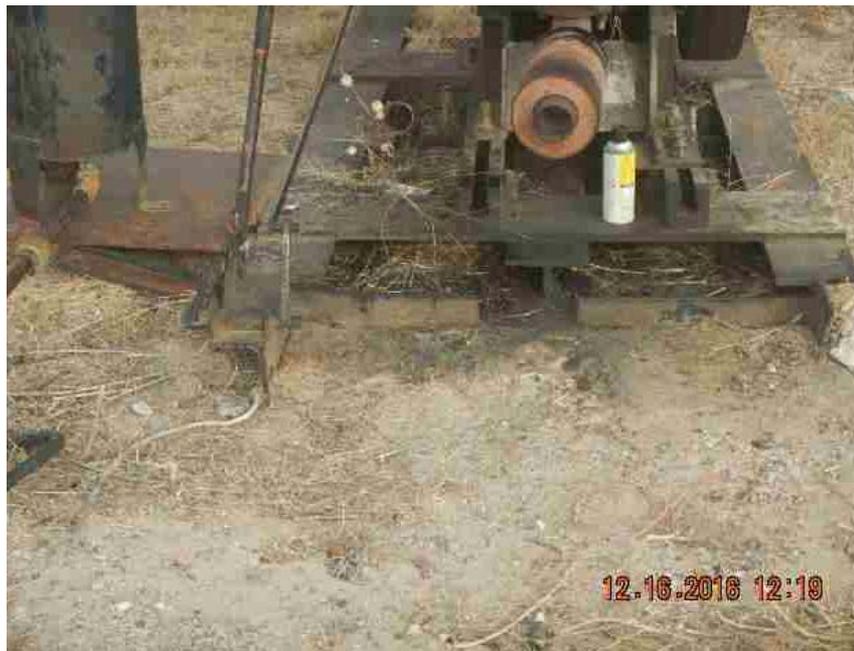
Photo from prior inspection for comparison

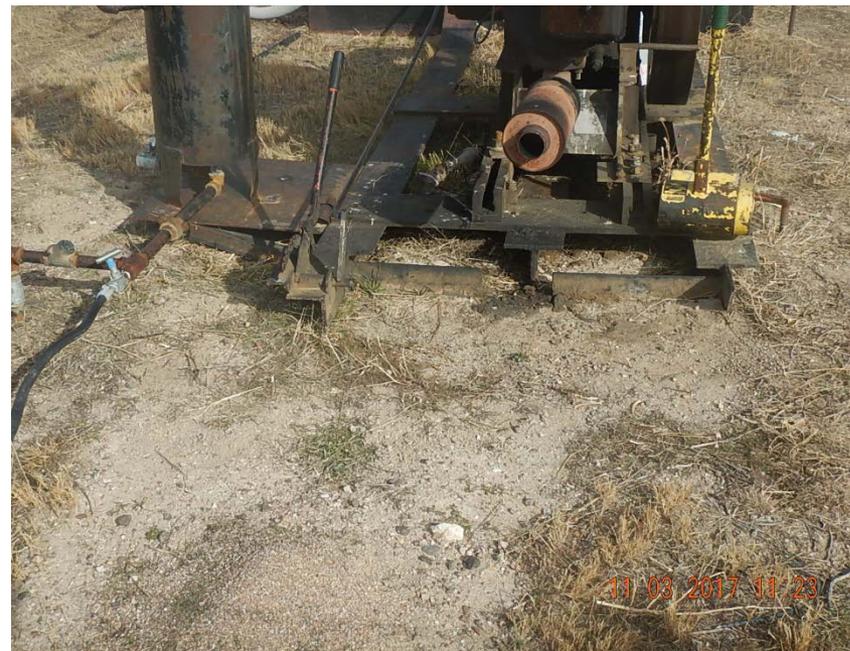
Photo 4: Stained soil at engine

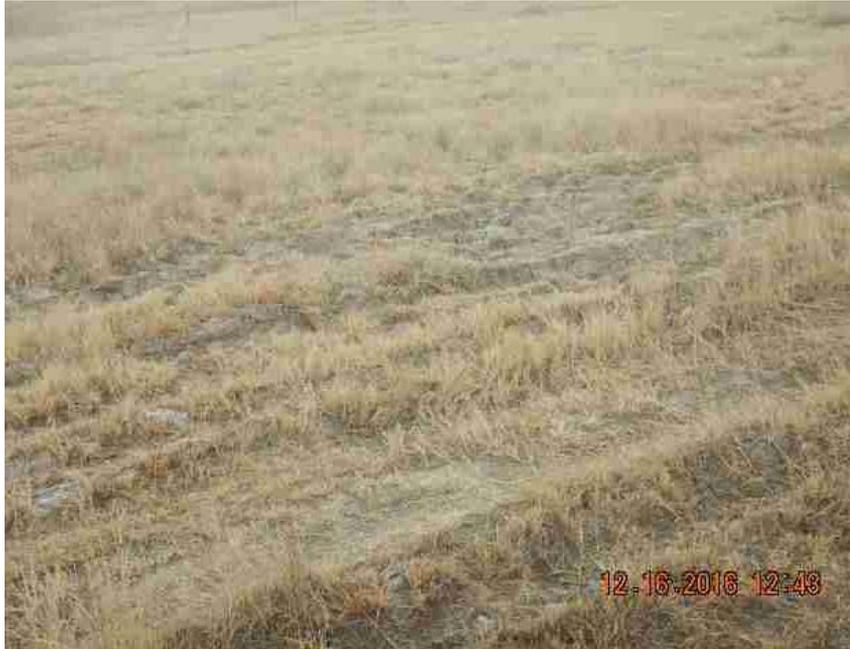
Photo from prior inspection for comparison

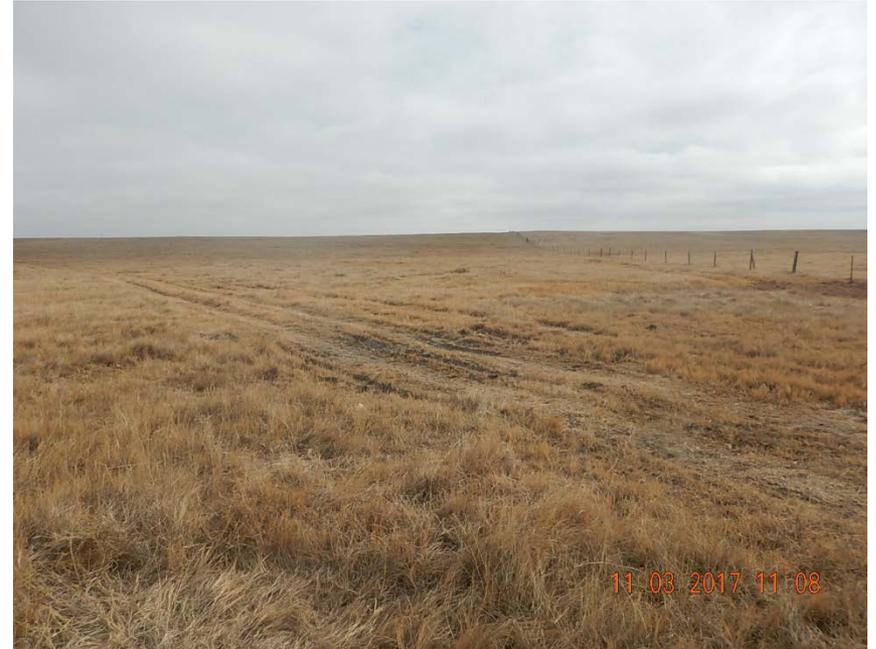
Photo 5: Rutting in lease road

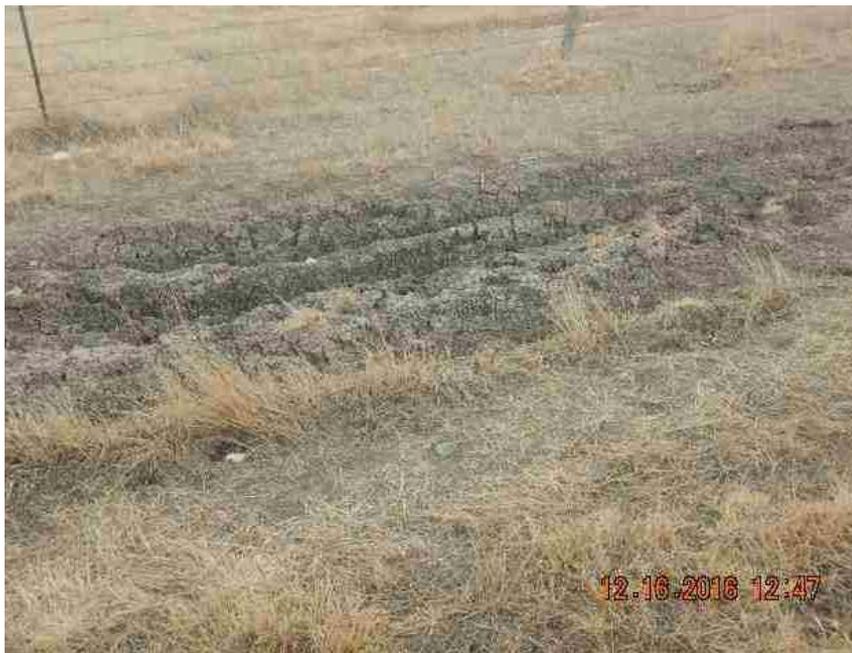
Photo from prior inspection for comparison

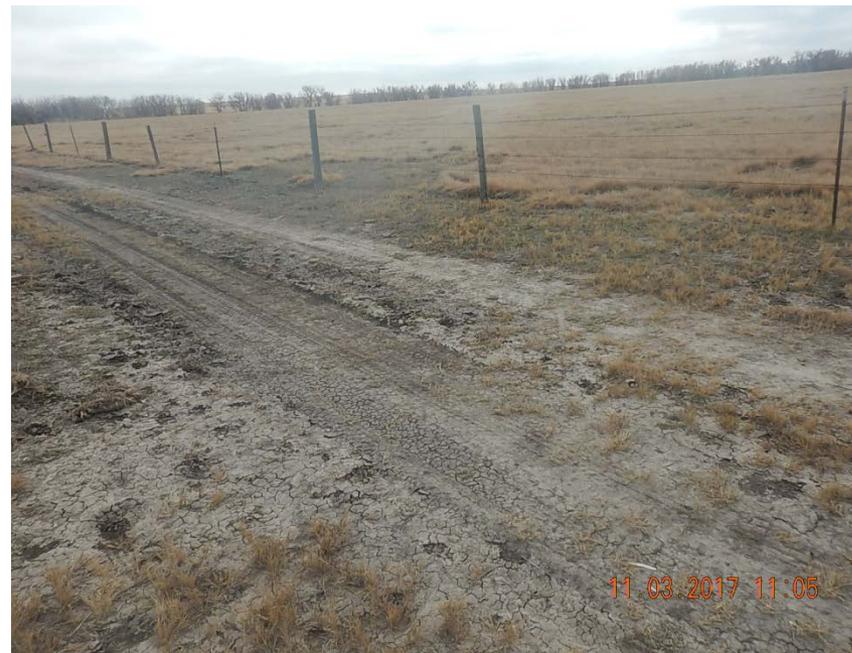
Photo 6: Some lease road repairs

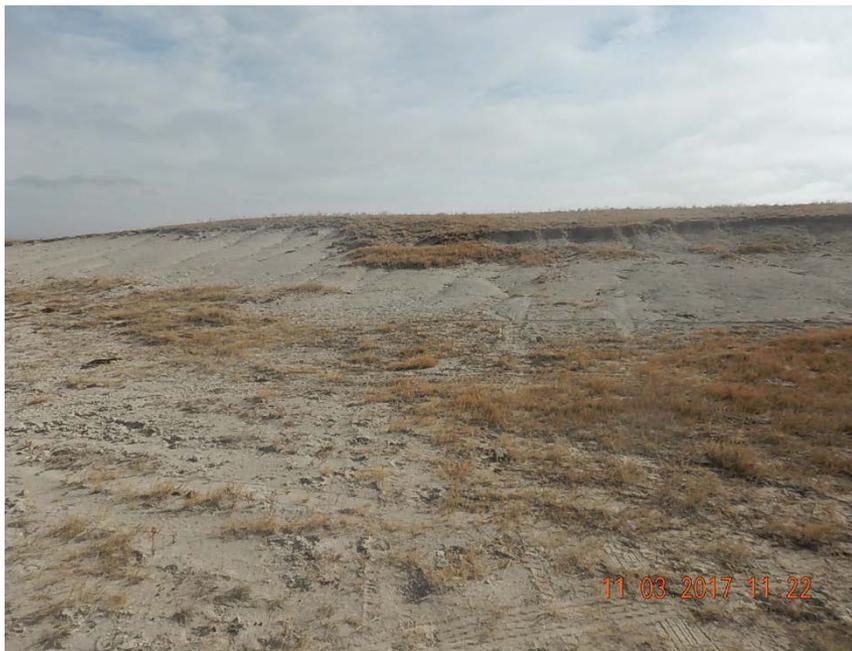
Photo 7: Stormwater erosion on E side of location

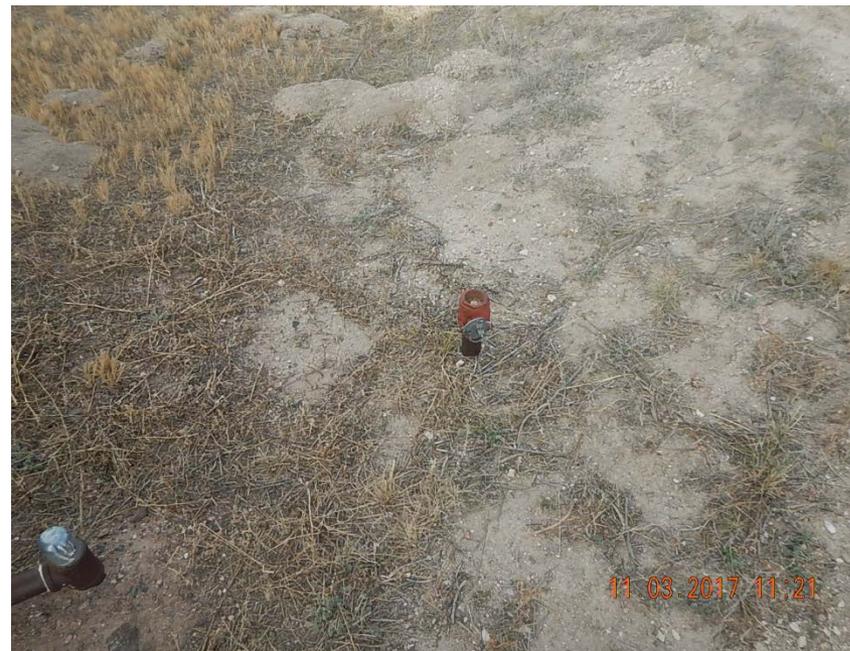
Photo 8: Riser in tank battery
