Inspection Photos
Location Name: Smuggler #16-10-62
API: 05-123-31853

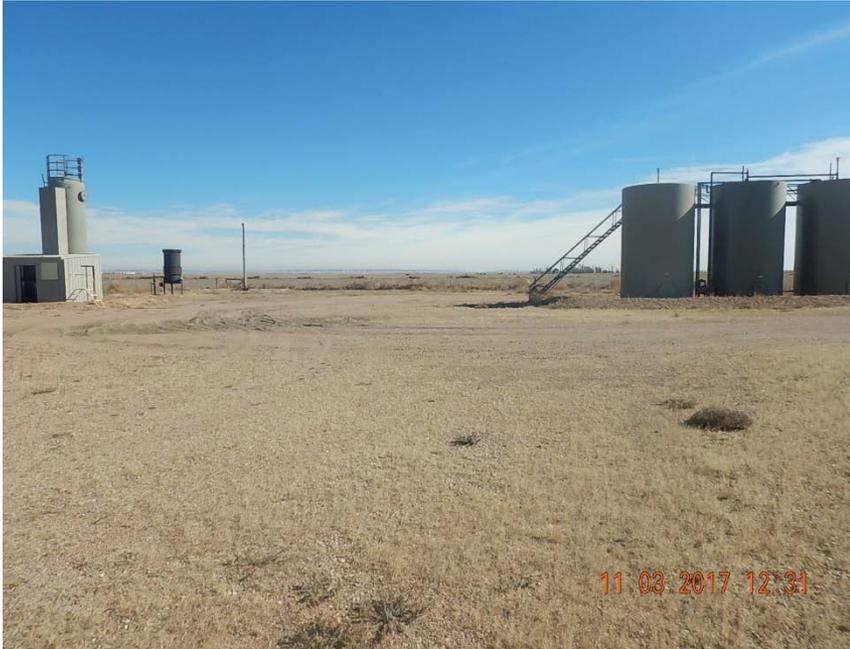
Photo 1: Location, looking SE

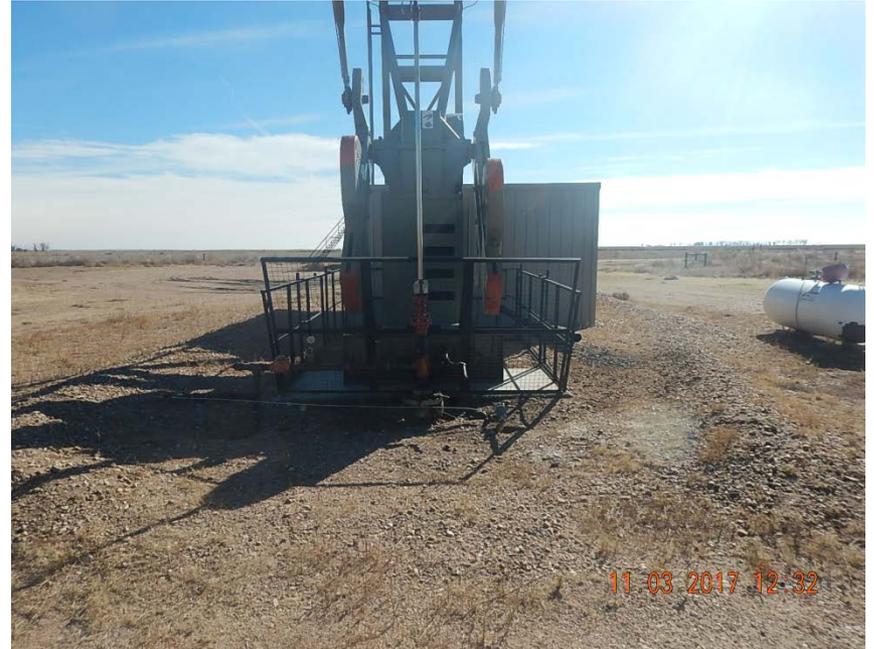
Photo 2: Wellhead, looking S

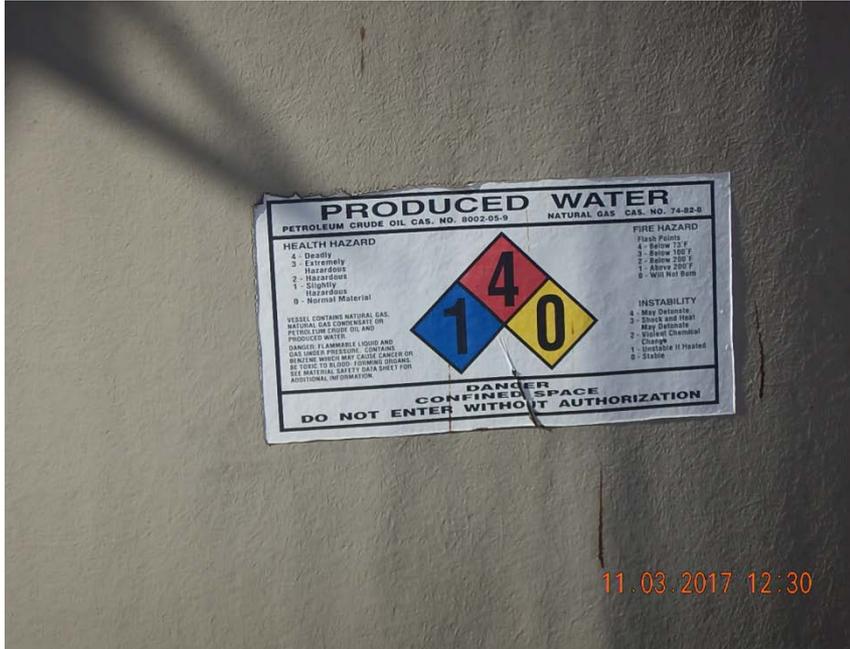
Photo 3: No capacity on produced water decal

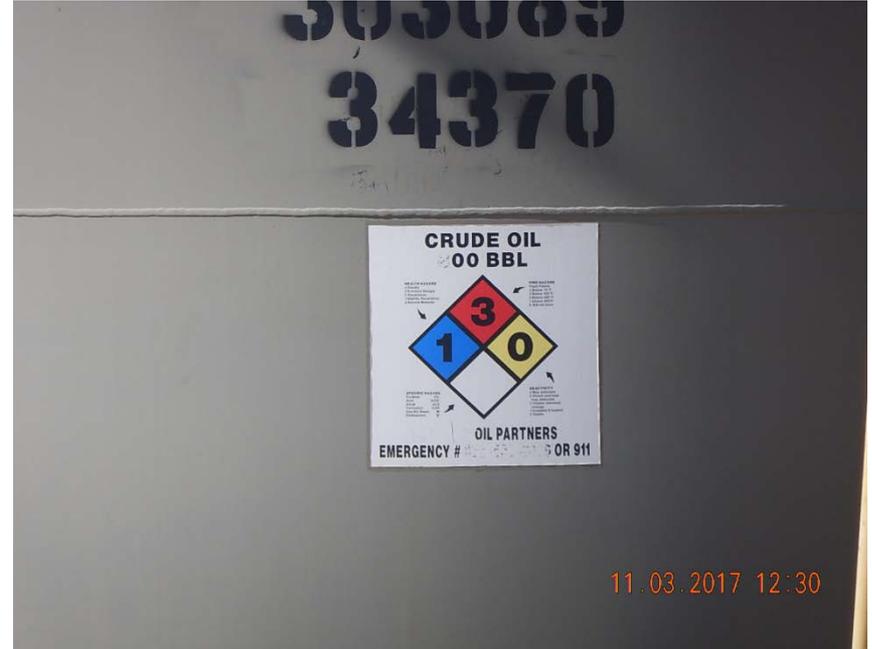
Photo 4: No capacity on crude oil decal

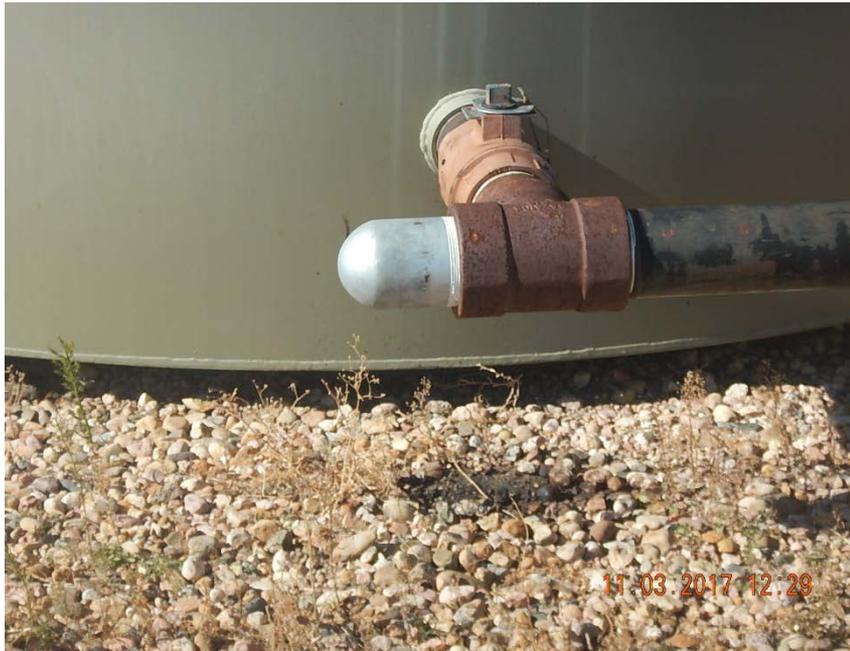
Photo 5: Stained soil at loadout

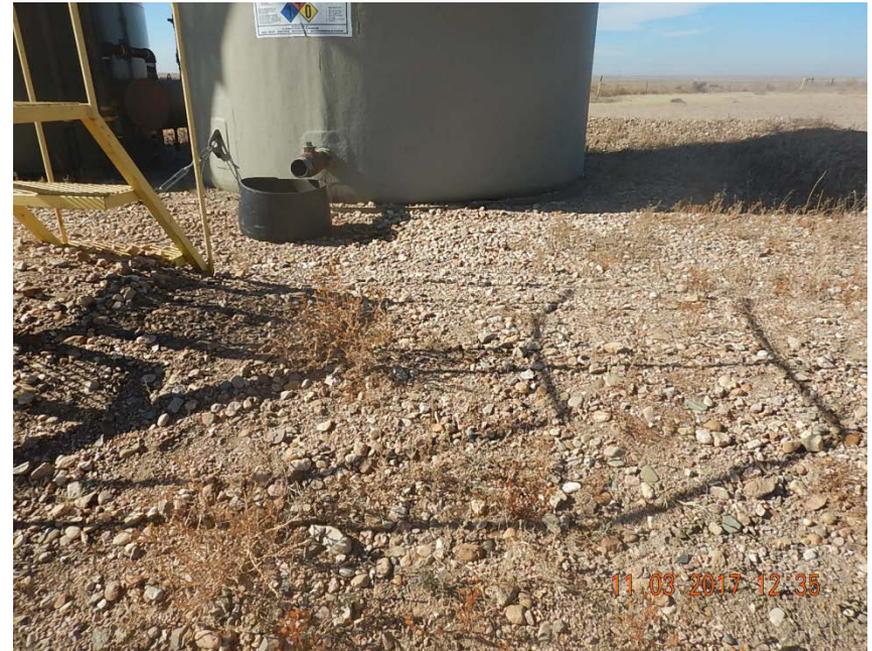
Photo 6: Berms eroded low, some weeds in battery

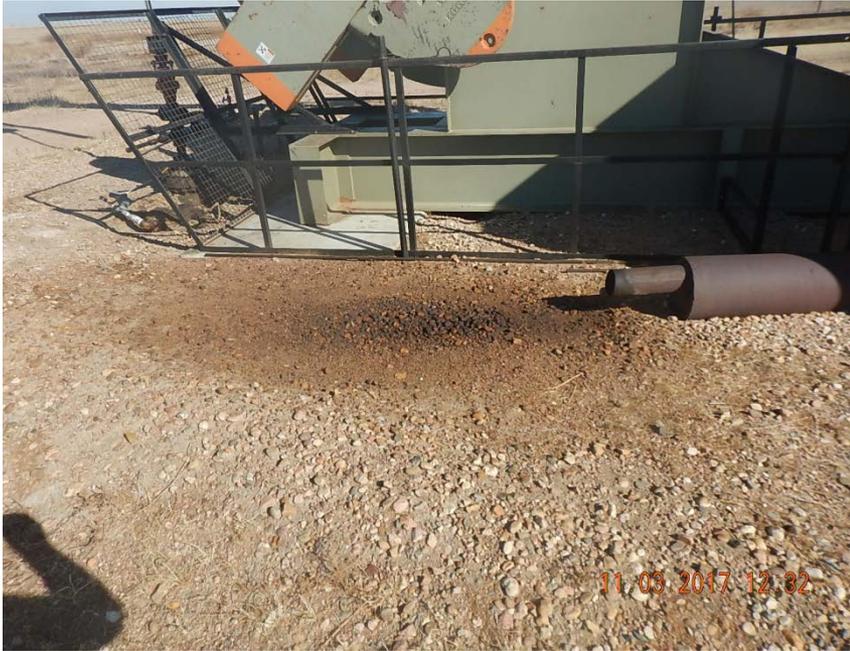
Photo 7: Stained soil at exhaust

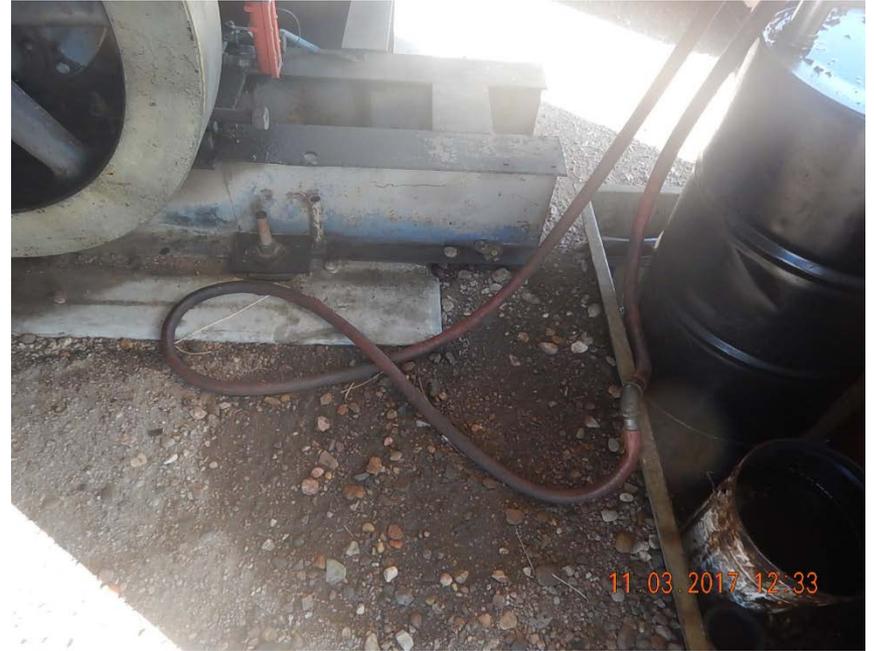
Photo 8: Stained soil

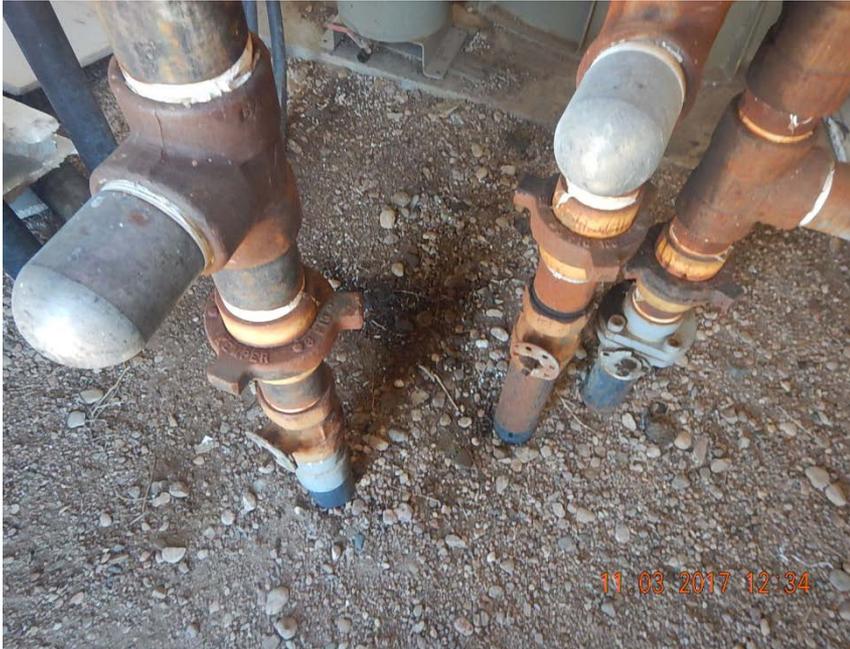
Photo 9: Stained soil in treater house

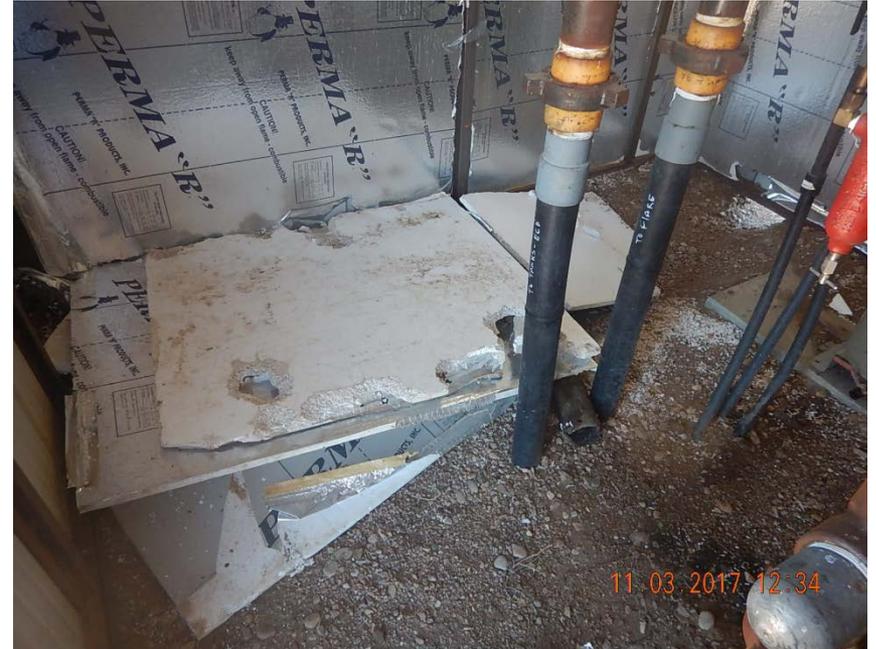
Photo 10: Debris in treater house

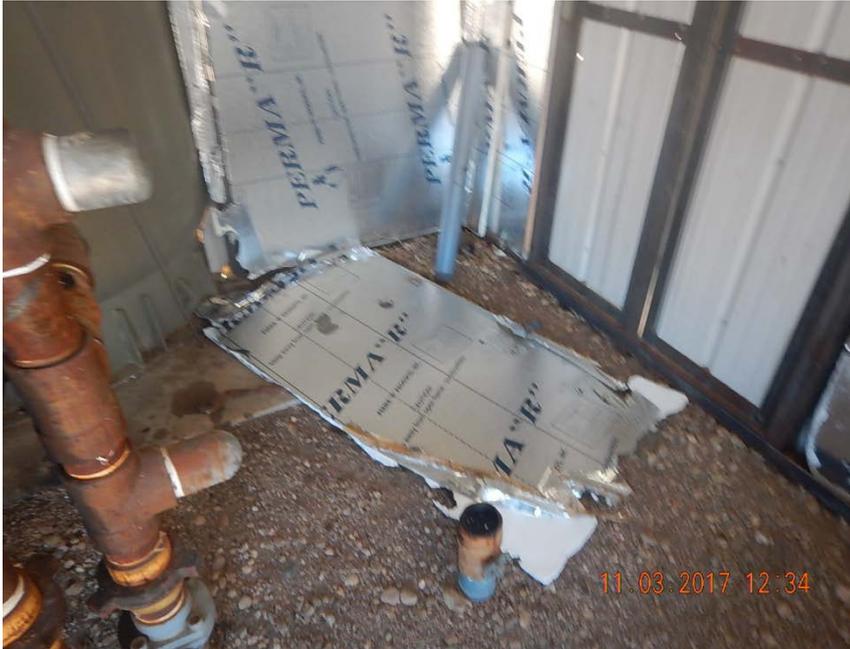
Photo 11: Debris in treater house
