Inspection Photos
Location Name: Dunbar #1
API: 05-123-23247

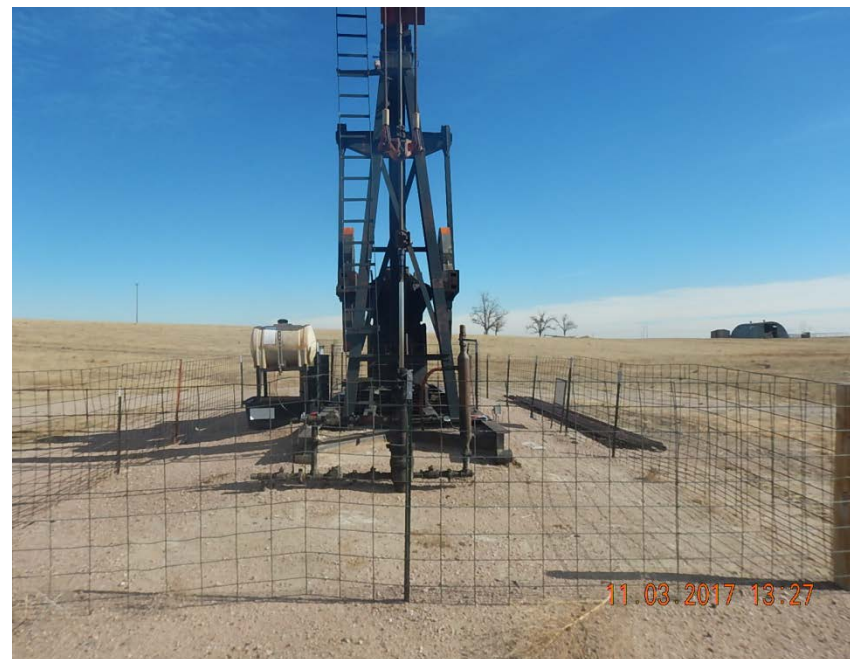
Photo 2: Wellhead, looking E

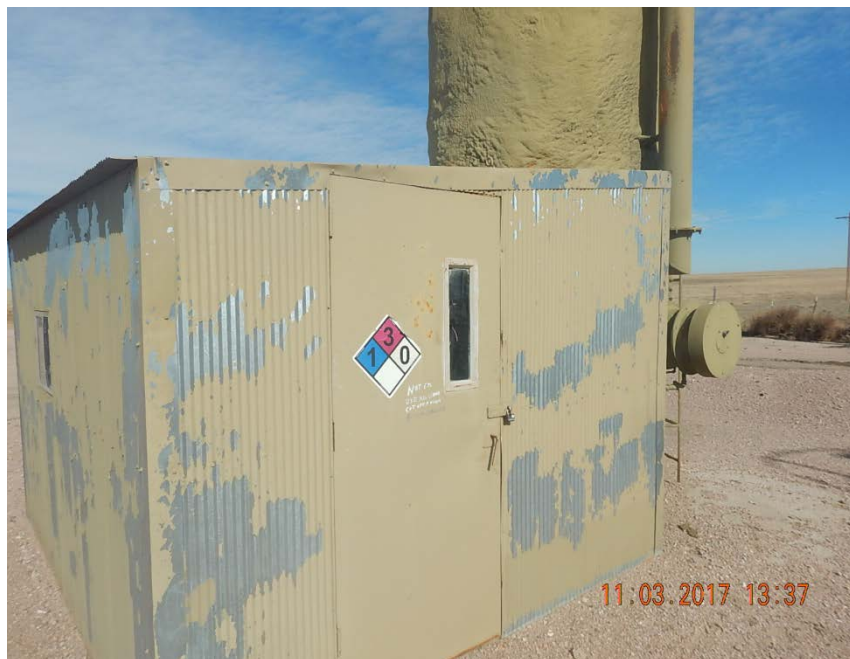
Photo 3: Unused treater and treater house

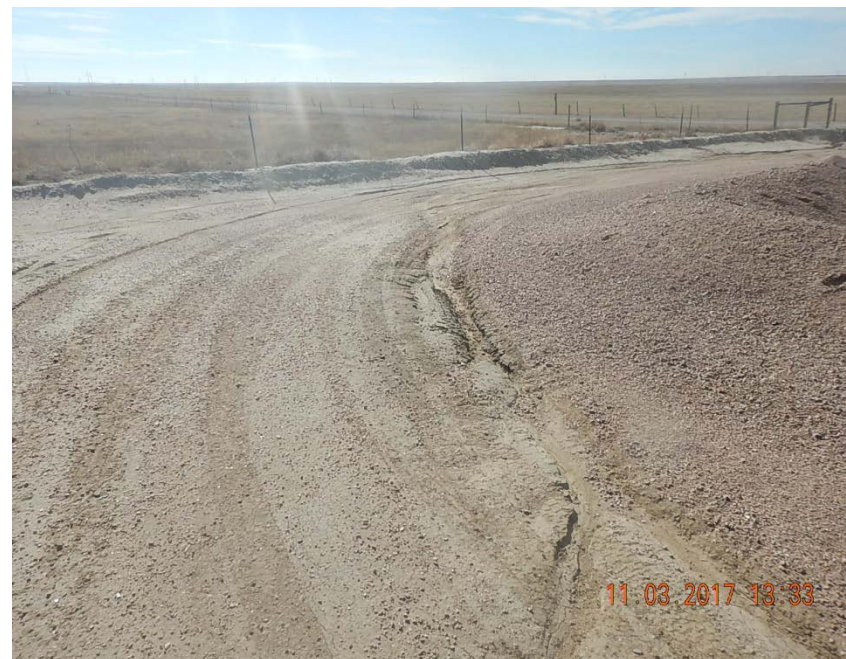
Photo 4: Stormwater on SE corner of battery berm

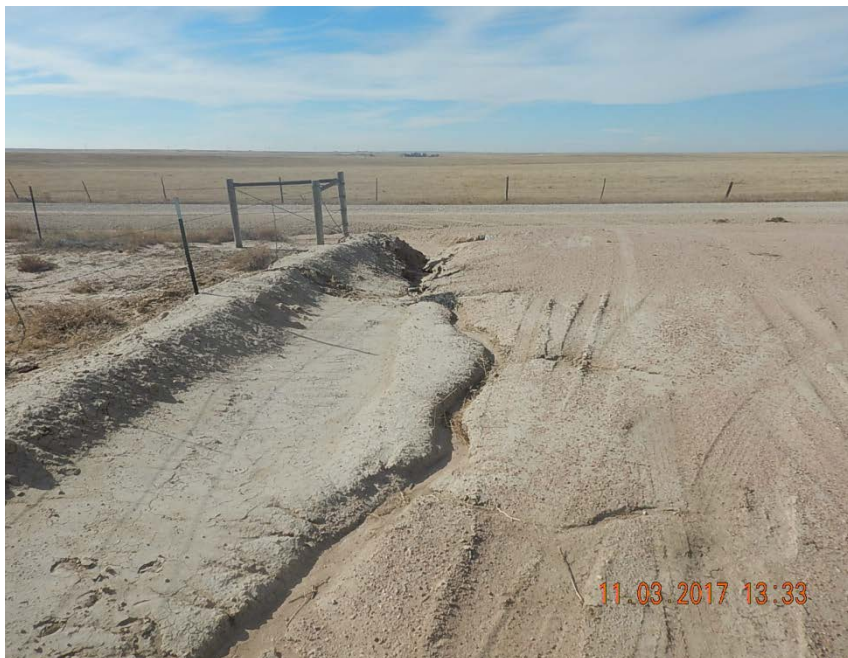
Photo 5: Stormwater erosion on SW corner of location

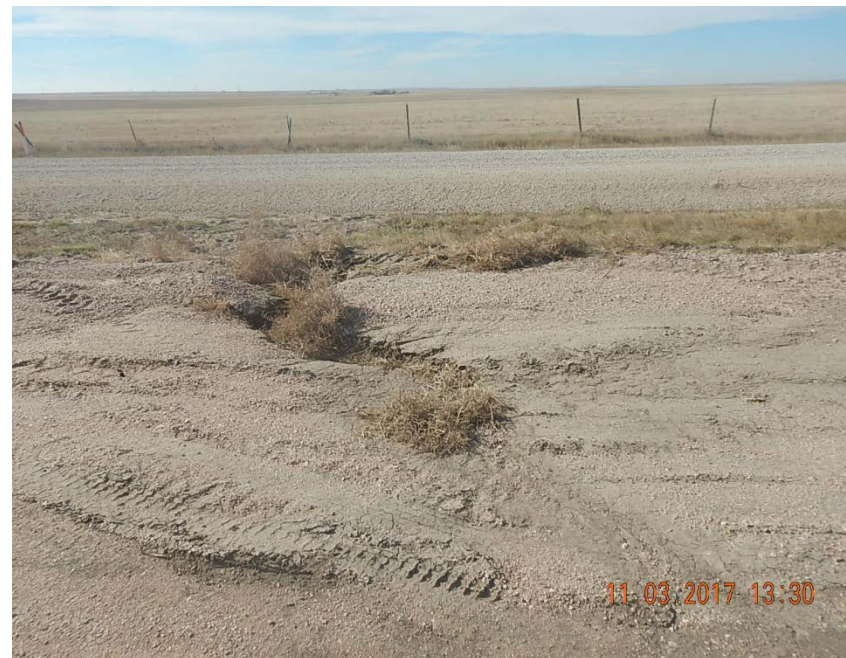
Photo 6: Stormwater erosion on W side of location

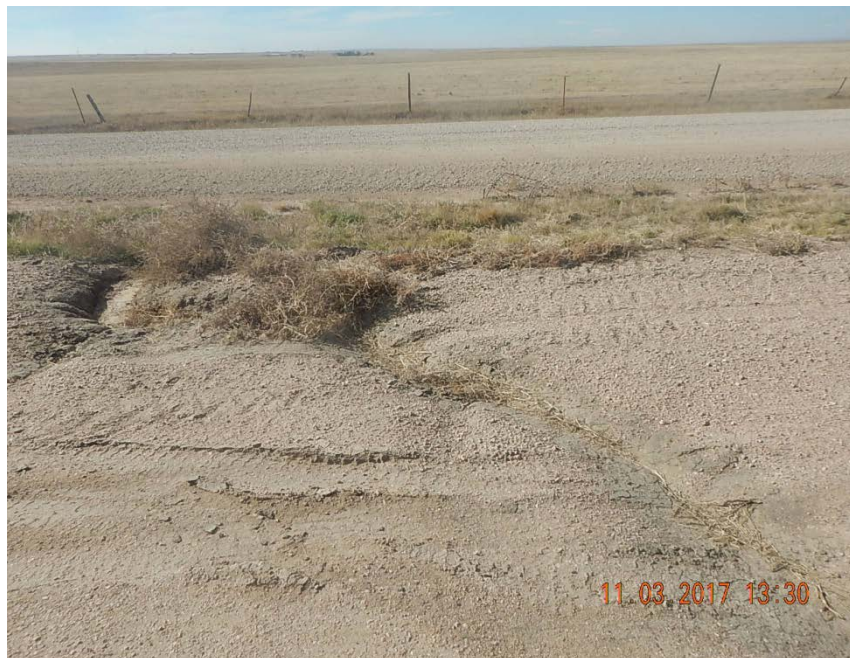
Stormwater erosion on W side of location

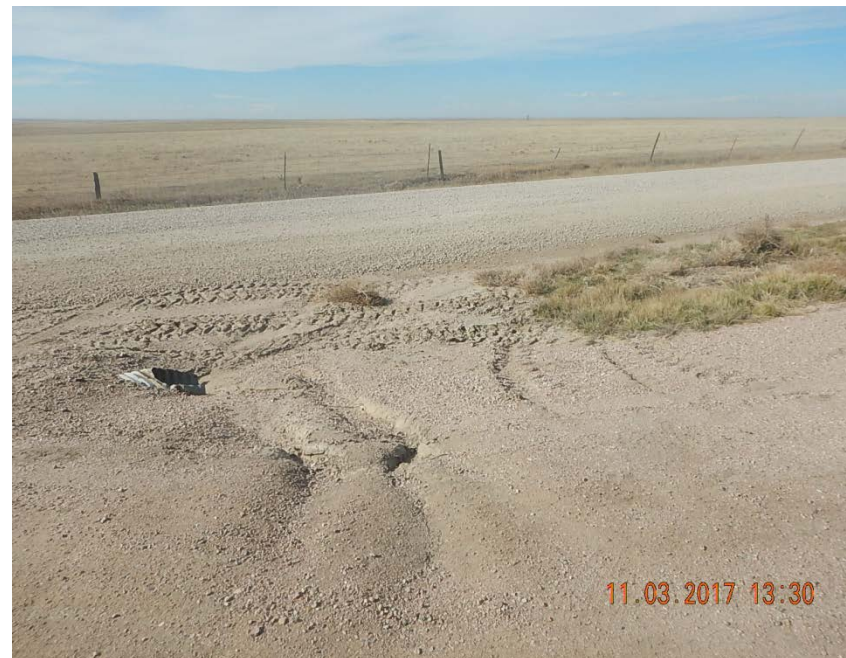
Stormwater erosion on W side of location
