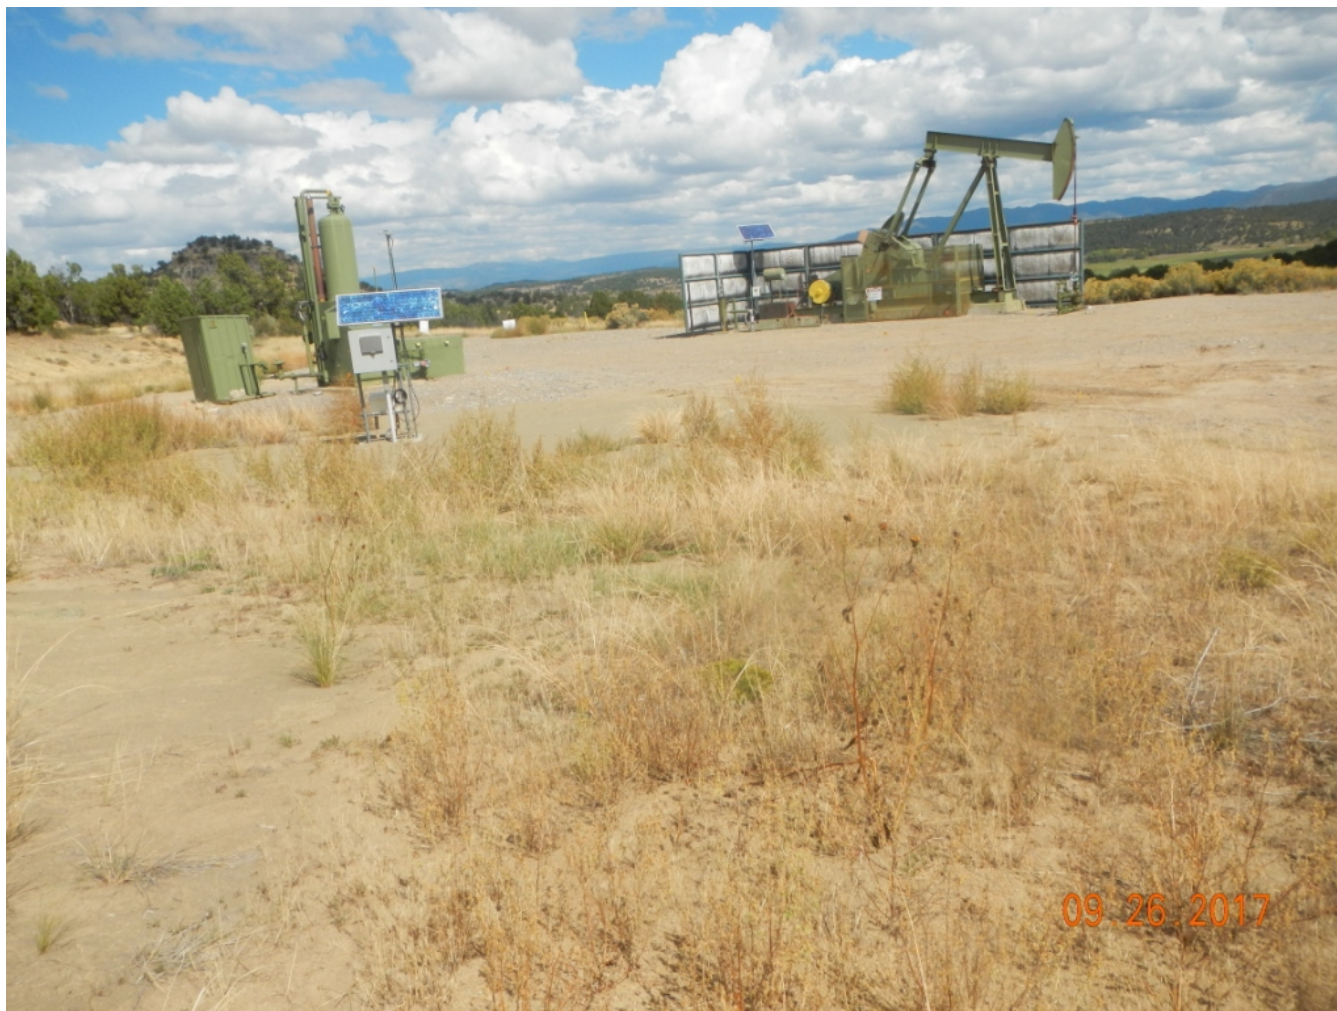
Photo 1. View of the project area from the southwestern corner facing center.

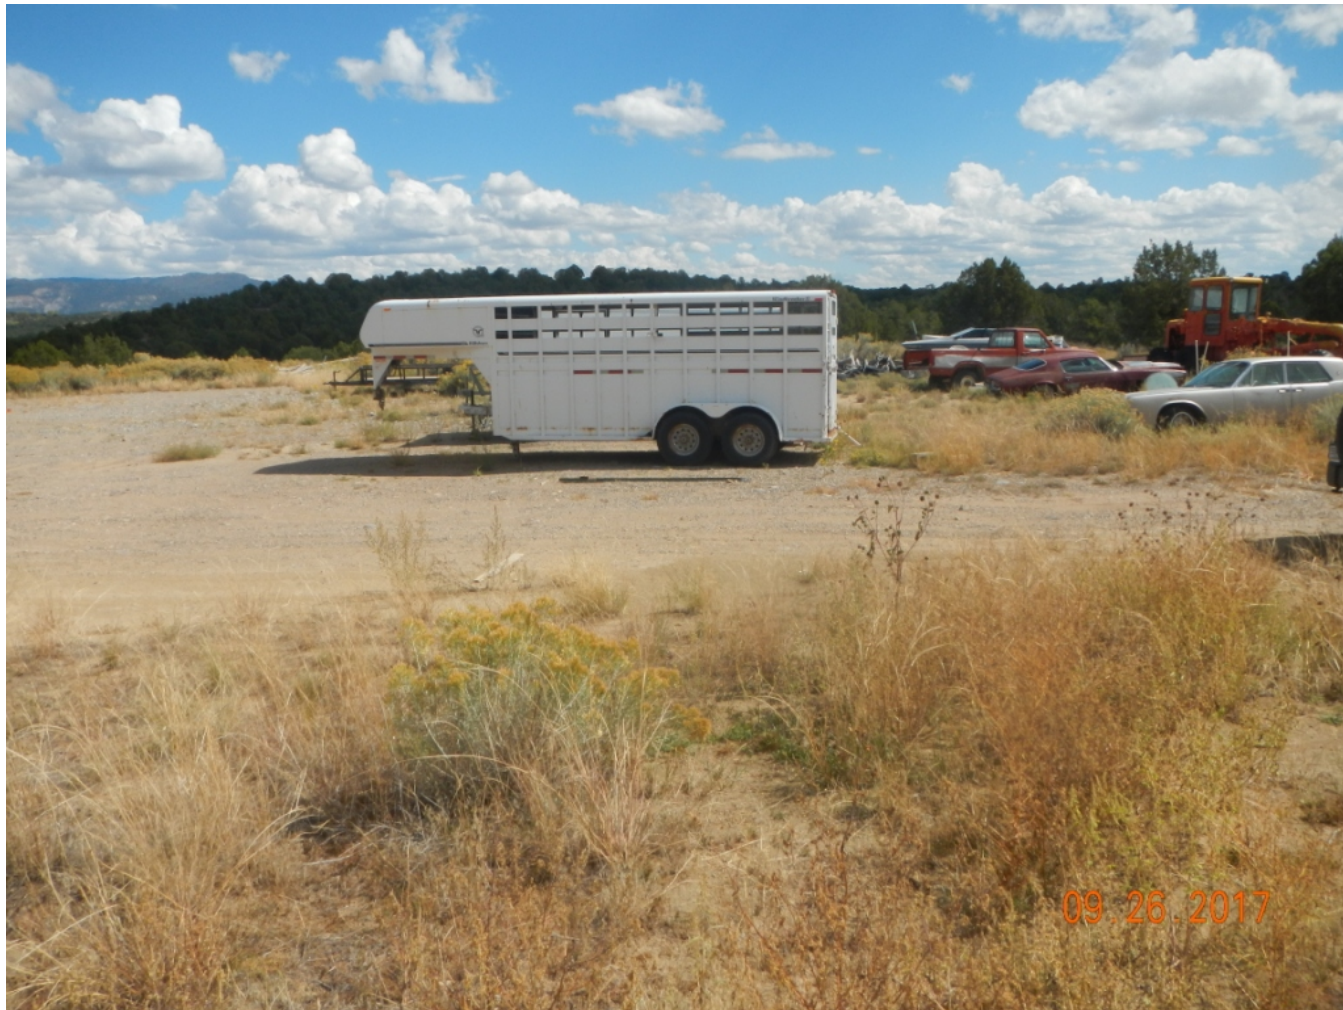
Photo 2. View of the southern portion of the project area from the southwestern corner facing eastward. Revegetation is progressing within the revegetation areas with grasses and shrubs such as crested wheatgrass (*Agropyron cristatum*), dropseed (*Sporobolus* sp.), and rubber rabbitbrush (*Chrysothamnus nauseosus*). Surface owner is storing vehicles and equipment in the southern portion of the project area.

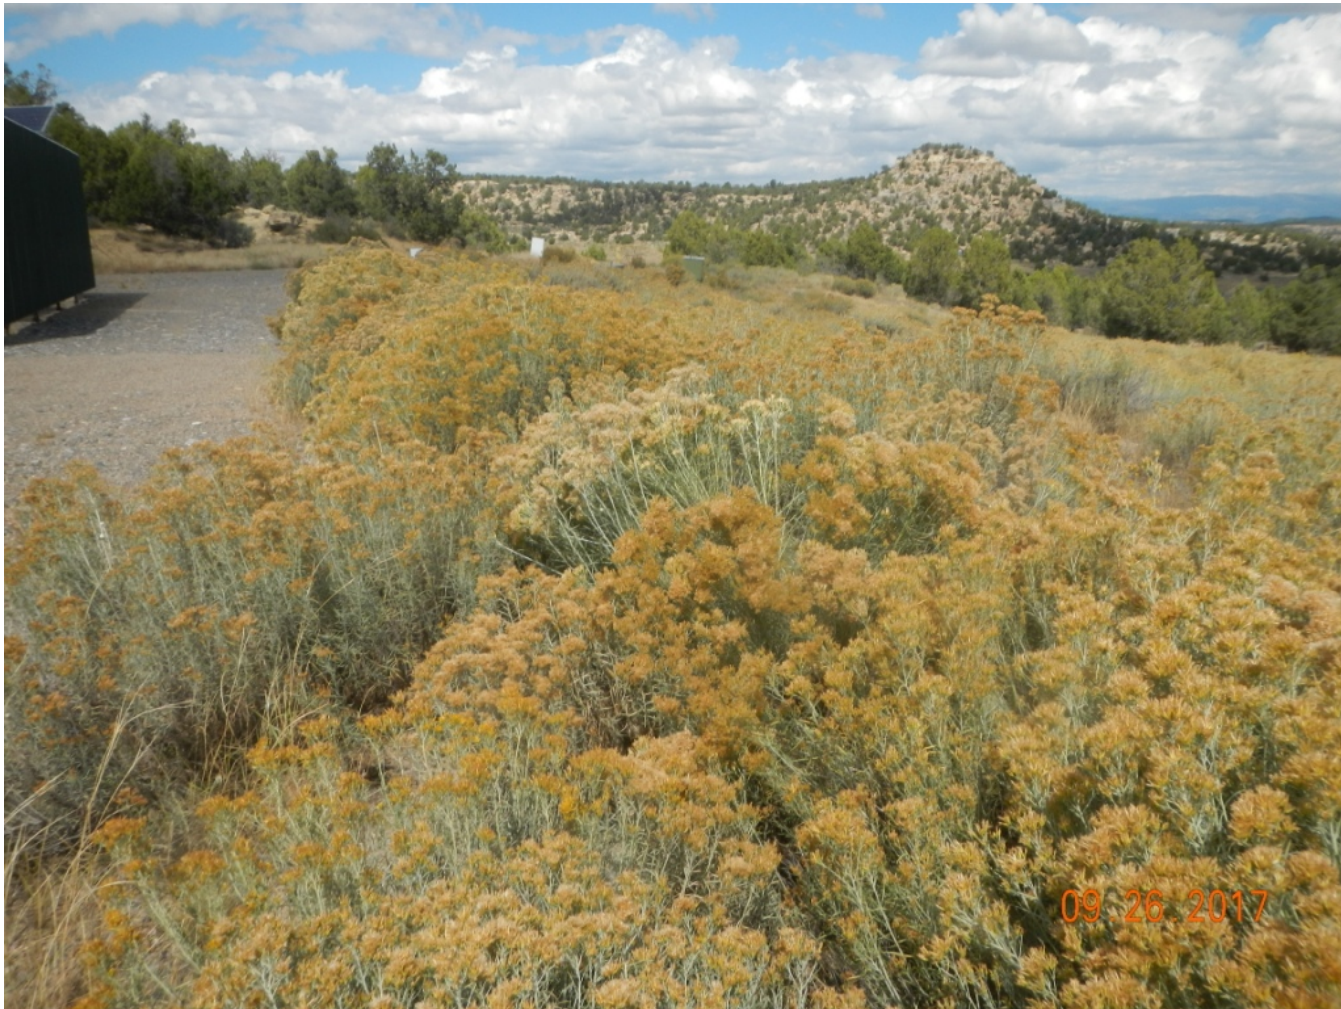
Photo 3. View of the eastern portion of the project area from the southeastern corner facing northward.

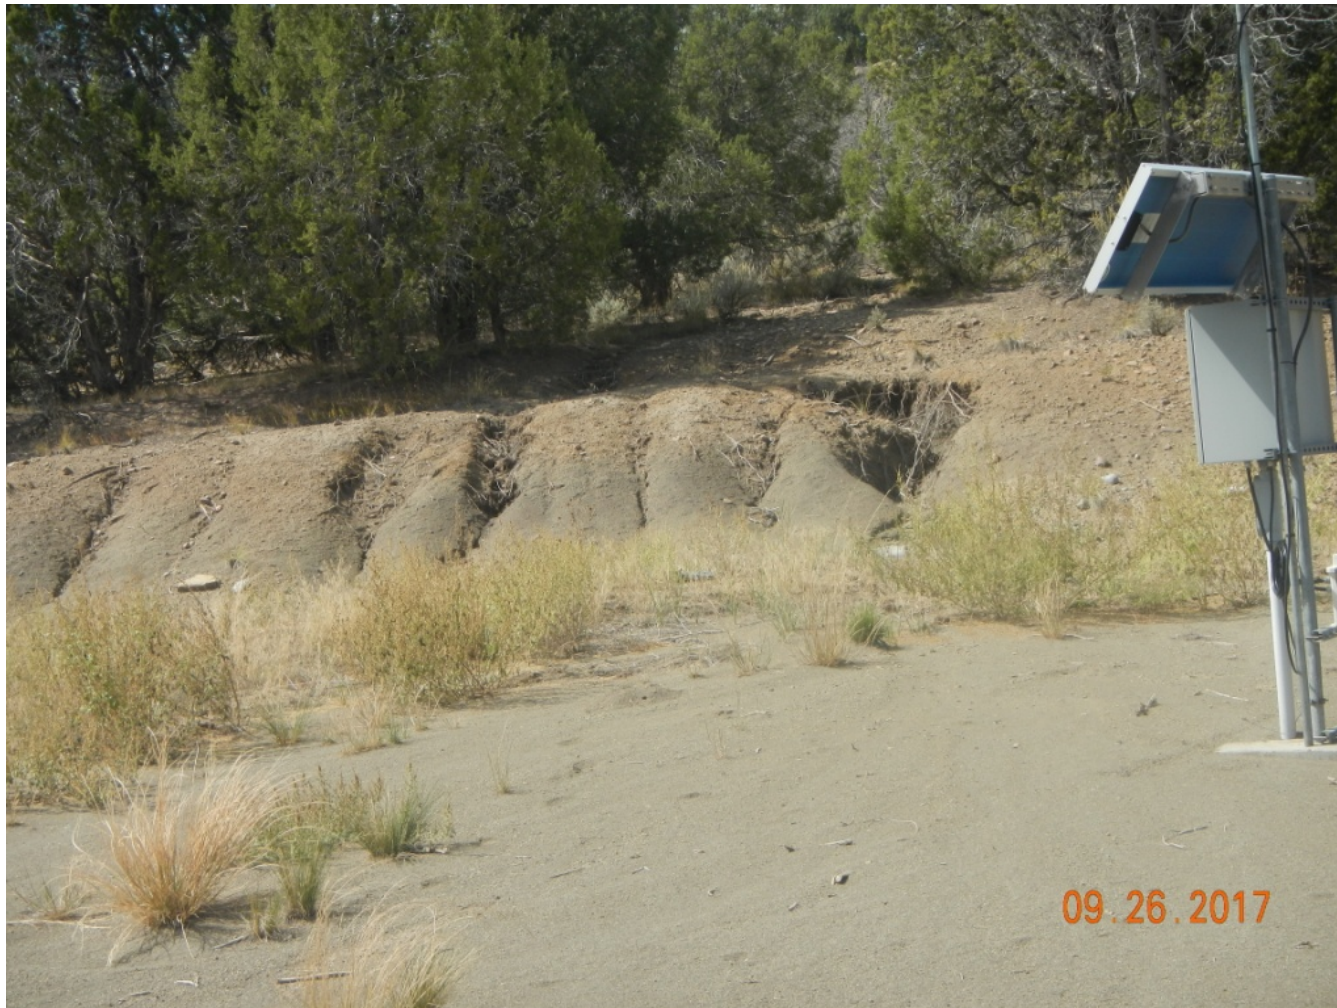
Photo 4. View of the eastern portion of the project area from the southeastern corner facing northward. Erosion is occurring within the western cut-slope. Stabilization is needed.
