Inspection Photos

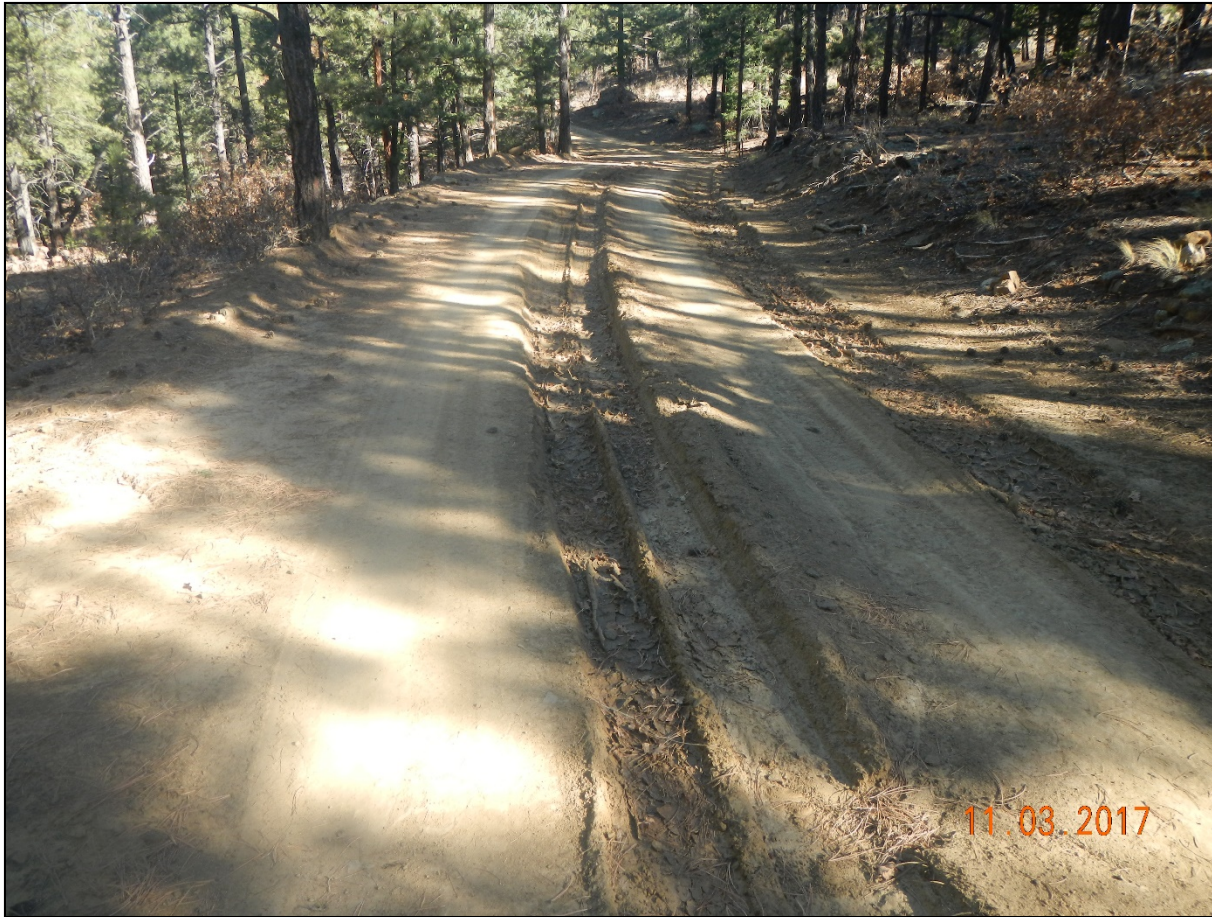
Photo 1. Facing north along the access road. There is vehicle rutting occurring along the road.

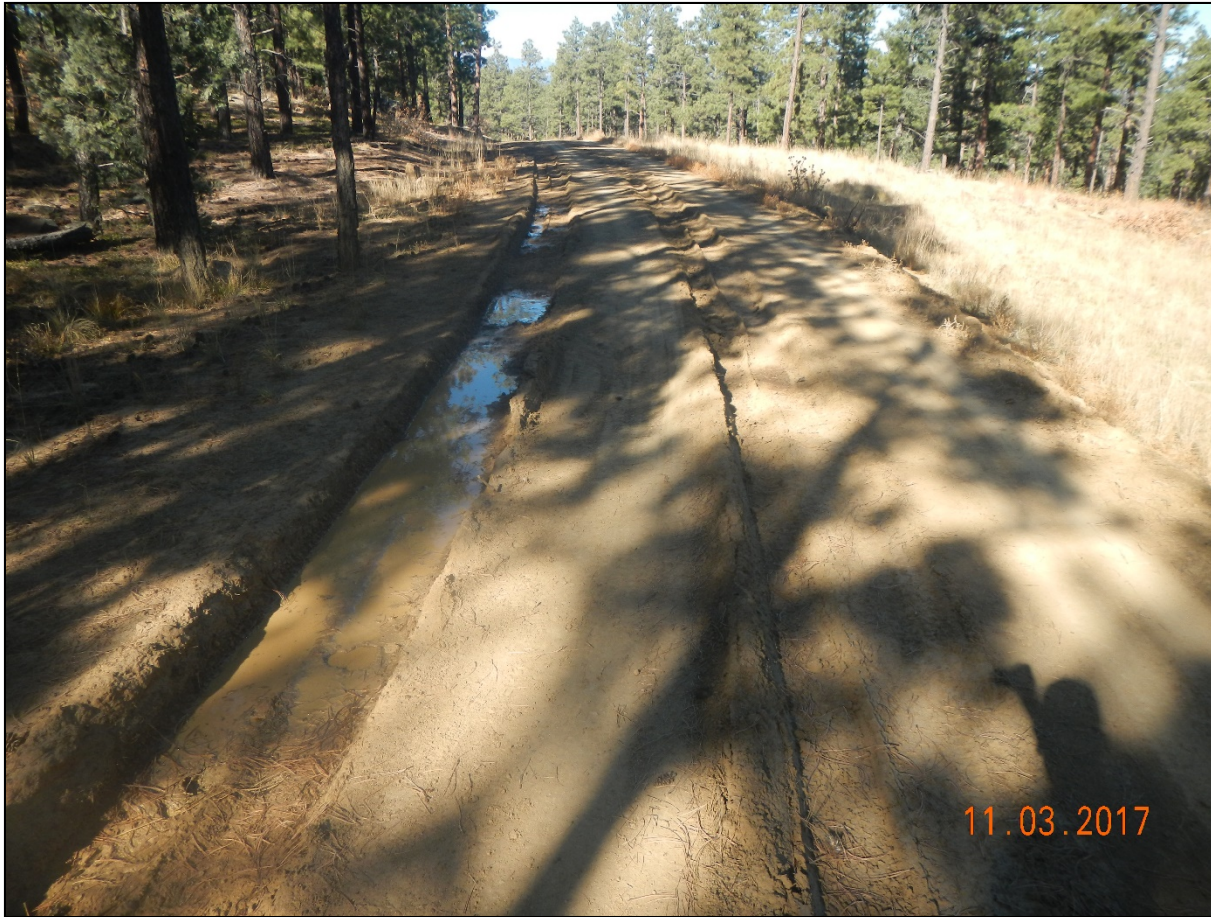
Photo 2. Facing northwest along the road. There is signs of vehicle rutting and widening of the road occurring.

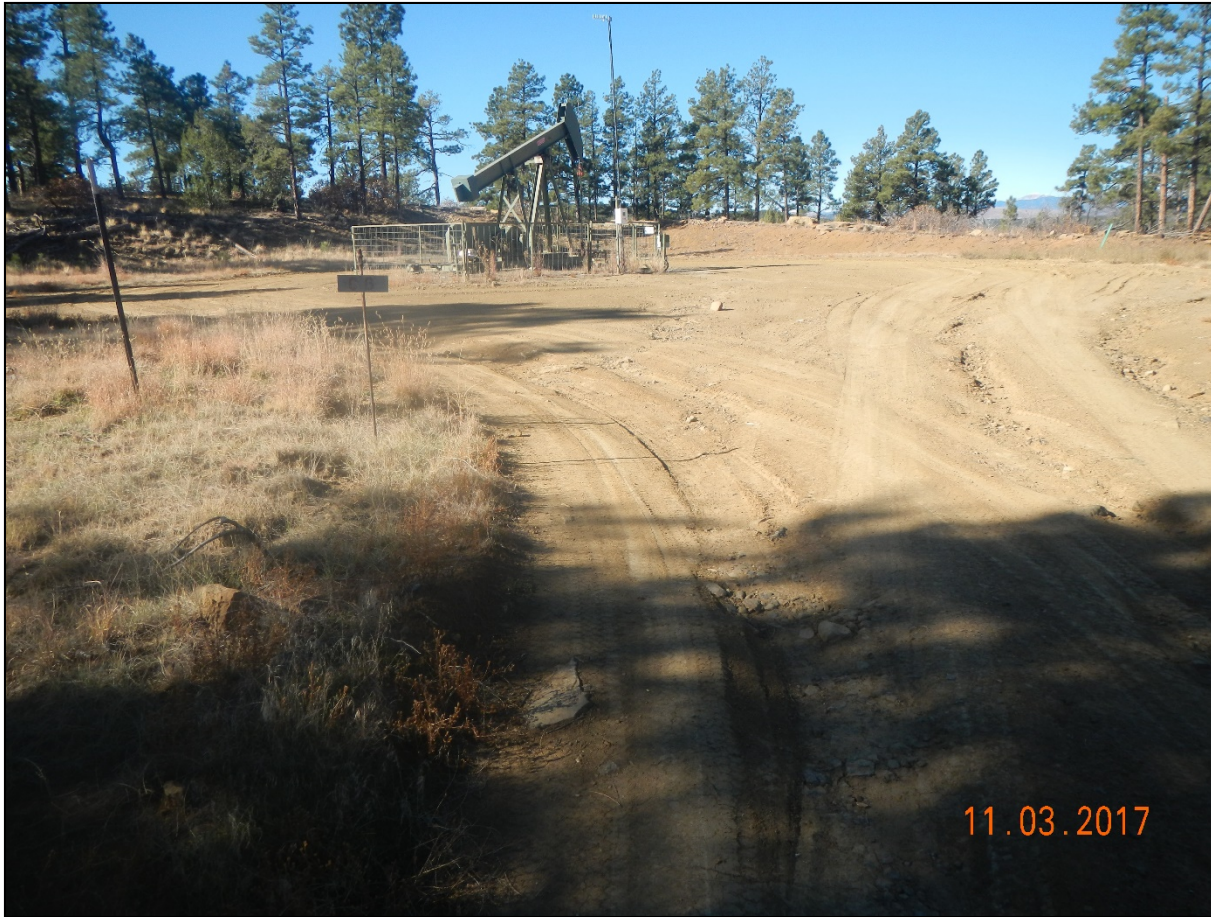
Photo 3. Facing west toward the location.

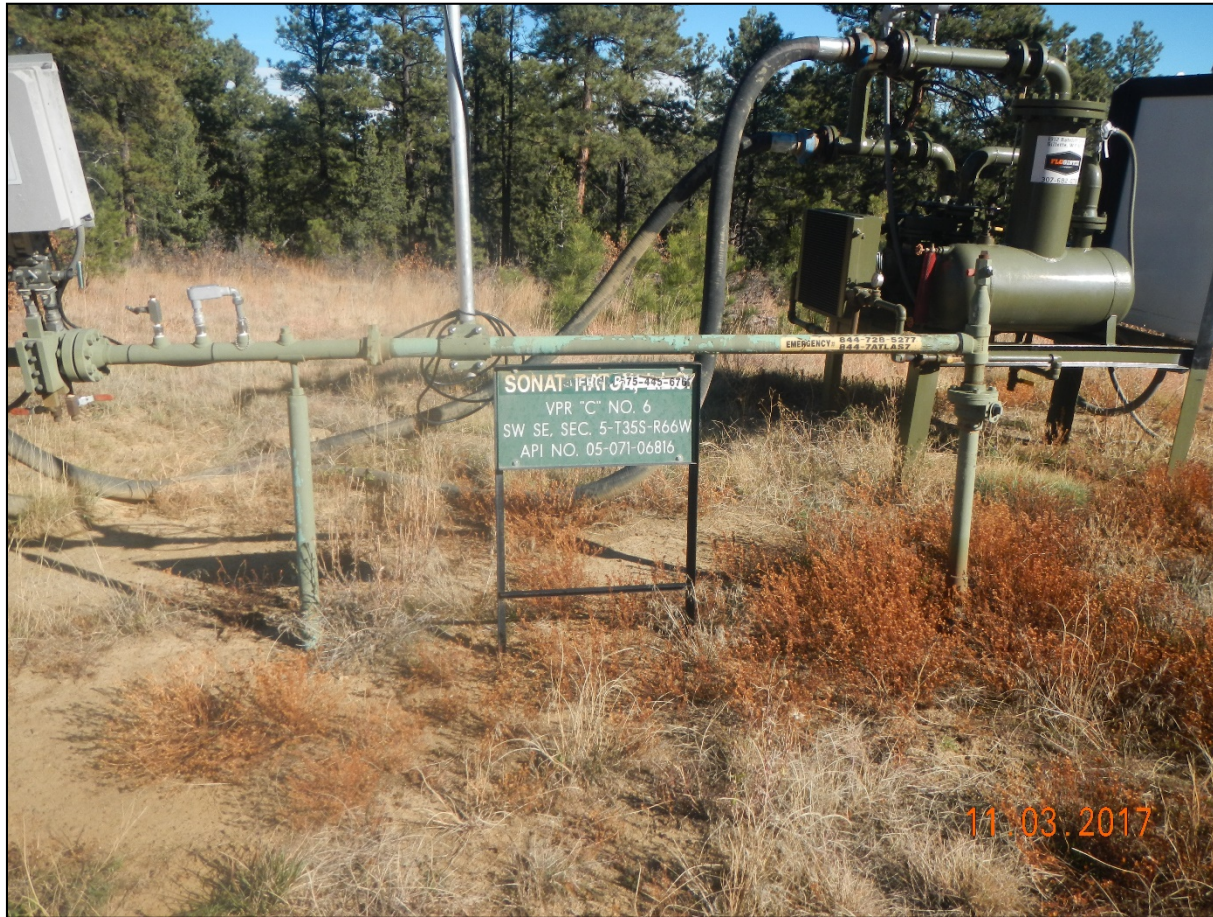
Photo 4. There is a well sign installed however the operator name and emergency contact information is faded and not legible.

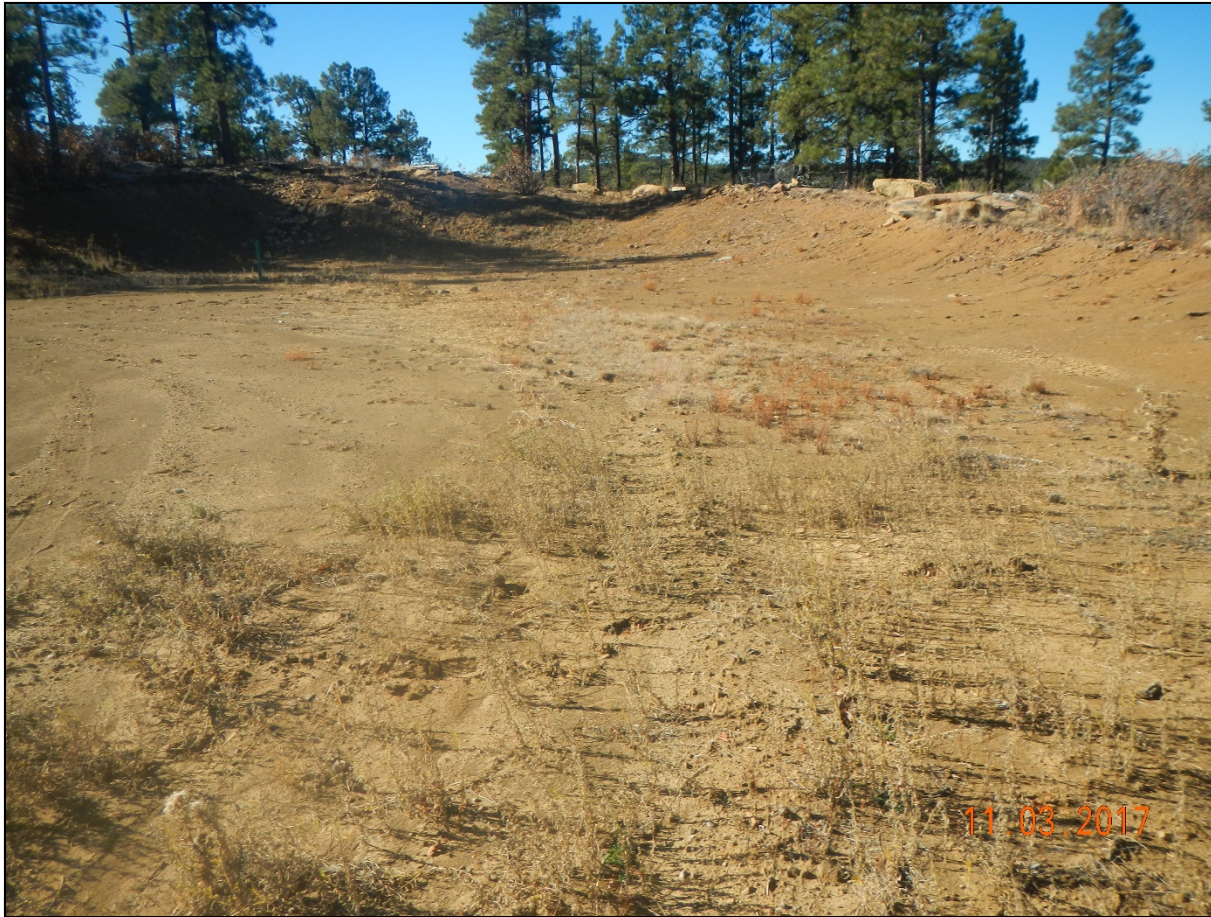
Photo 5. Facing toward the west side of the location. The vegetation has not established at this side of the location.

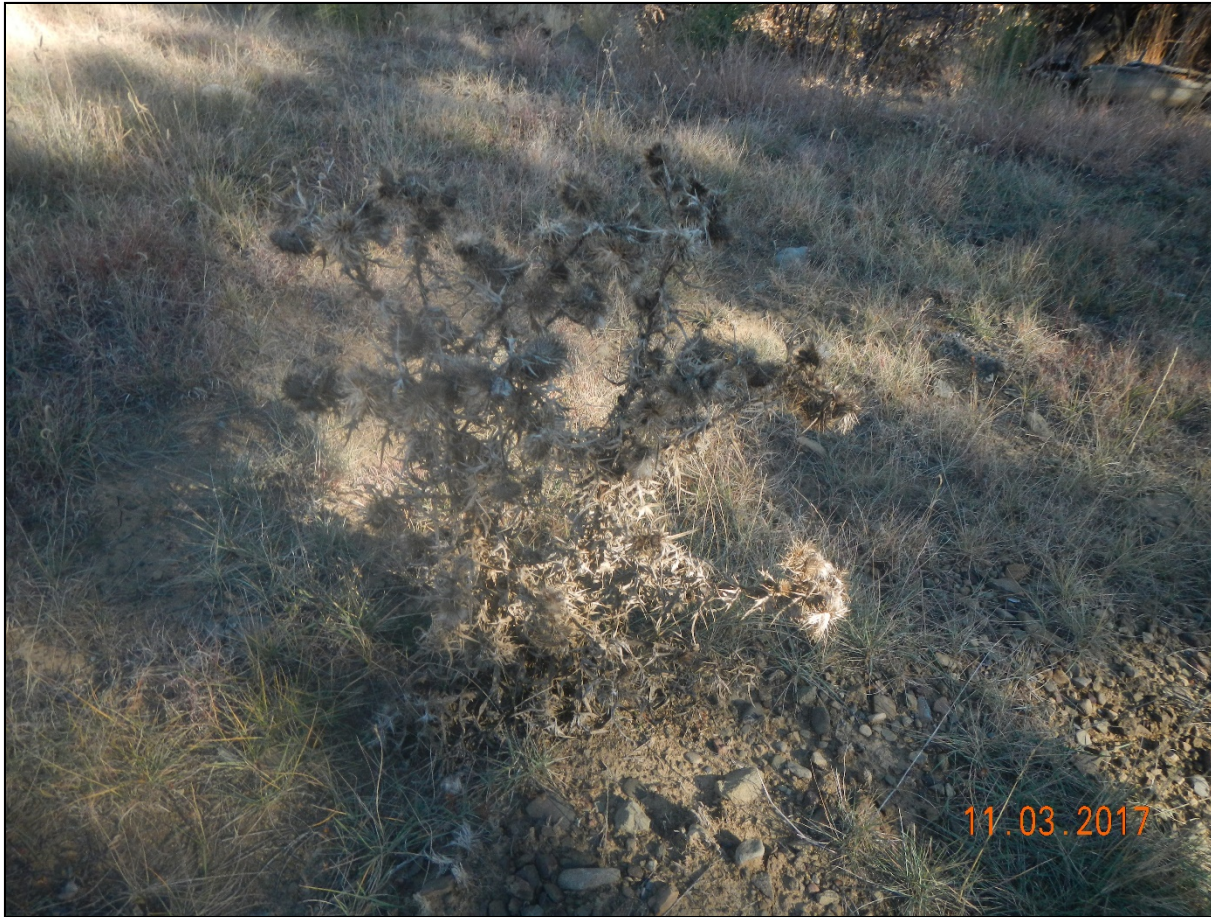
Photo 6. There is List B noxious weeds (Bull thistle) noticed at the location and along the access road.
