## Inspection Photos

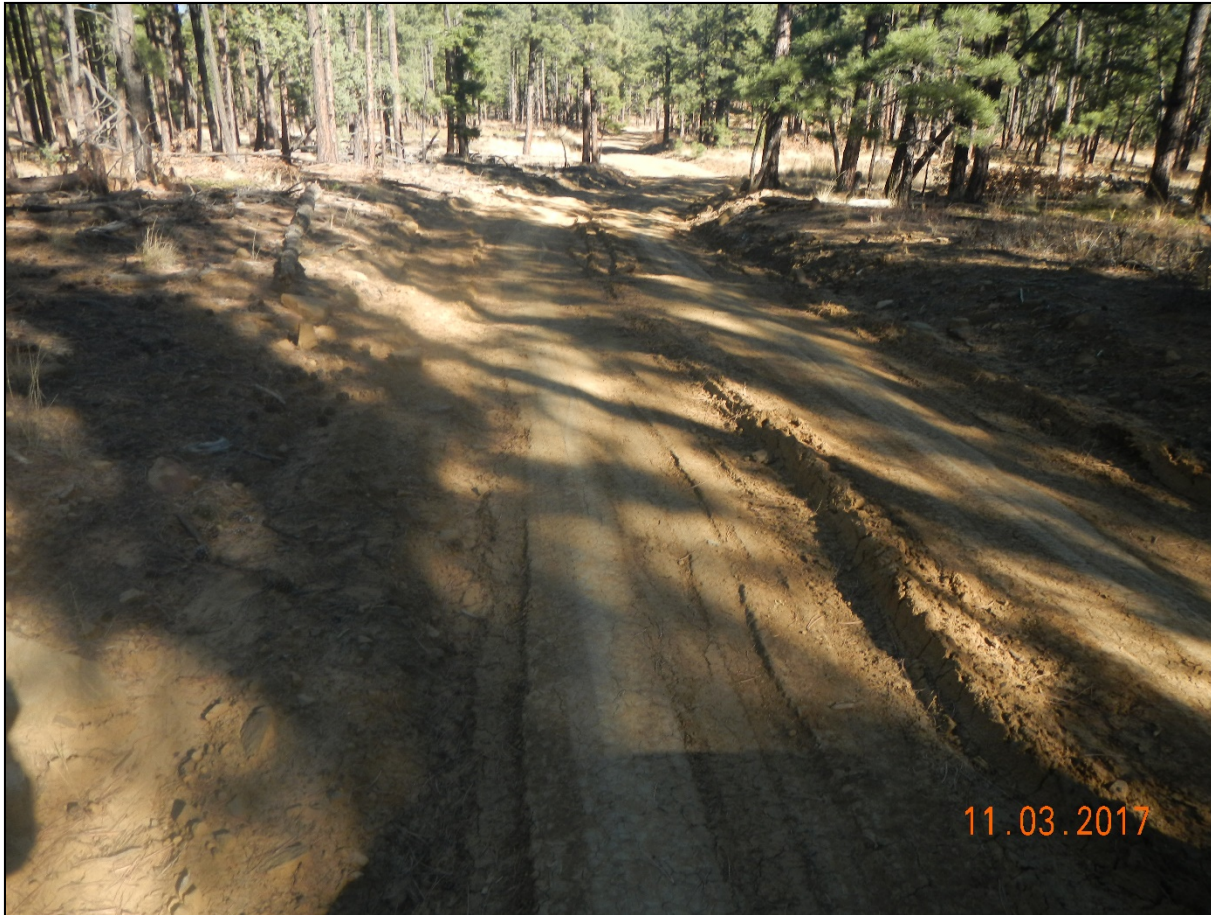
**Photo 1.** Facing north along the access road. There is vehicle rutting and erosion occurring along the road.

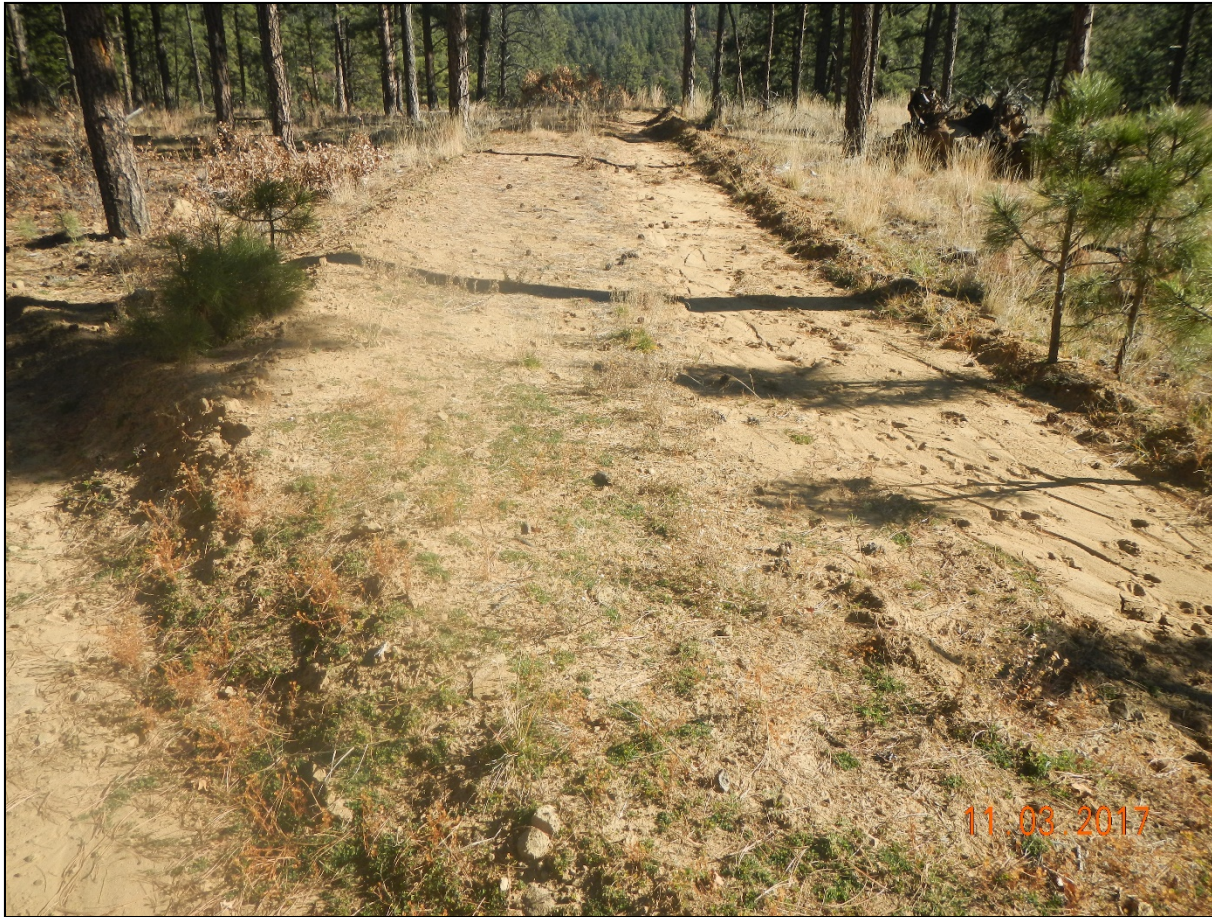
**Photo 2.** A diversion ditch was installed to divert stormwater off the road. This ditch has filled in with sediment and has created additional disturbance.

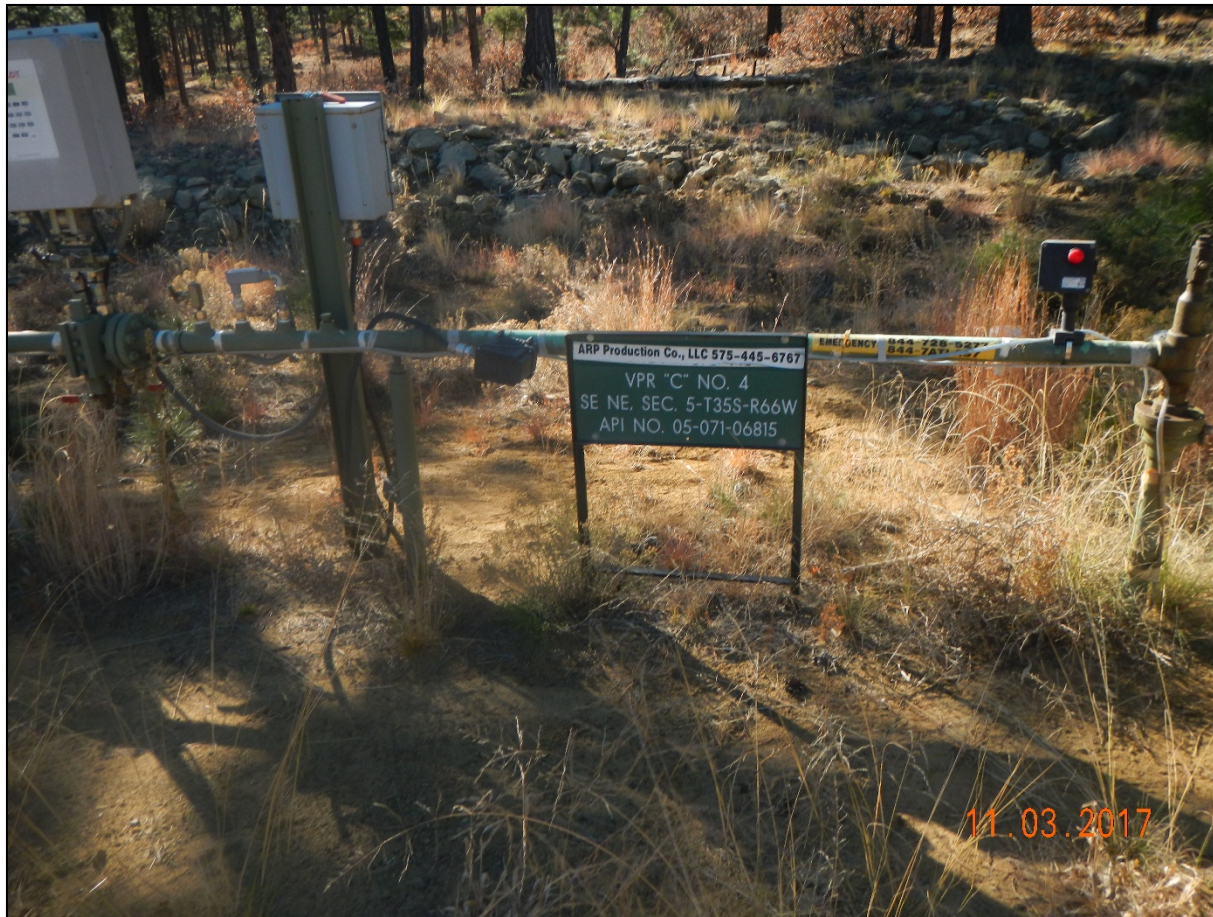
**Photo 3.** The well sign is installed and legible.
