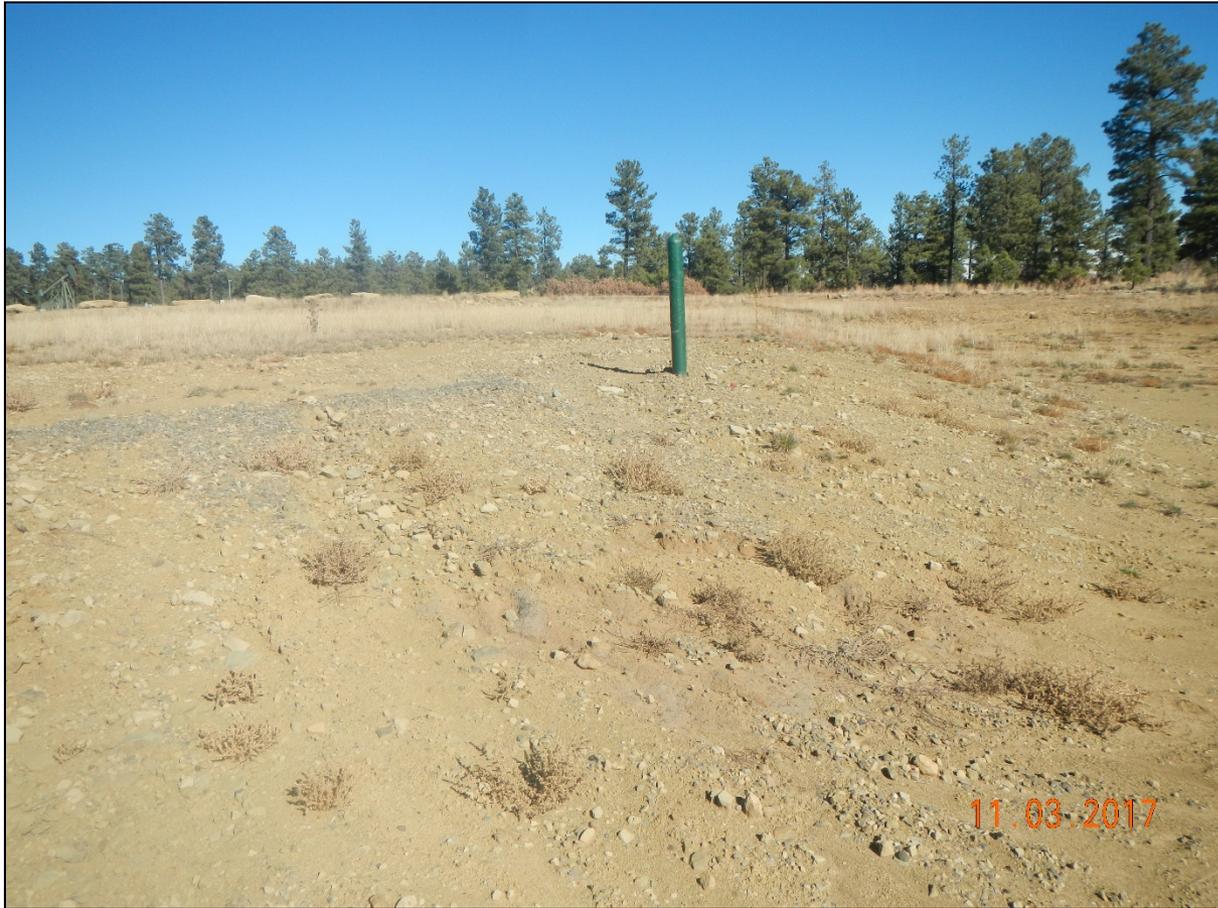
Photo 1. Facing north toward the P&A well marker. The vegetation has not re-established in this area

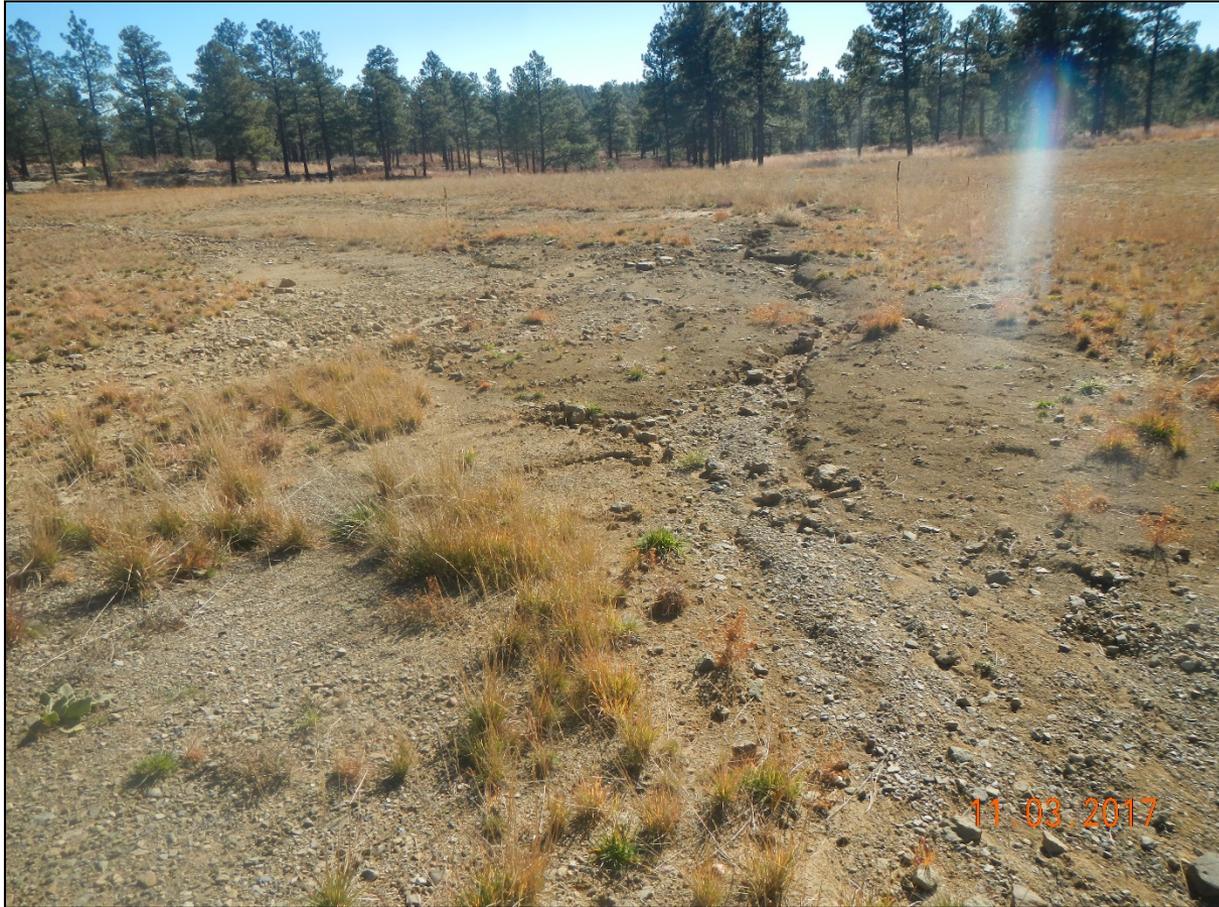
Photo 2. Facing southeast toward the location. There are signs of stormwater erosion occurring thru the location.

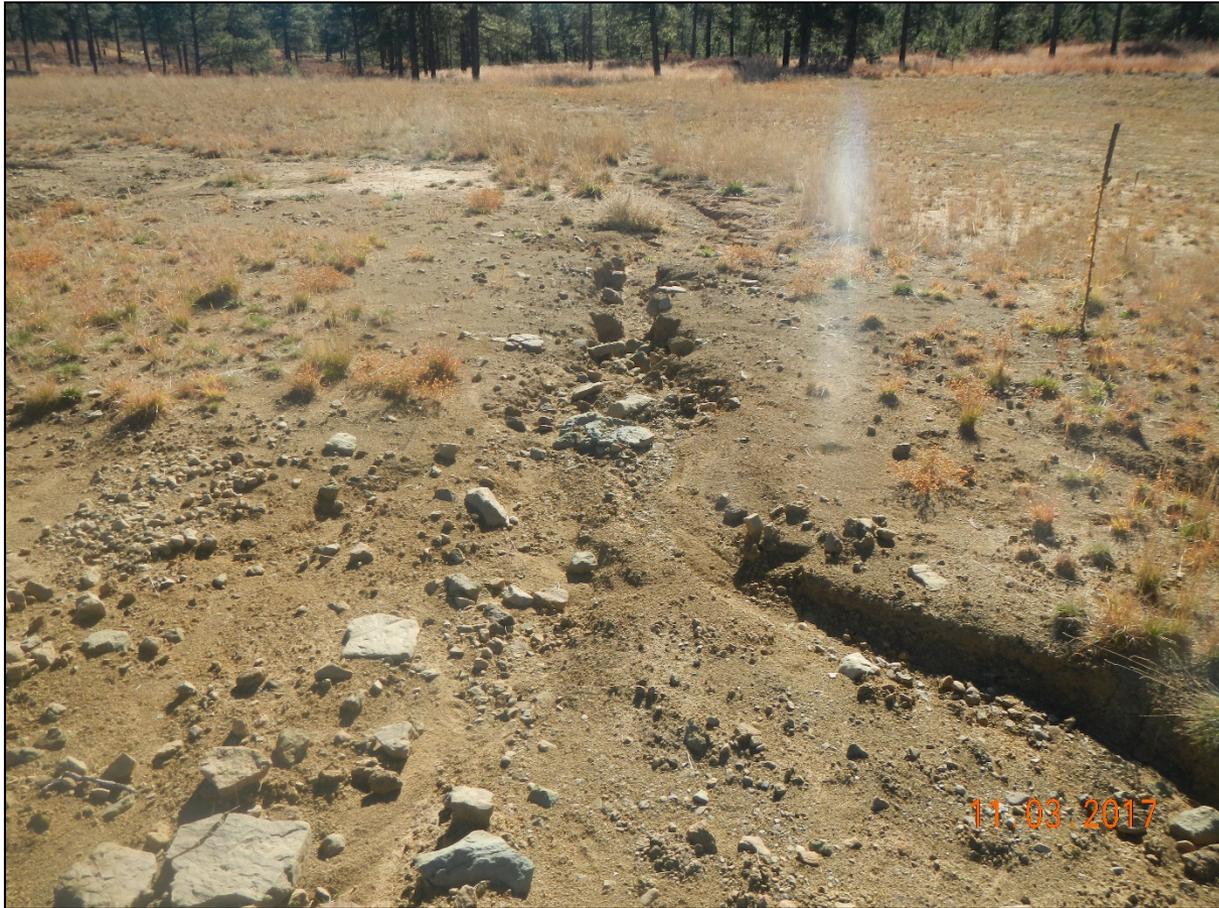
Photo 3. Facing southeast at the location. There are signs of stormwater erosion occurring thru the location.

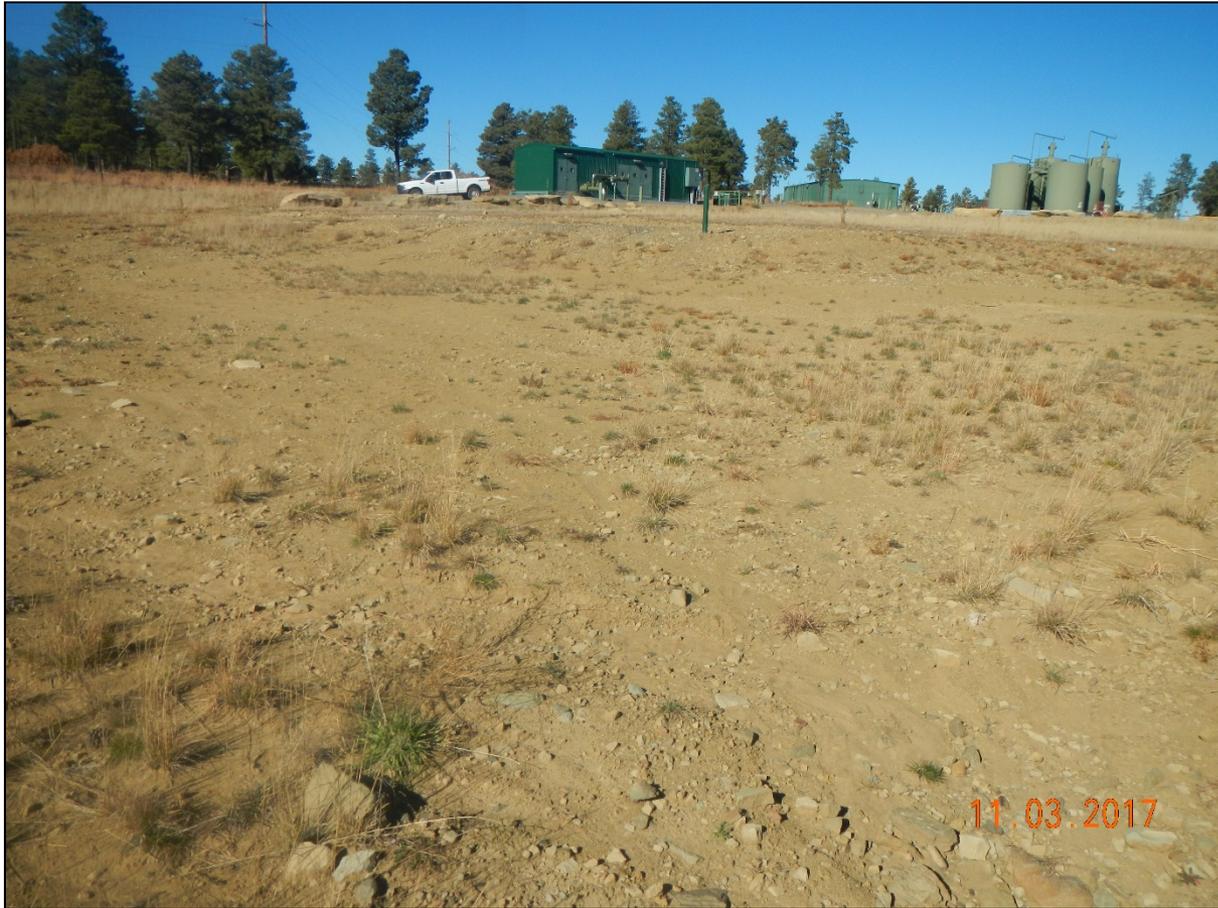
Photo 4. Facing northwest at the location. The vegetation has not adequately re-established and soils are not stabilized.

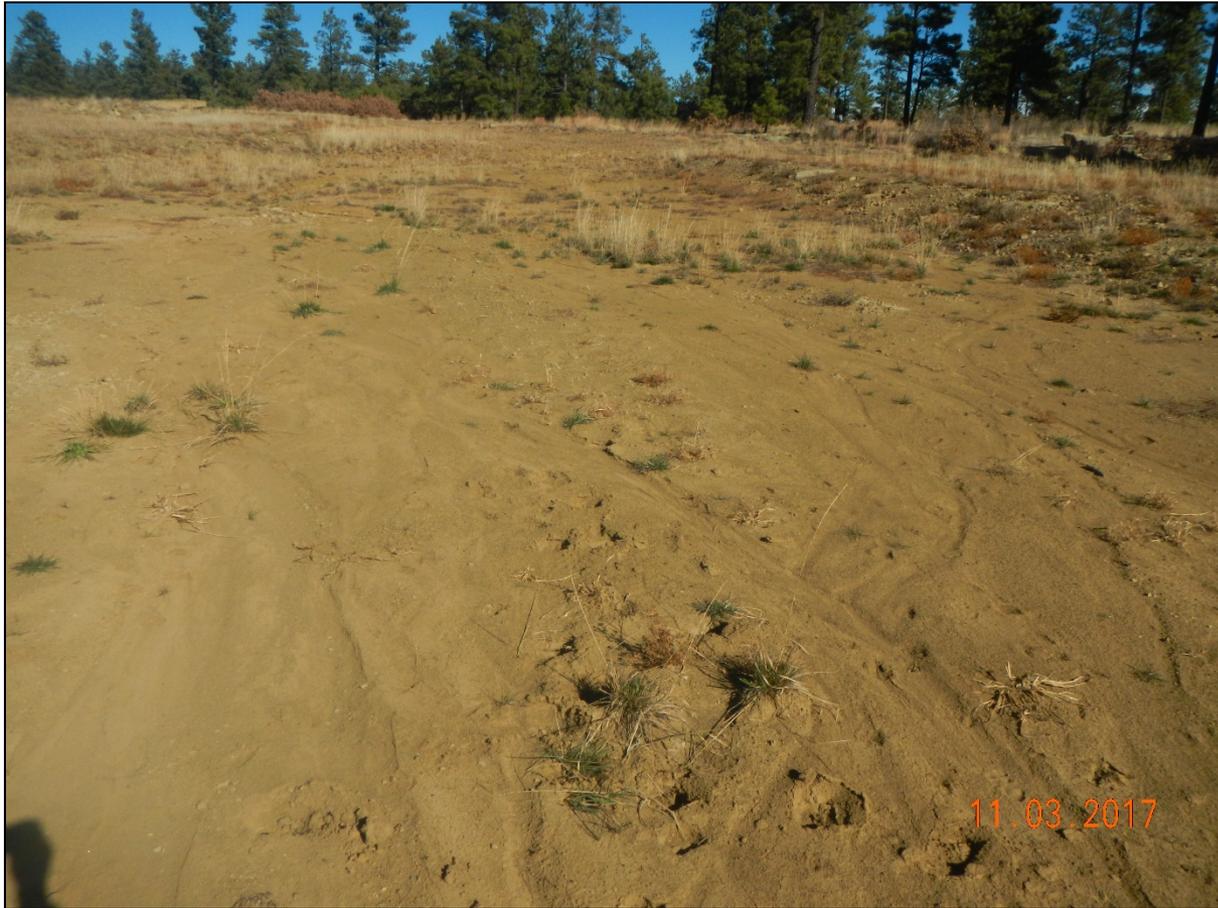
Photo 5. Facing north at the location. The vegetation has not adequately re-established and soils are not stabilized.

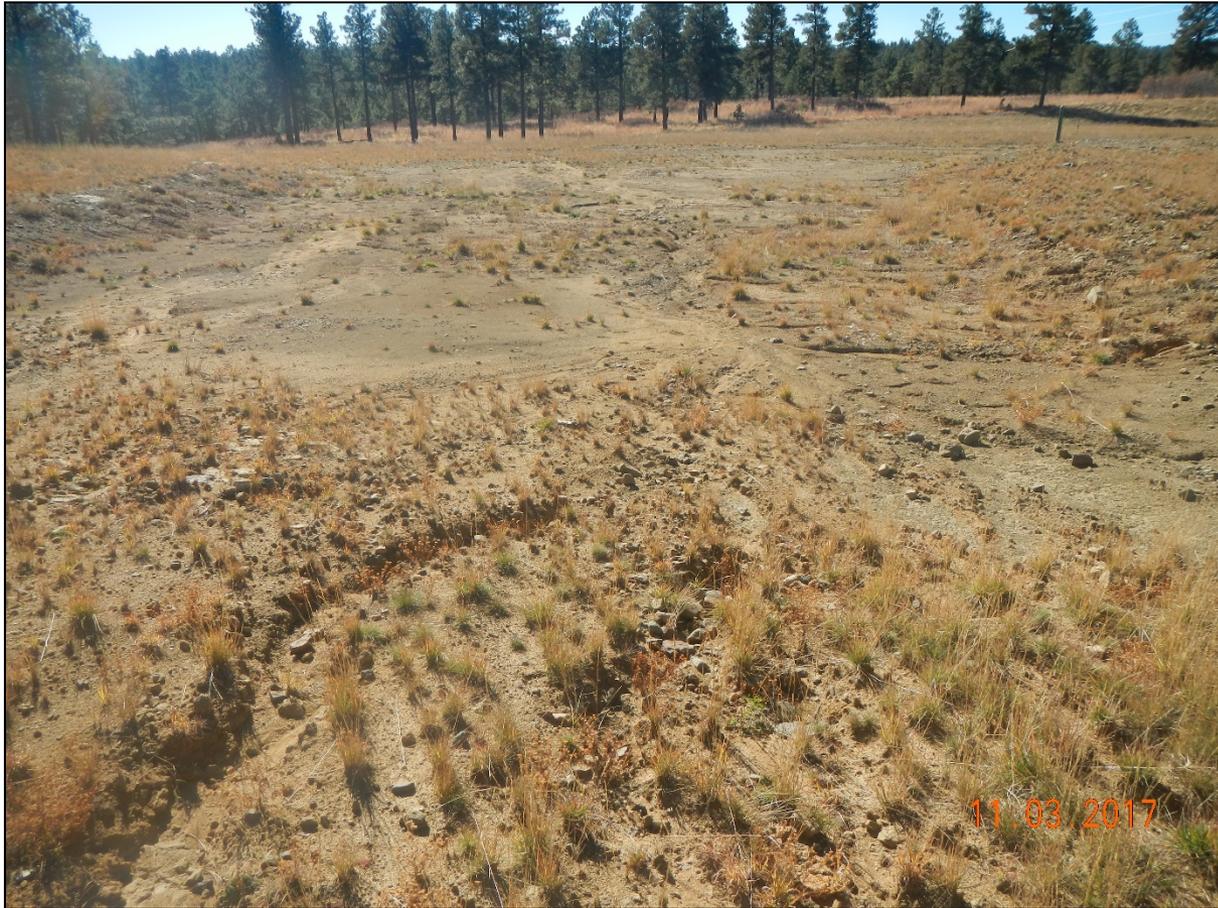
Photo 6. North side of the location facing south. There are signs of stormwater erosion occurring thru the location.
