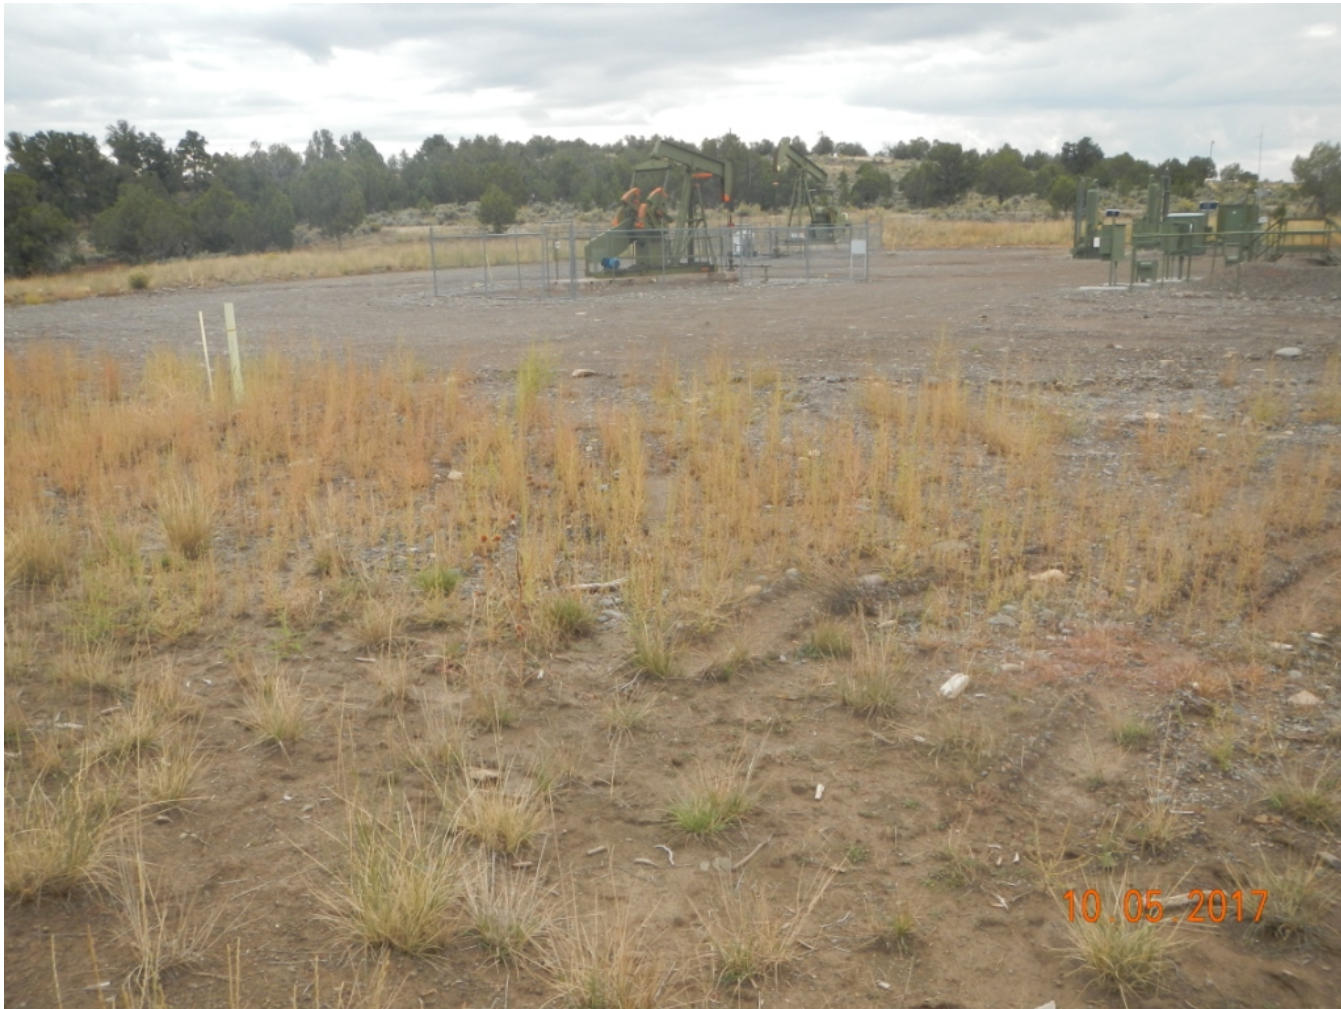
Photo 1. View from the northern corner of the well pad facing center.

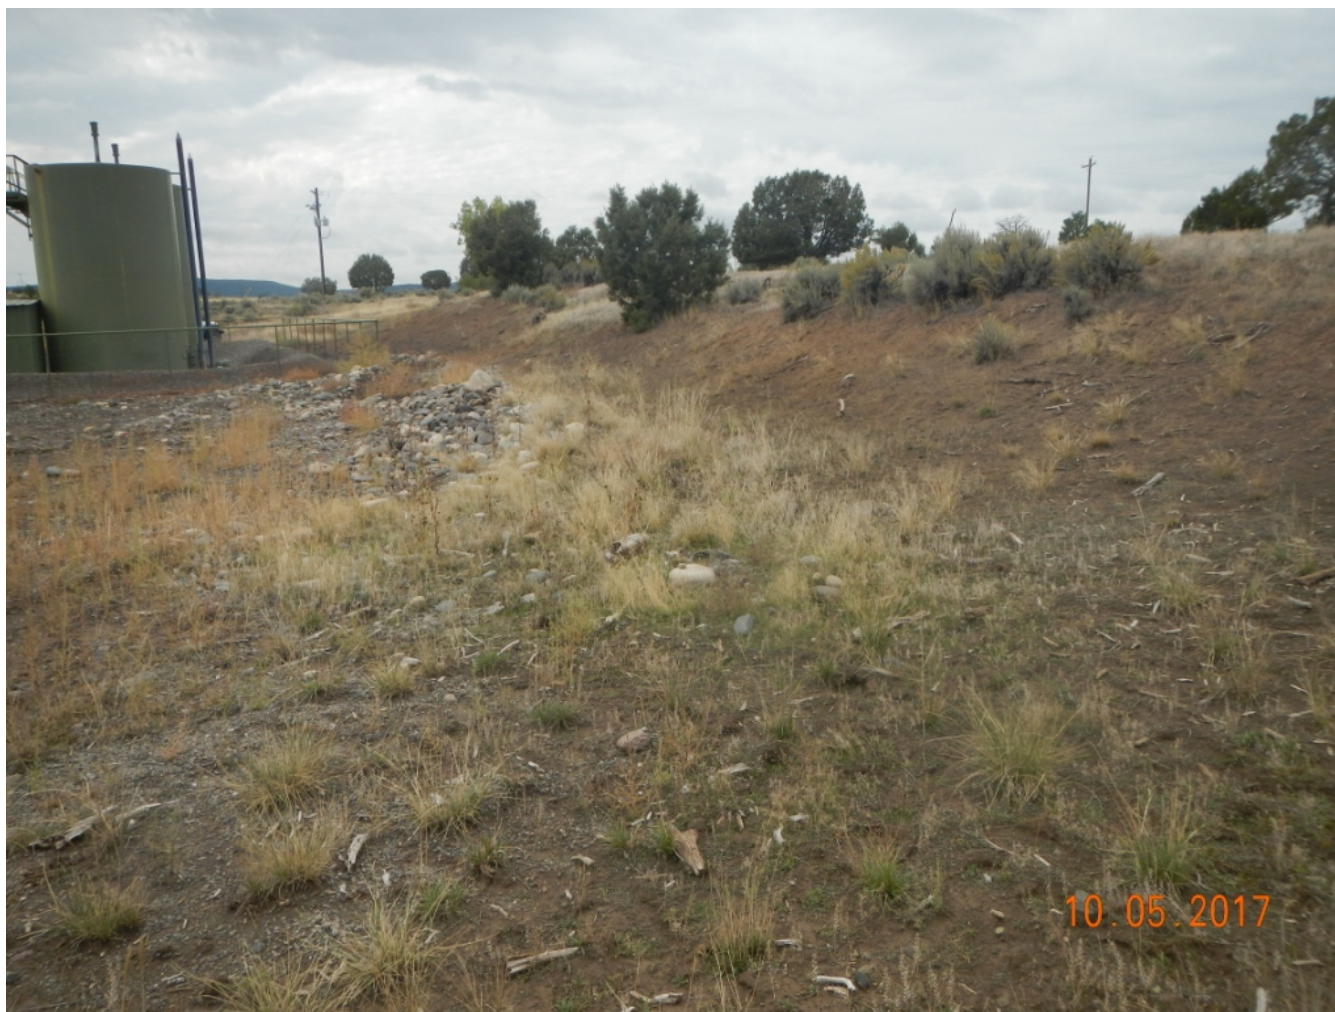
Photo 2. View of the northwestern portion of the well pad from the northern corner facing southwestward. Revegetation is progressing (although sparse on cut-slope) with grasses such as western wheatgrass (*Pascopyrum smithii*) and Indian ricegrass (*Achnatherum hymenoides*).

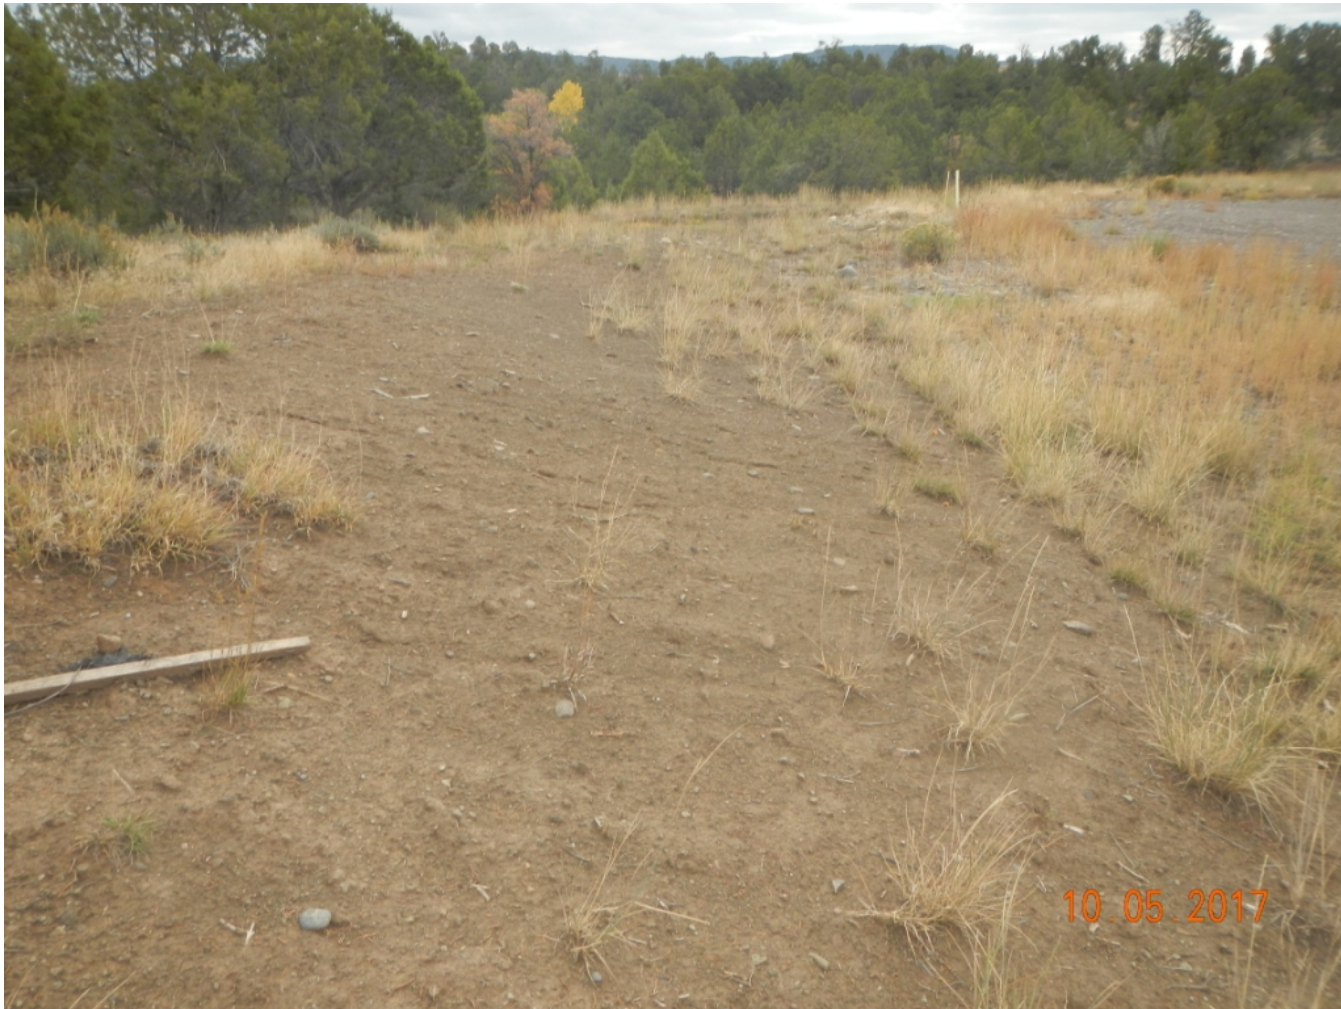
Photo 3. View of the northern portion of the project area from the northern corner facing eastward.

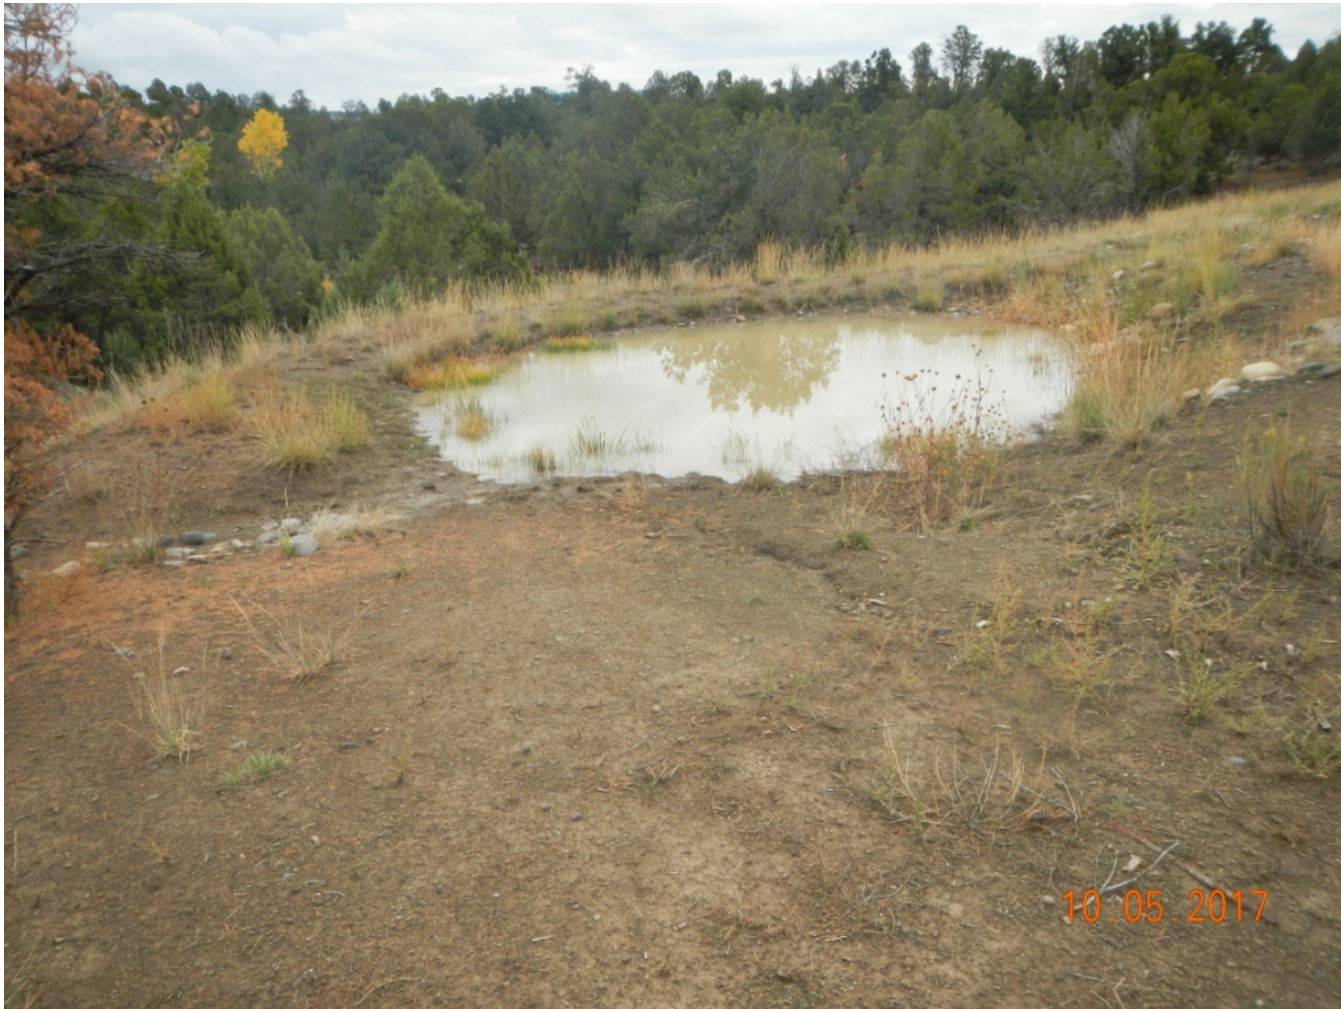
Photo 4. View of silt trap in the northeastern portion of the project area. Evidence of overflow and erosion downstream indicates silt trap needs maintenance.

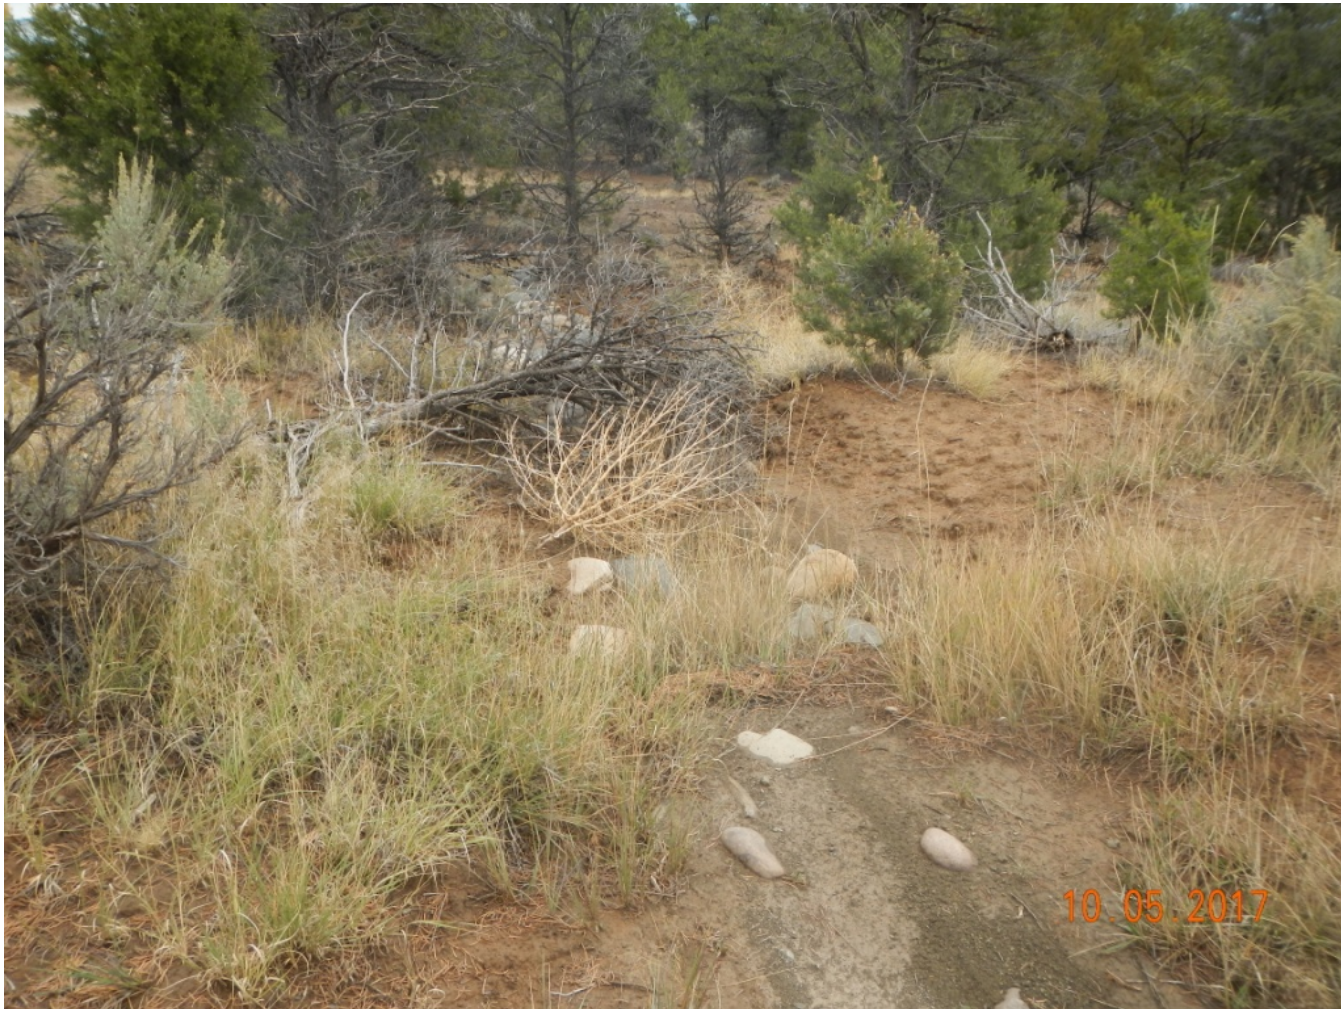
Photo 5. View of area downstream of silt trap where sediment is being carried offsite and erosion is occurring.
