**Inspection Photos**  
**Location Name: Catamount Semler GU #1**  
**API: 05-067-07909**

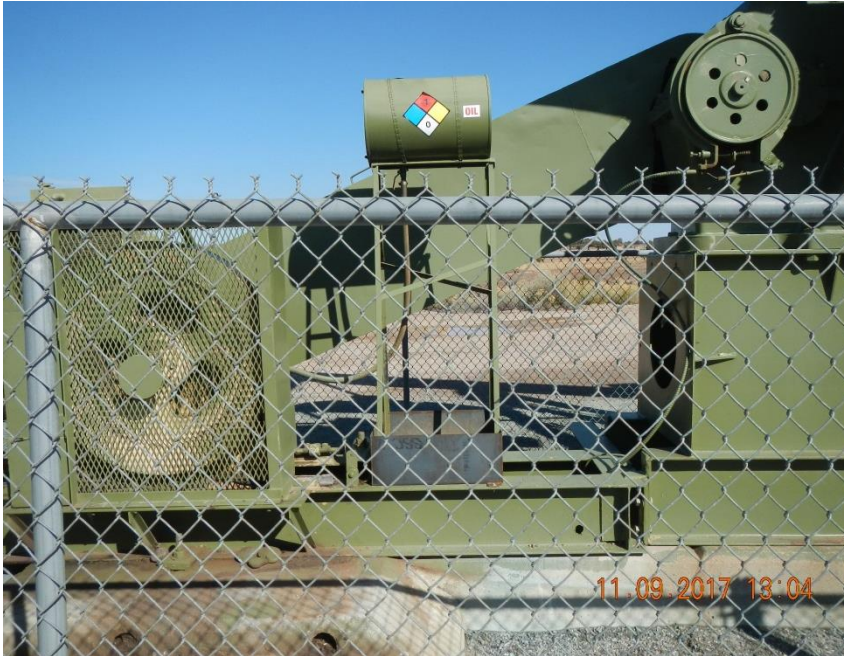
**Secondary containment for lube oil container.**

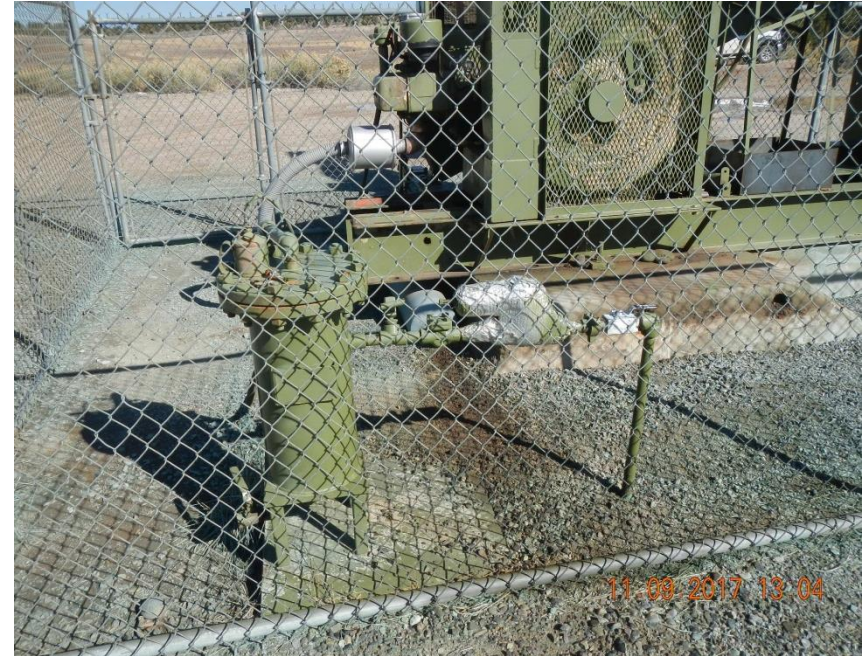
**Stained soil and gravel near exhaust.**

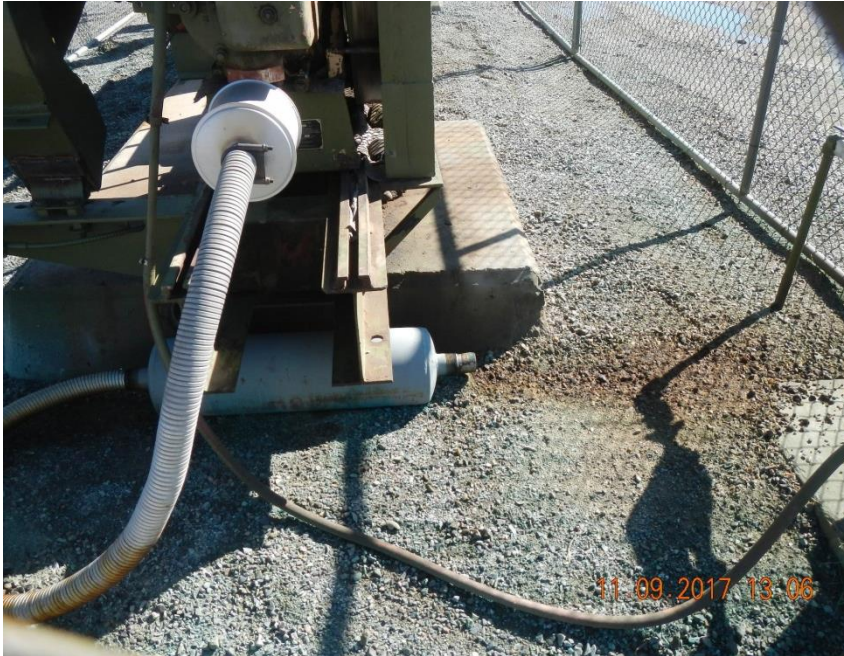
**Stained soil and gravel near muffler exhaust.**

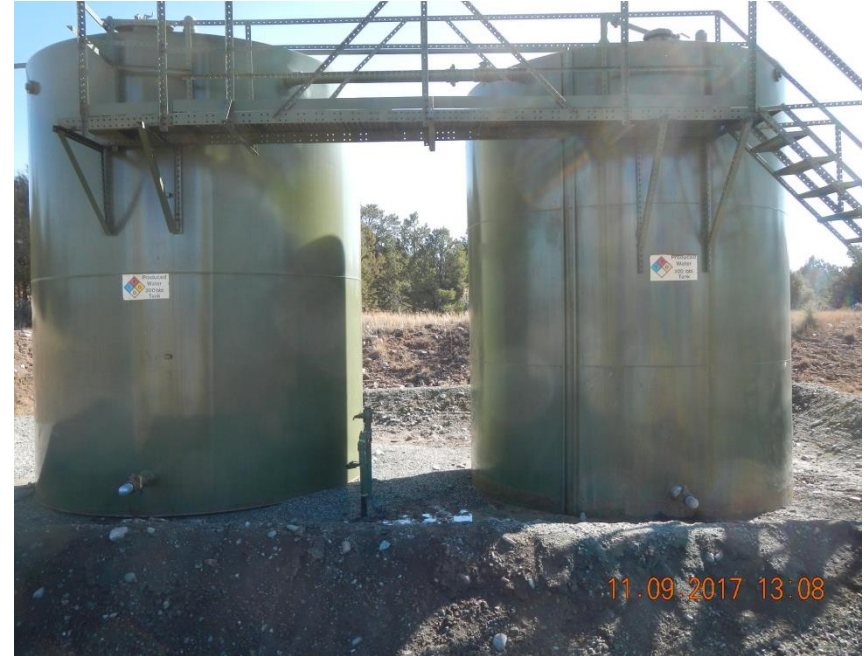
**Location of spill/release #452581.**

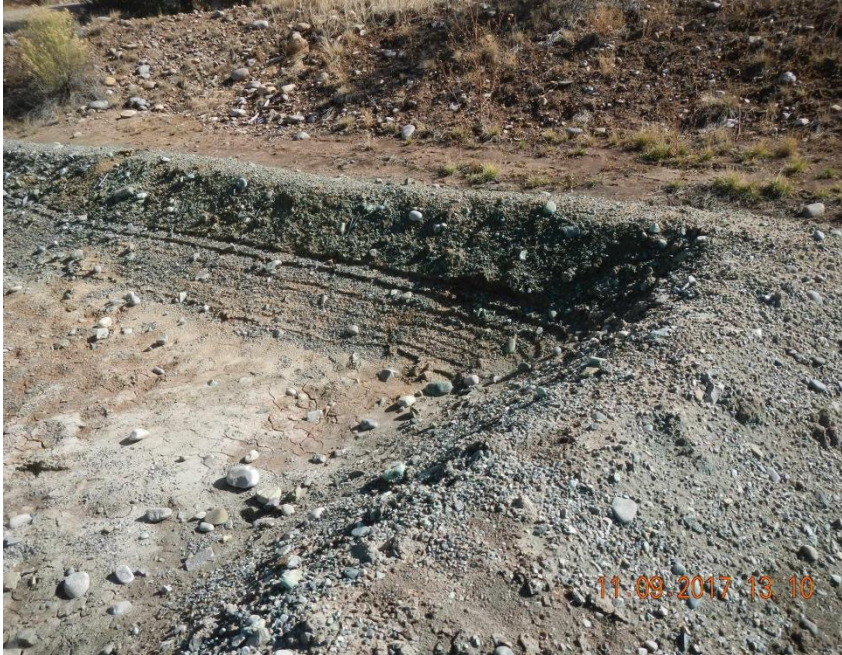
**Evidence of fluids in secondary containment berm.**

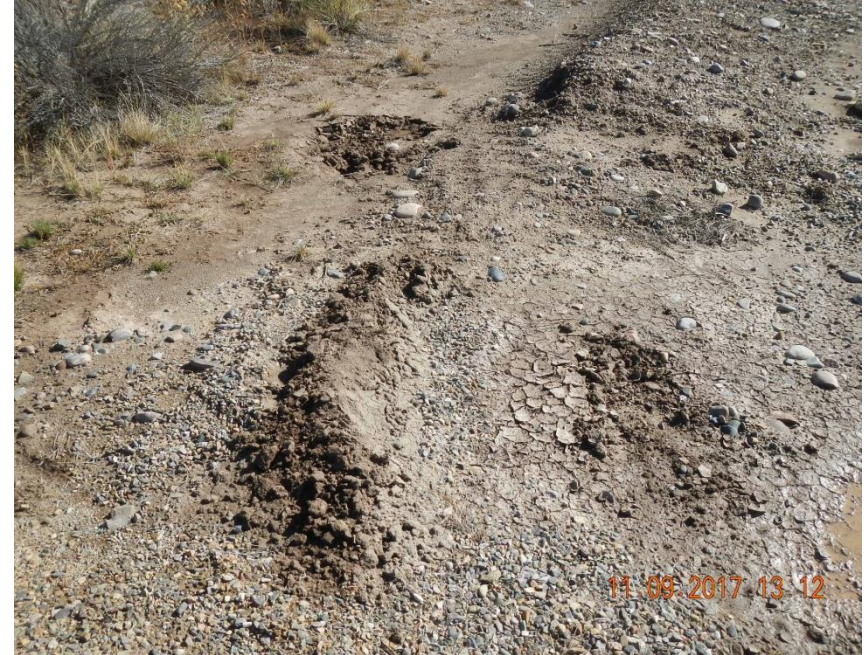
**Earthen dam near lateral extent of release.**
