Inspection Photos
Location Name: Catamount Herrera MV #1
API: 05-067-05410

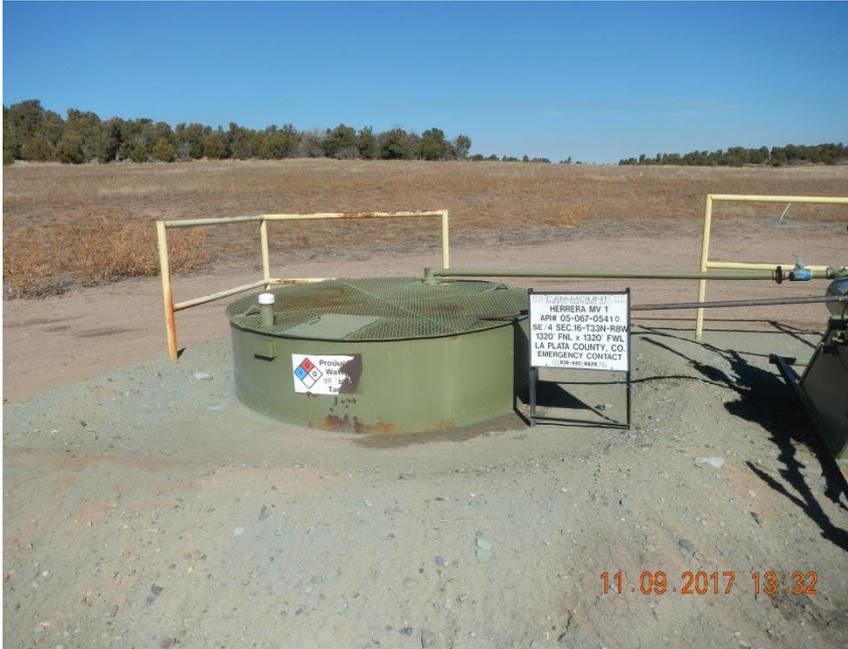
Open topped produced water vessel with expanded metal cover.

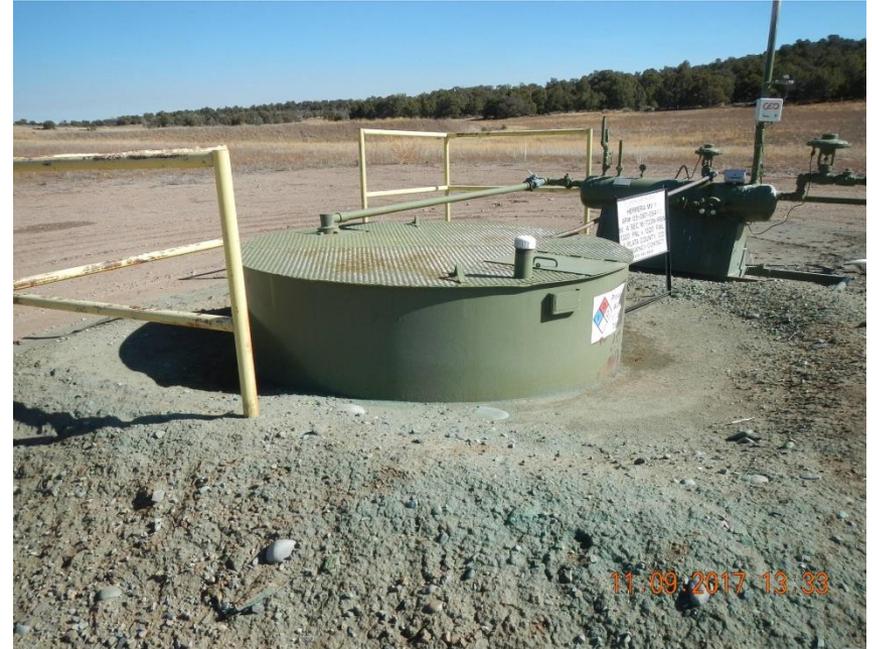
Produced water vessel with insufficient capacity of secondary containment.

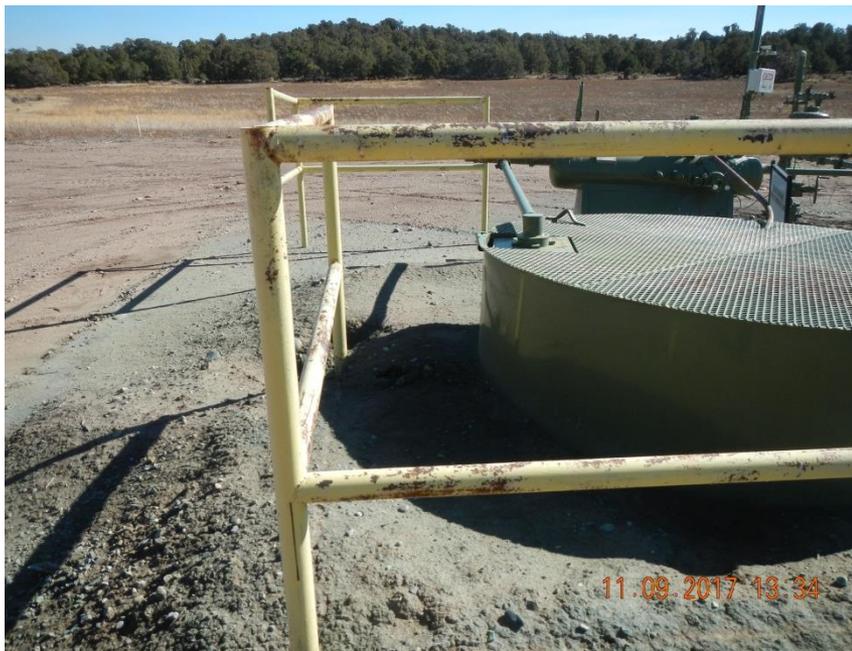
Secondary containment berm with insufficient capacity.

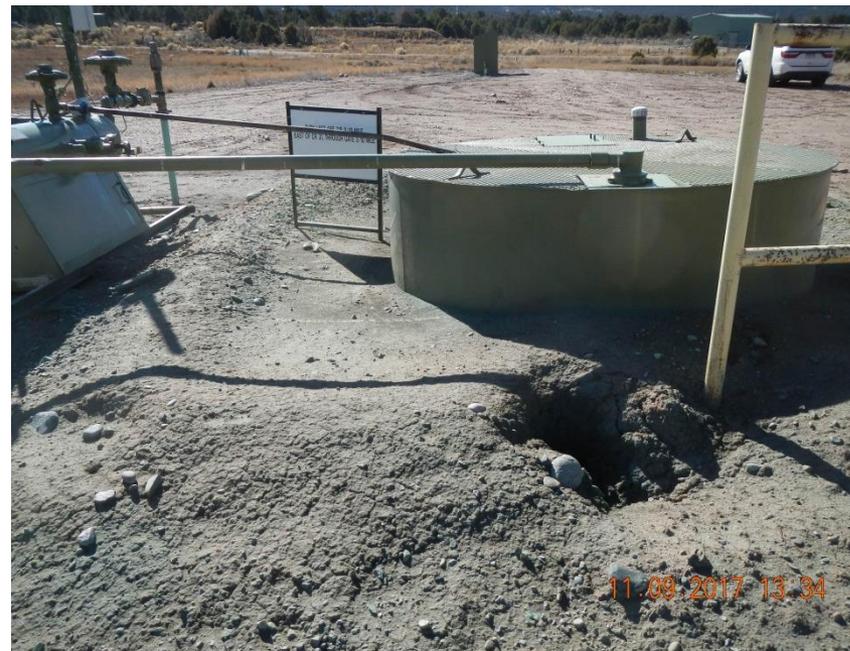
Animal burrow further compromising secondary containment berm.
