COGCC conducted an inspection of the Steve J 18-10 location (Location ID 333001) on October 26, 2017 (Document 689300334). During that inspection, COGCC made the following observations:

Name: Steve J 18-10

Location ID: 333001

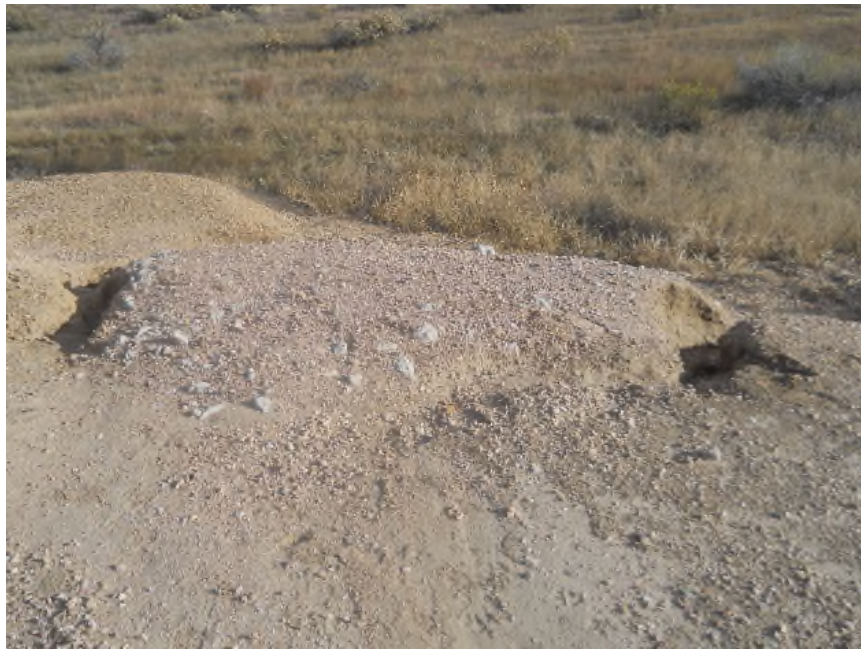
COGCC – 10/26/17

1. Storm Water: Location is washing out on east side of separator, discharging sediment off of location. Install or repair required BMPs per Rule 1002.f.

Photo 1. Location is washing out on east side of location, discharging sediment off of location.

Response: Noble Energy repaired the erosion, tracked the slope, and installed rock at the drainage point.
