Inspection Photos
Location Name: Ridgeview 32-16-1
API: 05-081-07747

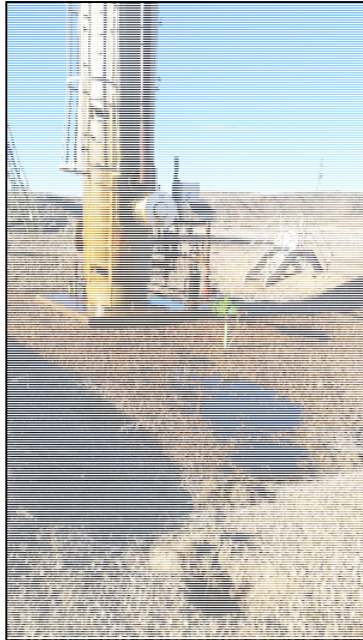
Photo 1. Fluid and stained soil in separator berm.

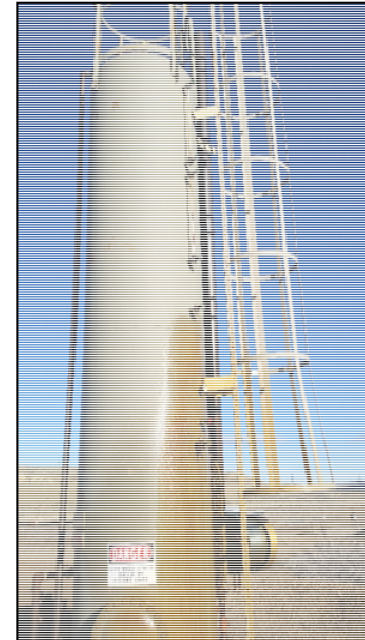
Photo 2. Broken sight glass on separator.

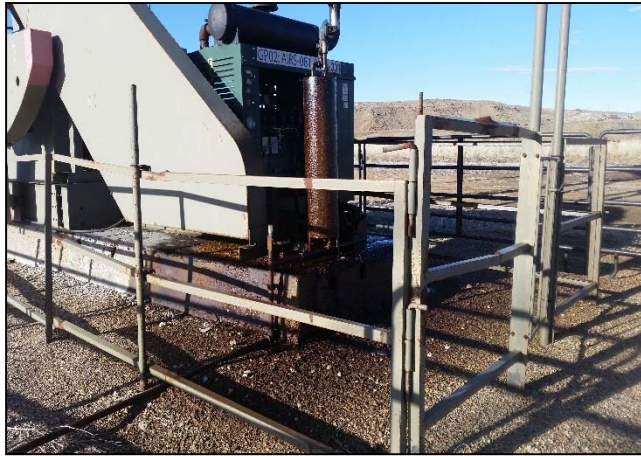
Photo 3. Fluid and stained soil at pump jack motor. No containment.

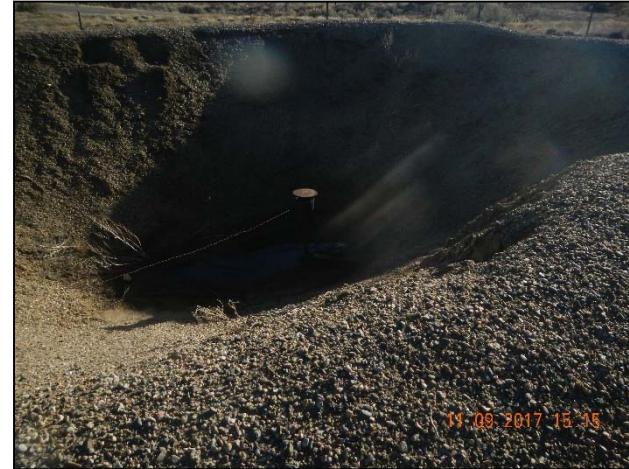
Photo 4. Fluid on flare pit.
