Inspection Photos
Location Name: Ridgeview 32-16-1
API: 05-081-07747

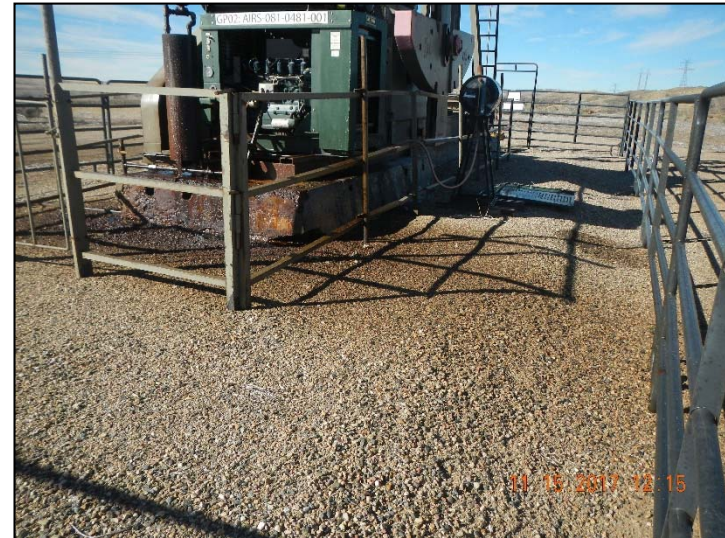
Photo 2. Fluid and stained soil at pump jack motor. No containment.

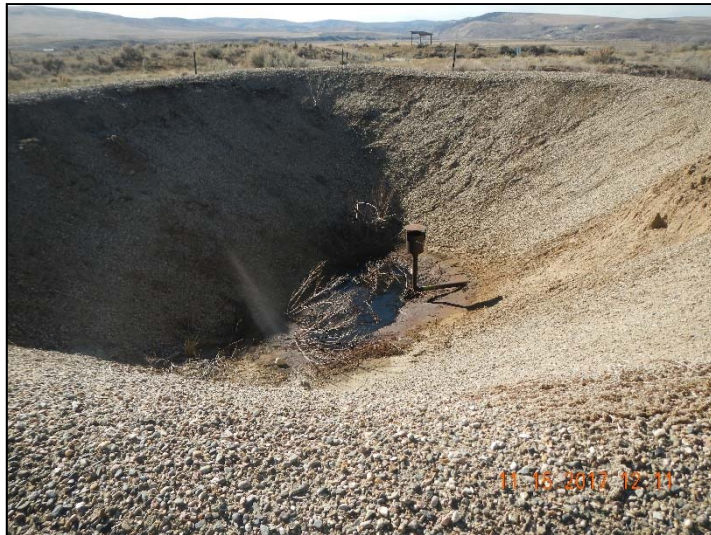
Photo 3. Oil in flare pit.

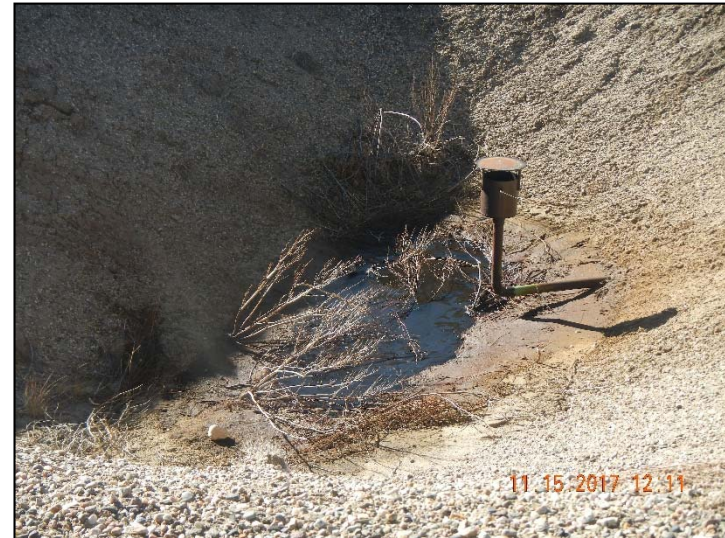
Photo 4. Oil in flare pit

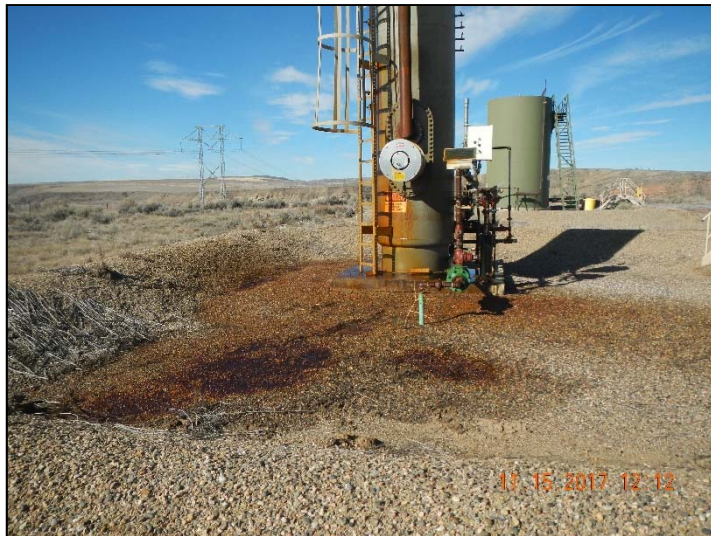
Photo 5. Fluid in separator berm.

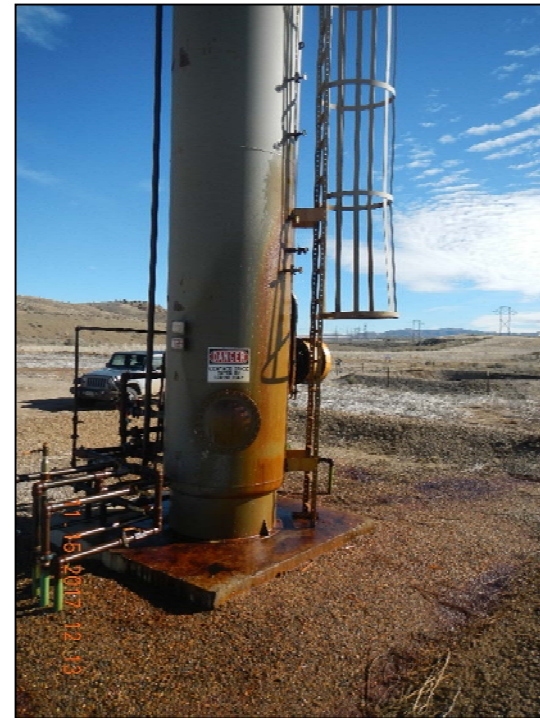
Photo 6. Broken sight glass on separator and fluid in separator berm.
