Inspection Photos

Operator: WIEPKING-FULLERTON ENERGY LLC -
96340

Location ID: 453027

Inspection Doc. Number: 682502822
Lincoln County, CO

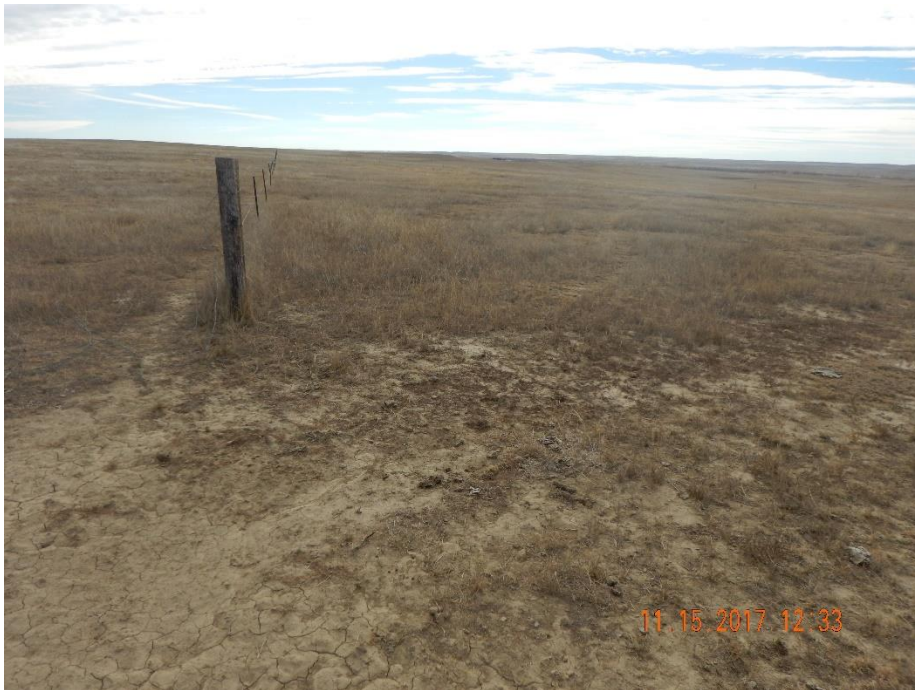
Photo 1: Photo taken from the northeast corner of the location, facing south. Photo shows overview of the reclamation area.

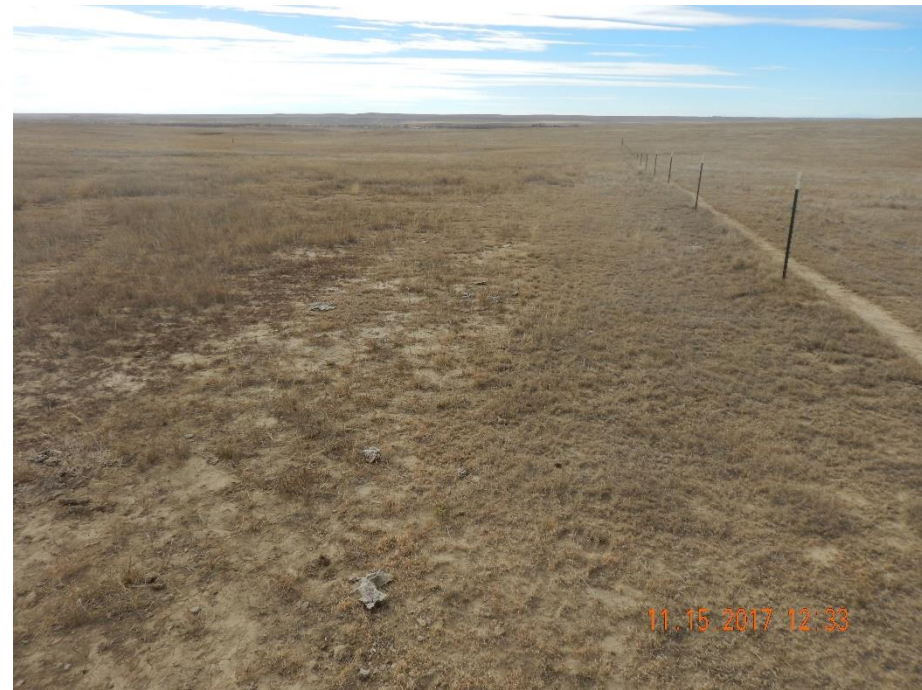
Photo 2: Photo taken from the northeast corner of the location, facing west. Photo shows overview of the reclamation area.

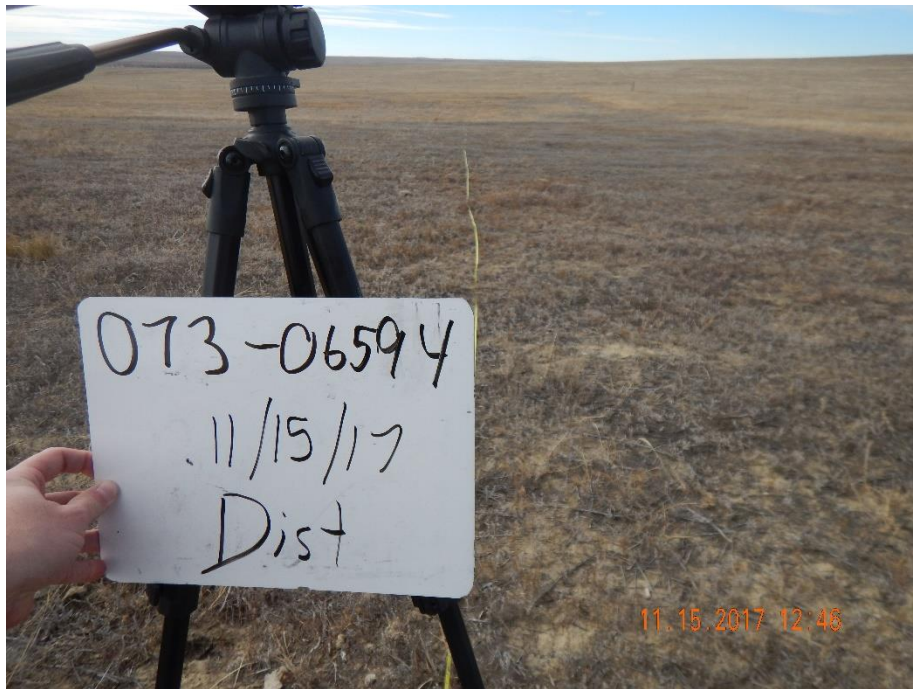
Photo 3: Photo taken from the location, facing west. Photo shows the start point for the disturbance transect.

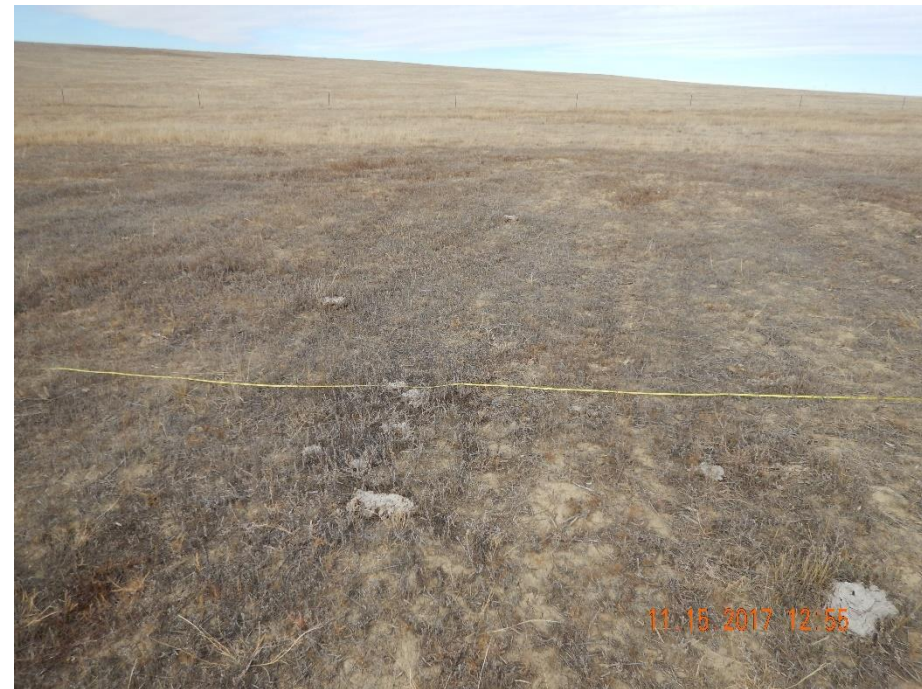
Photo 4: Photo taken from the 50th point of the disturbance transect, facing north. Photo shows vegetation over the reclamation area.

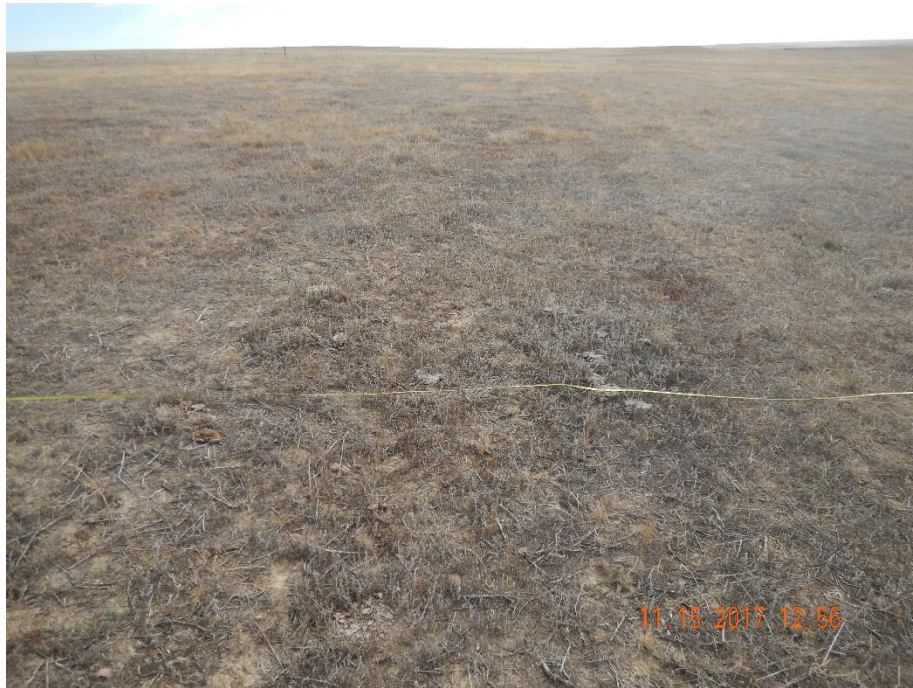
Photo 5: Photo taken from the 50th point of the disturbance transect, facing south. Photo shows vegetation over the reclamation area.

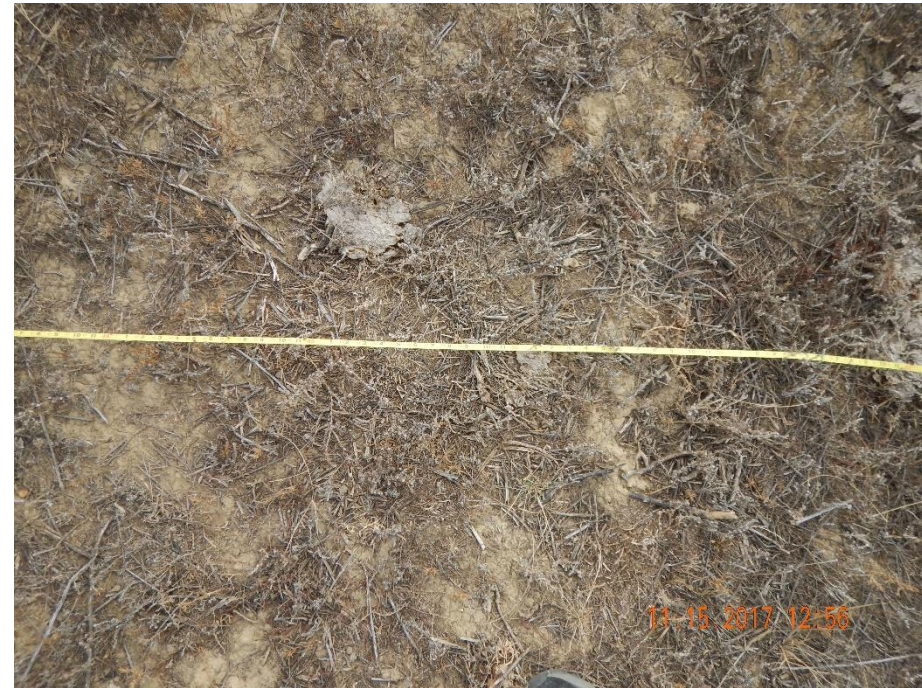
Photo 6: Photo taken from the 50th point of the disturbance transect. Photo shows vegetation over the reclamation area.

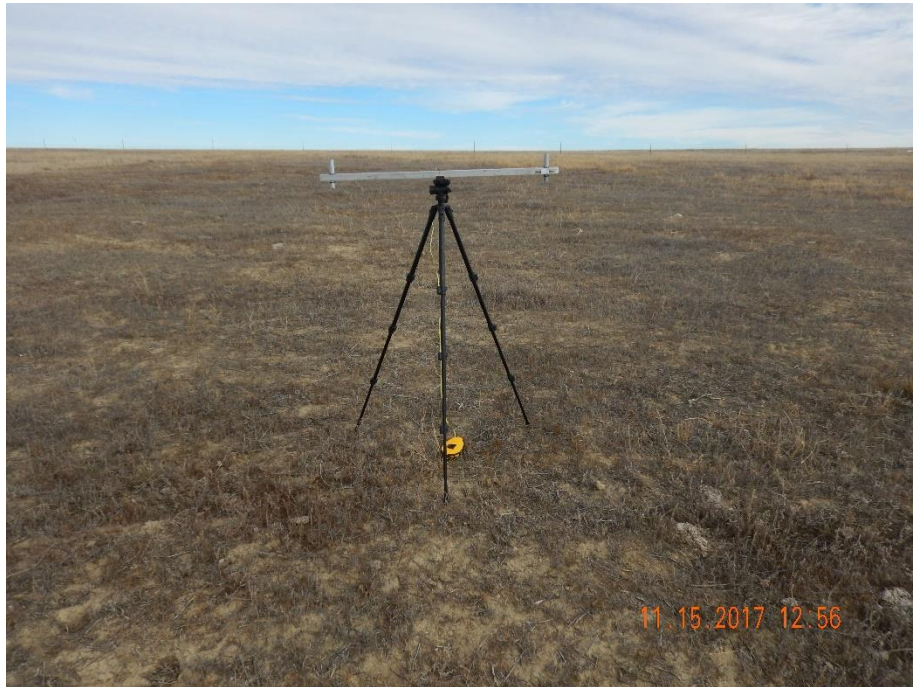
Photo 7: Photo taken from the location, facing east. Photo shows the end point for the disturbance transect.

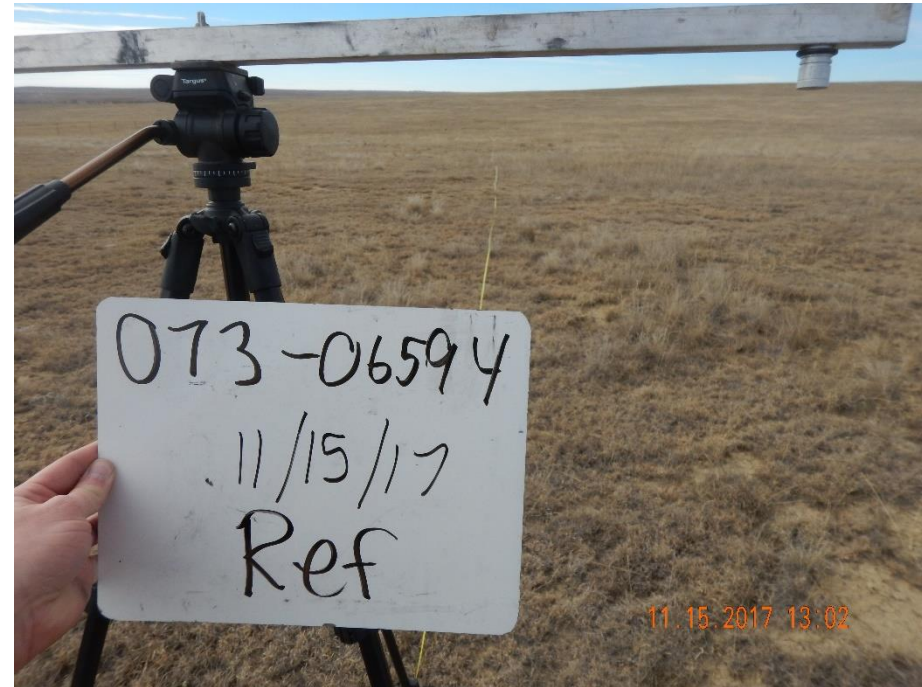
Photo 8: Photo taken from the reference area location, facing west. Photo shows the start point for the reference transect.

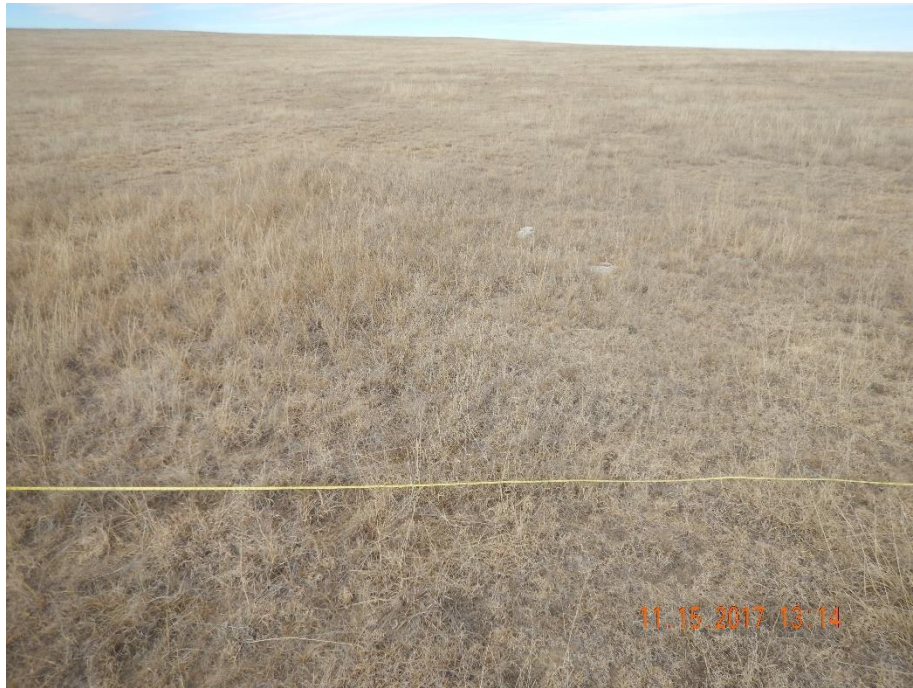
Photo 9: Photo taken from the 50th point of the reference transect, facing north. Photo shows vegetation over the reference area.

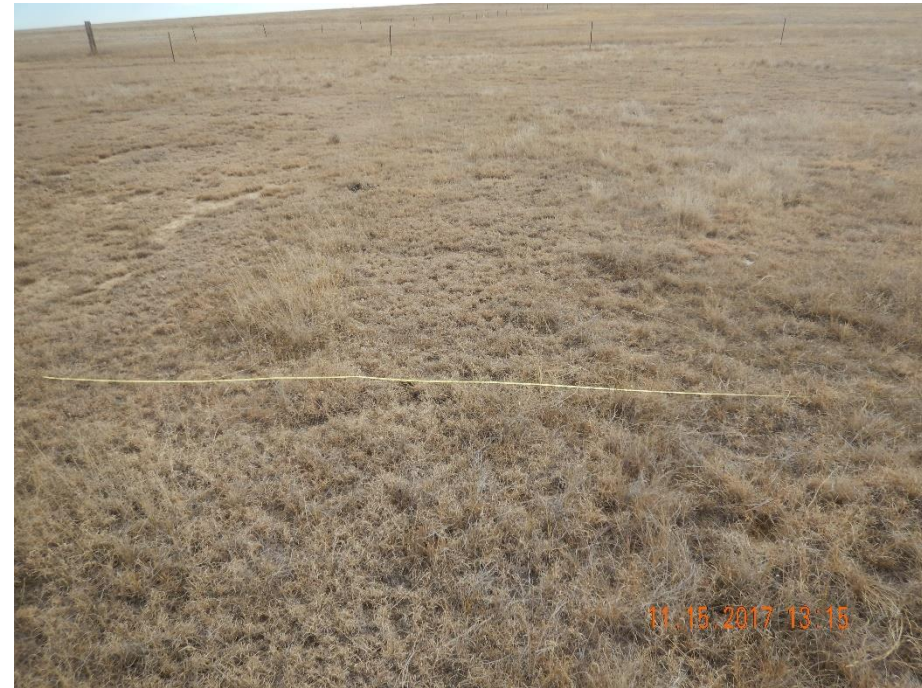
Photo 10: Photo taken from the 50th point of the reference transect, facing south. Photo shows vegetation over the reference area.

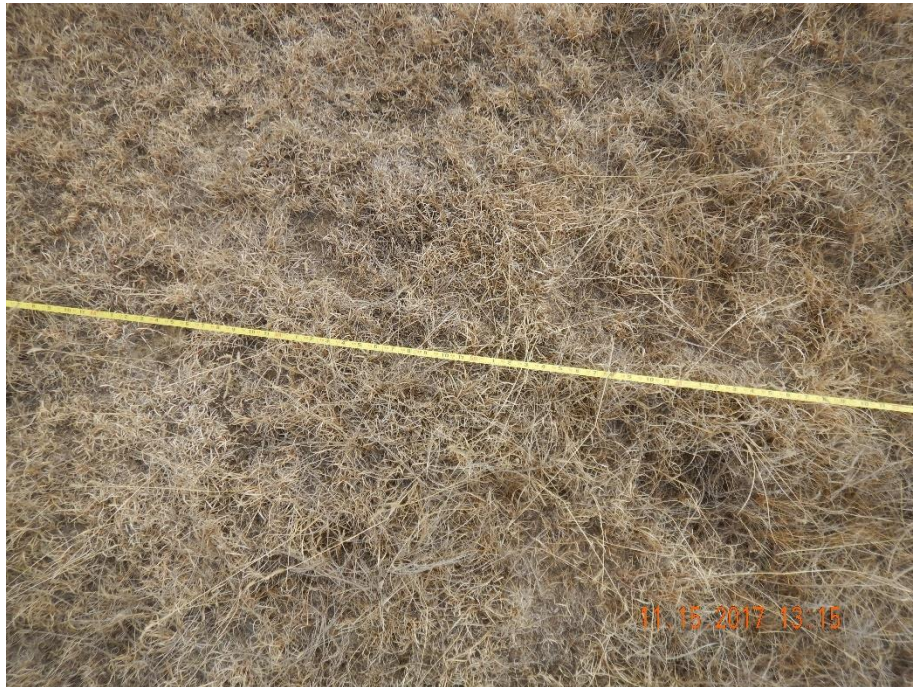
Photo 11: Photo taken from the 50th point of the reference transect. Photo shows vegetation over the reference area.

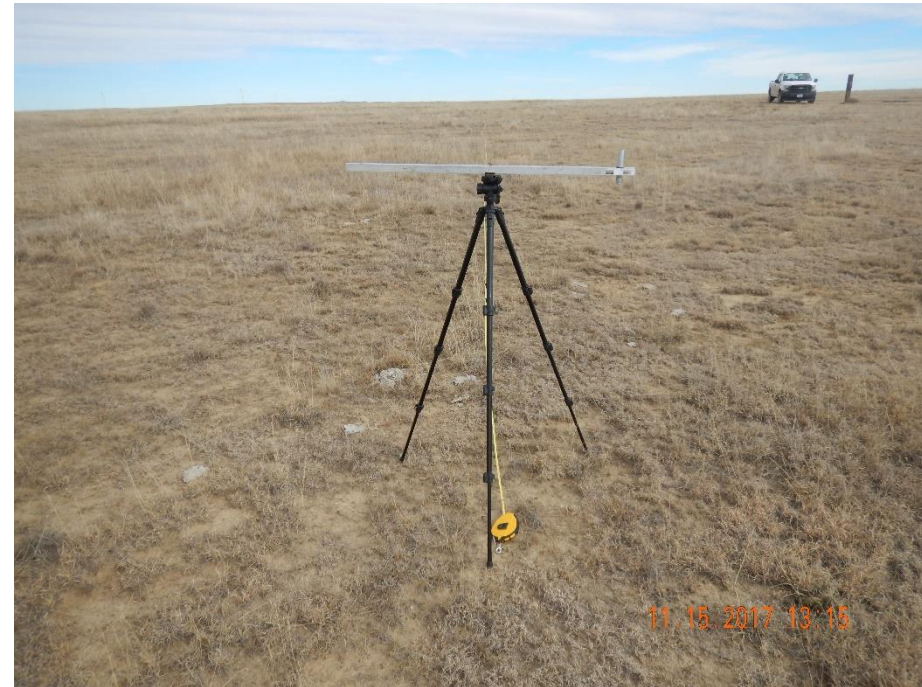
Photo 12: Photo taken from the reference area, facing east. Photo shows the end point for the reference transect.

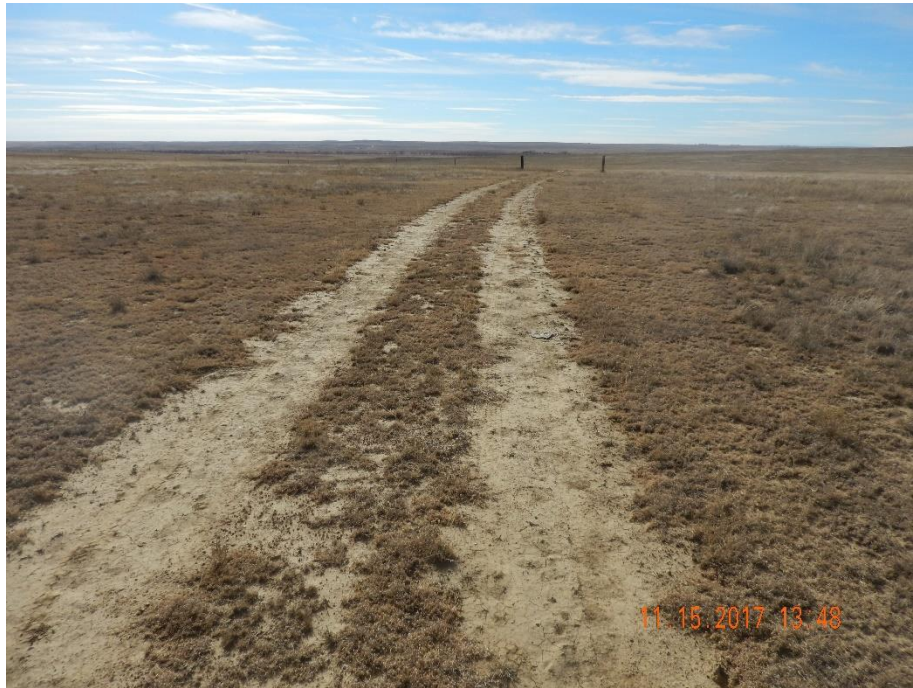
Photo 13: Photo taken from the east of the location, facing west. Photo shows access road has not been reclaimed in accordance to COGCC 1000 series reclamation rules and requirements.

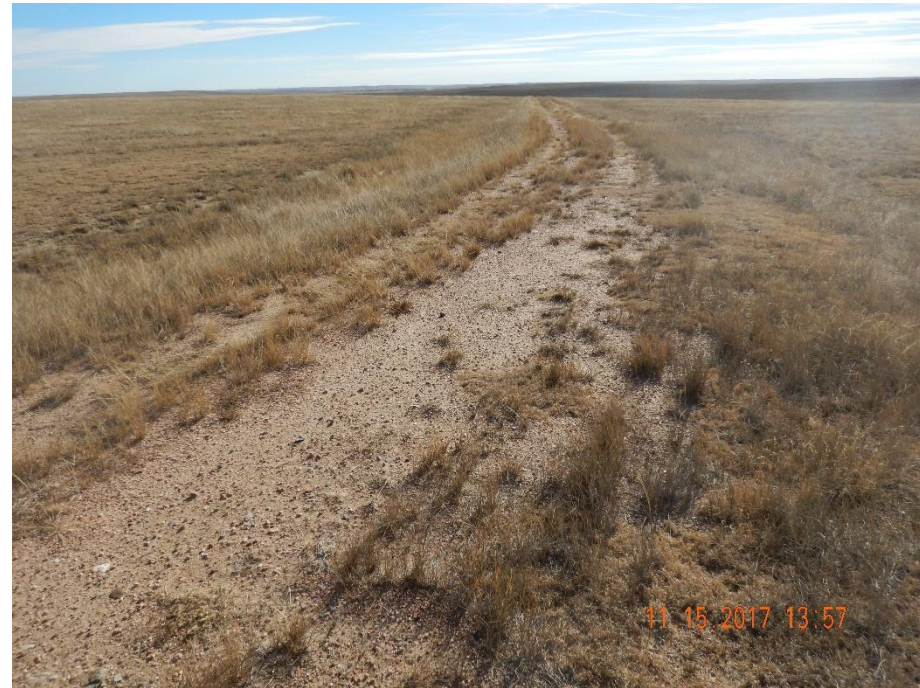
Photo 14: Photo taken from the access road, facing south. Photo shows access road has not been reclaimed in accordance to COGCC 1000 series reclamation rules and requirements.

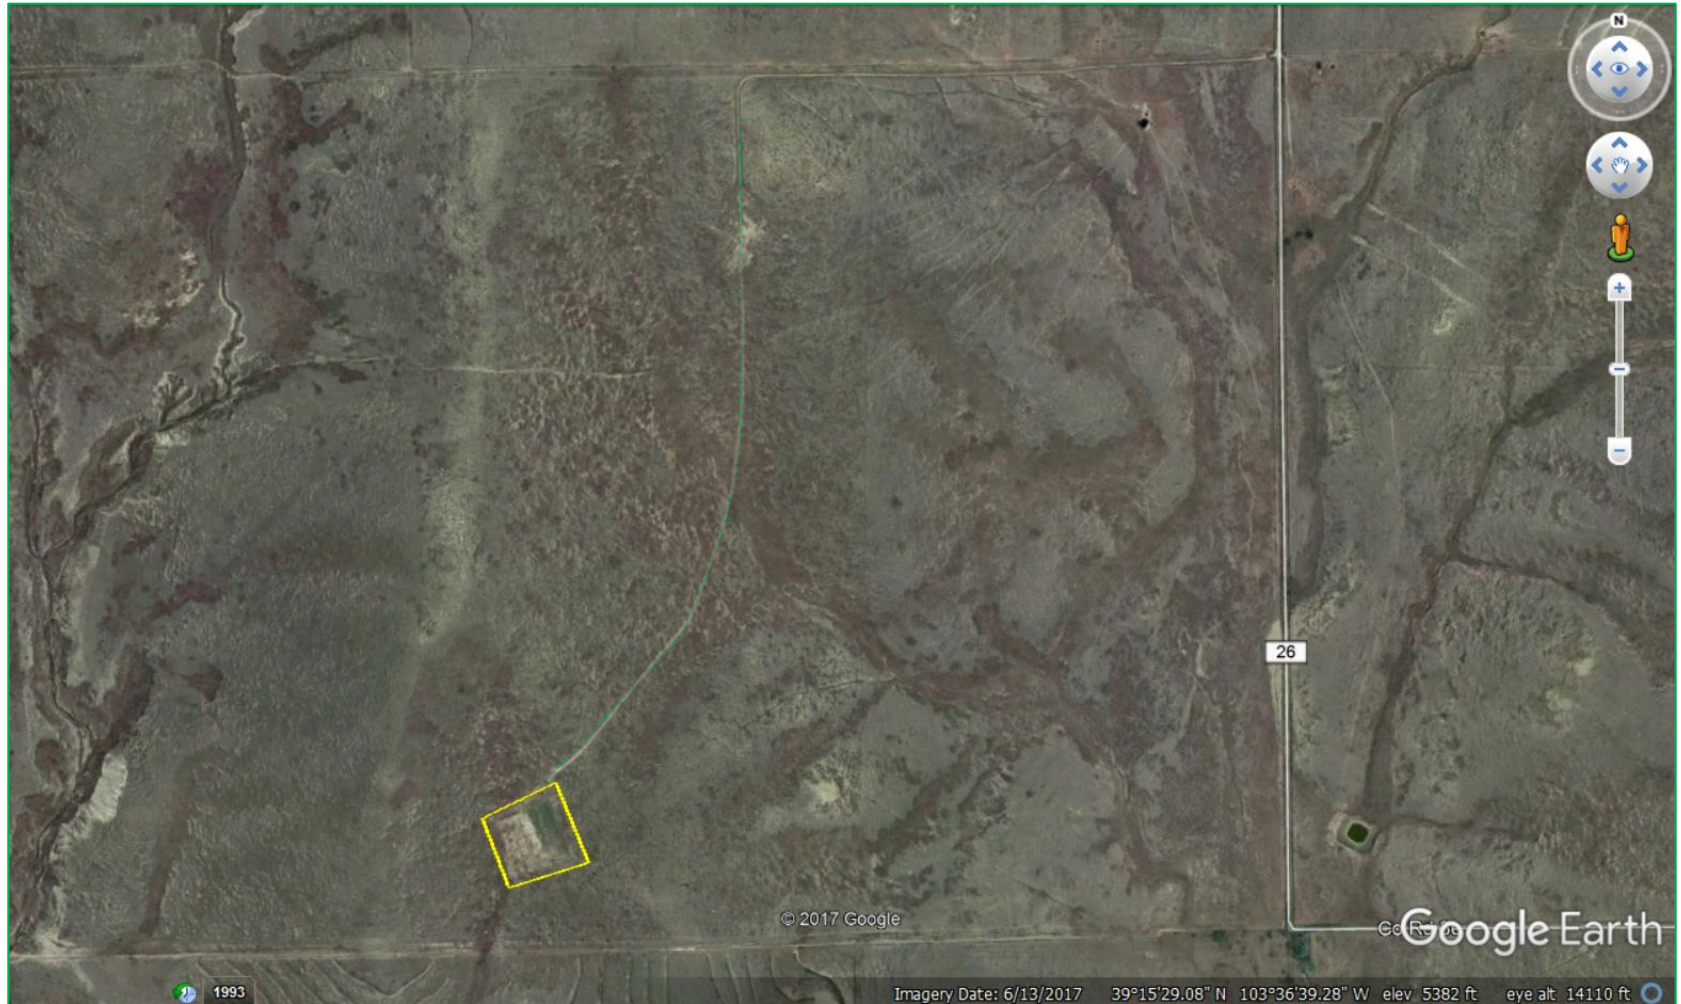
Photo 15: Current aerial imager (6/16/2017). Photo shows area of the well location (yellow) and the access road (green). ~0.87 miles of access road has not been reclaimed per 1000 series reclamation requirements.

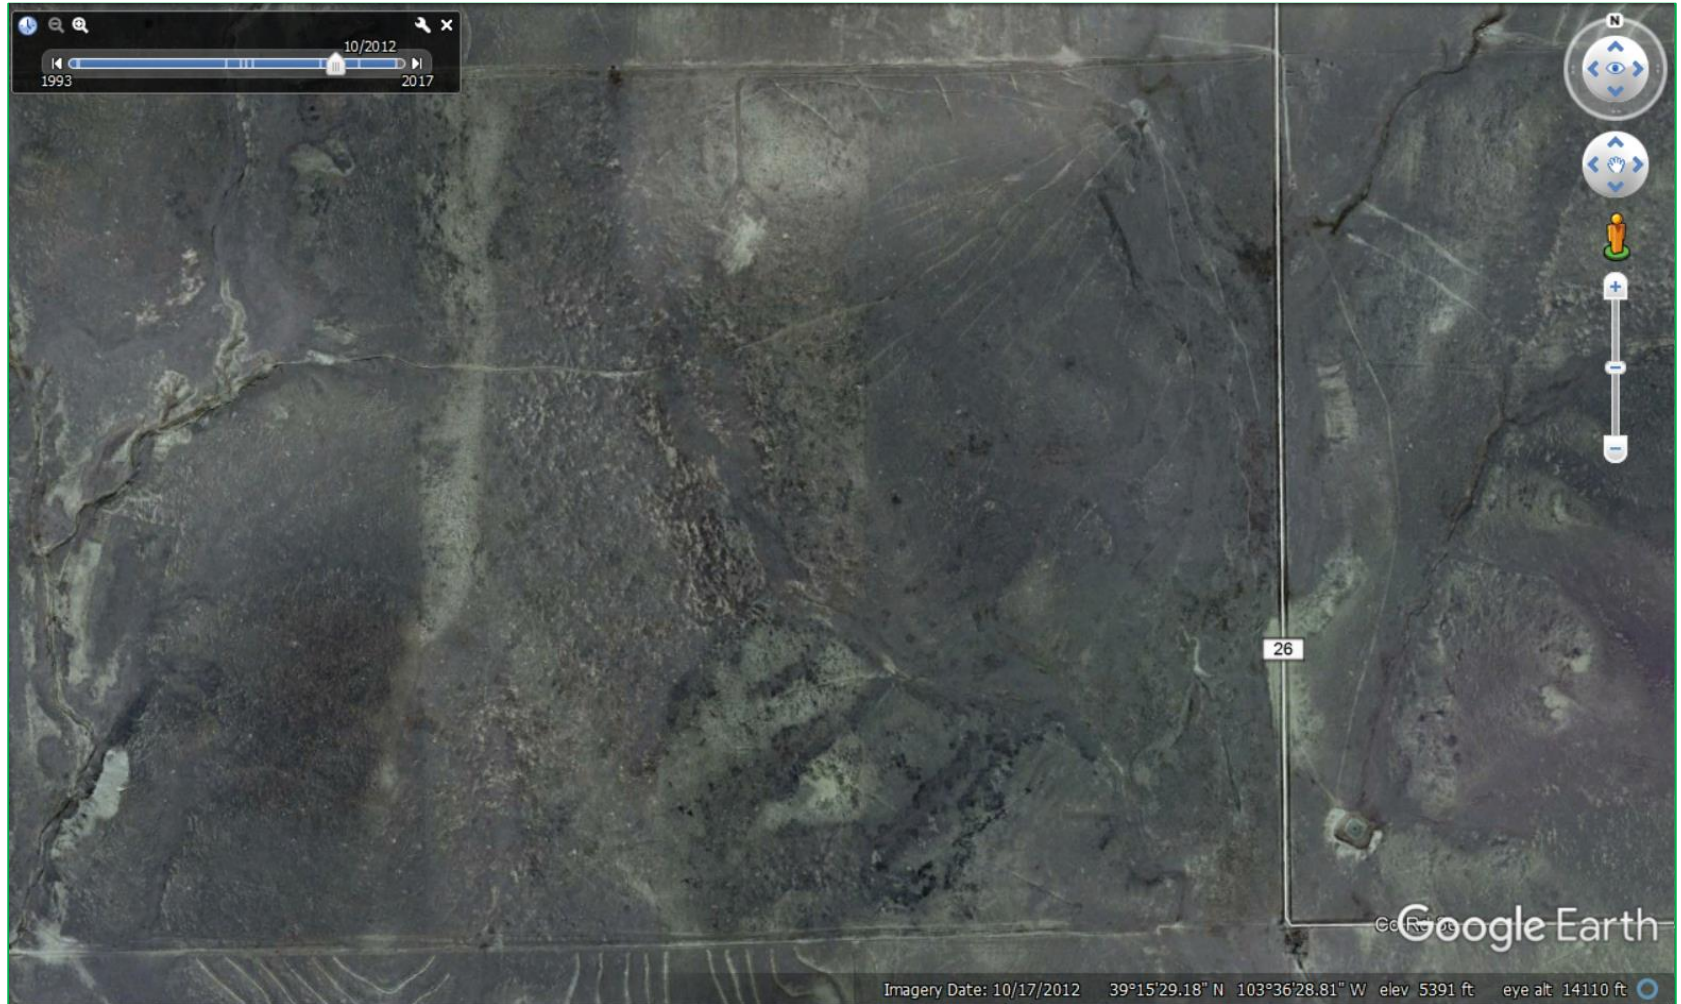
Photo 16: 2012 Aerial imagery. Well was SPUD 2014. Photo shows access road had not been pre-existing.
