**Inspection Photos**  
**Location Name: Ruebel et al 1-4**  
**API: 05-001-08755**

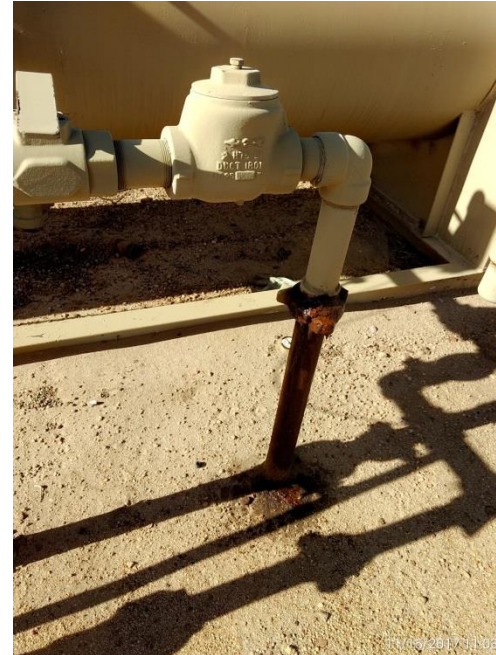
**Riser at Separator Detail, Corrective Action: Leaking Hammer Union, Stained Soil.**

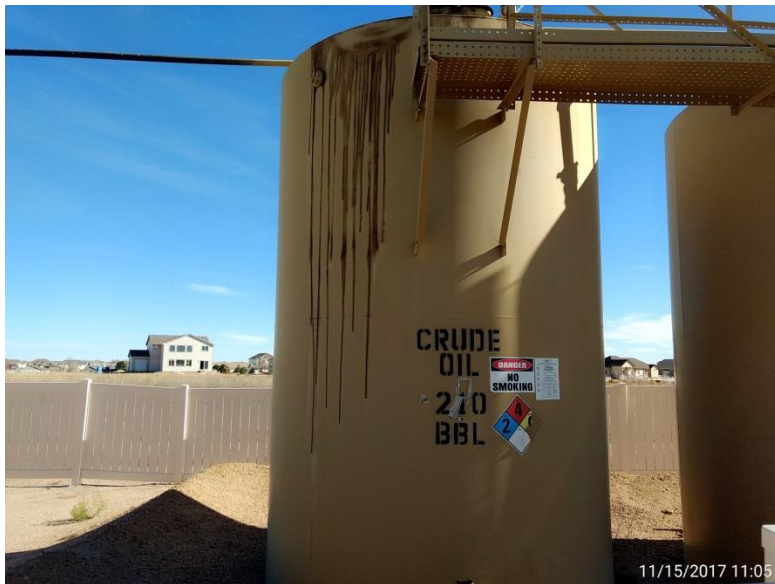
**North Production Tank Detail, Corrective Action: Staining on Side of Tank.**

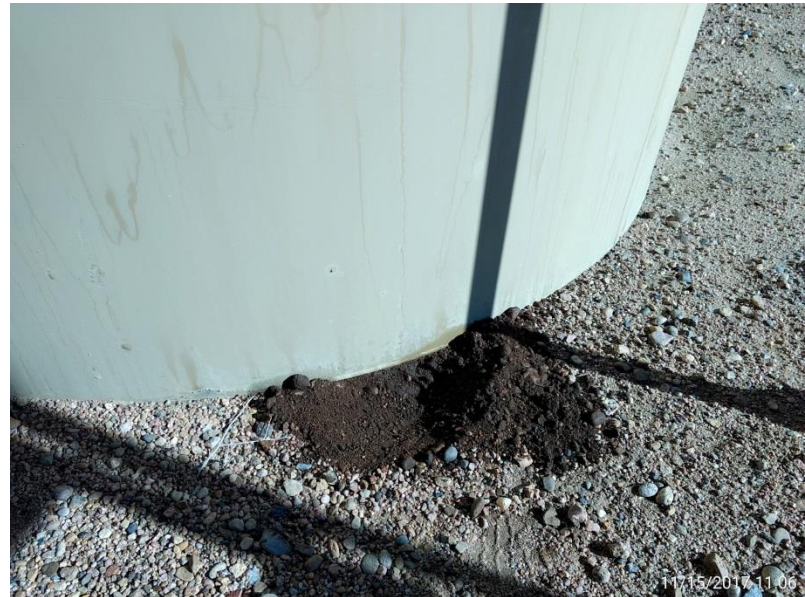
**South Production Tank Detail, Corrective Action: Stained soil at base.**
