**Inspection Photos**  
**Location Name: Ruebel et al 1-3**  
**API: 05-001-08732**

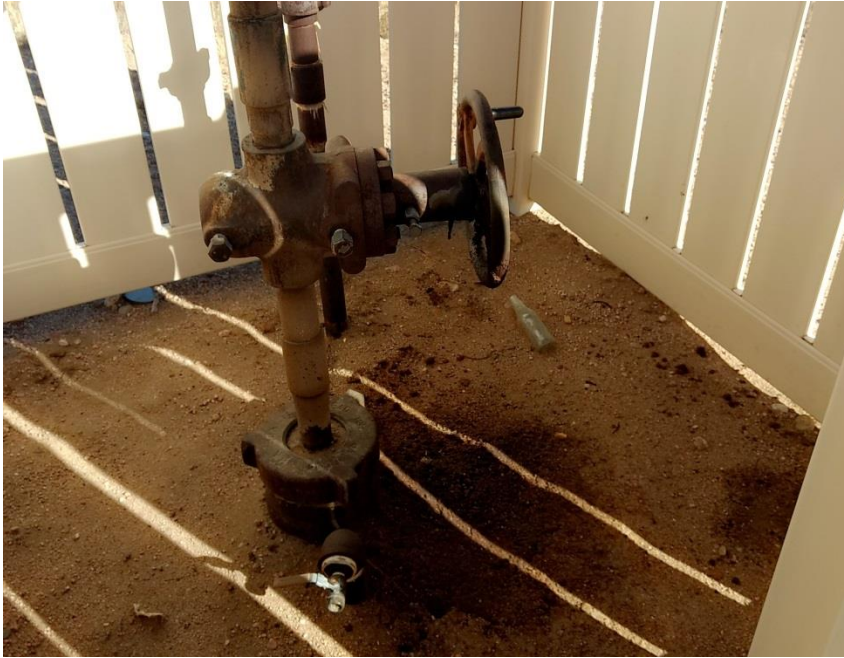
**Wellhead, Corrective Action: Packing in master valve appears to be leaking causing stained soil.**

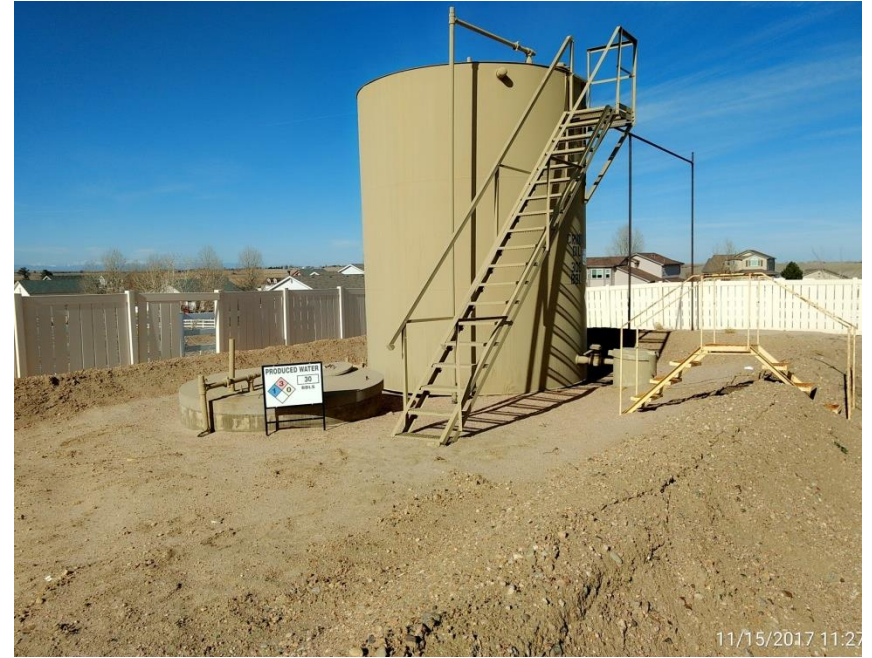
**Battery, Corrective Action: Fencing damage.**

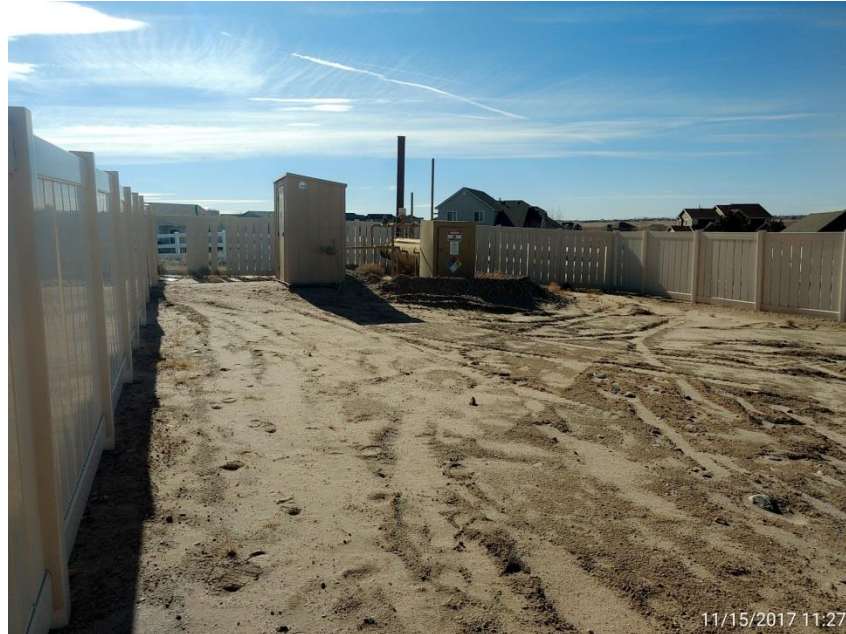
**Separator & Meter Run, Corrective Action: Fencing damage.**
