Inspection Photos
Location Name: Red Mesa Holdings JCK #3
API: 05-067-06033

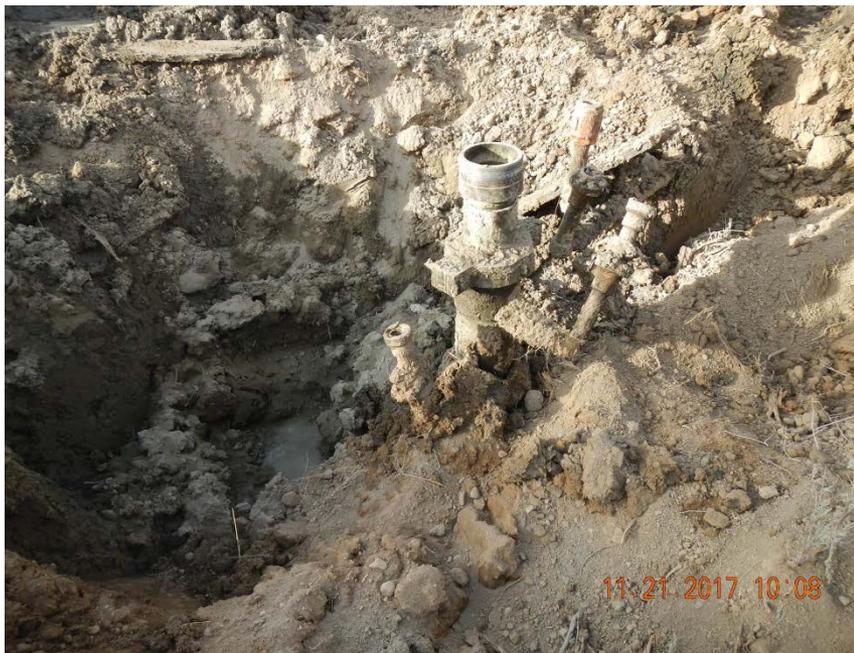
JCK #3 wellhead.

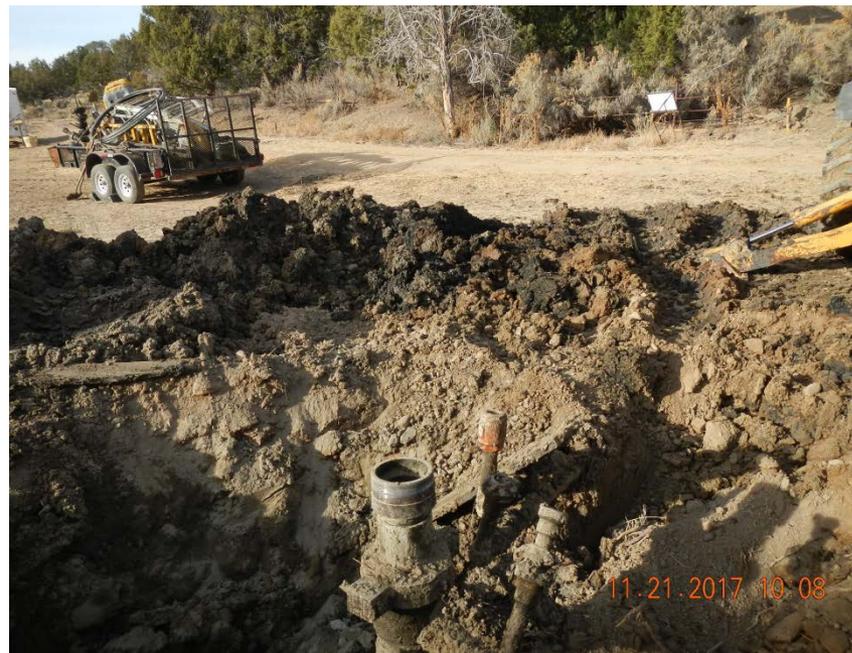
Impacted material excavated from around wellhead.

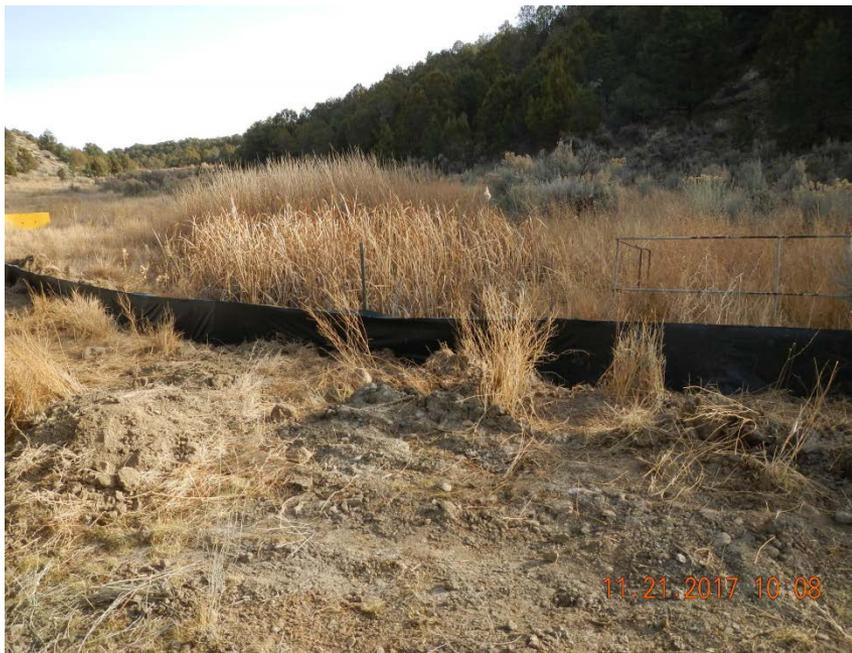
Silt fence installed by A+ Well Services.

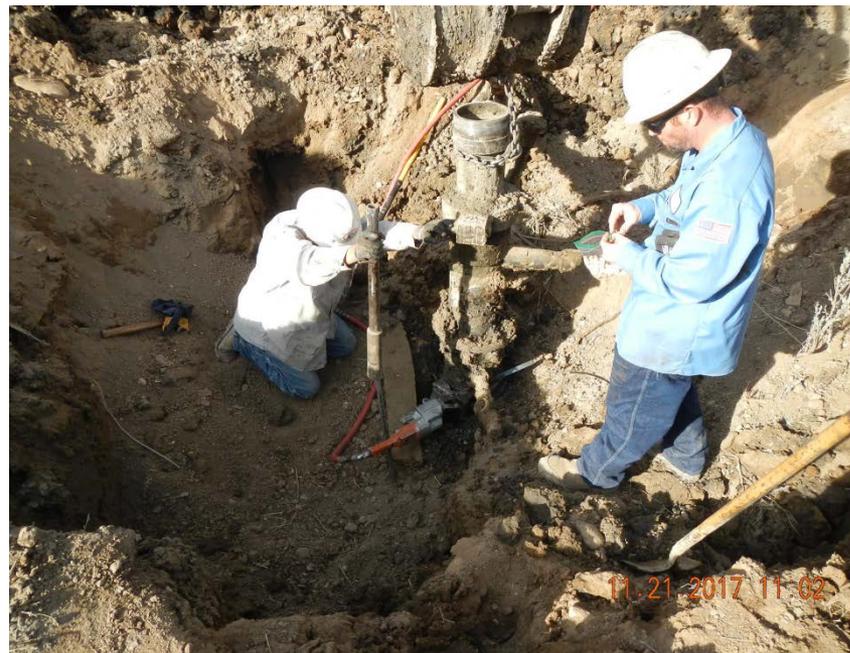
Cutting off wellhead.

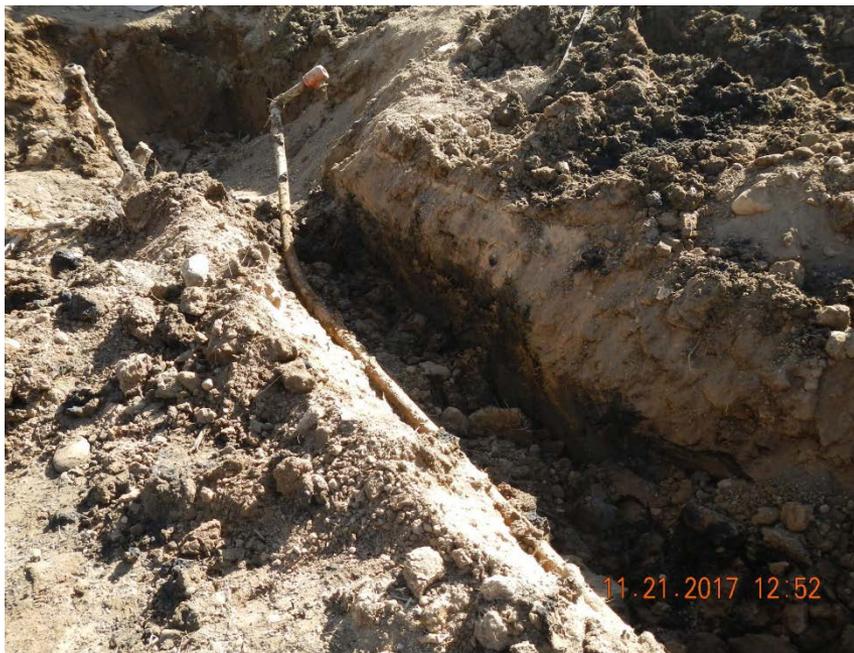
Impacted material surrounding flow lines.

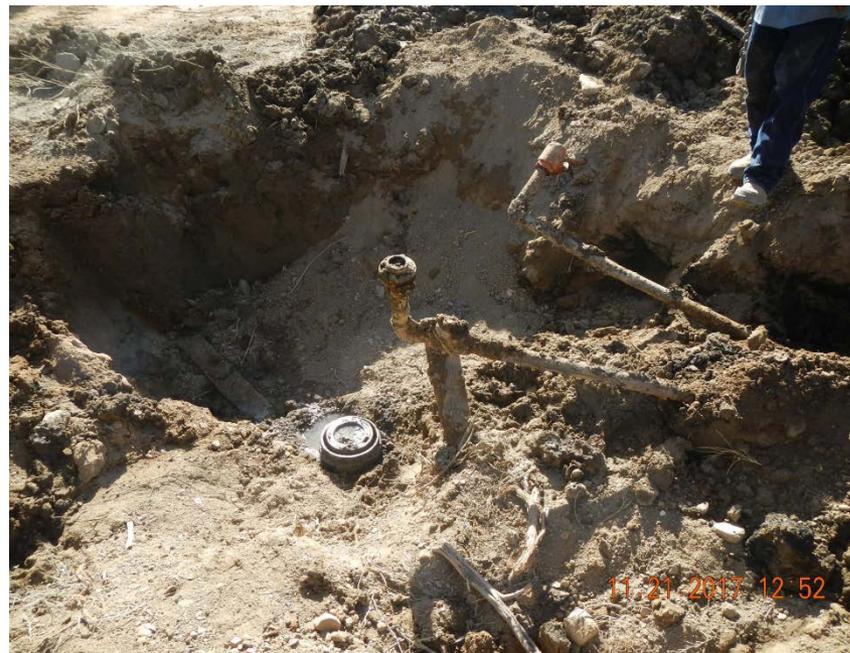
Flowline terminations near cut off well head.

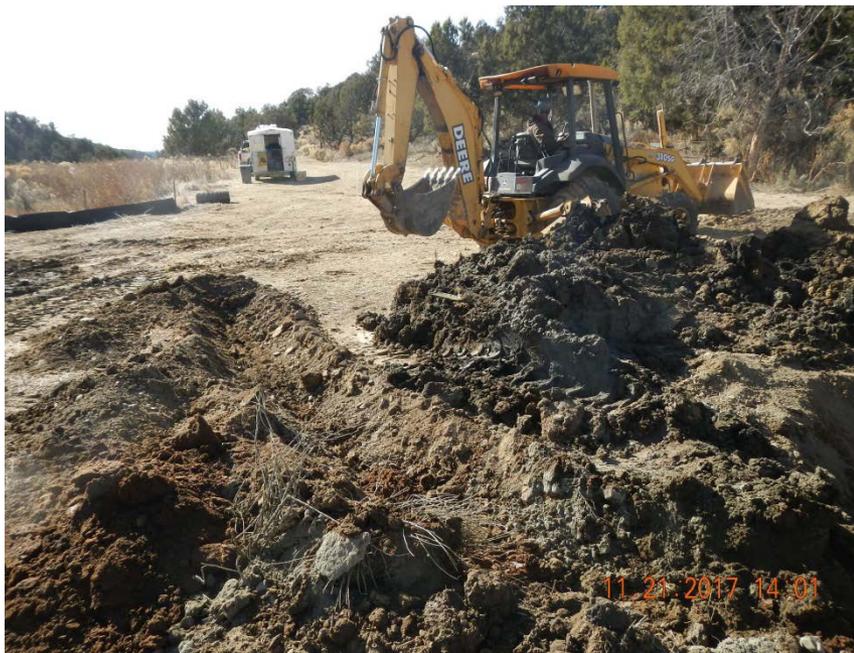
Back hoe digging perimeter trench around impacted material.

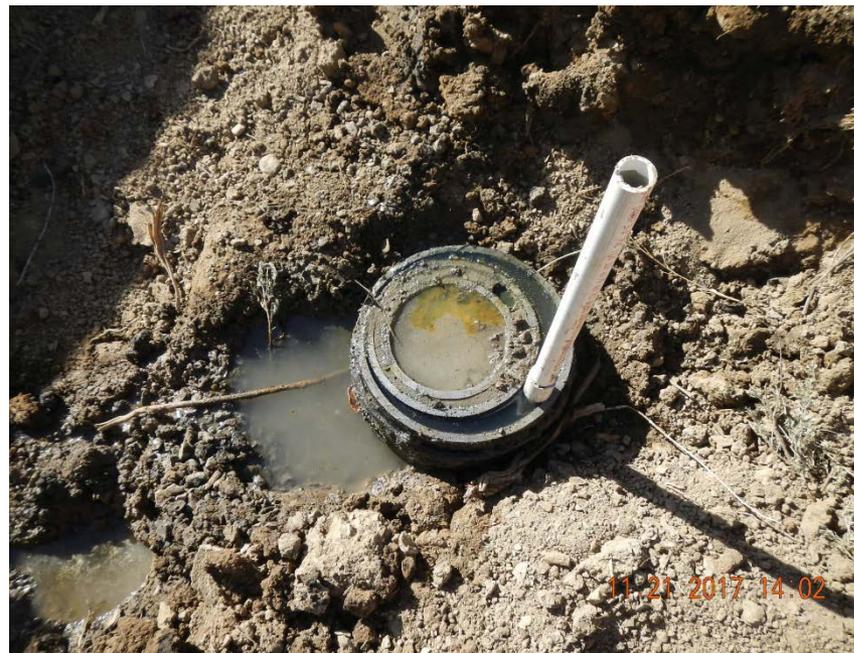
Close up of cut off casing.

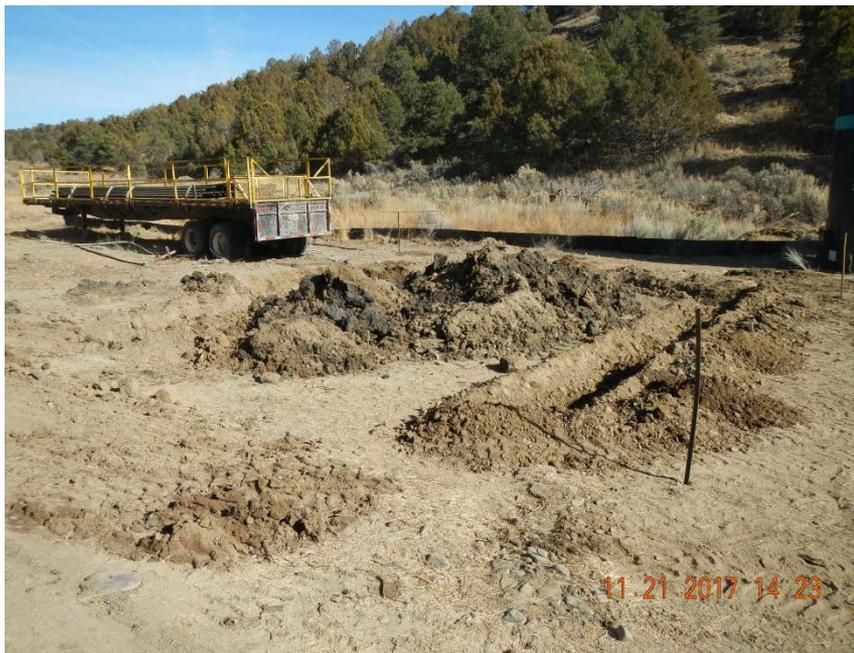
Containment trench dug around stained soil.

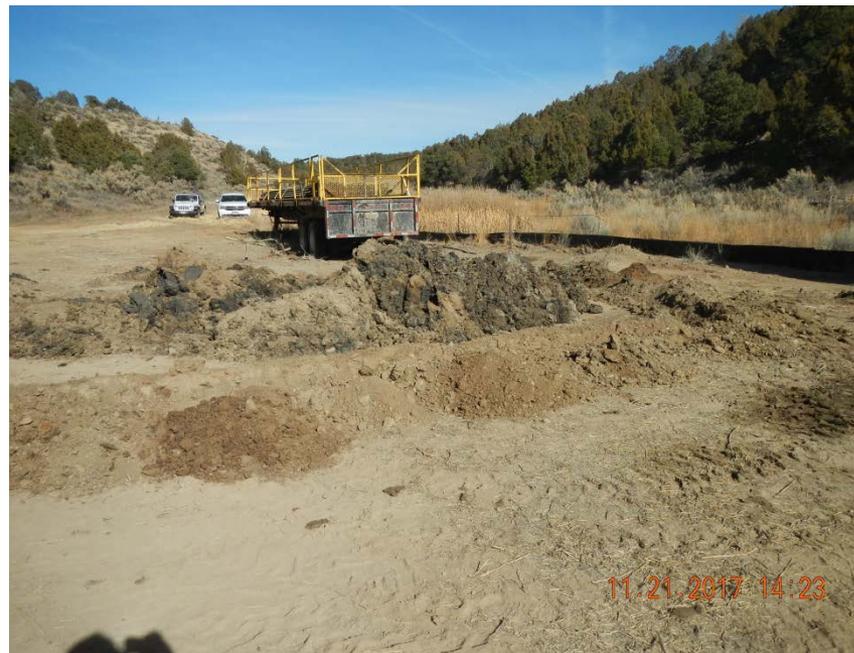
Photo of containment trench on downhill sides of stain soil stockpile.
