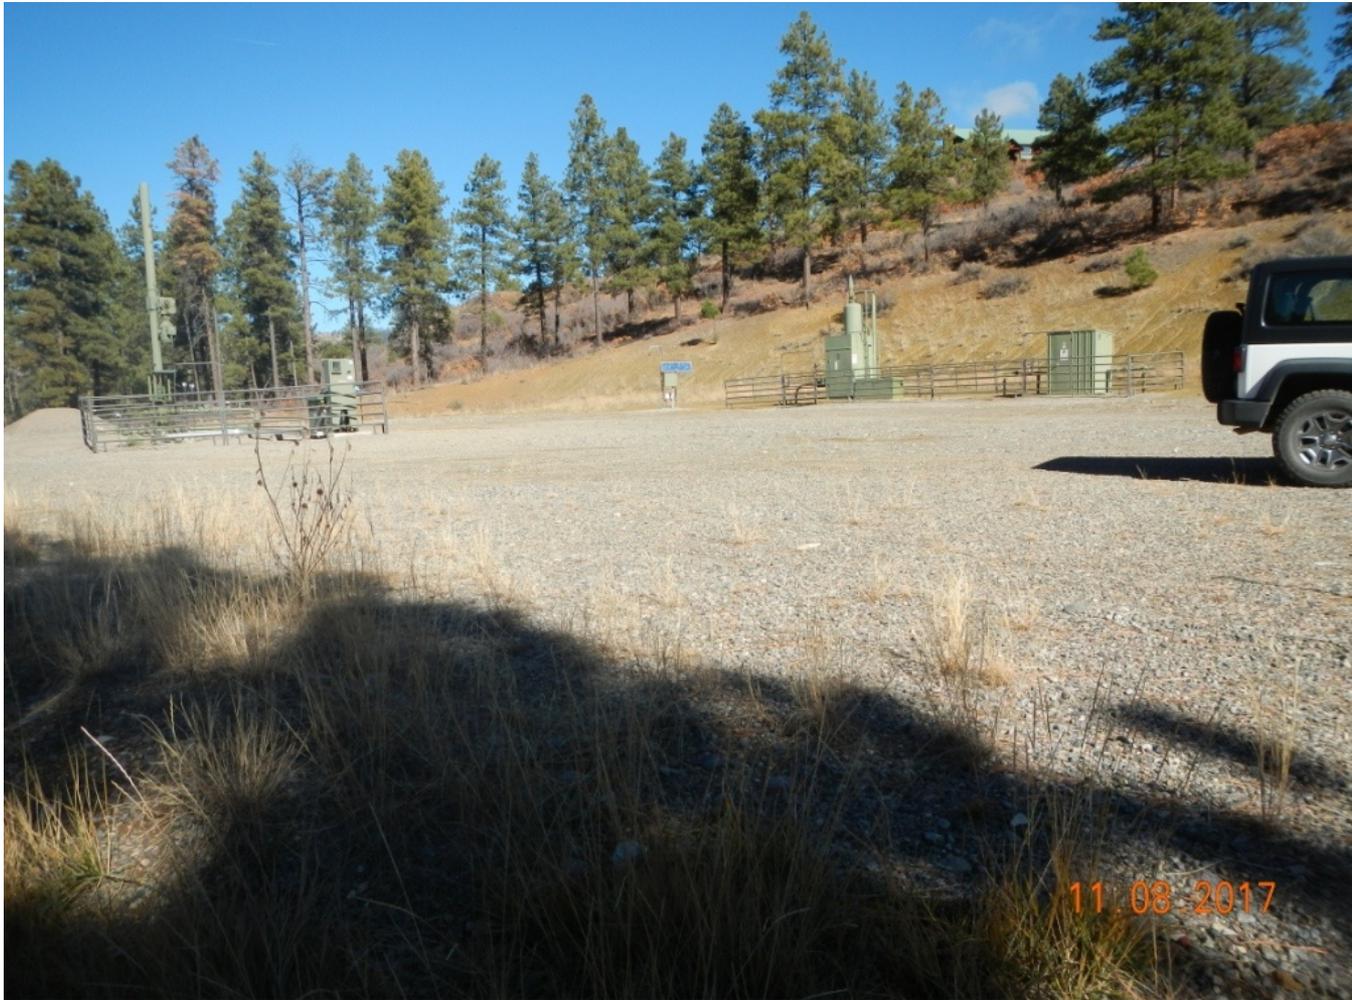
Photo 1. View of the project area from the southwestern corner facing center.

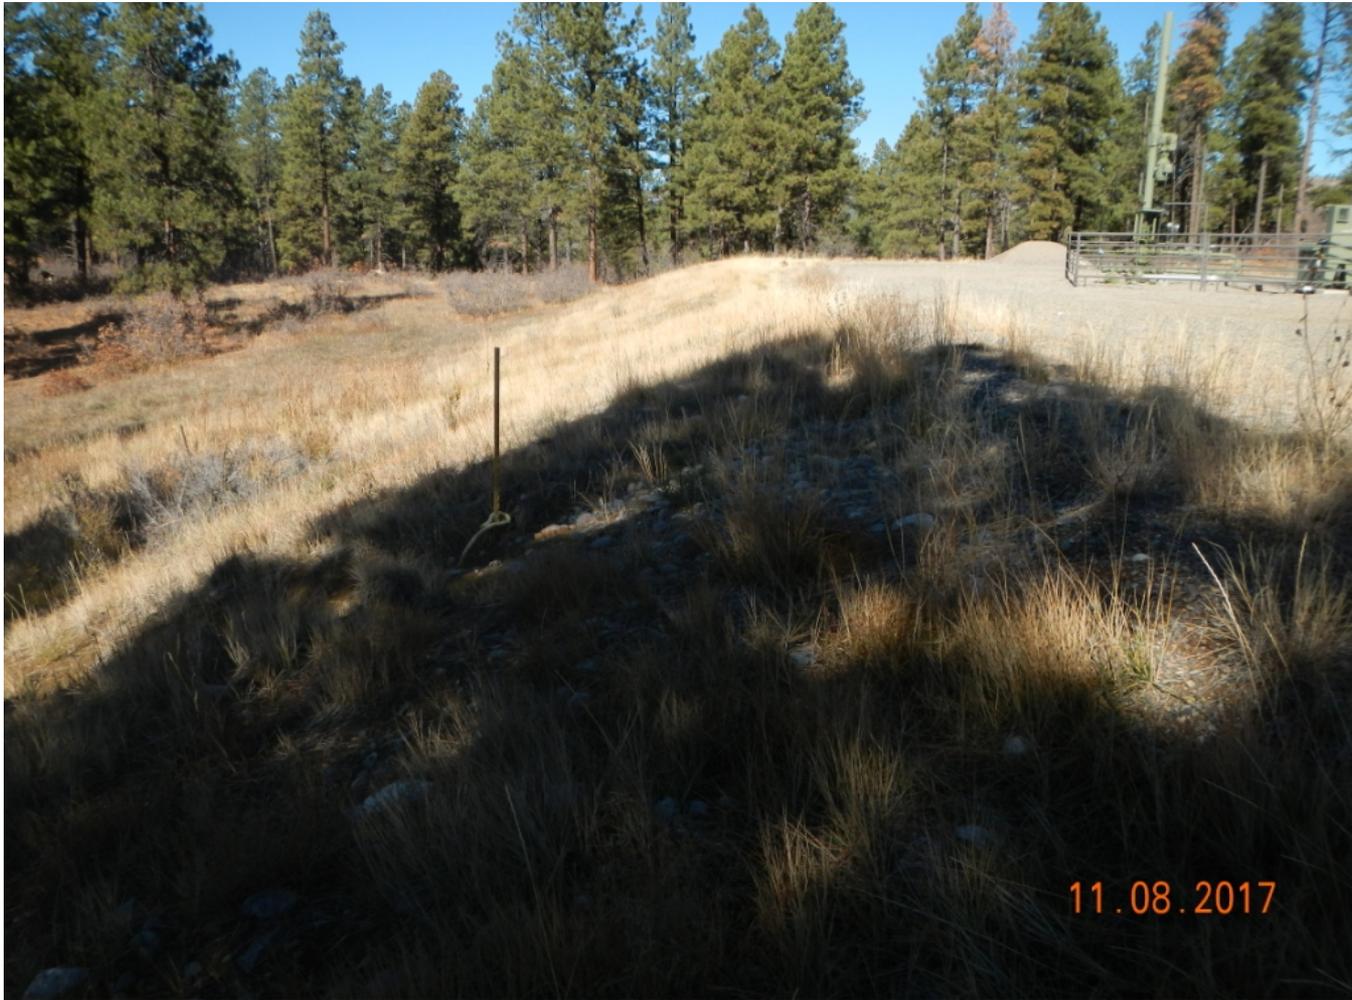
Photo 2. View of the western portion of the project area from the southwestern corner facing northward.

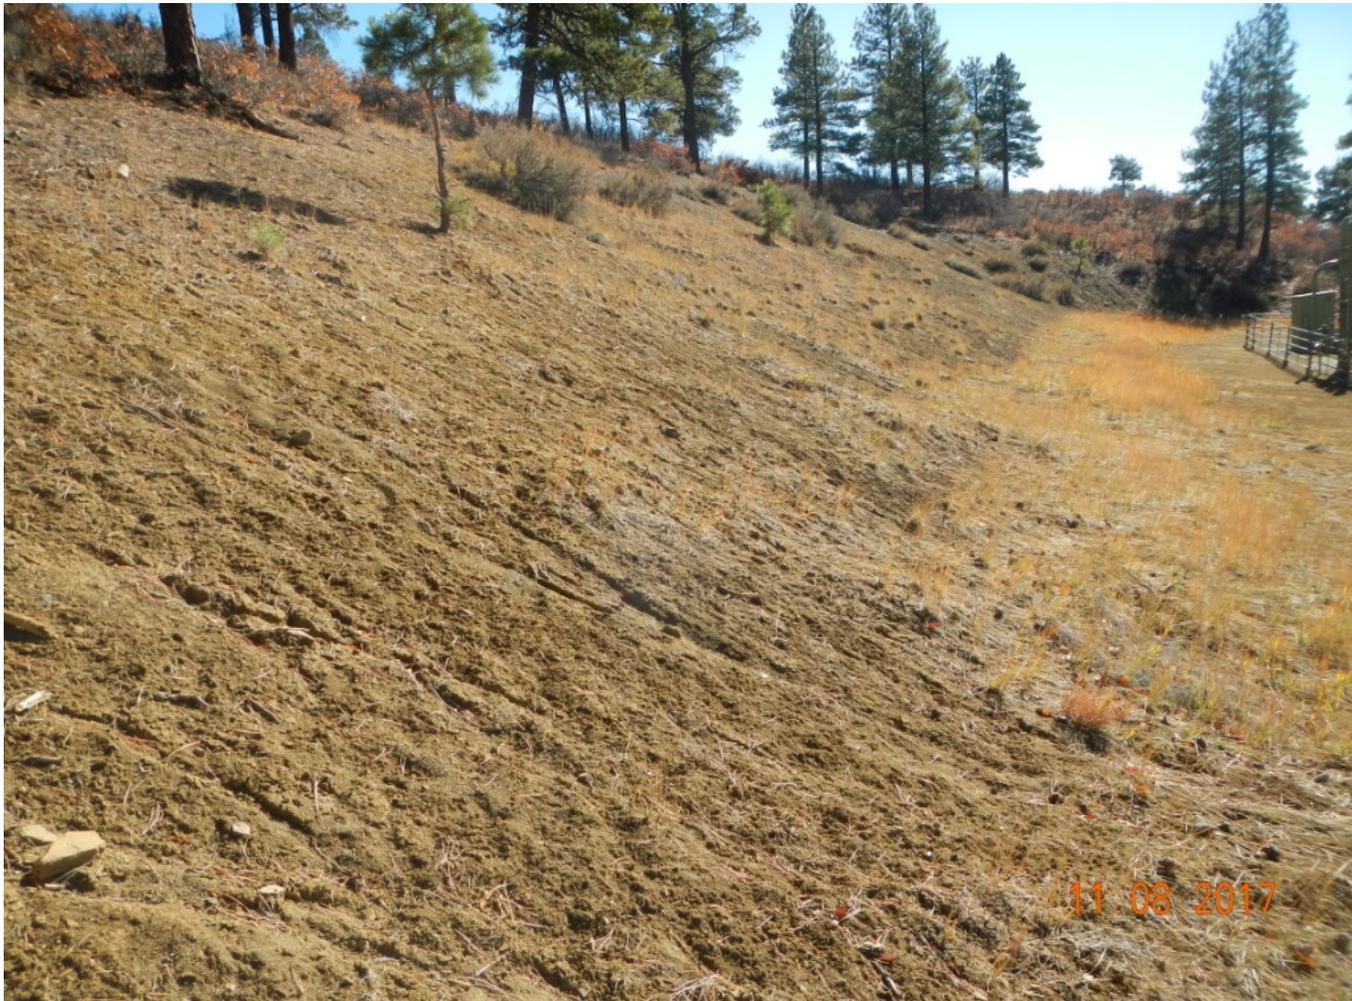
Photo 3. View of the eastern portion of the project area from the northeastern corner facing southward.

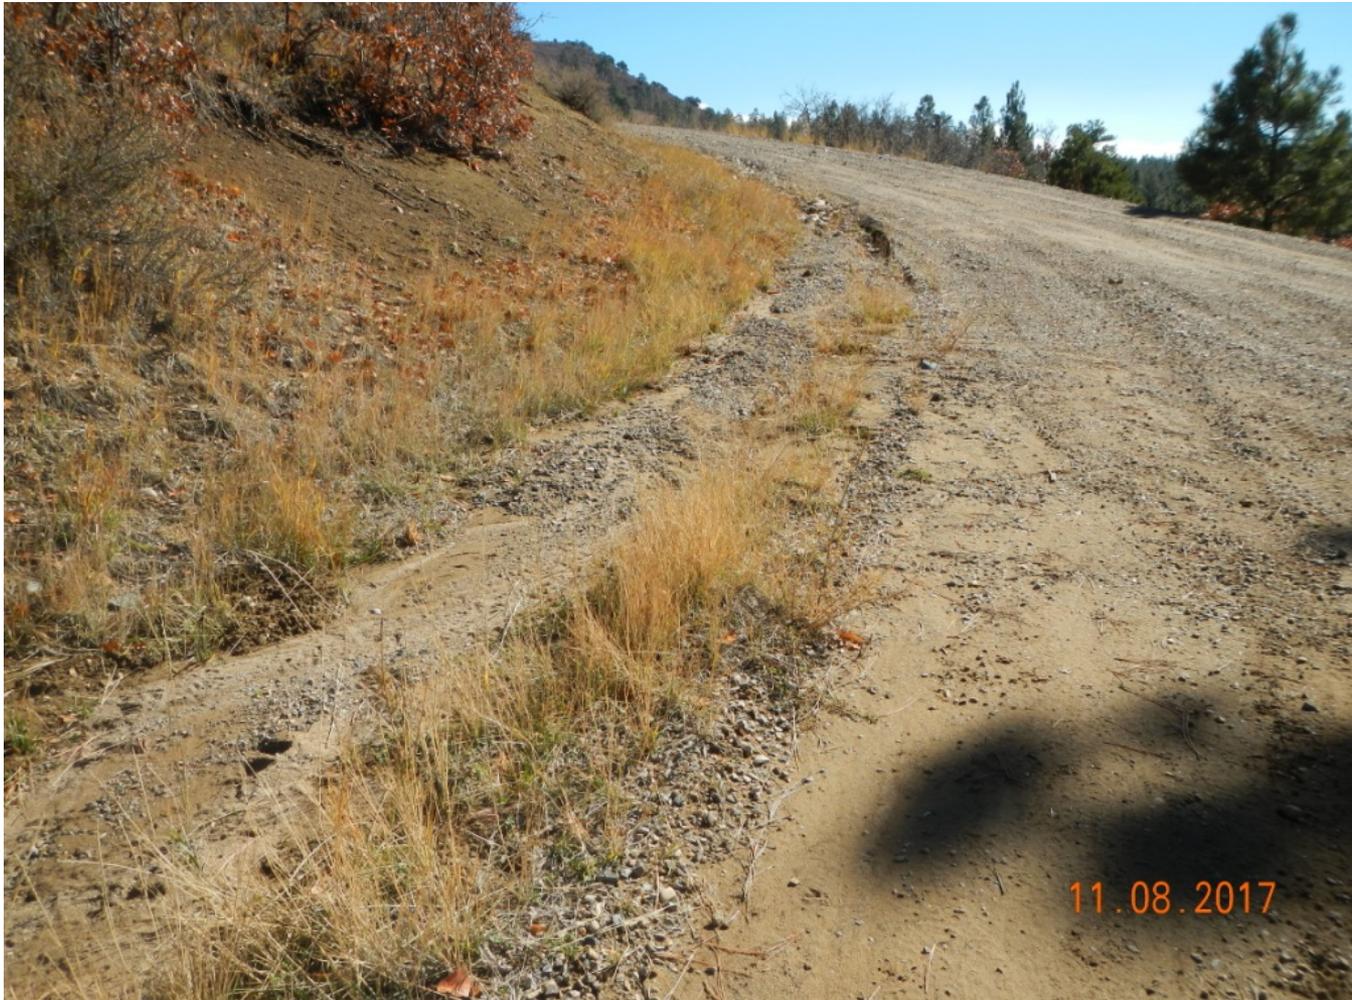
Photo 4. View of the erosion occurring at the access road entrance. Ditch is full of sediment and stormwater is diverted and flows across lease road.

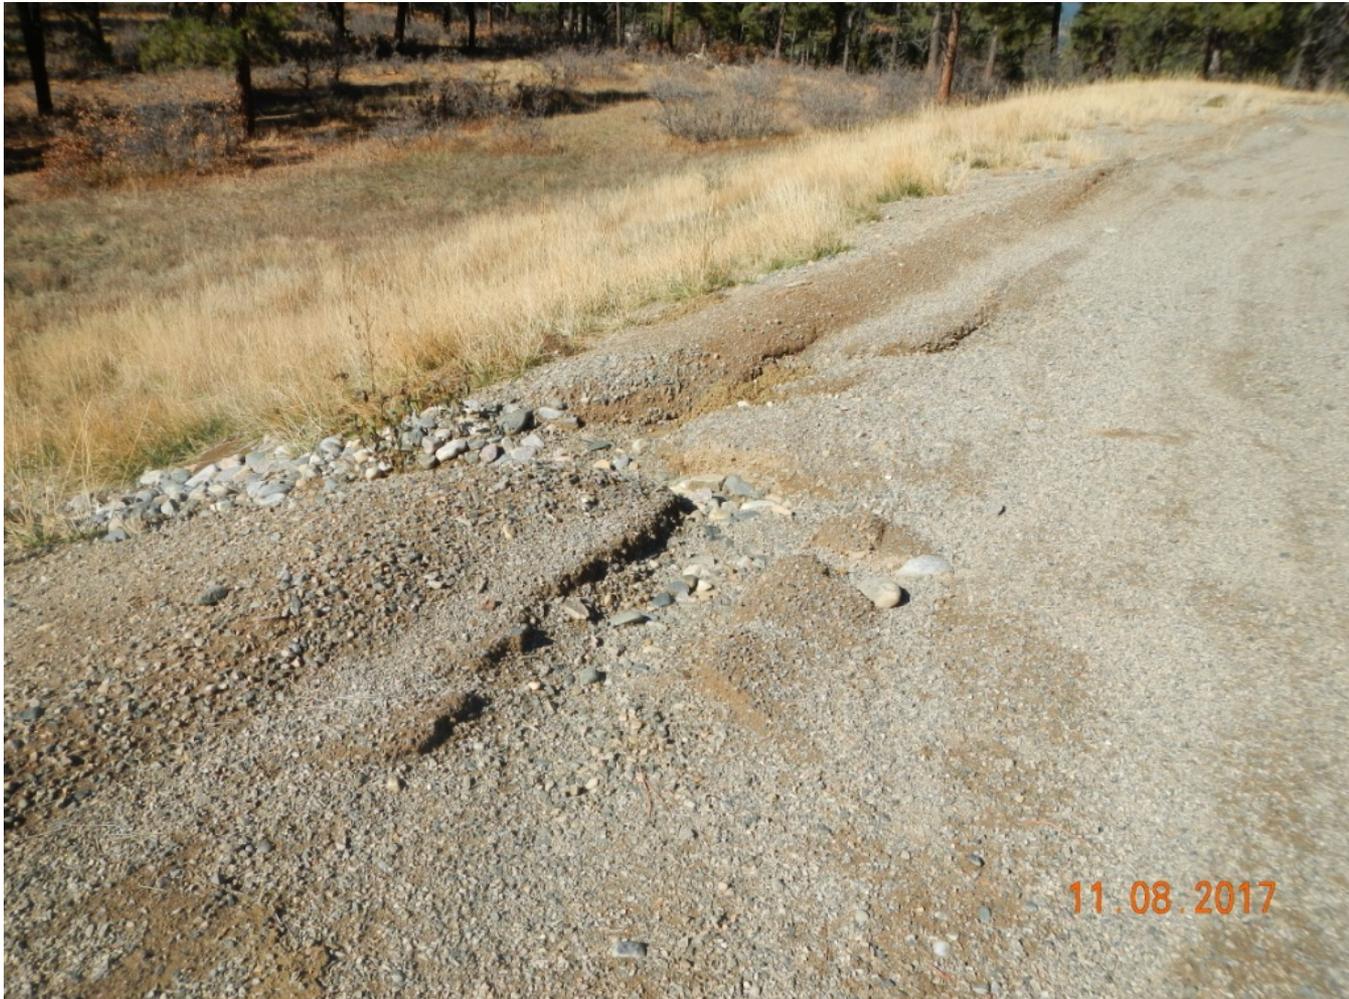
Photo 5. View of area in the western project area where concentrated flows are eroding and stormwater controls need maintenance.

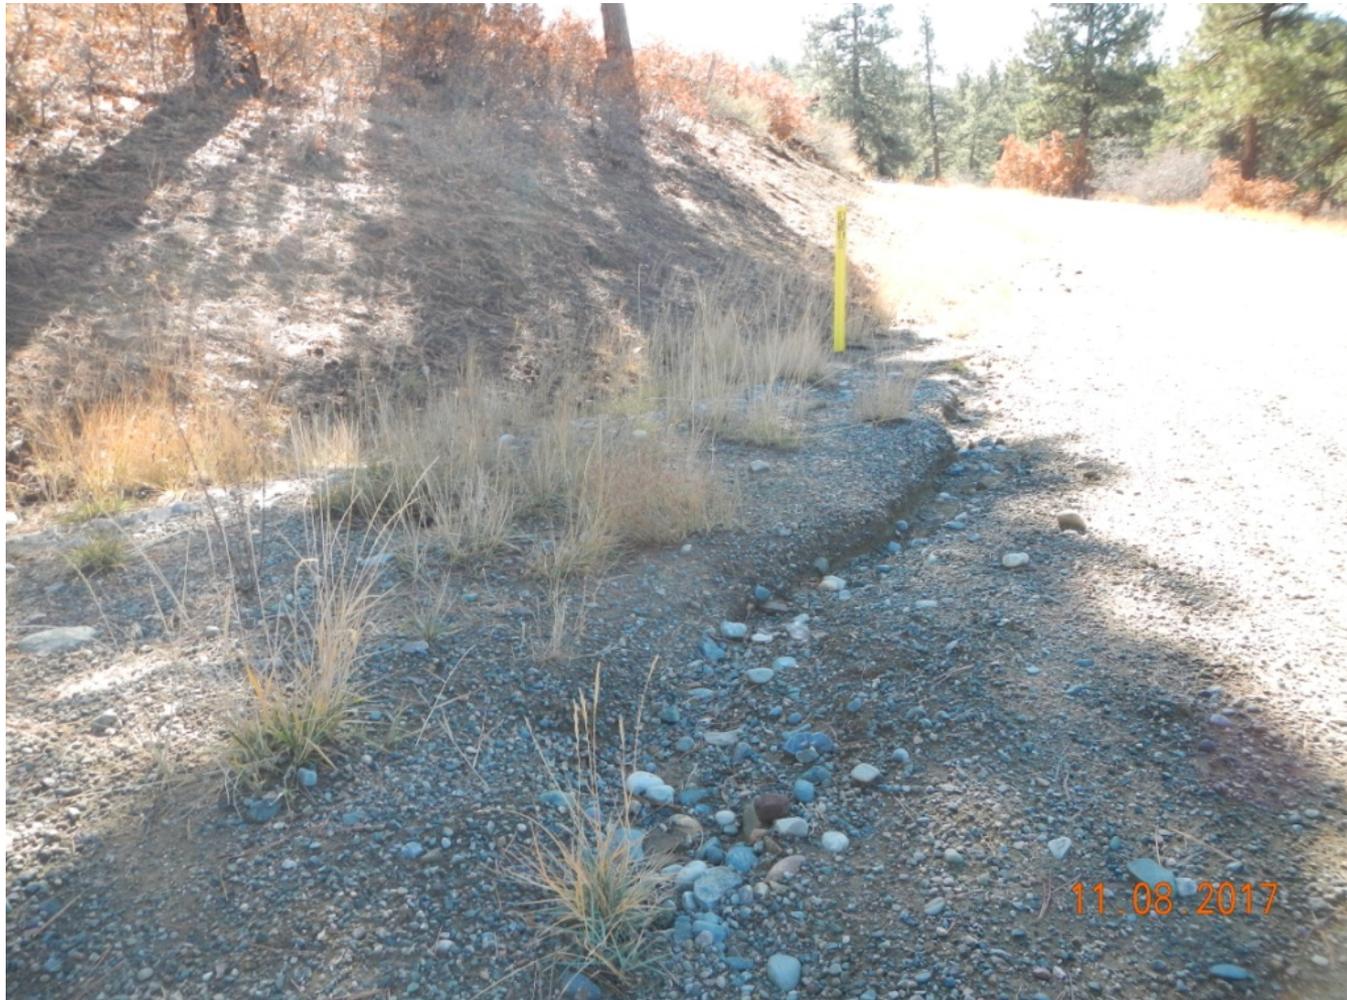
Photo 6. View of erosional channel forming at the well pad entrance where diverted stormwater flows off of the eastern well pad.
