Inspection Photos
Location Name: Haller 32-12
API: 05-123-08513

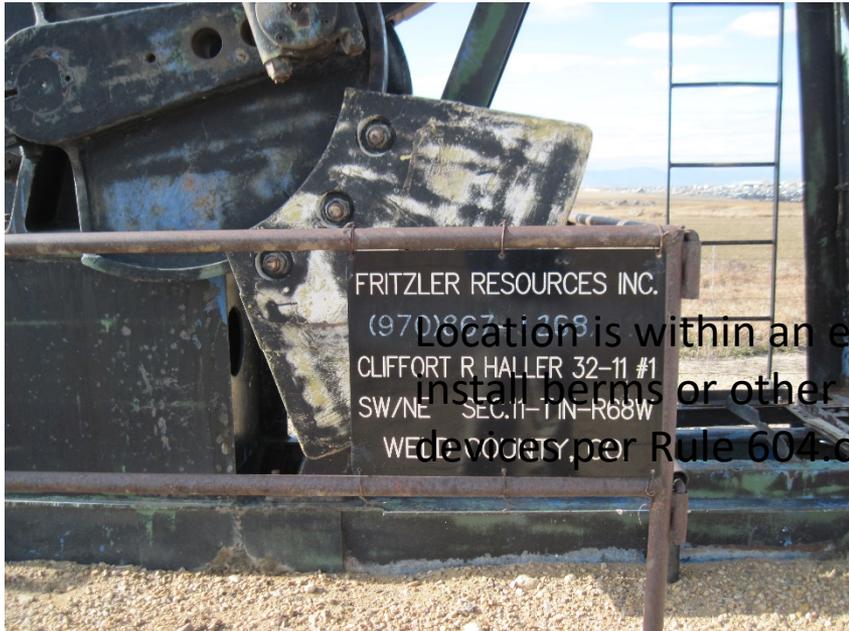
Wellhead sign

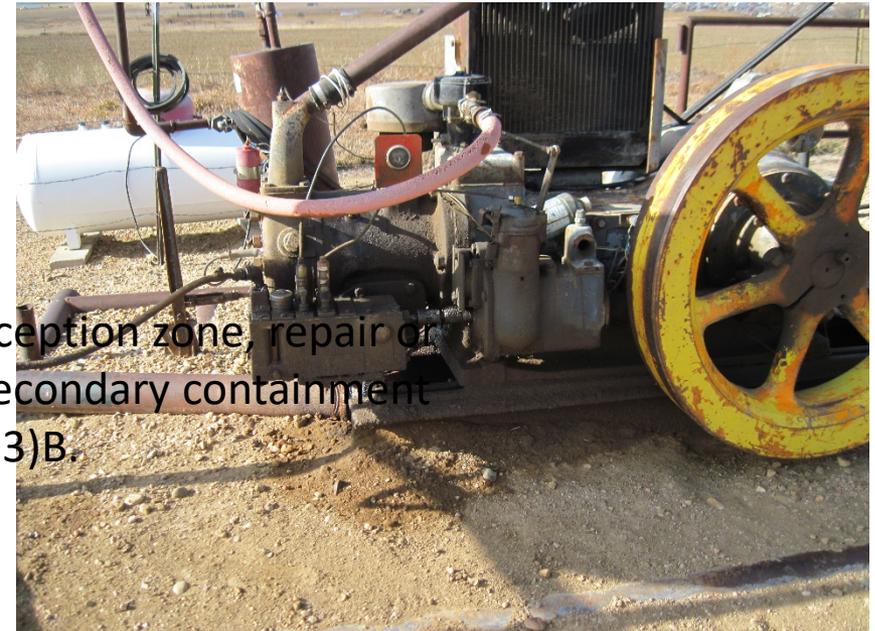
Well motor mounts oil soaked dirt
