Inspection Photos
Location Name: Tiffany #1R
API: 05-067-08737

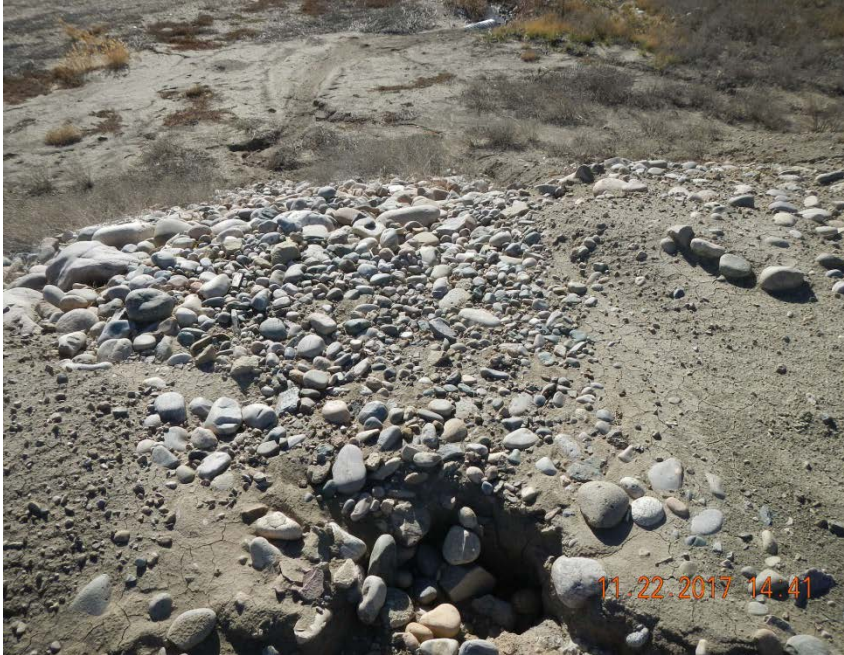
Rip rap run down in SW corner of location requires maintenance.

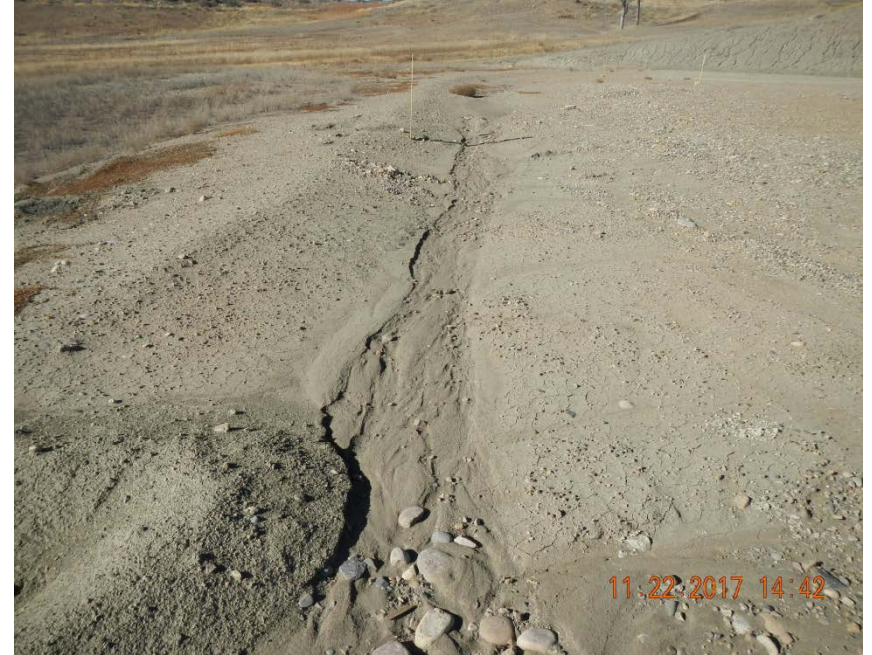
Erosional channel along western edge of location.

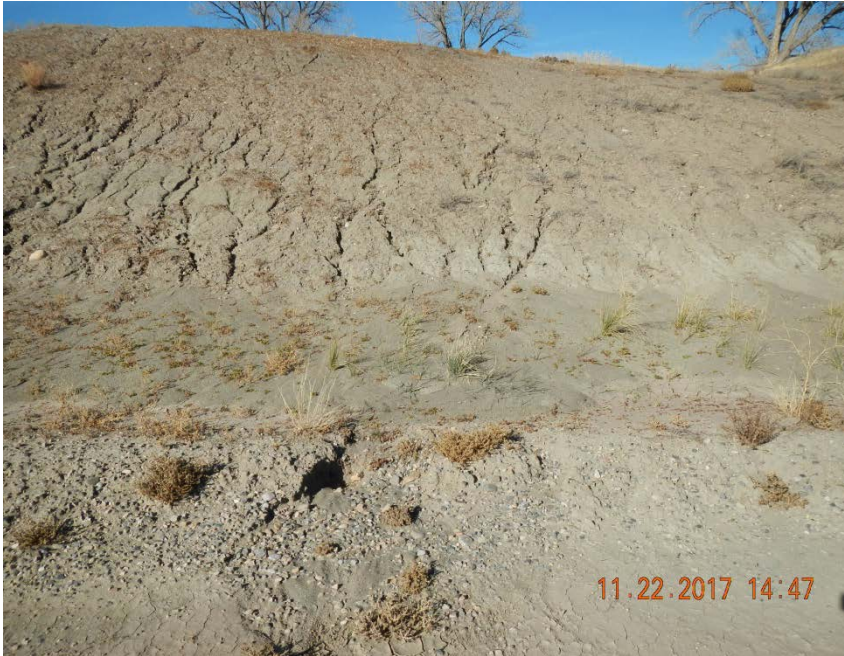
Location berm has been breached.

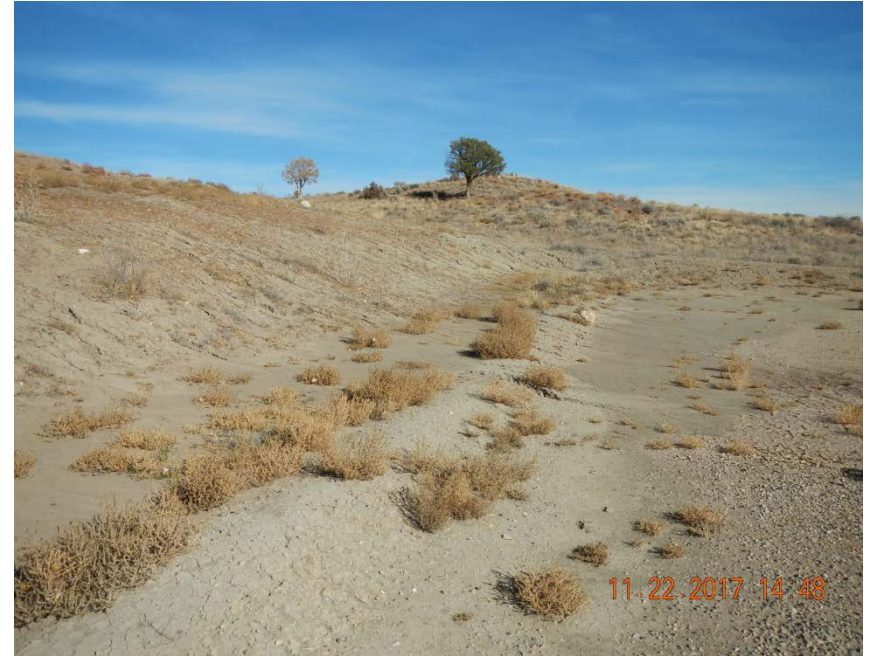
Run on control berm has filled in with sediment.
