**Inspection Photos**  
**Location Name: Tiffany Lease Tank Battery**  
**Facility ID: 453284**

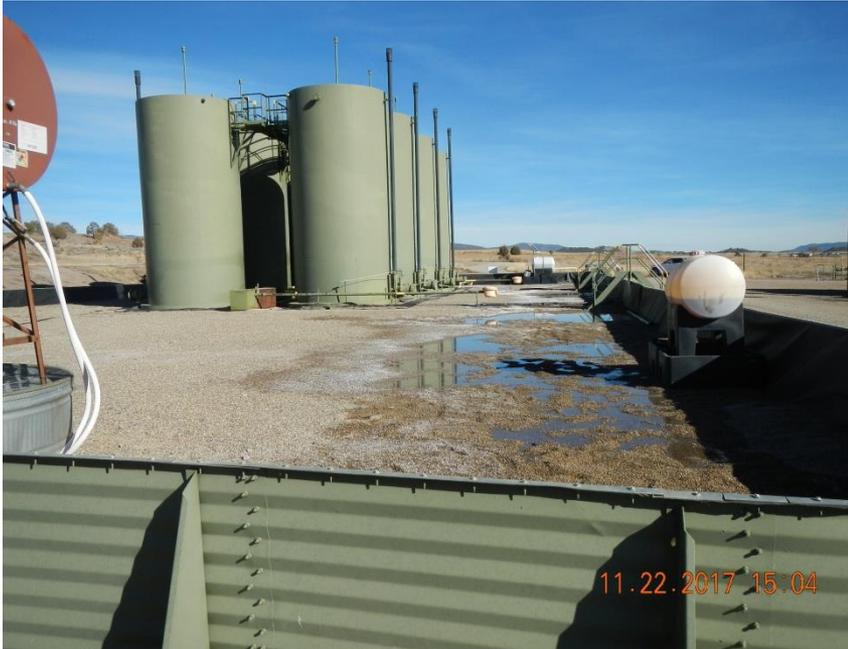
**Standing water in secondary containment area.**

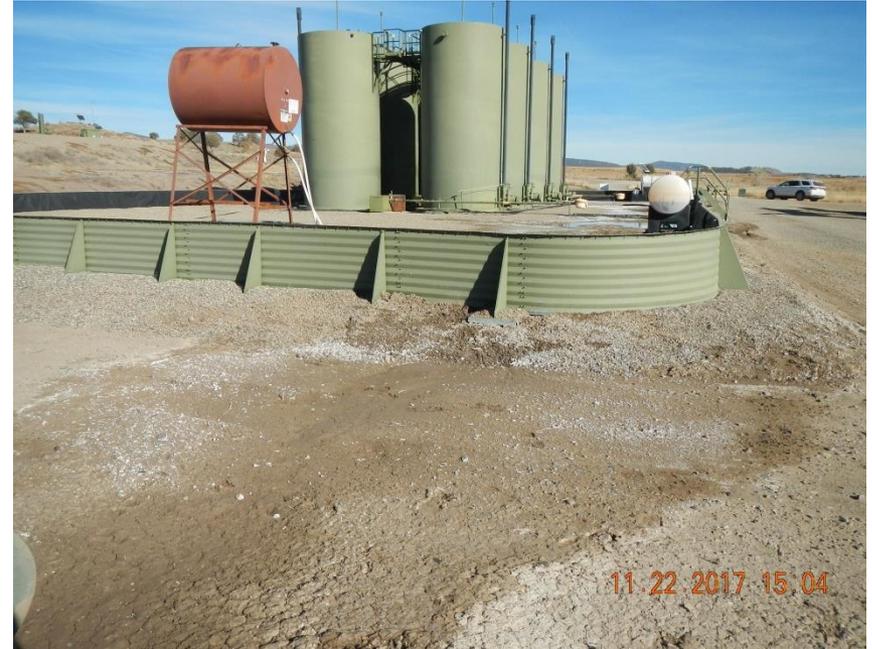
**Damp area adjacent to SW corner of containment area.**

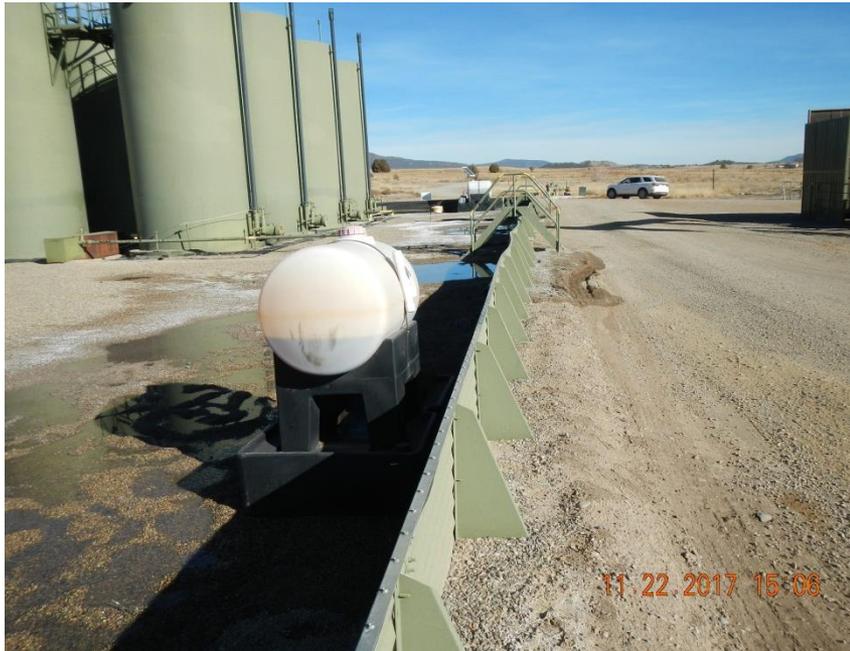
**Other damp areas along southern edge of containment area.**

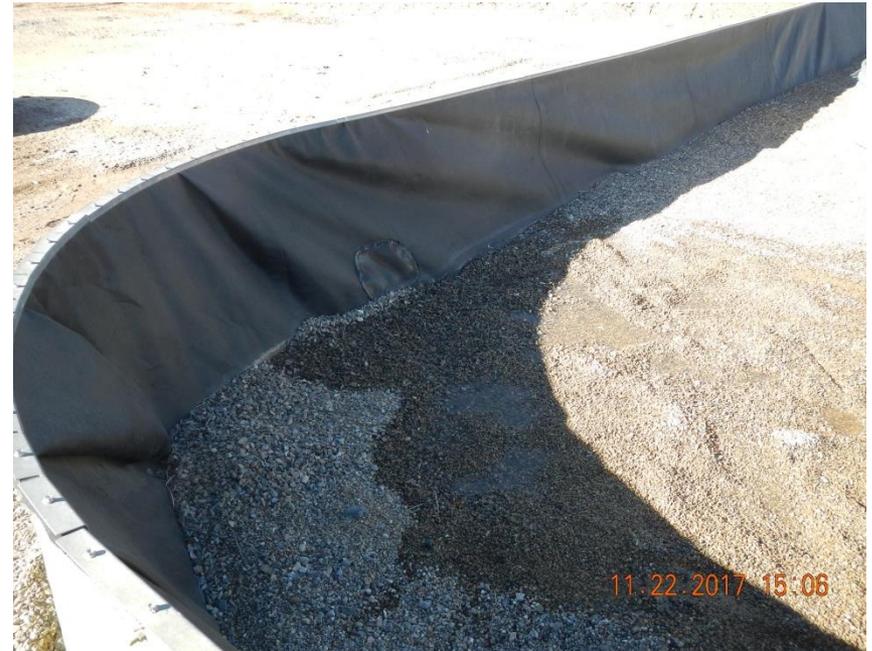
**Patched liner in SW corner of containment area.**

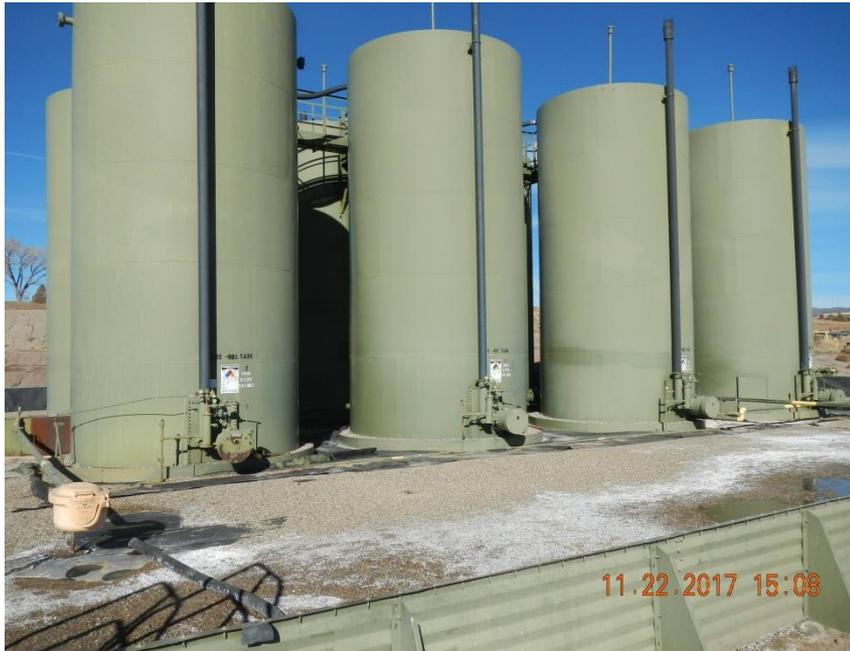
**Standing water and white residue inside secondary containment area.**

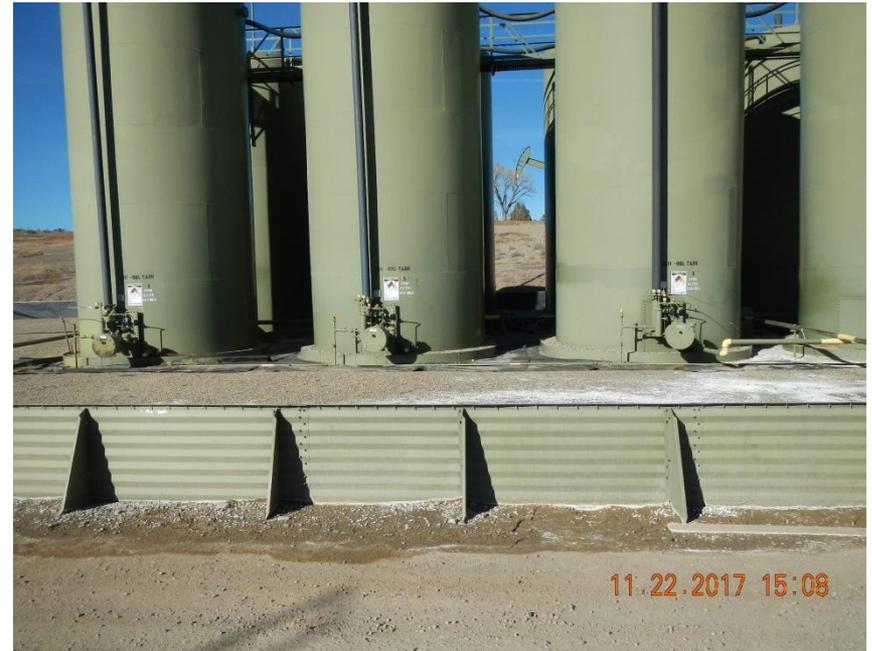
**Damp soil outside of secondary containment ring.**

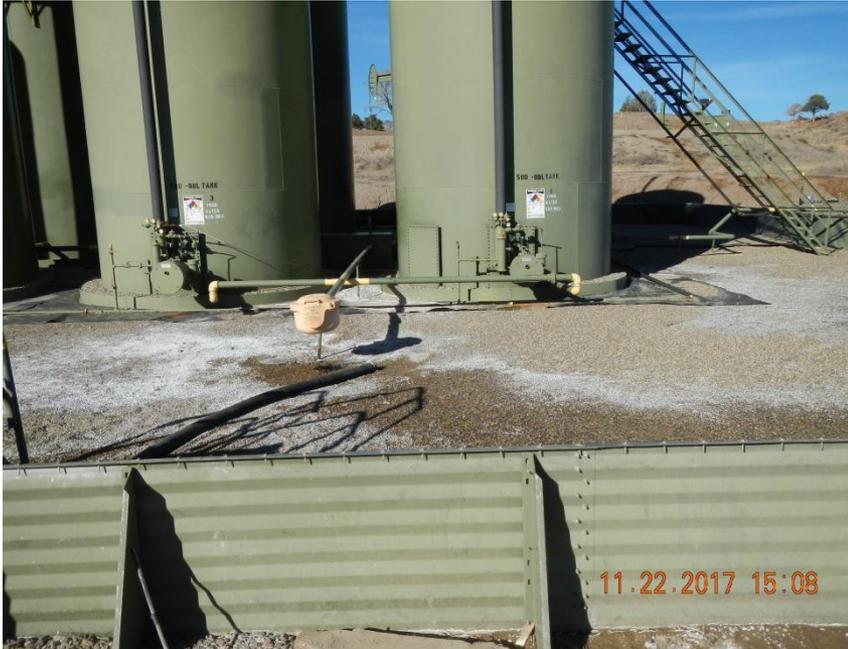
**Load out valve was leaking upon arrival. Drip pot is cracked and not functioning properly.**

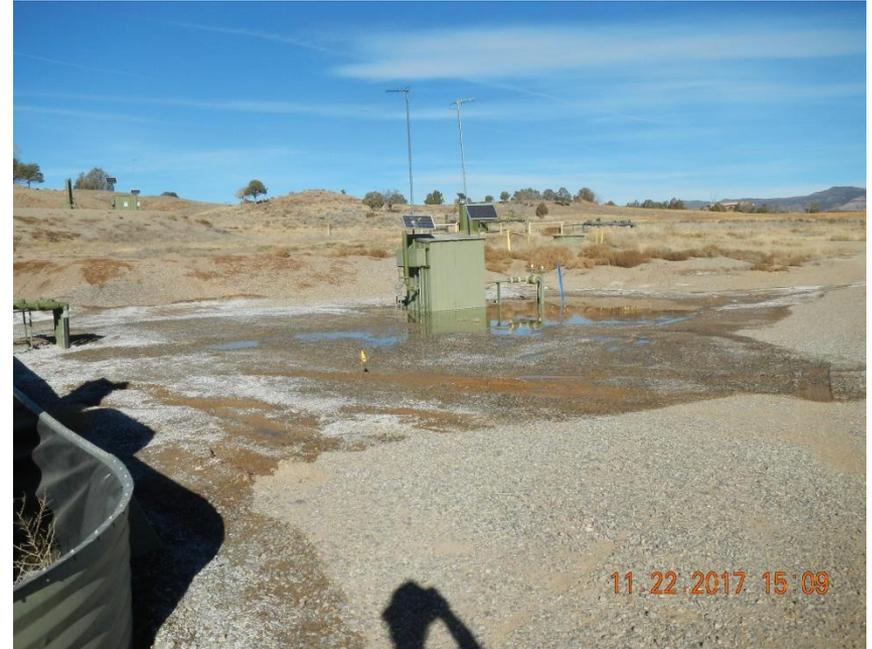
**Wet area east of tank battery.**

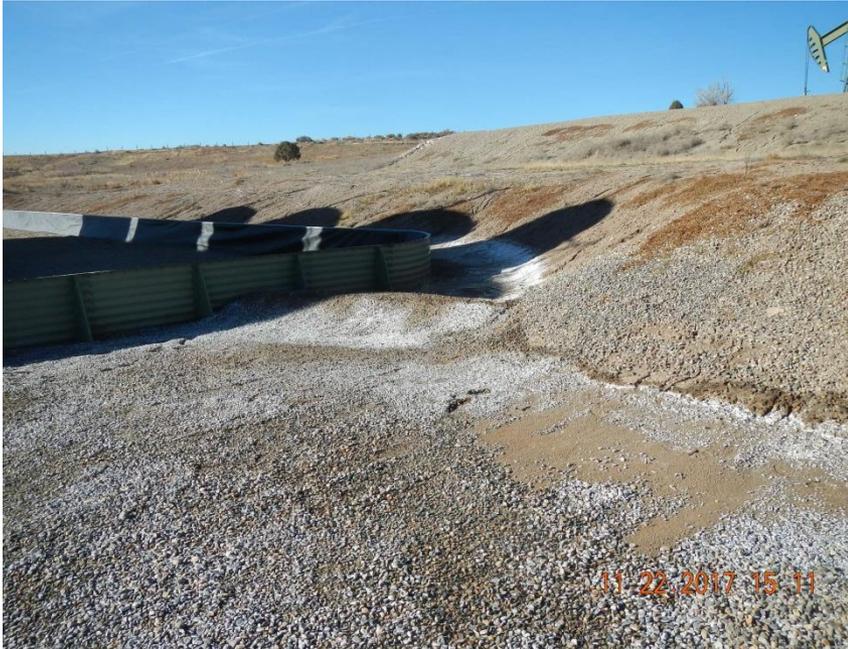
**Damp soil and white residue in northwest corner of tank battery.**

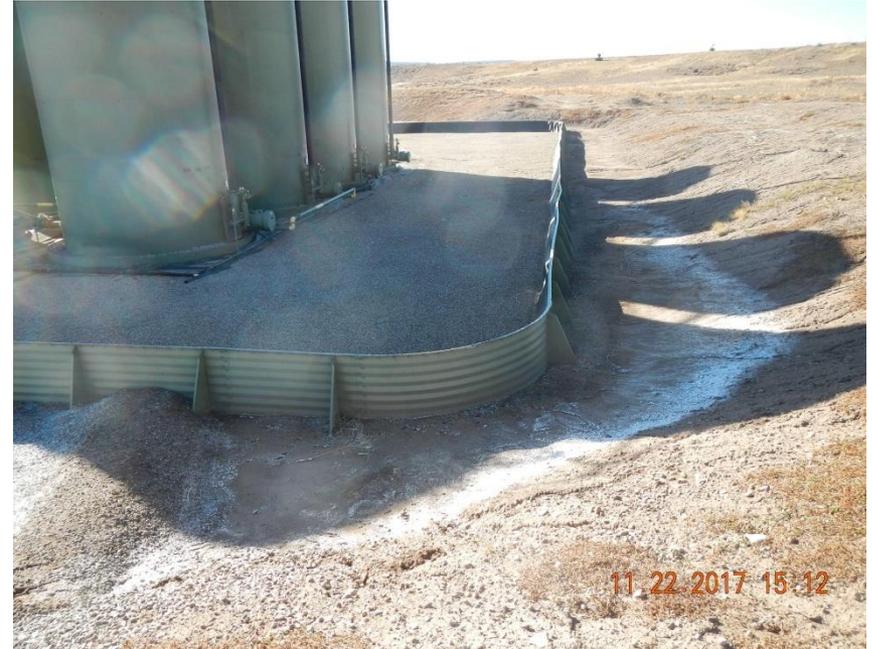
**White residue and damp areas on north and east side of tank battery.**

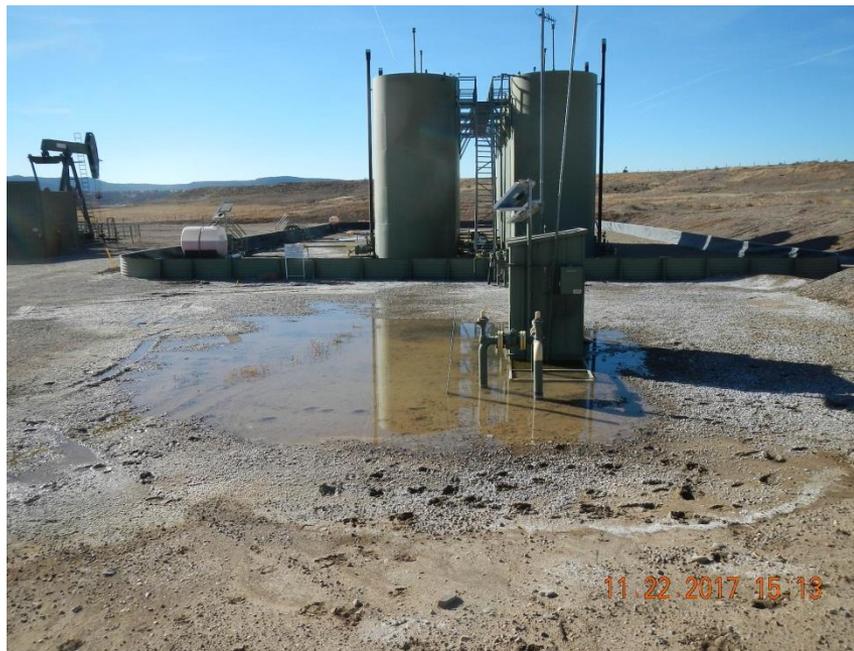
**Standing water around facility equipment on east side of tank battery.**
