COLORADO
Oil & Gas Conservation
Commission
Department of Natural Resources

Inspection Photos: Laramie Gunderson Loc#452797

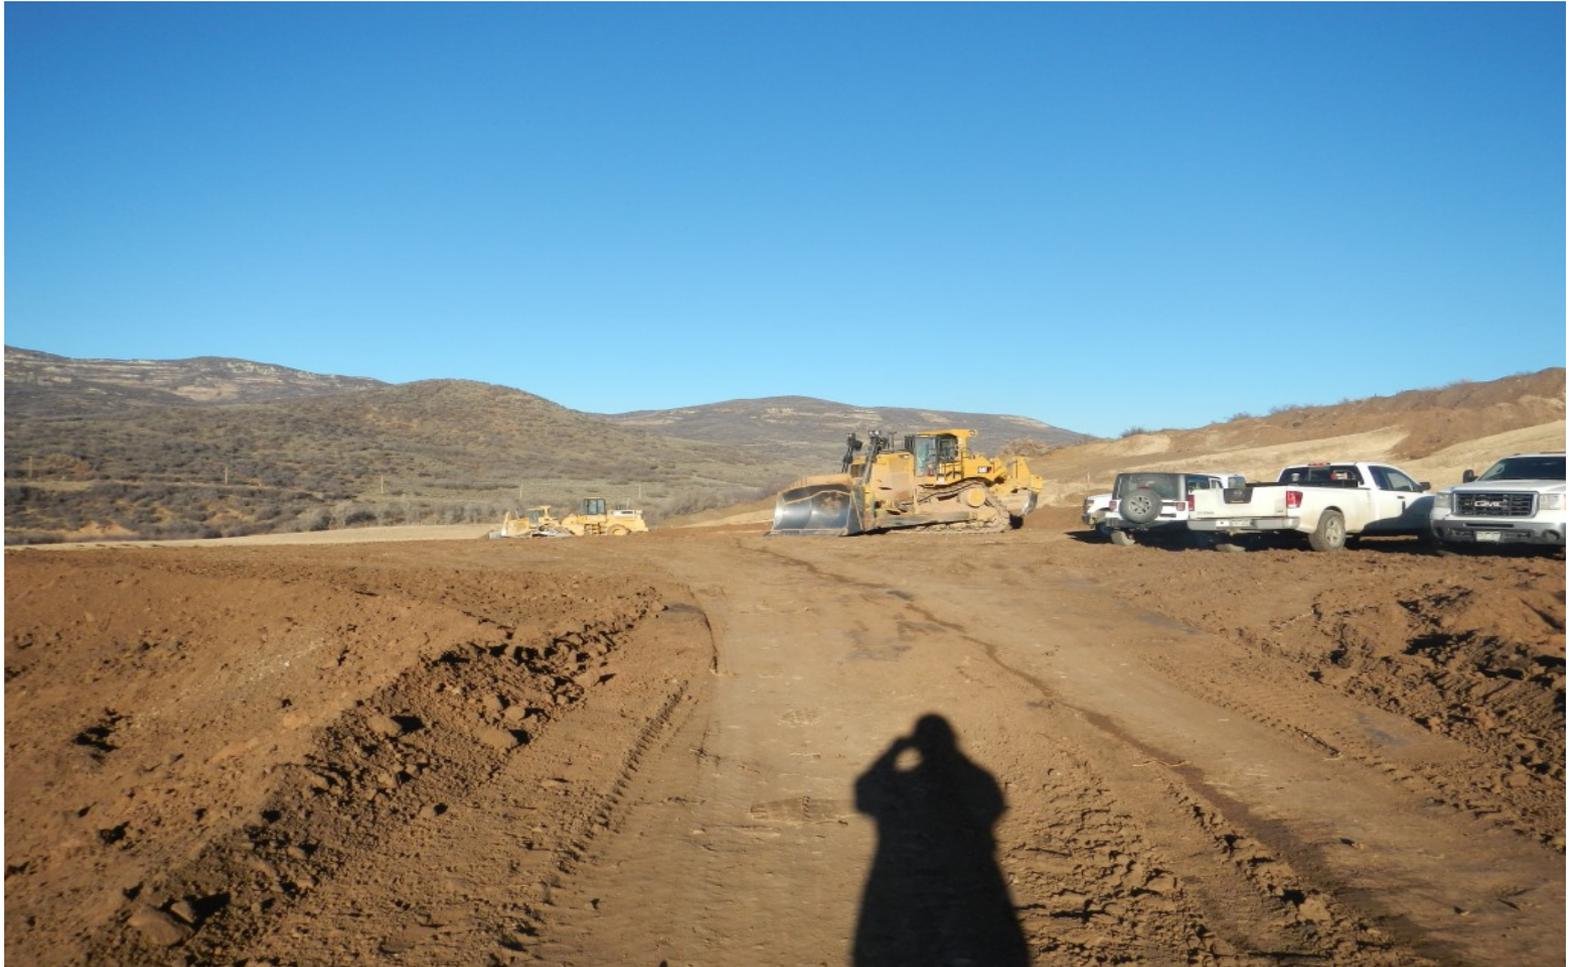
Photo#1:
Overview of Location from Entry to Northeast.

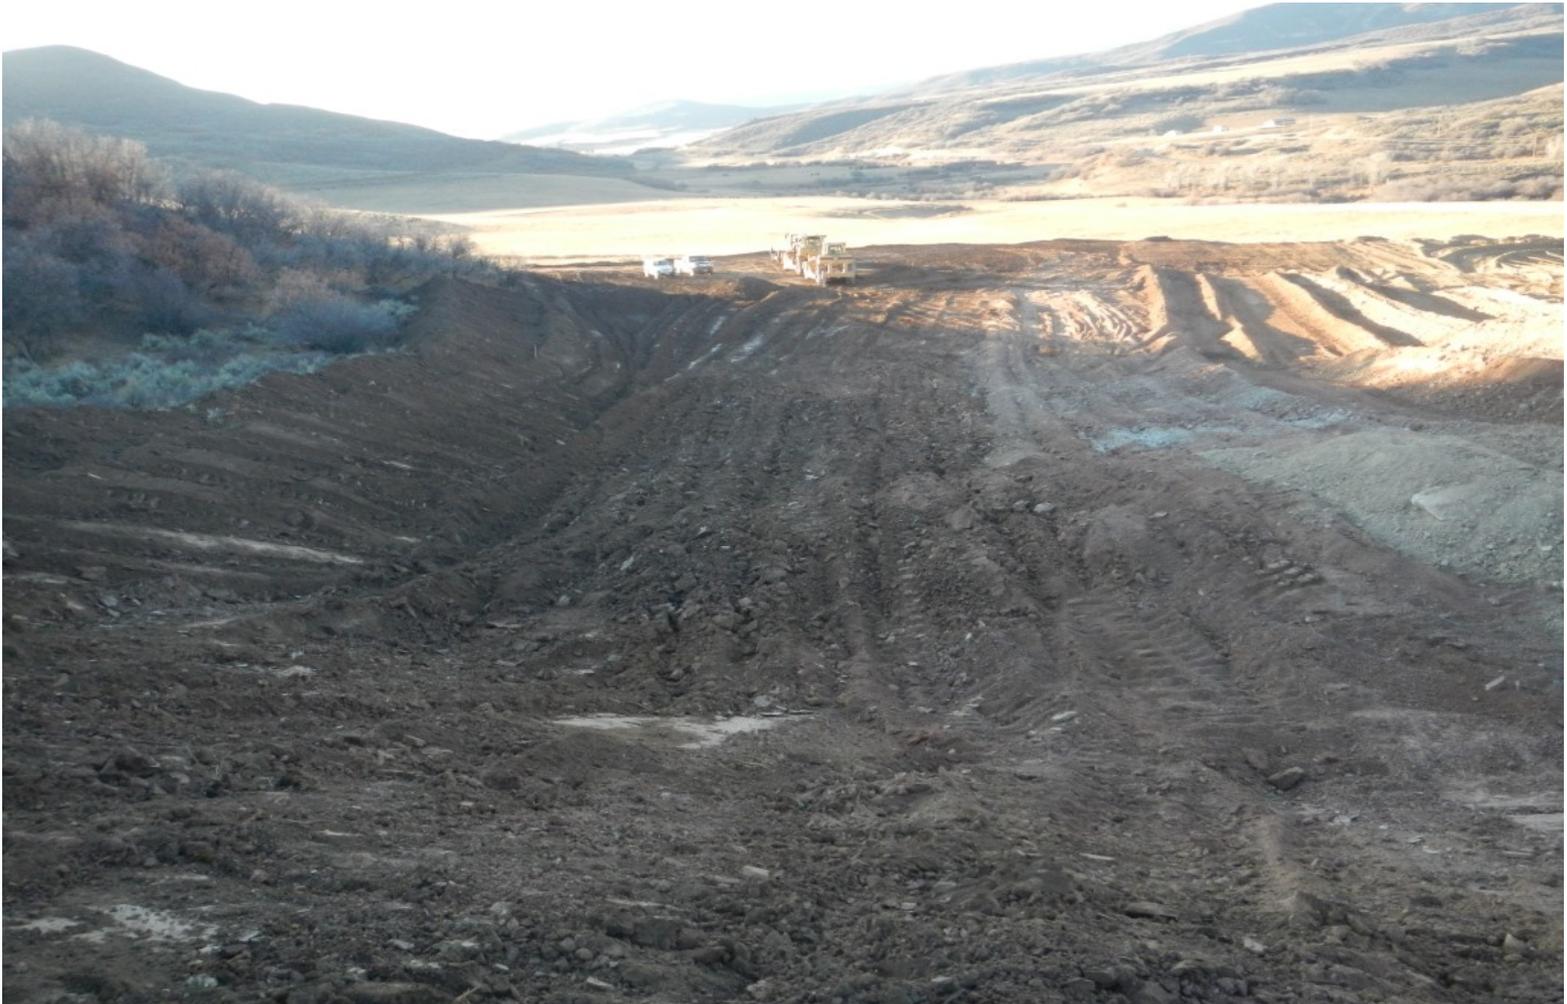
Photo#2:
Overview of Location to West.

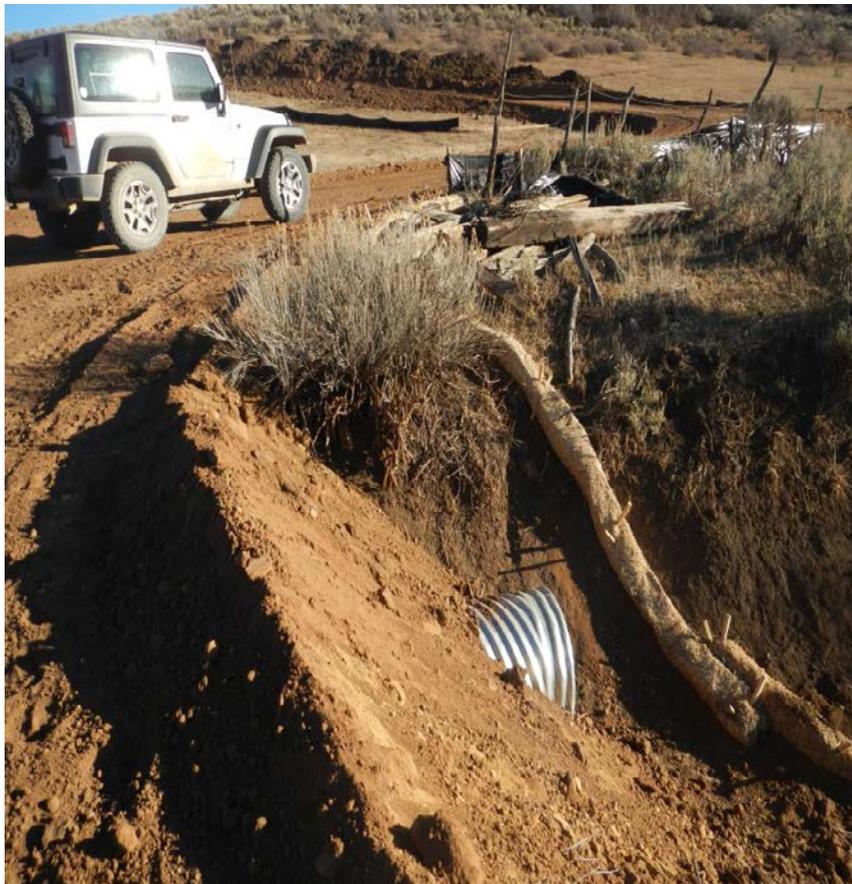
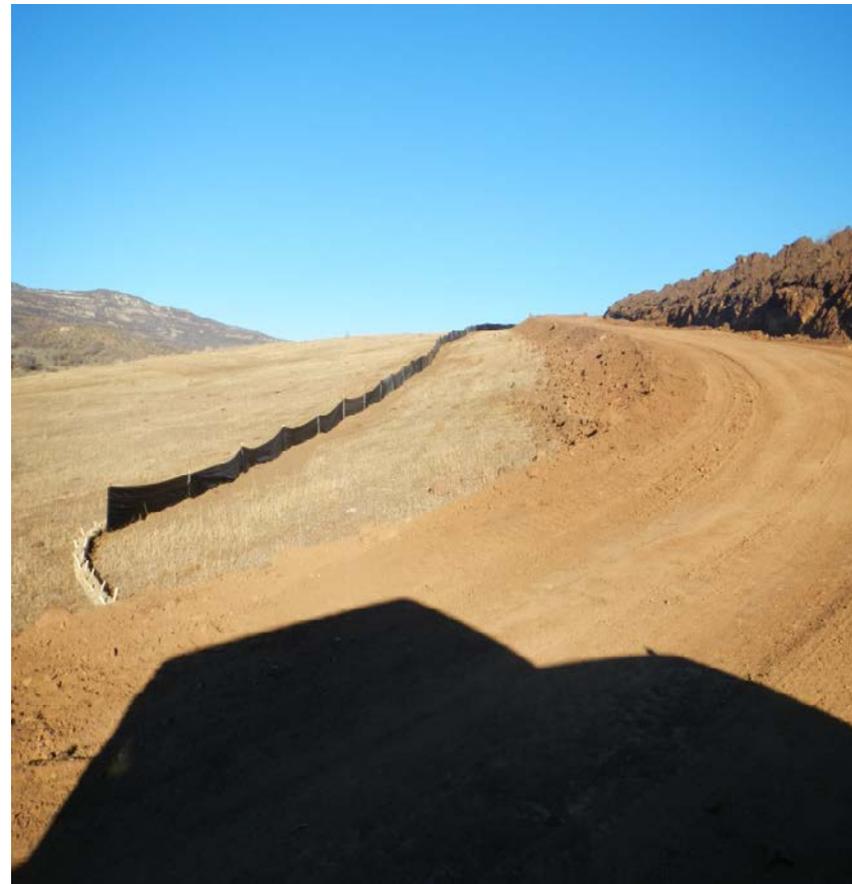
BMPs installed at each side of Access Road Entry.

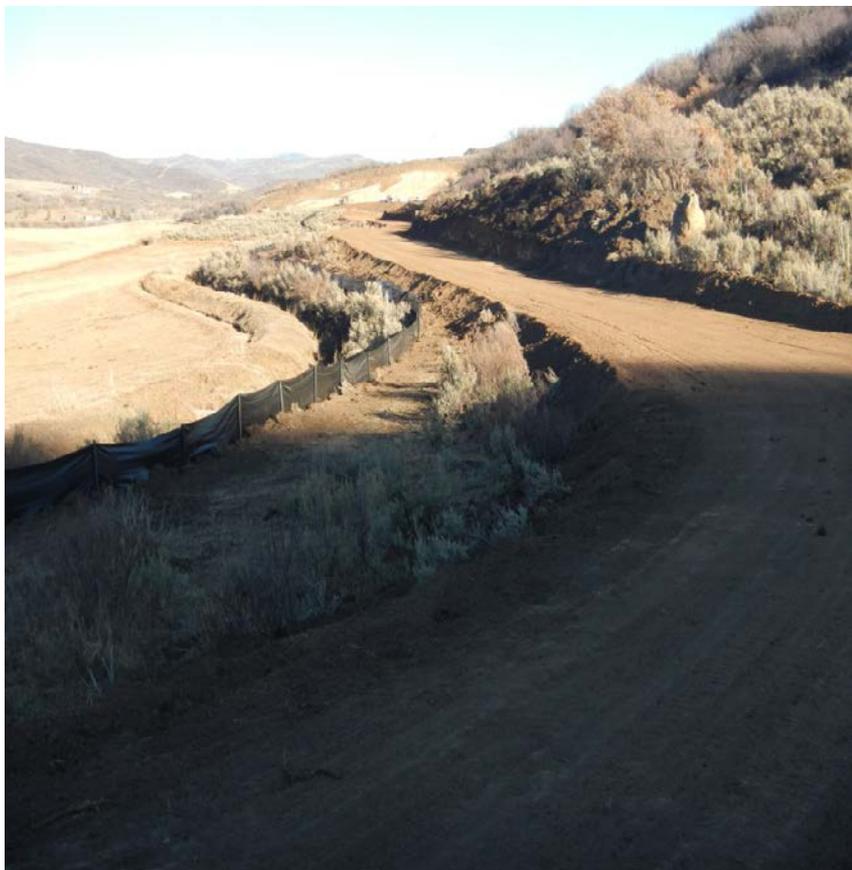
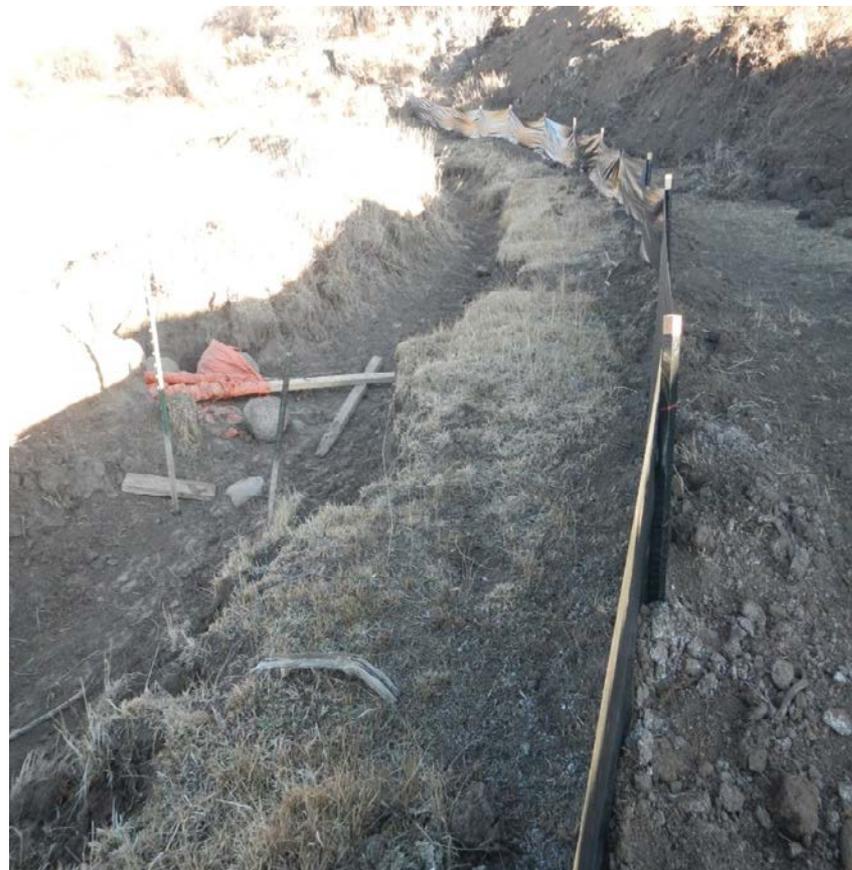
Silt Fence Installed along Access Road & Perimeter of Location.

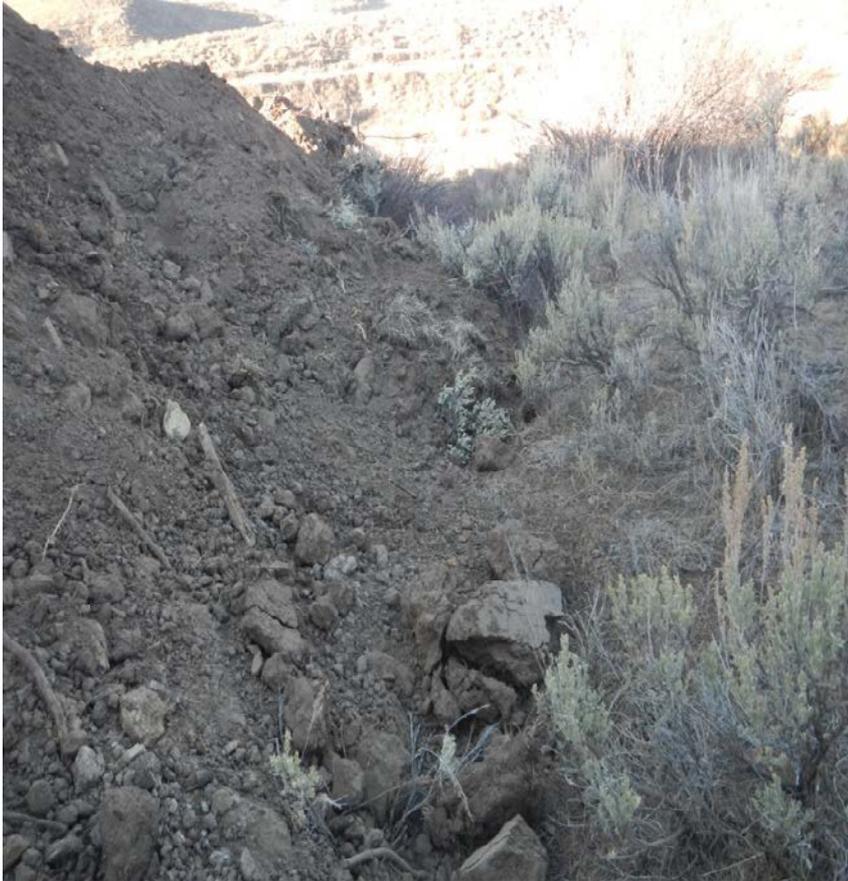
Photo#6:

Top soil piled at top of Cut Slope; view to North. Loose piles of Soil are Potential Pollution Sources. Control measures should be implemented to manage stormwater runoff from all potential pollutant sources.

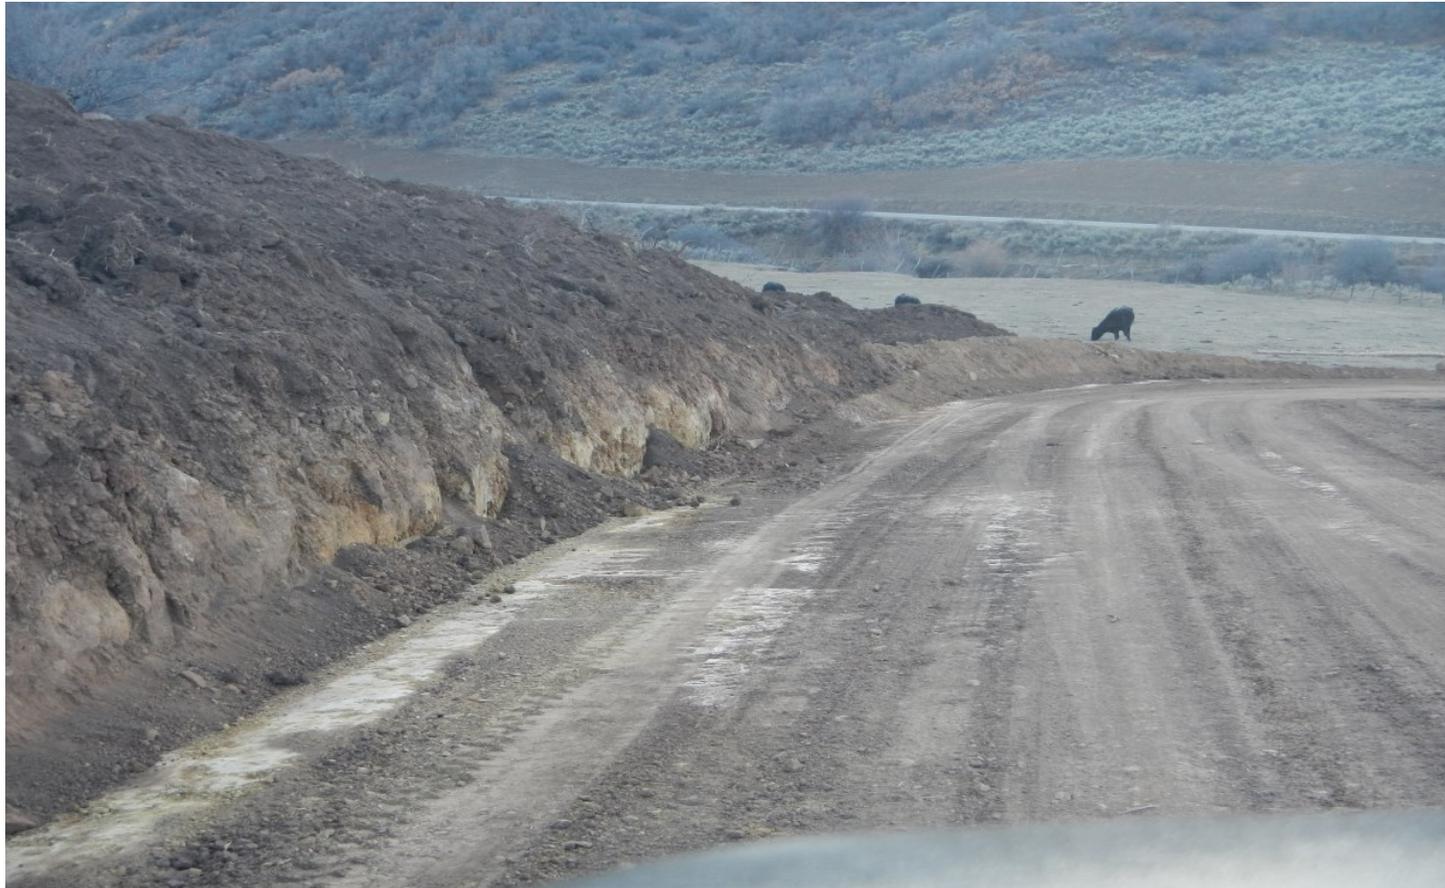
Photo#8:

Steep Cut bank side of Access road is awaiting installation of Pipeline. Operator will self inspect; if any Sediment migration is noted BMPs will be installed.
