Inspection Photos
Location Name: Wickstrom #6-4
API: 05-123-38576
Inspection Date: November 28, 2016

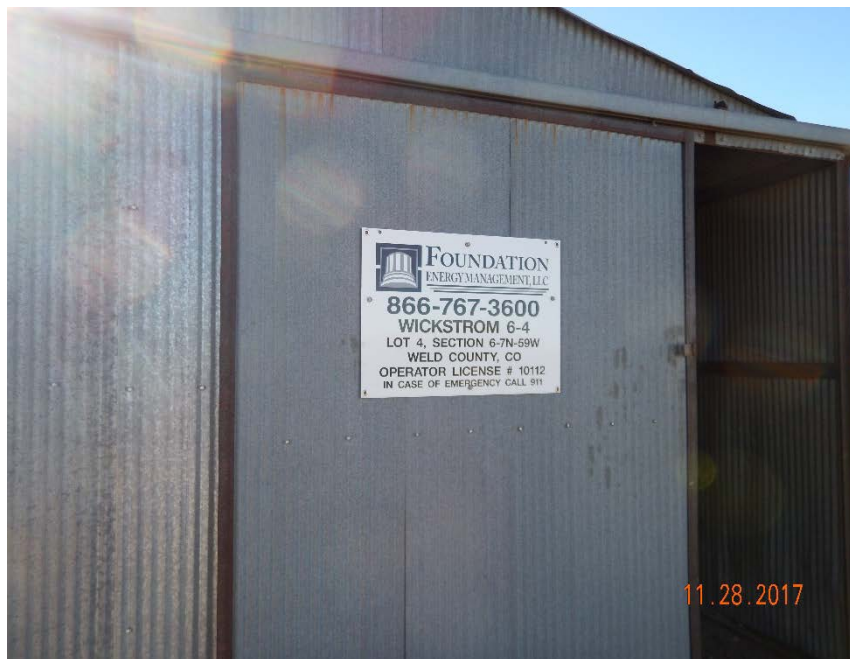
Photo #1 – Well sign at pump jack shed.

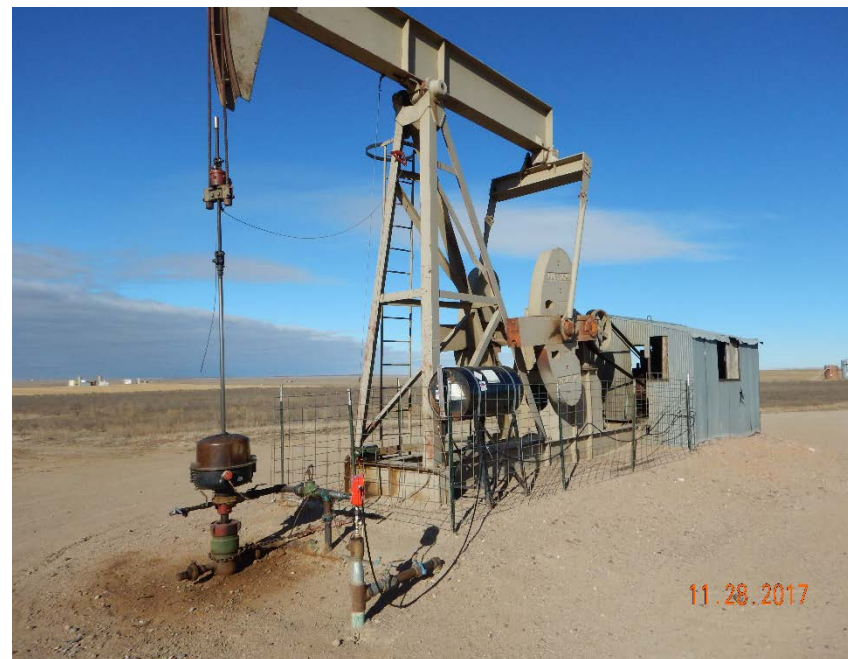
Photo #2 – View of wellhead, looking northwest. Note localized, oil-stained soil at wellhead and day tank at SE corner of pump jack lacking secondary containment device.

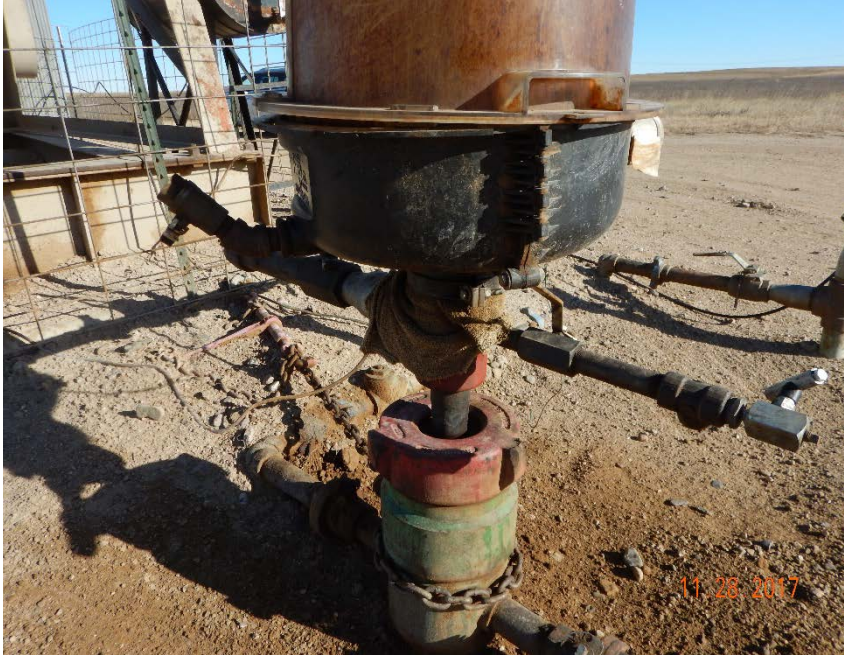
Photo #3 – Oily rag remains tied to wellhead.

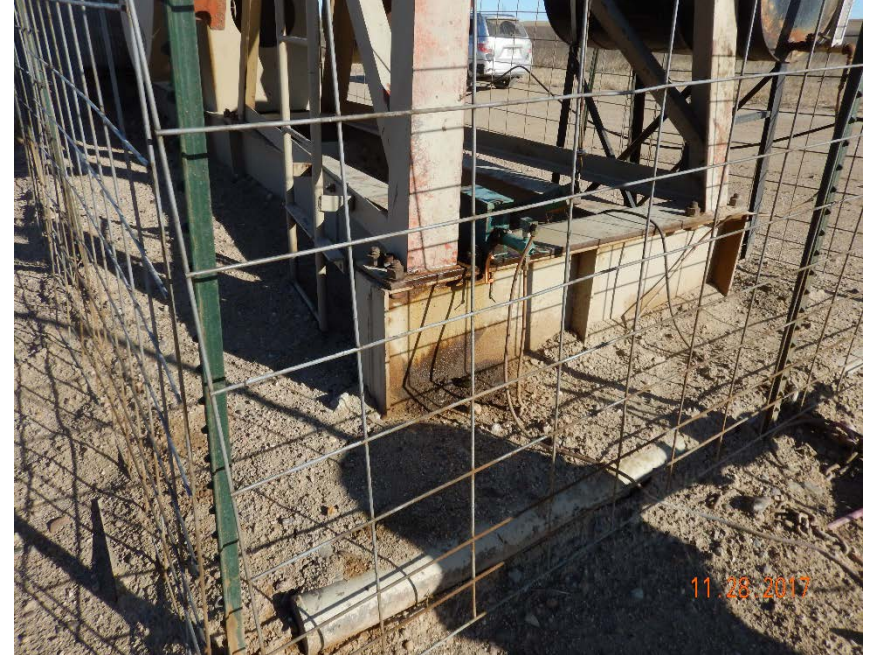
Photo #4 – Localized, oil-stained soil beneath SW corner of pump jack.

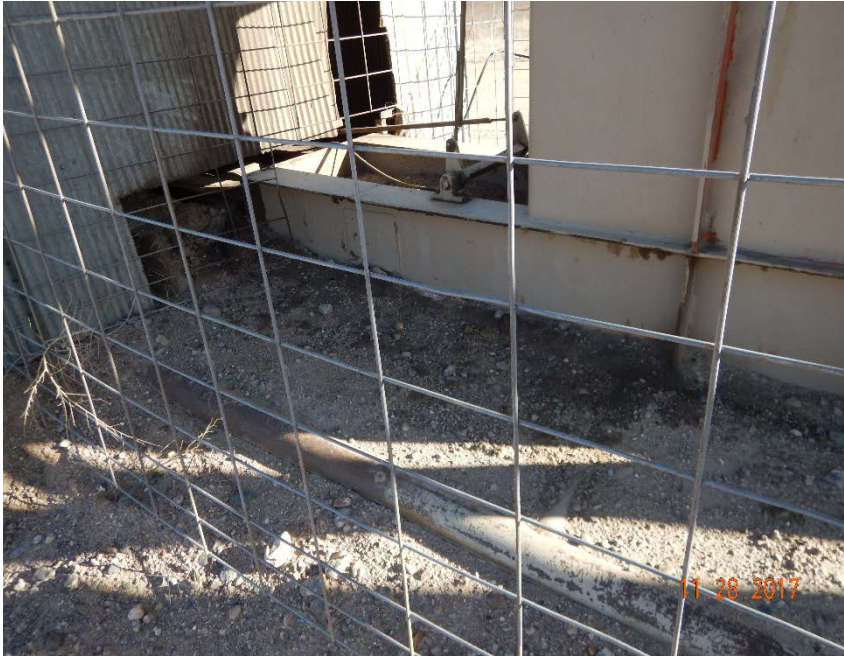
Photo #5 – Oil-stained soil beneath NW corner of pump jack.

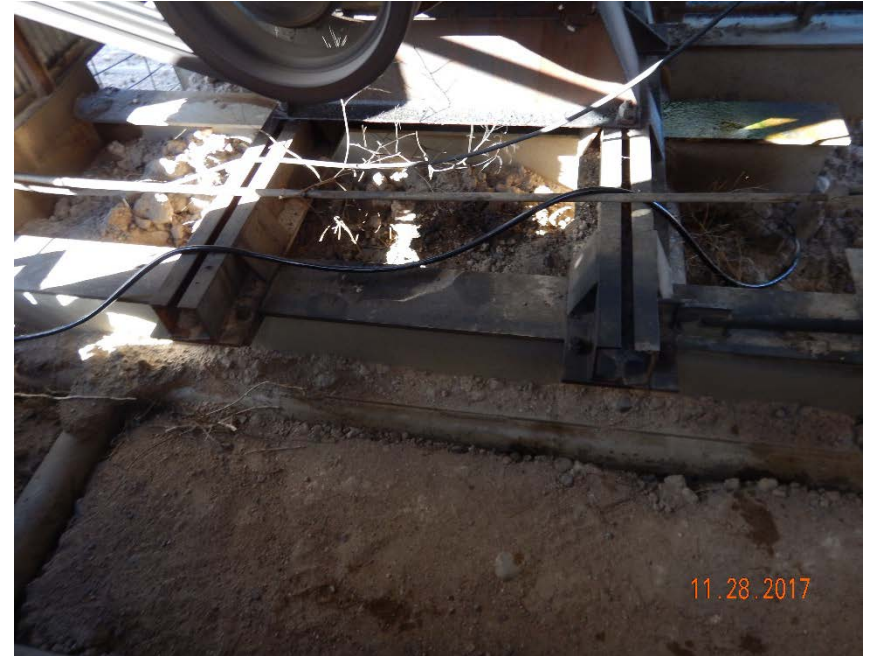
Photo #6 – Oil-stained soil beneath prime mover (1).

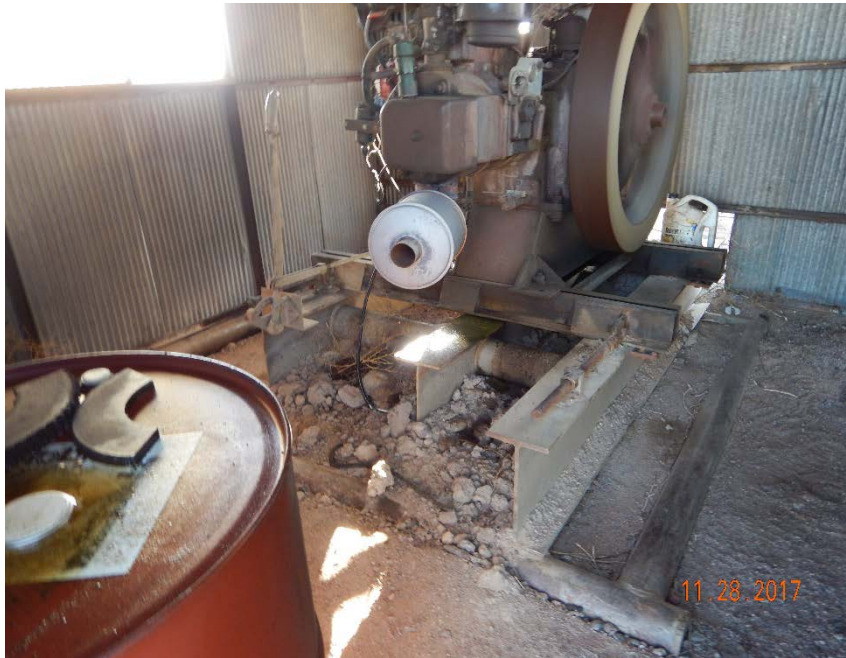
Photo #7 – Oil-stained soil beneath prime mover (2).

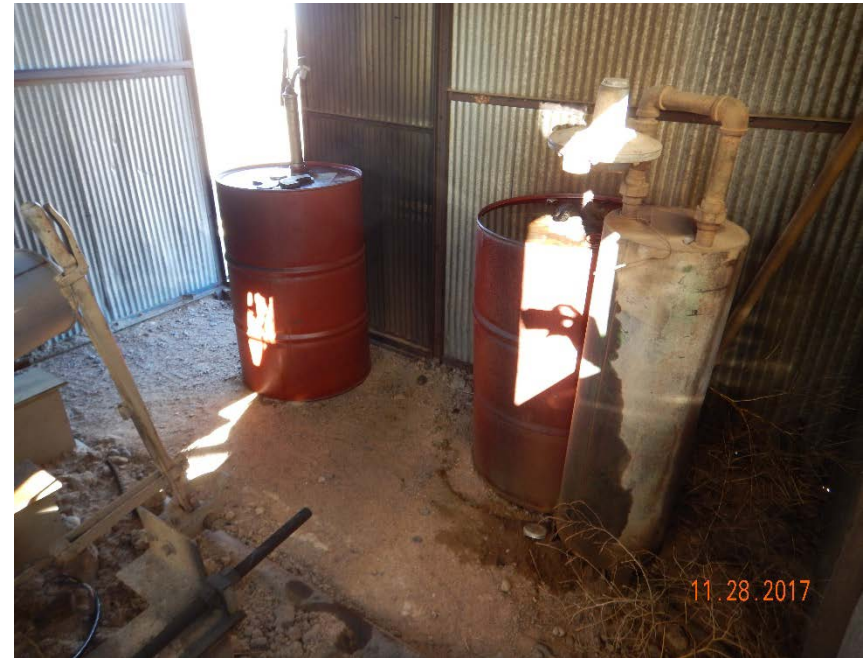
Photo #8 – Chemical storage inside of pump jack shed.
