May 12, 2016

Inspection Photos: QuickSilver Alpha State #1-16

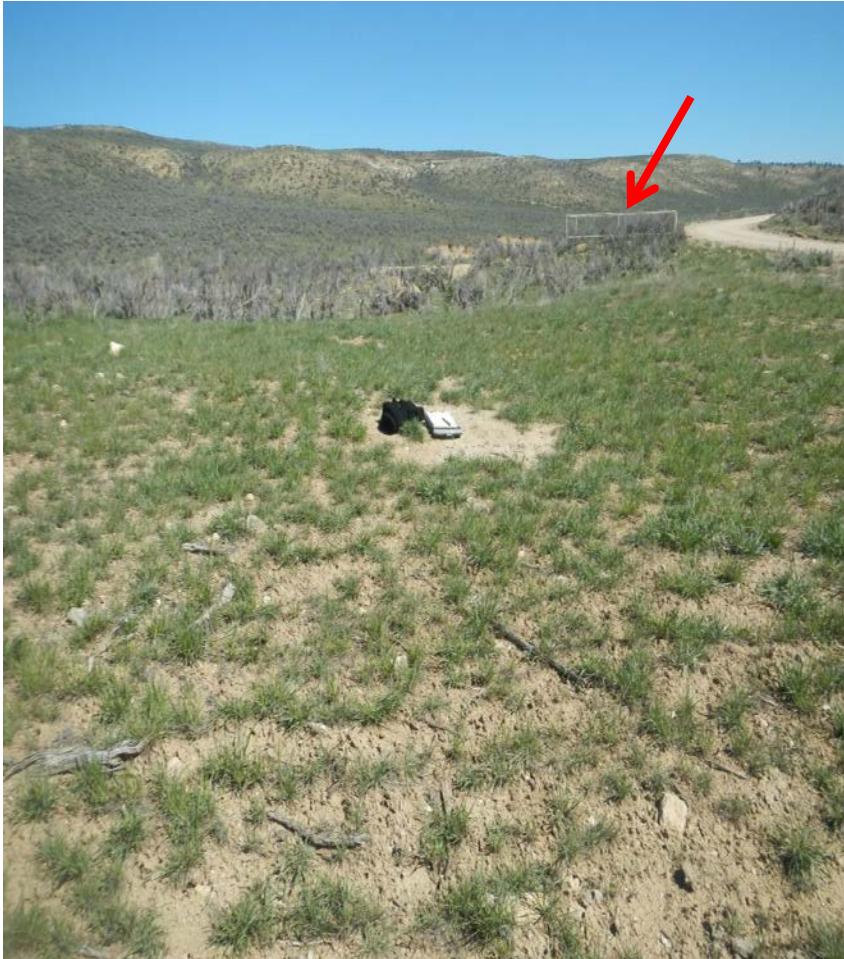
Photo#1:  
View North over Location ;  
Associated Facilities Marked with Arrow.

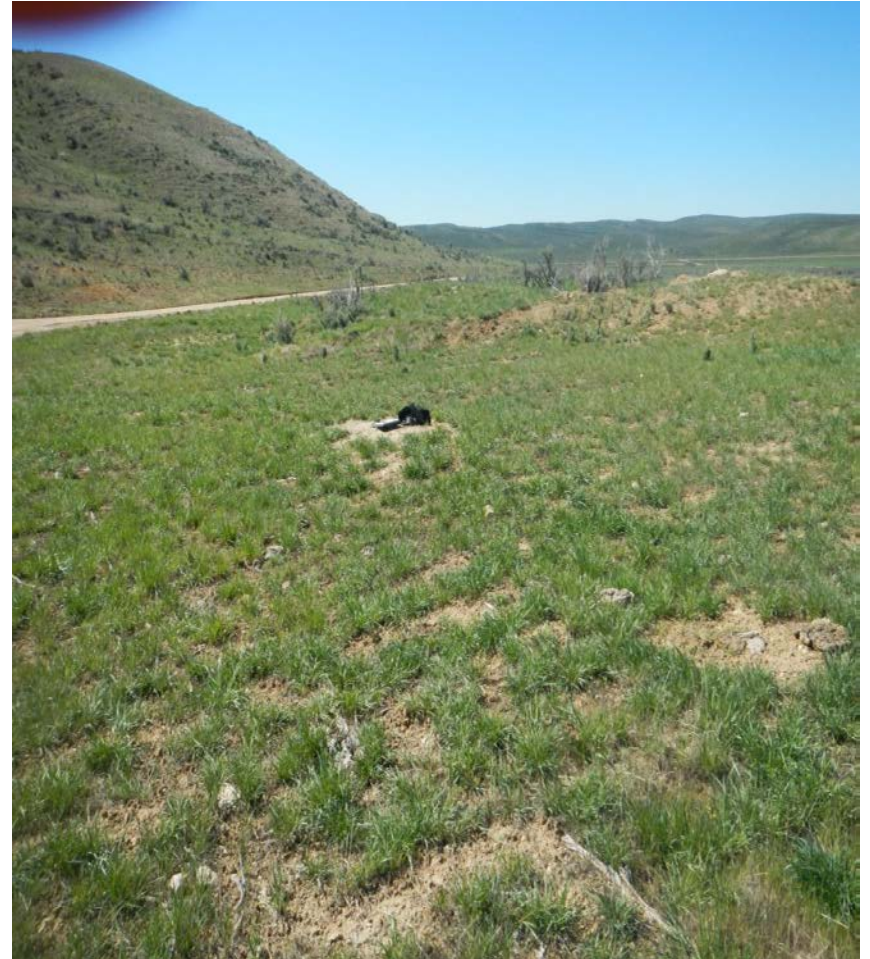
Photo#2:  
View South over Location.

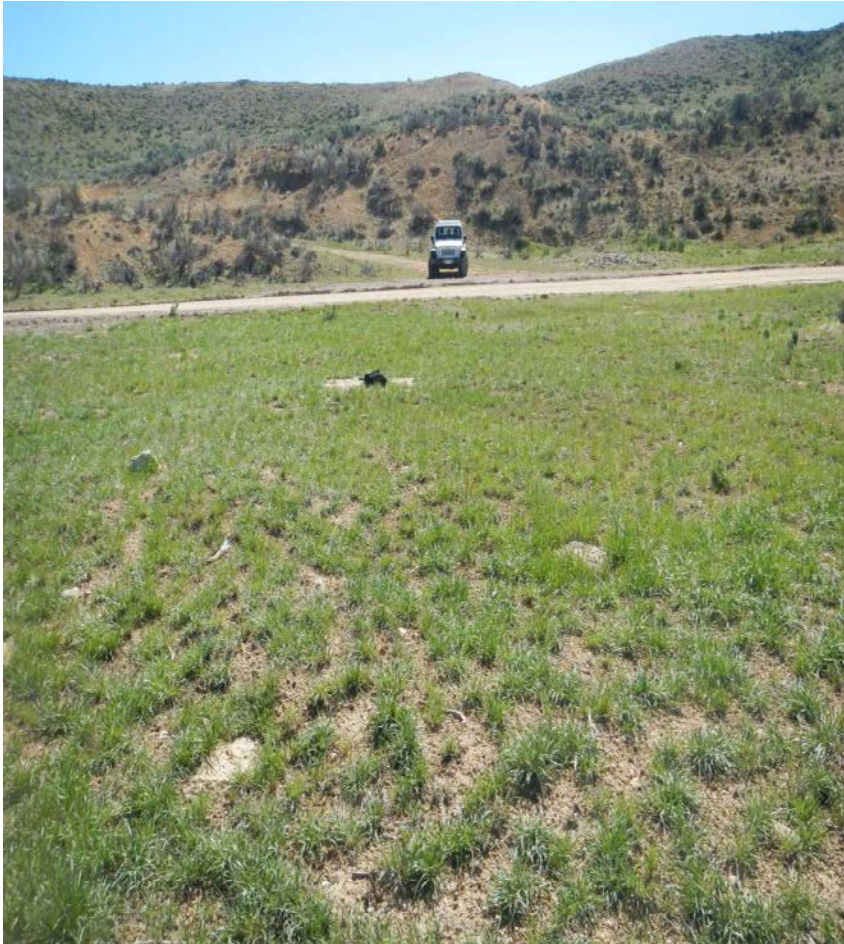
Photo#3:

View East over Location

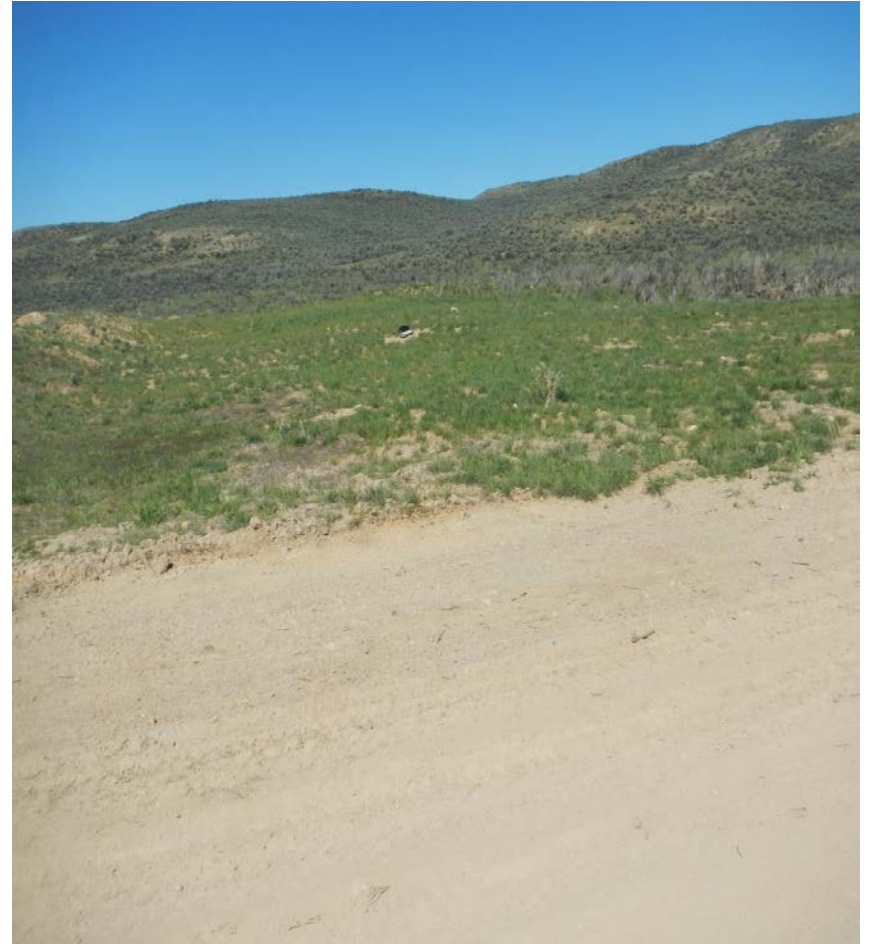
Photo#4:

View West over Location

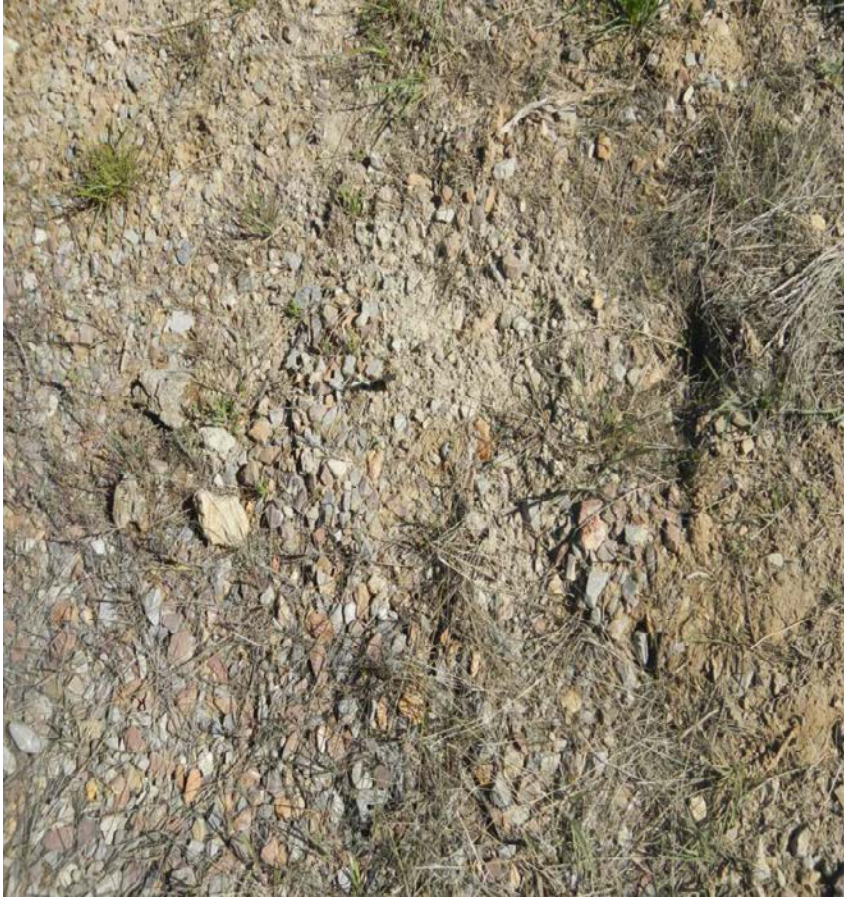
Photo#5:  
Gravel on Location .

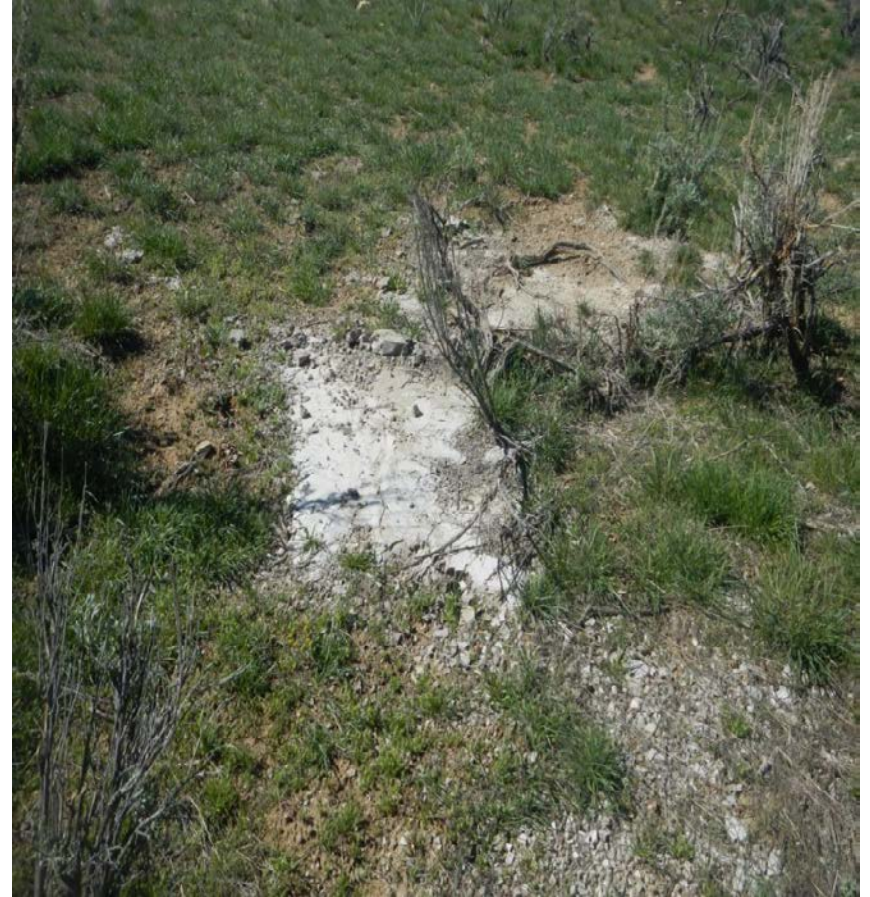
Photo#6:  
Concrete wash out on Location

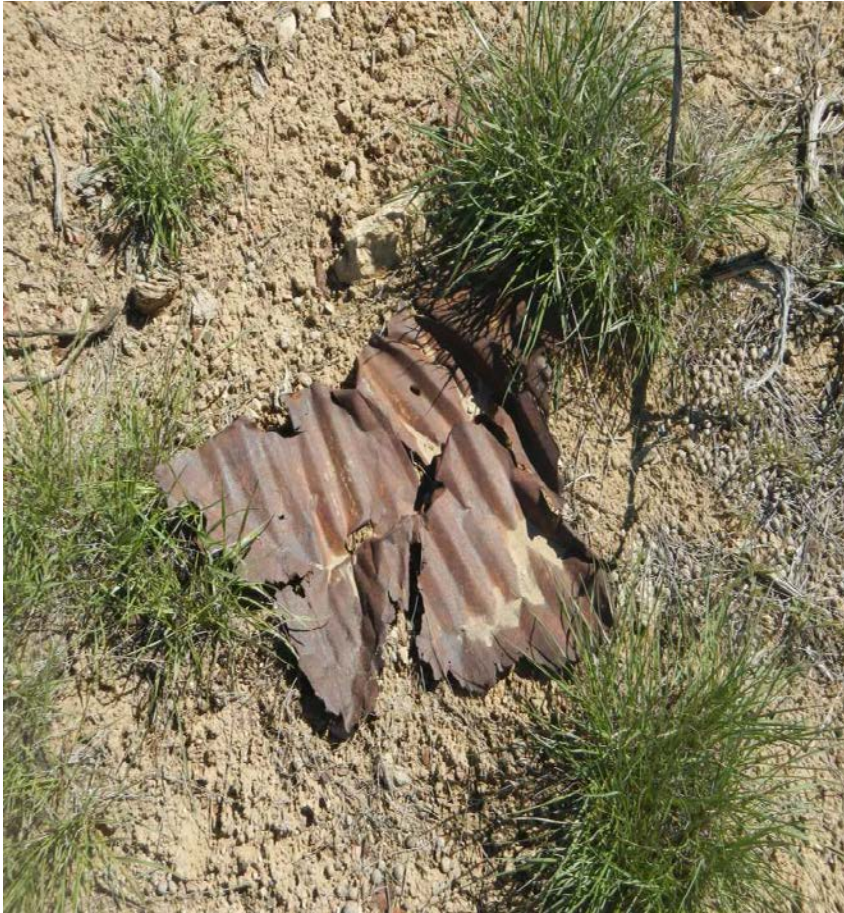
Photo#7:

Debris remains on Location

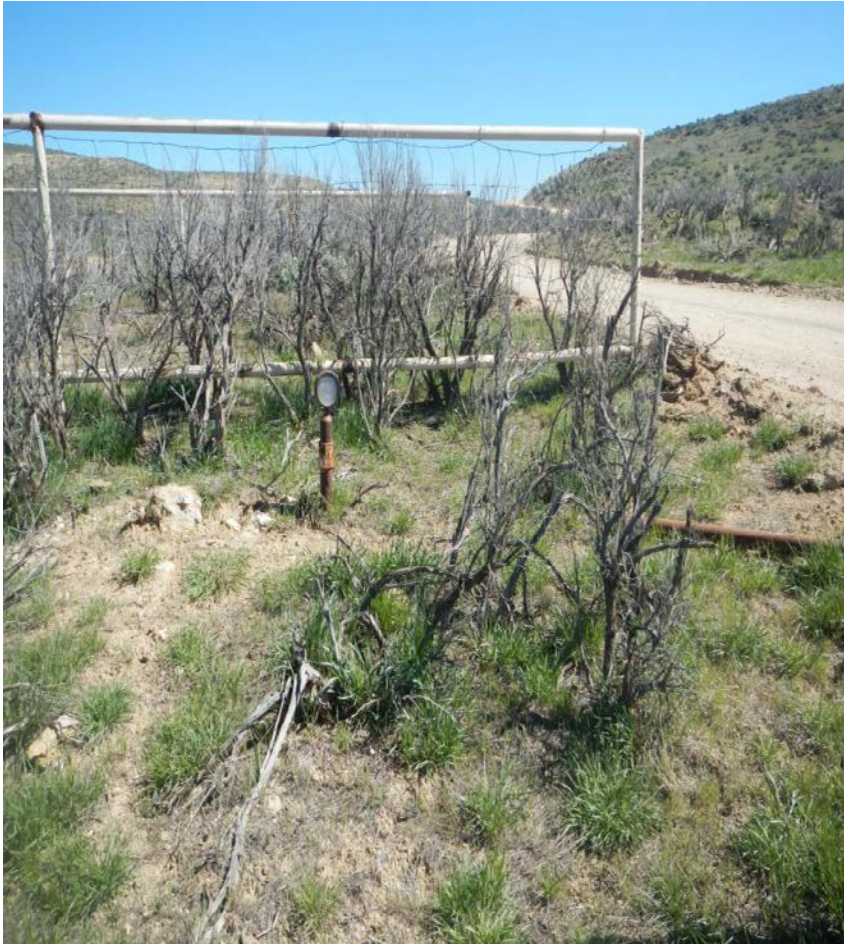
Photo#9:

View to North of Facilities Located North of Well.

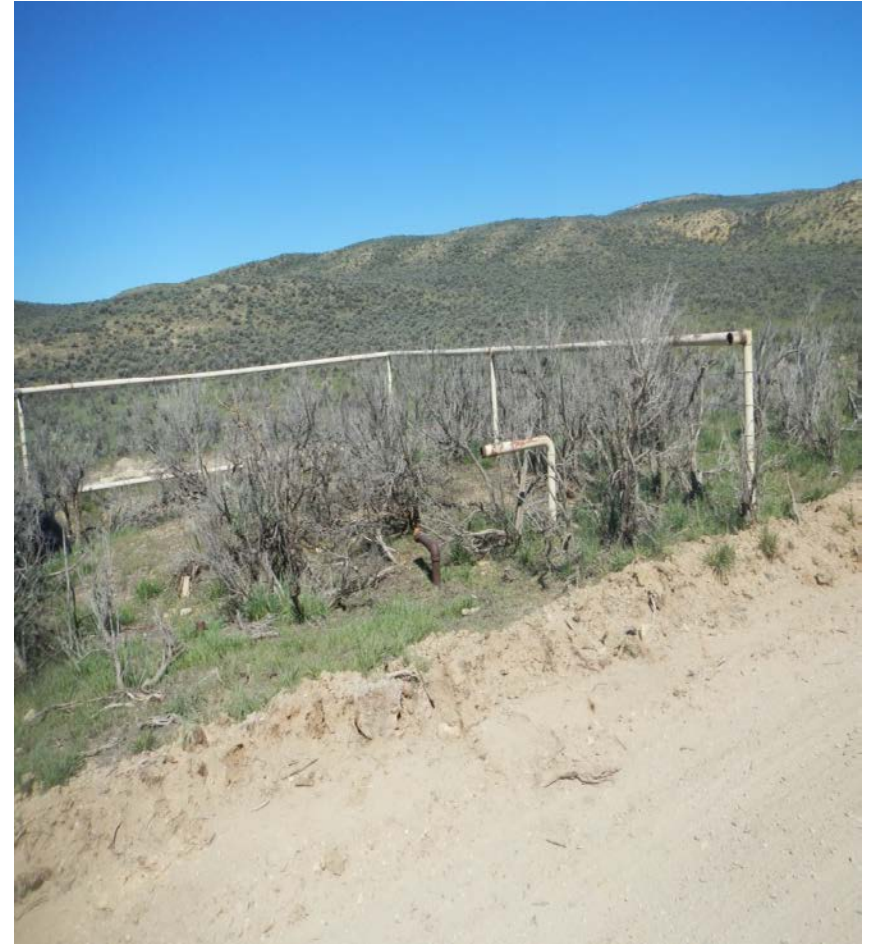
Photo#10:

View to West of same Facilities which appear to feed across Road East to Compressor Station ( Photo #13)

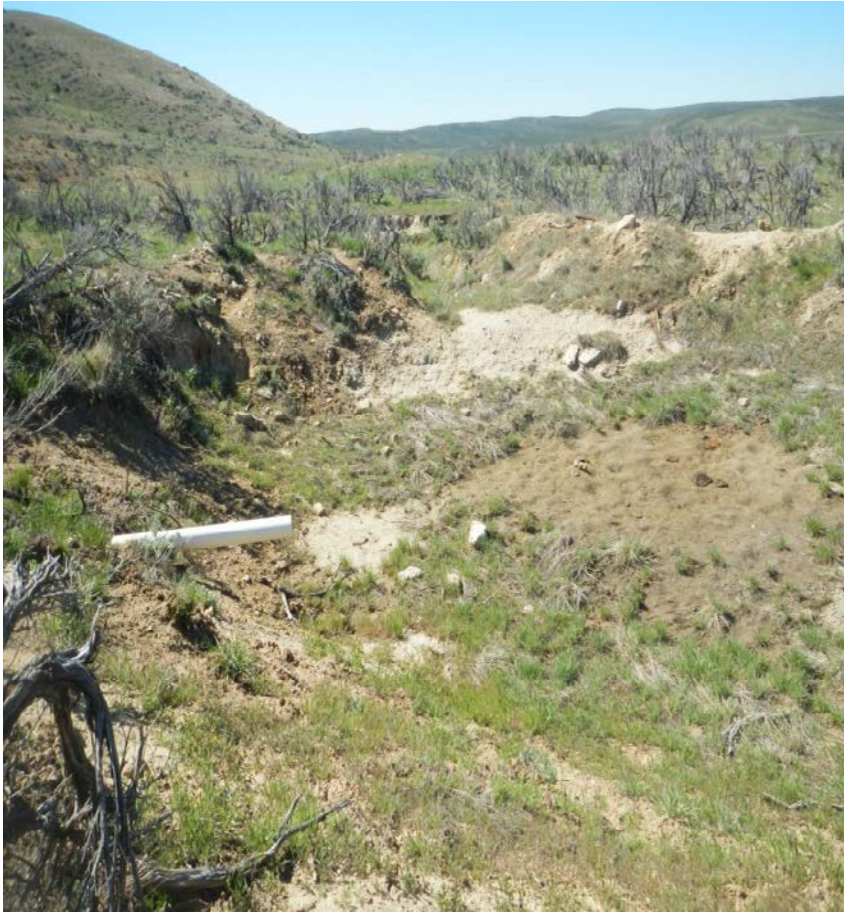
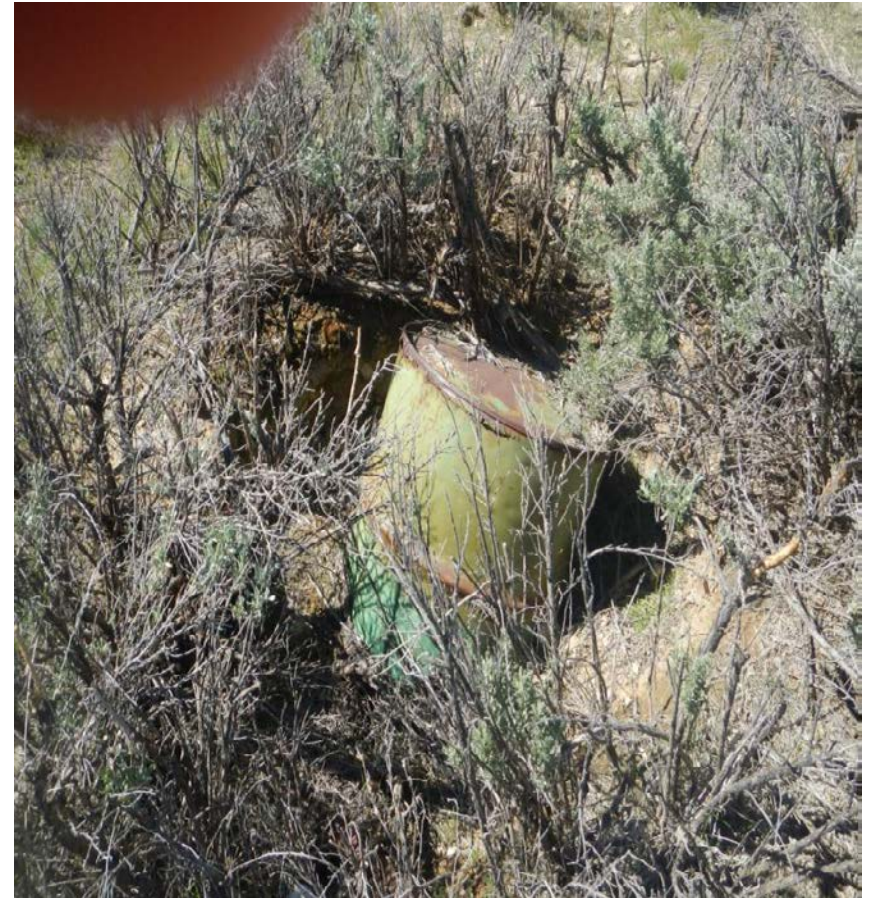
Retention/ drainage area and Debris West of Facilities

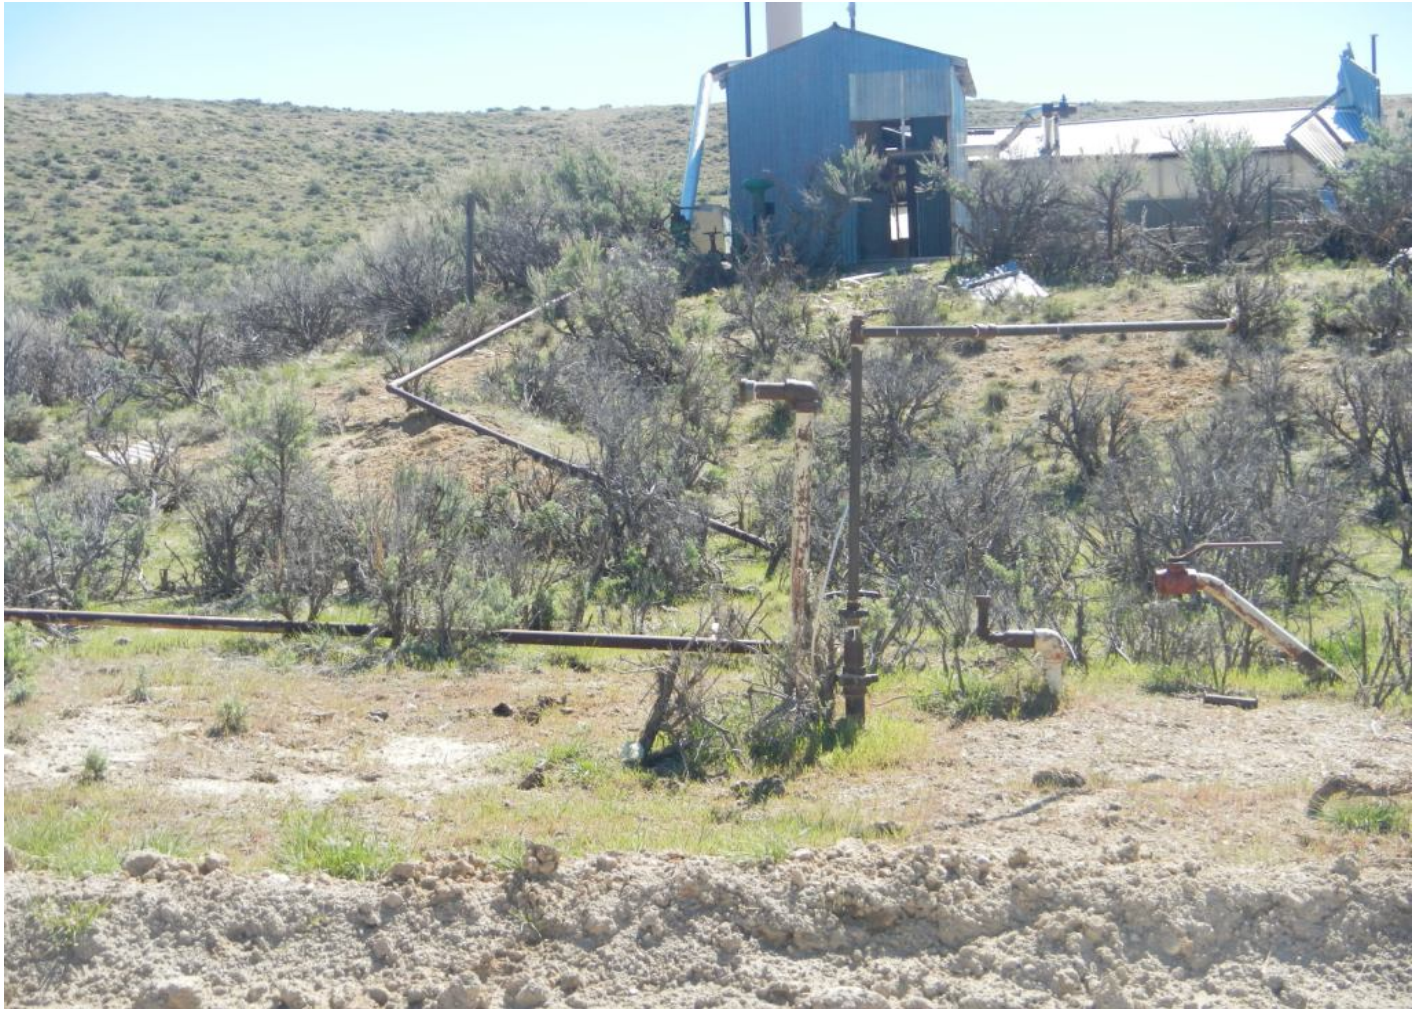
Photo#13: View across road to East from Facilities in Photos # 9 & 10; showing Compressor Station, associated Flow lines, Facilities.

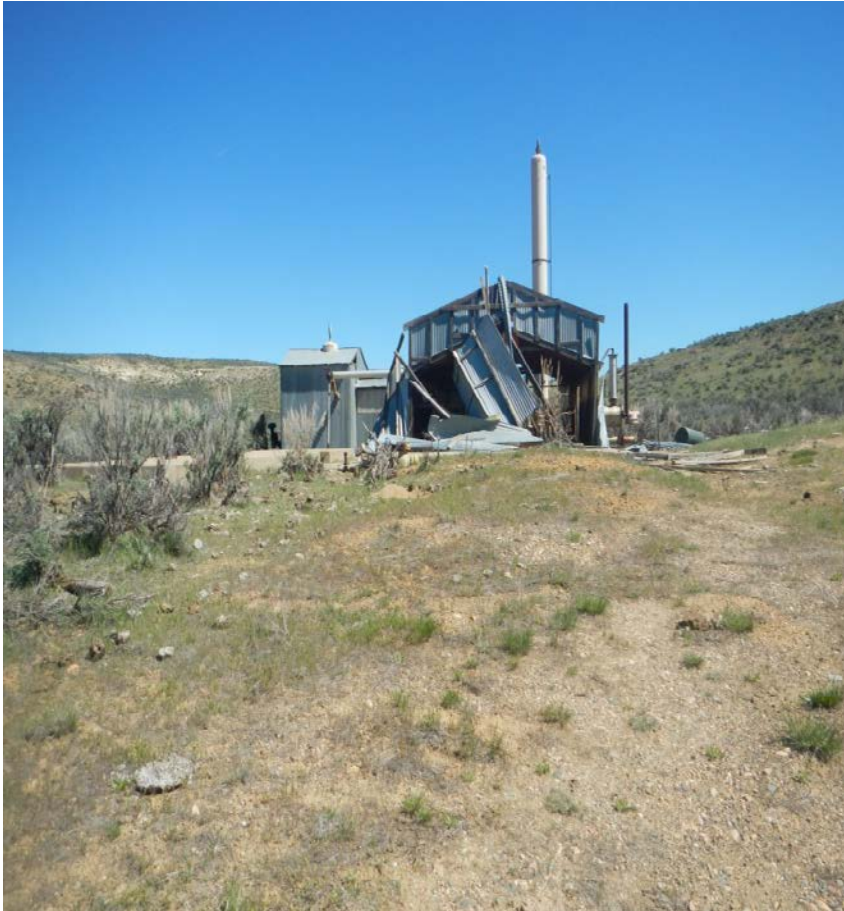
Photo#14:

View North at Compressor Station.

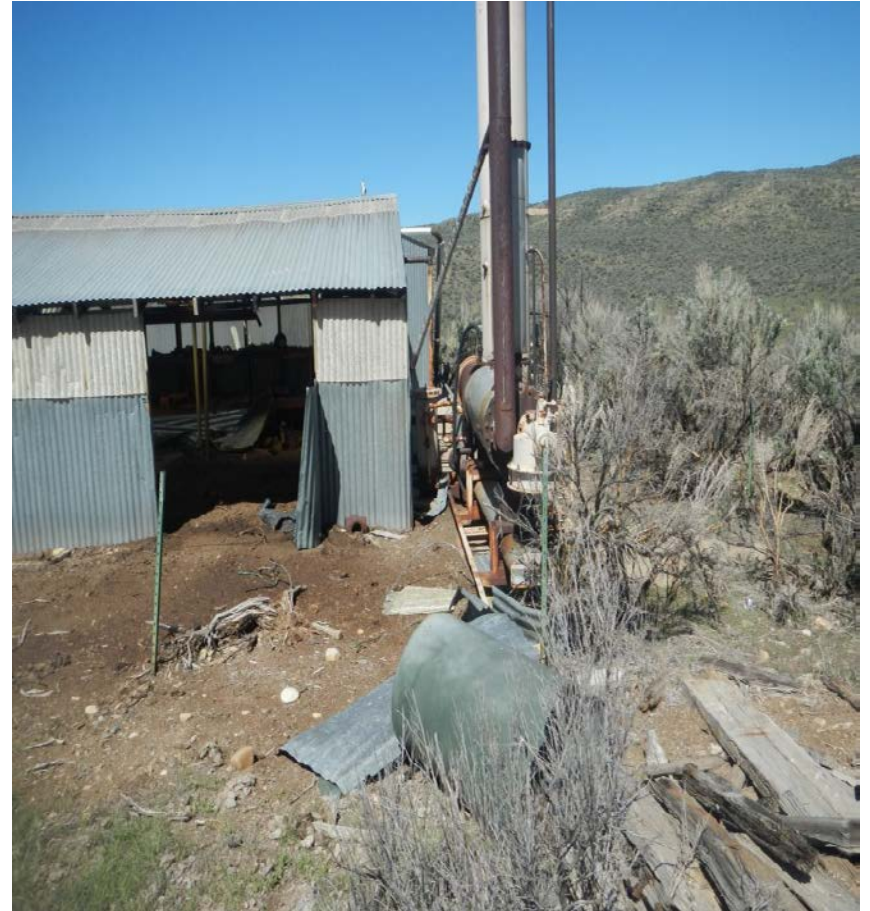
Photo#15:

View West at Compressor Station

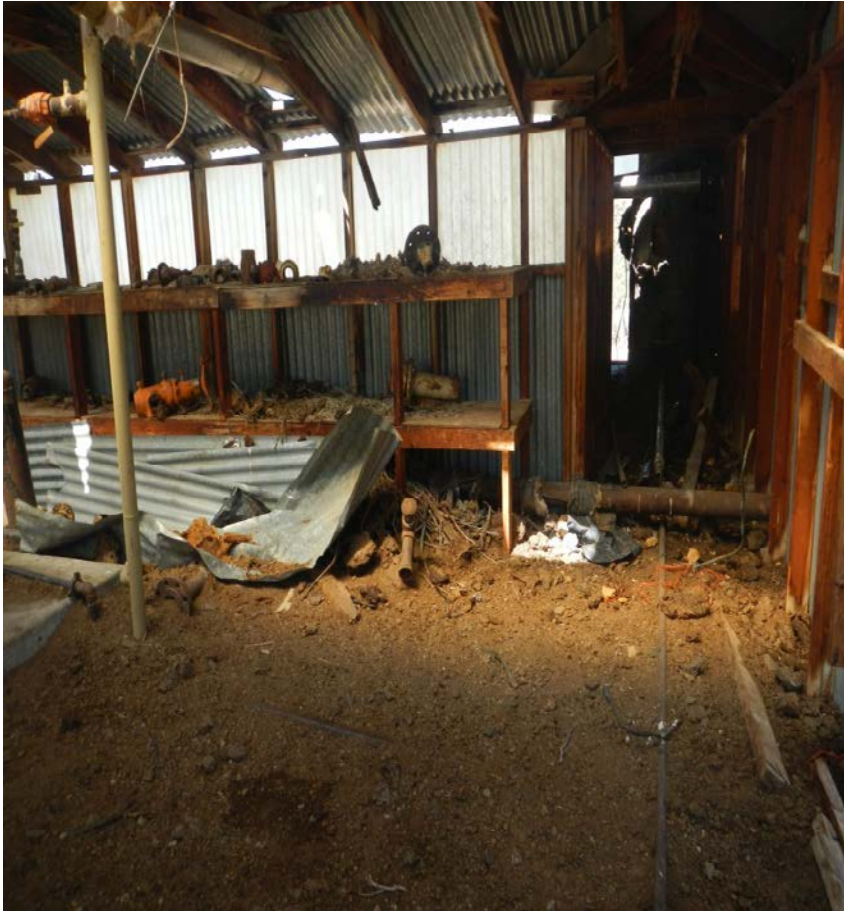
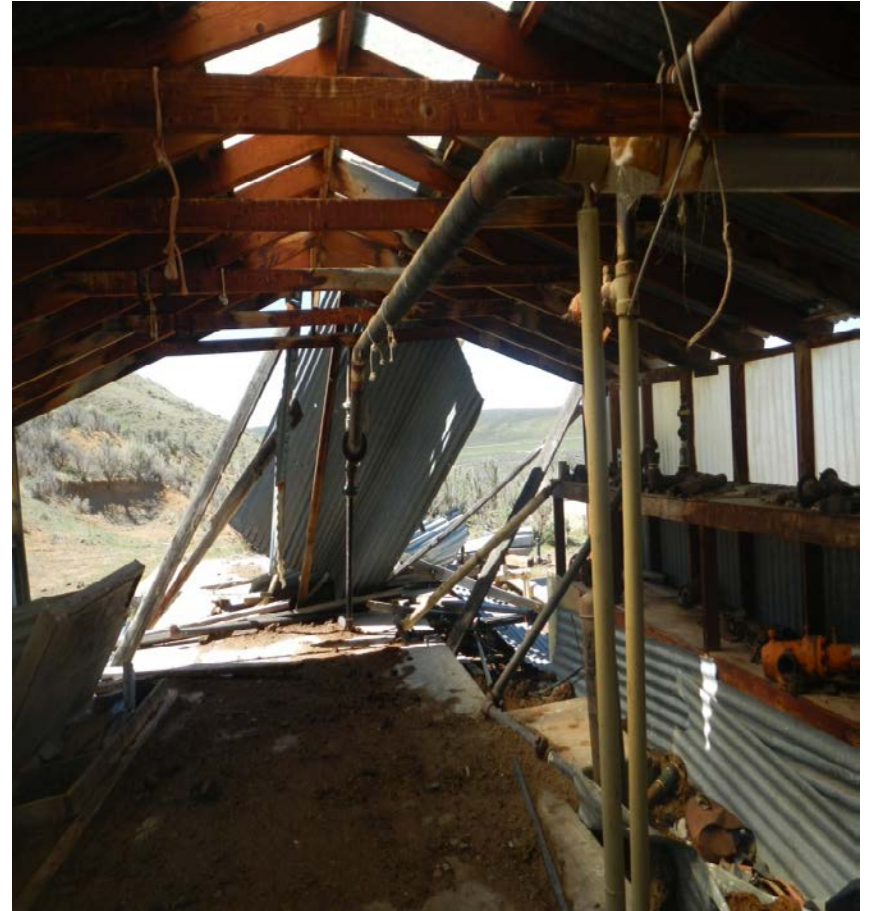
Inside Views of Compressor Station Building

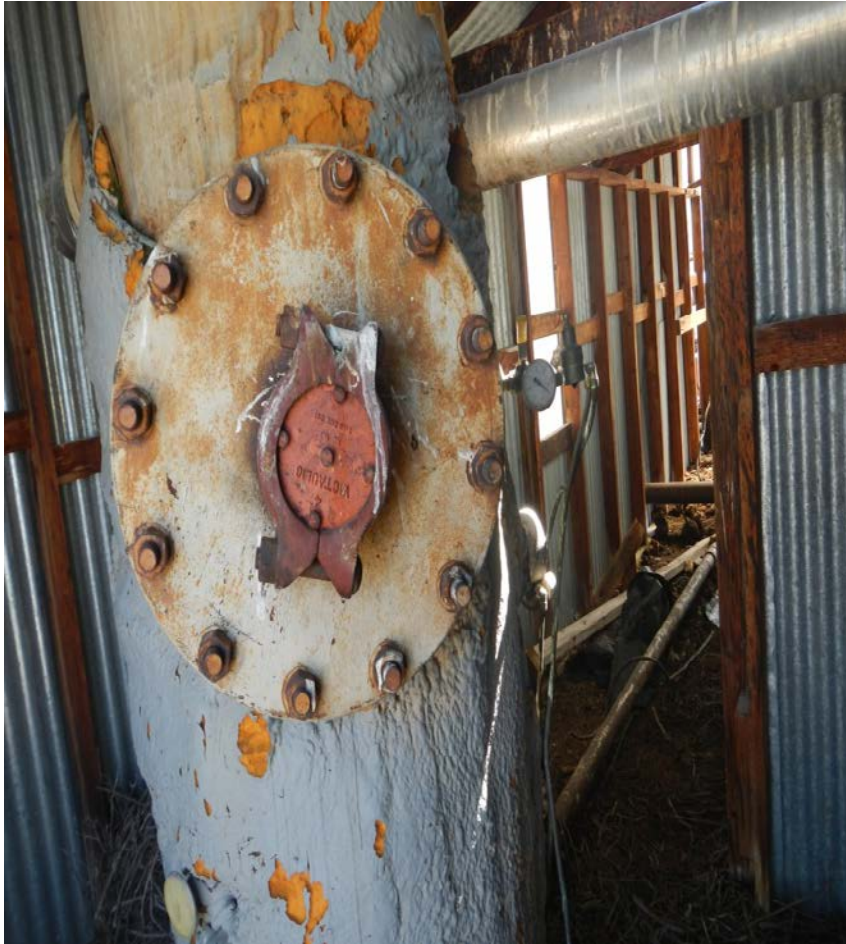
Photo#18:  
Equipment inside Building

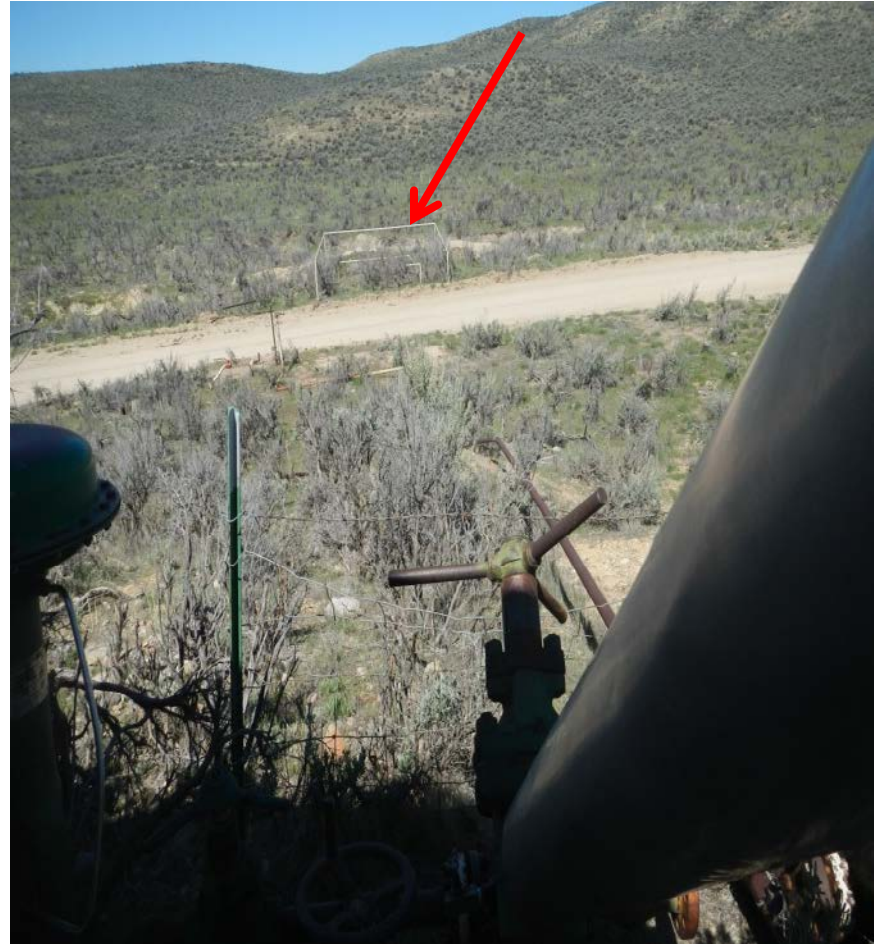
Photo#19:  
View from Bldg to West; showing Facilities photo #9 & 10
