Inspection Photos

Location Name: Hoffman #34-10

API: 05-123-20097

Inspection Date: November 28, 2017

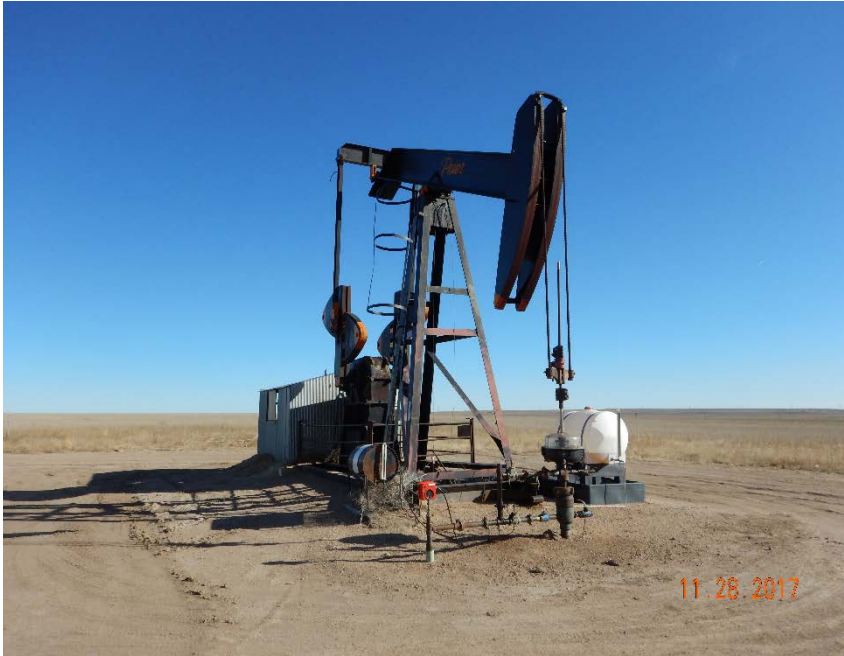
Photo #1 – View of wellhead and pump jack from SW corner. Note accumulation of wind-blown weeds and absence of secondary containment device beneath day tank at SW corner of pump jack.

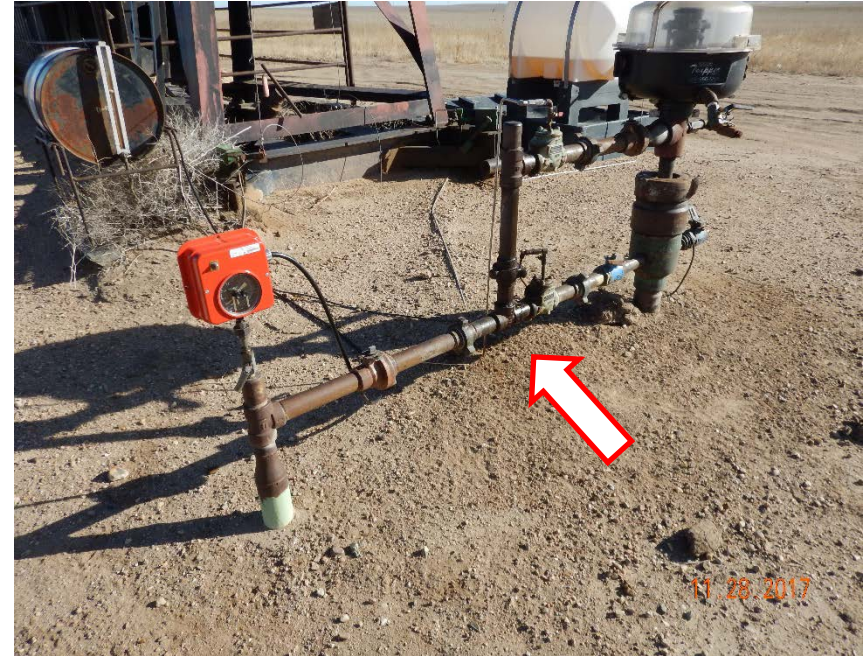
Photo #2 – Oil-stained equipment plumbed to wellhead.

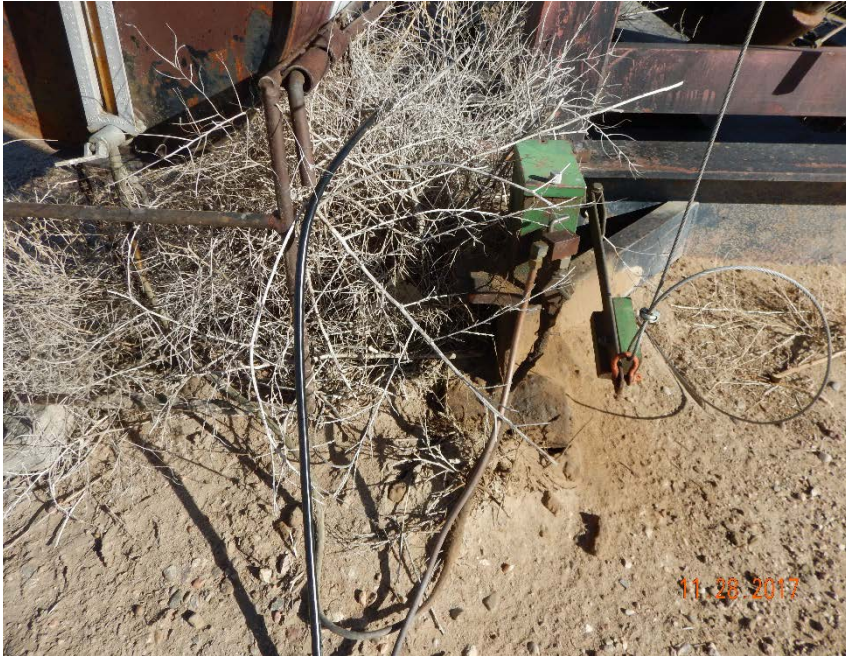
Photo #3 – Localized accumulation of oil-stained soil and wind-blown weeds beneath day tank and SW corner of pump jack.

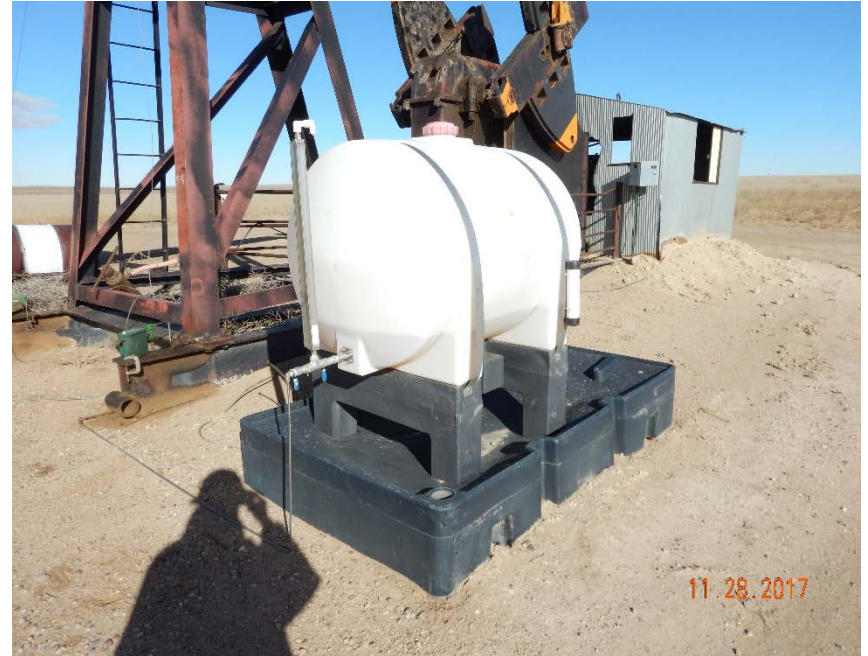
Photo #4 – Day tank at SE corner of pump jack has adequate secondary containment device.

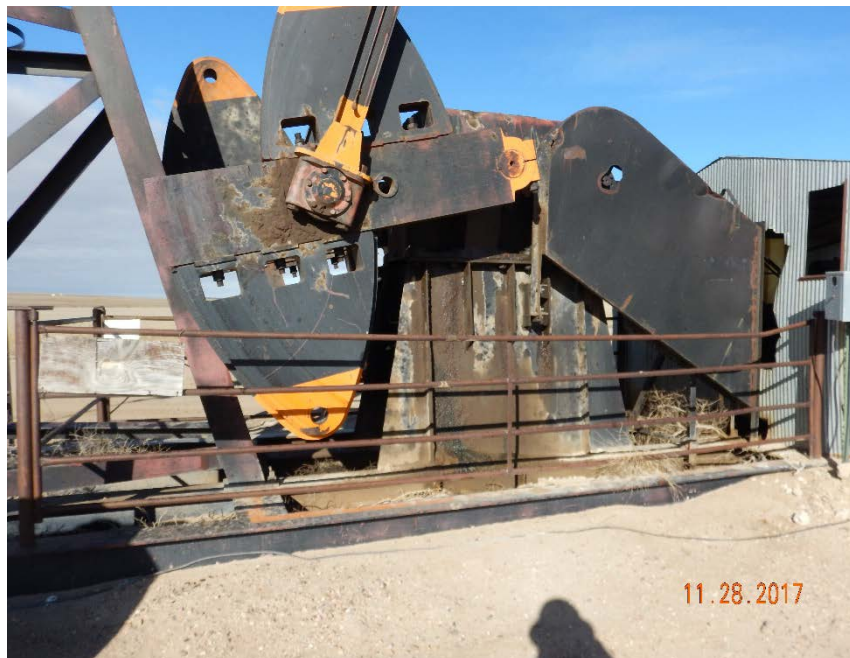
Photo #5 – Oil-stains on east side of pump jack.

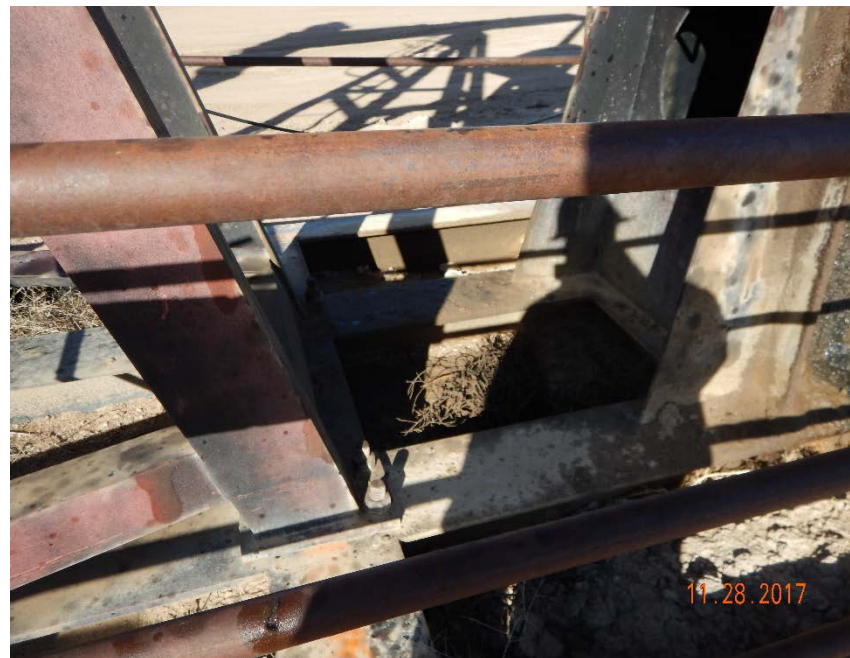
Photo #6 – Oil-stained soil and weeds accumulating beneath pump jack.

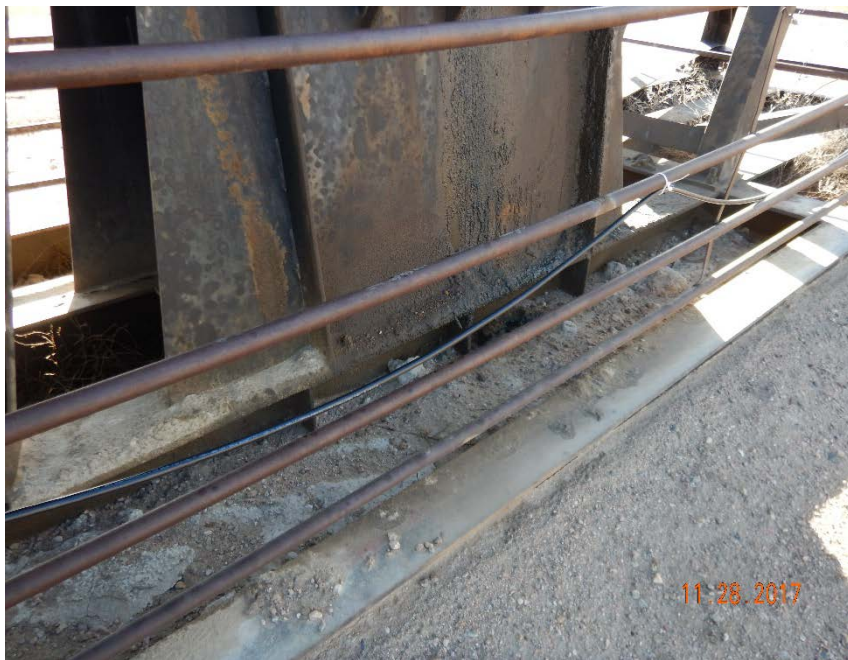
Photo #7 – Oil-stained soil and equipment on west side of pump jack.

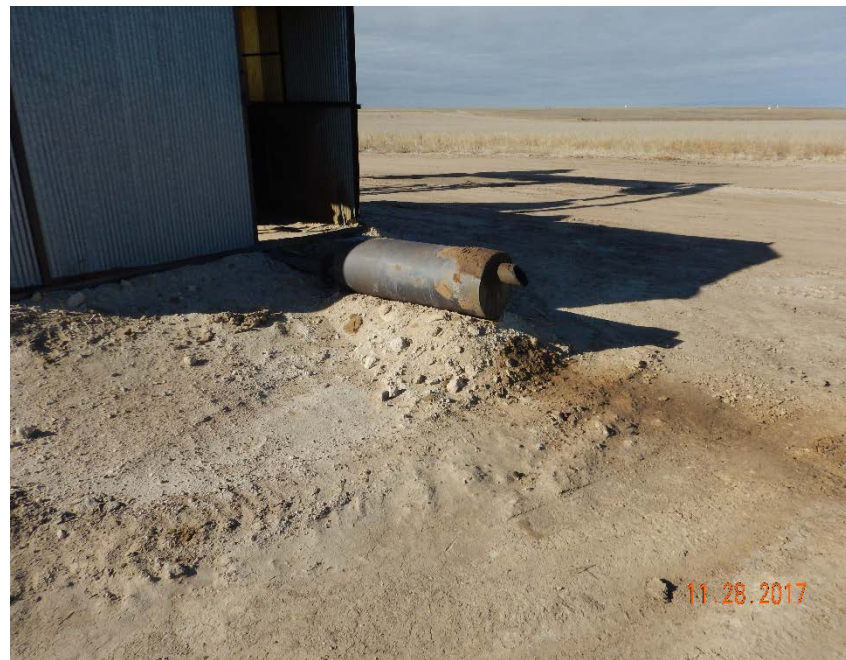
Photo #8 – Localized accumulation of oil-stained soil at prime mover exhaust.

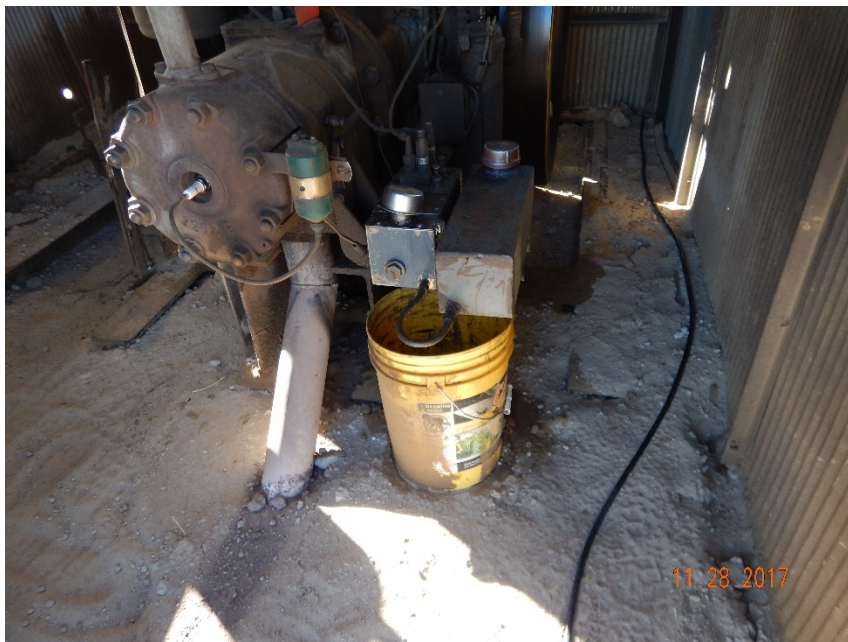
Photo #9 – Historical accumulation of oil-stained soil beneath prime mover (1).

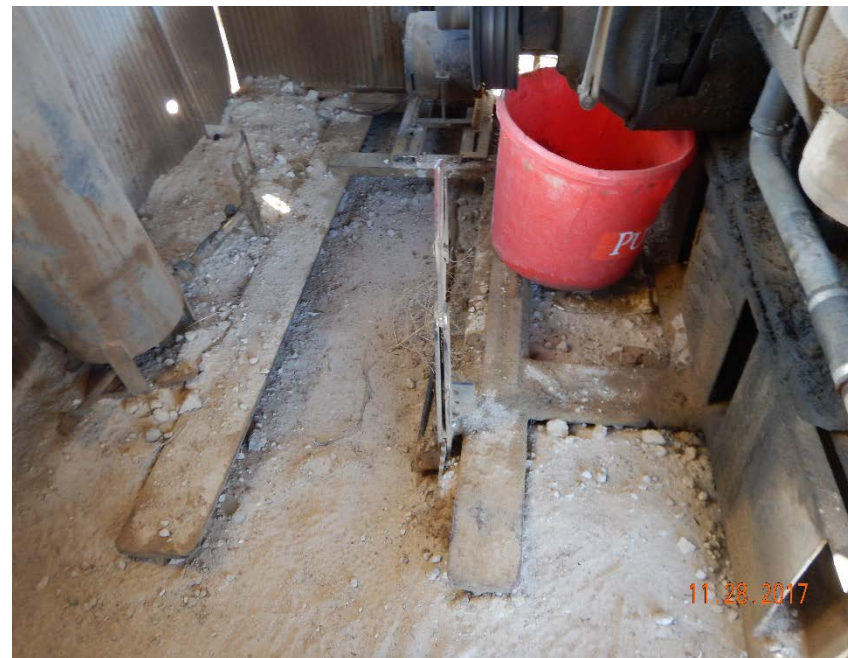
Photo #10 - Historical accumulation of oil-stained soil beneath prime mover (2).

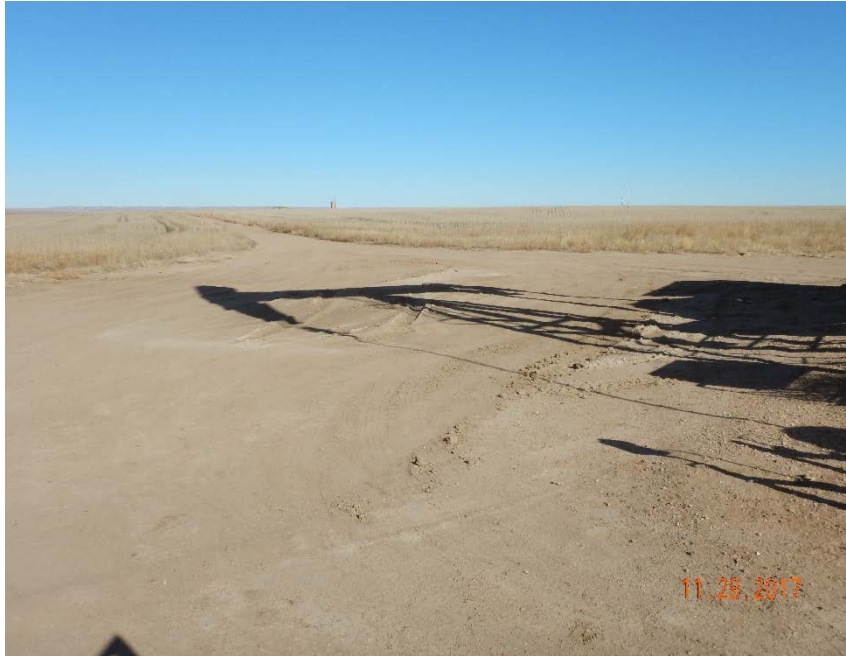
Photo #11 – Rutted well pad northwest of pump jack.

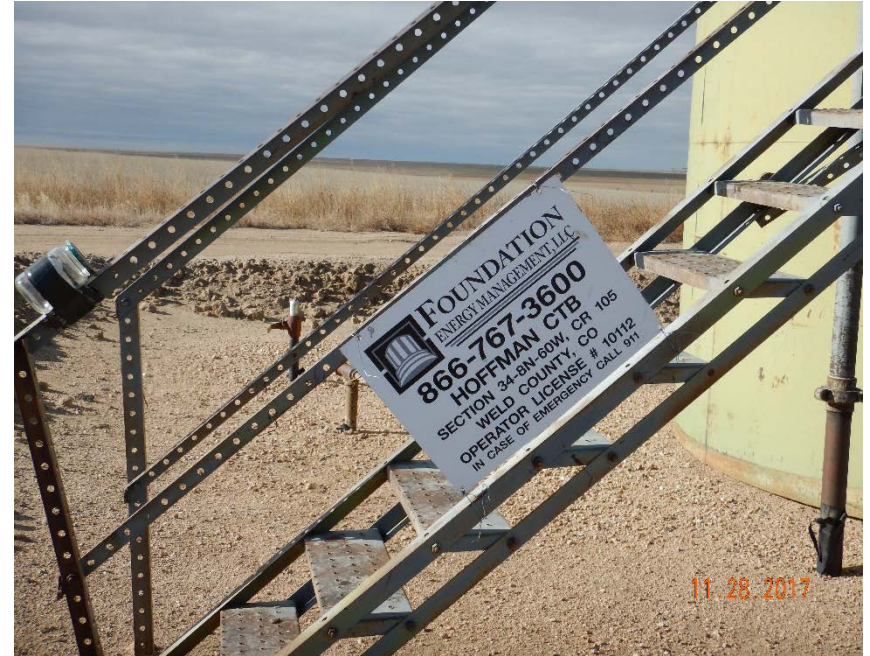
Photo #12 – Battery sign.

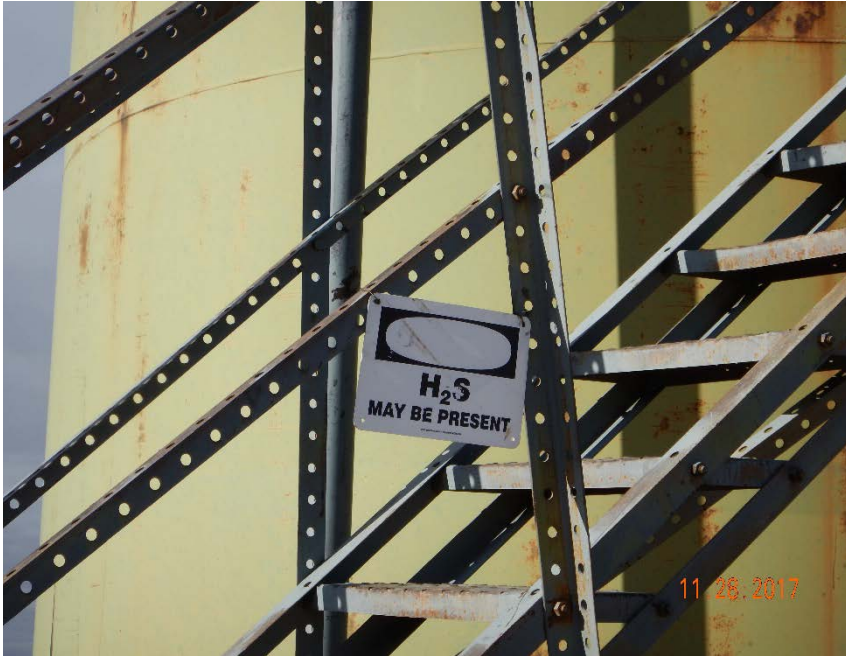
Photo #13 – H₂S warning sign is faded.

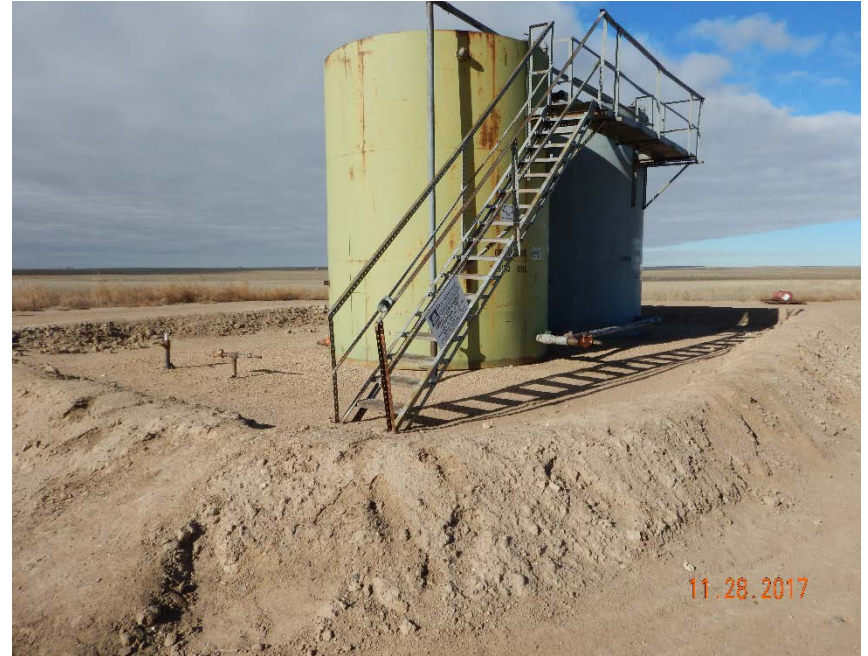
Photo #14 – View of crude oil tank battery from southeast corner. Note erosion of earthen berm and two (2) 2" steel flowline risers SW of tanks.

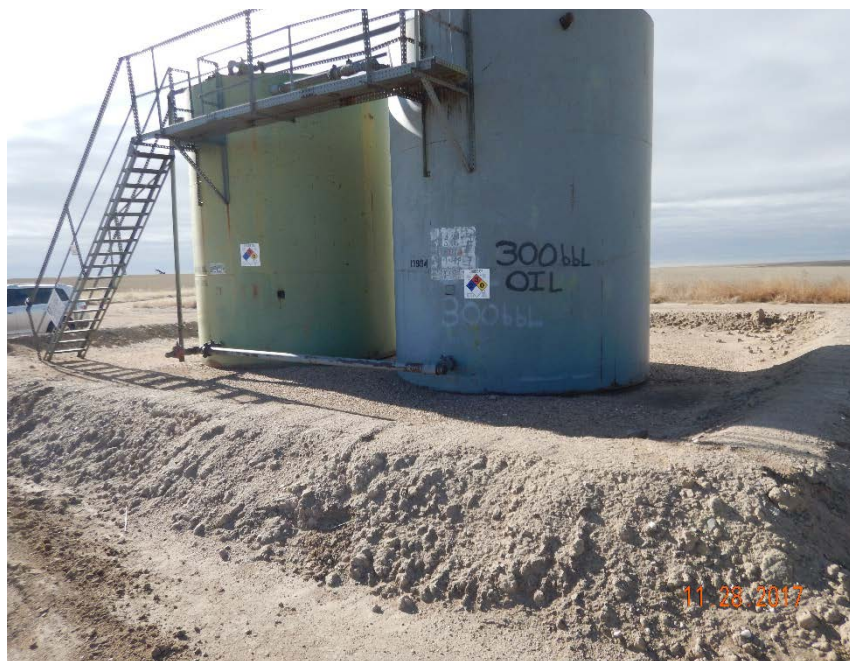
Photo #15 – Shallow, eroded tank berm at northeast corner.

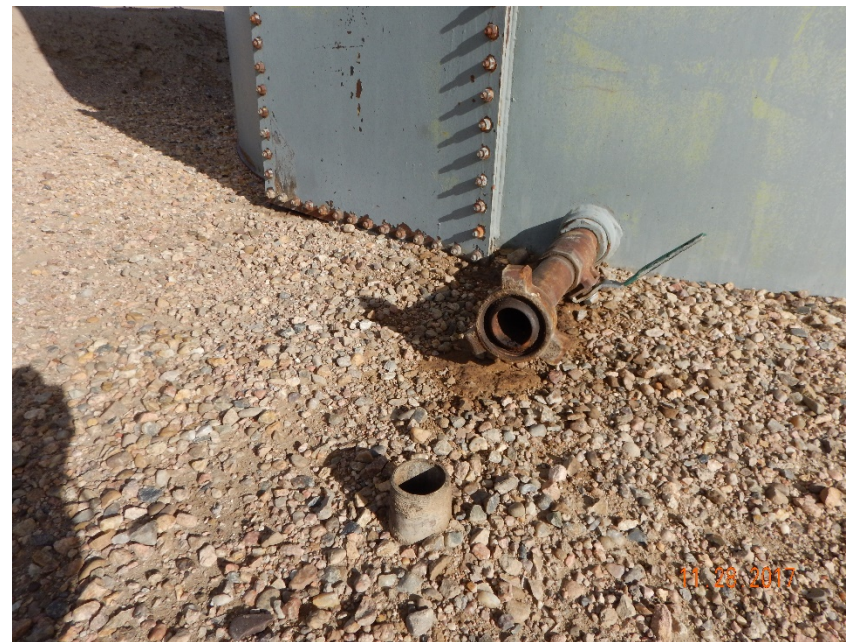
Photo #16 – Localized, oil-stained soil and uncapped pipe riser beneath tank valve.

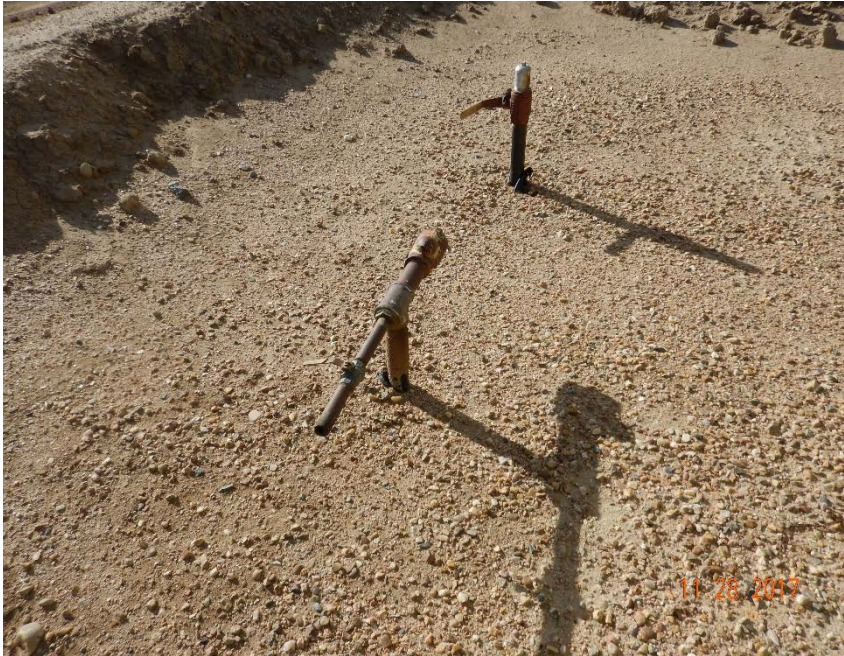
Photo #17 – Unused flowline risers SW of crude oil ASTs.

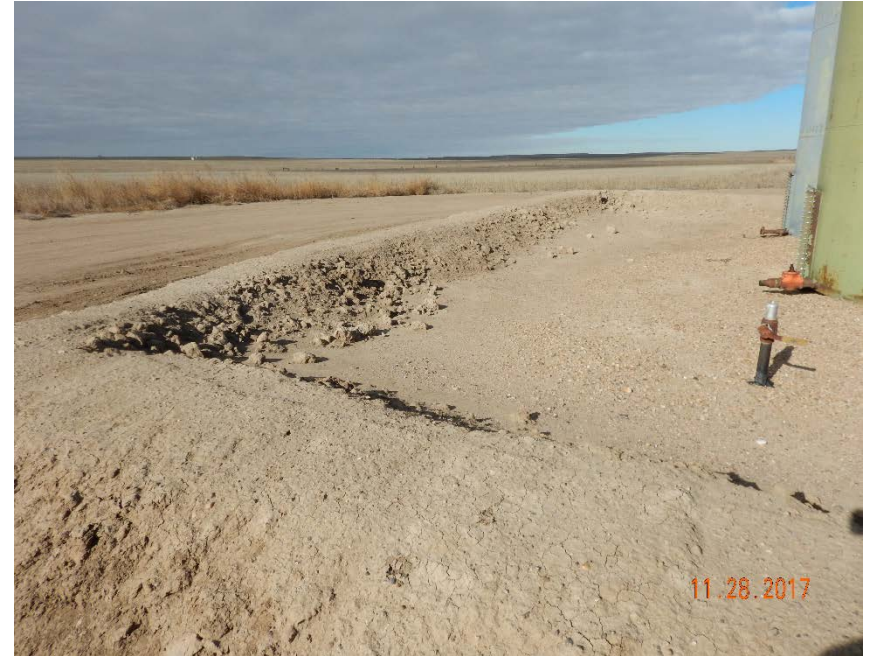
Photo #18 – Eroded earthen berm west of tanks.

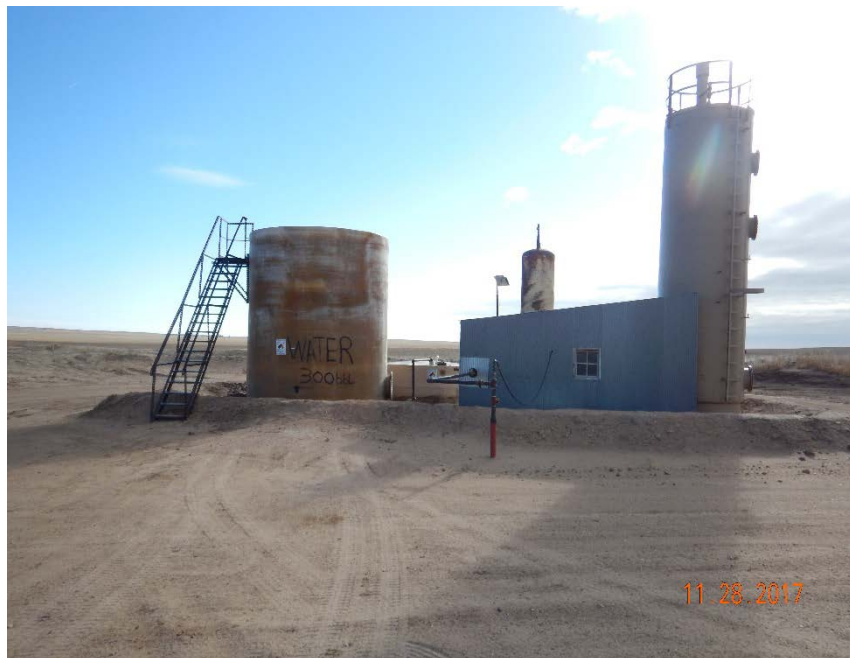
Photo #19 – View of 300 bbl produced water AST, produced water fiberglass PBV, and separator/treater shed from west side.

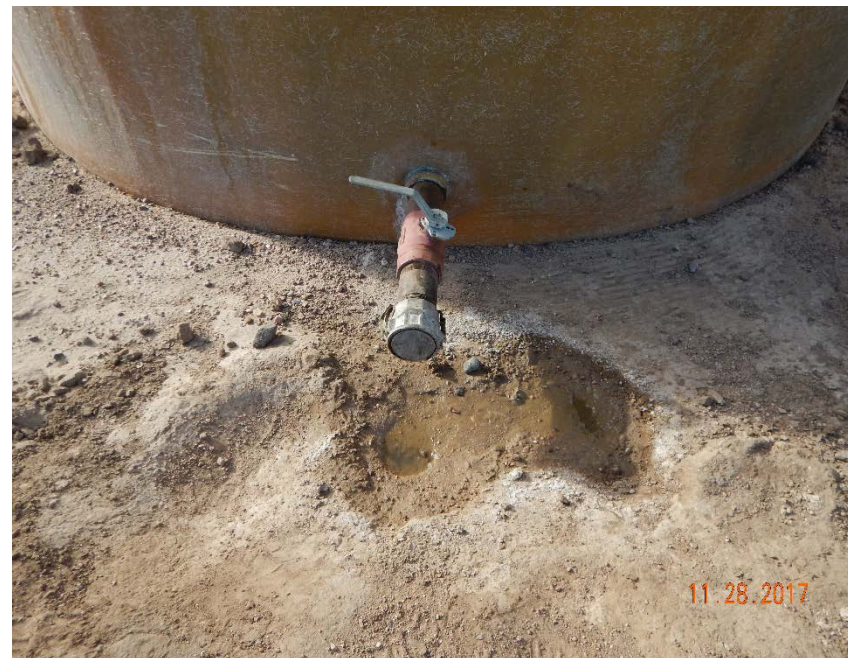
Photo #20 – Produced water pooling at fiberglass AST loadout valve.

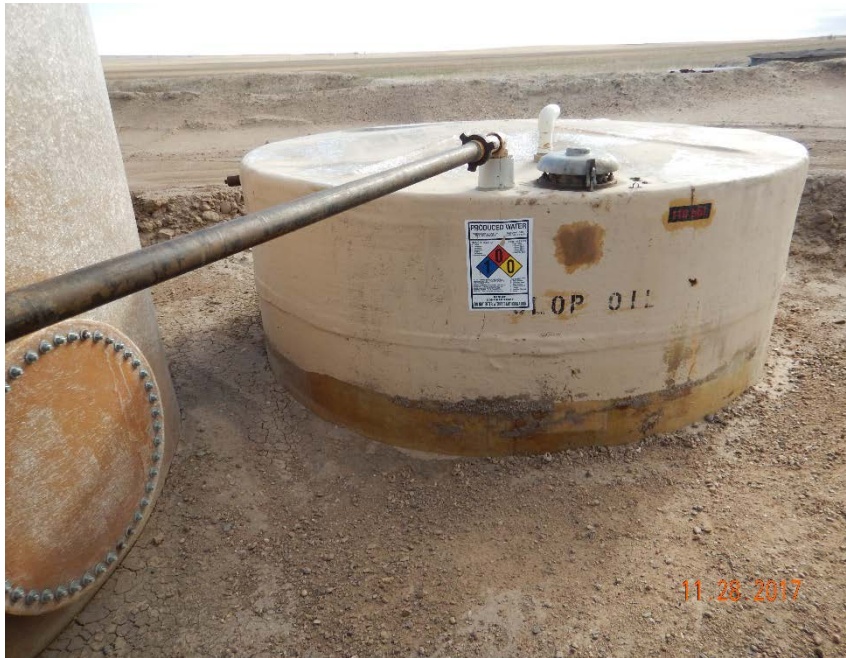
Photo #21 – 110 bbl fiberglass produced water PBV.

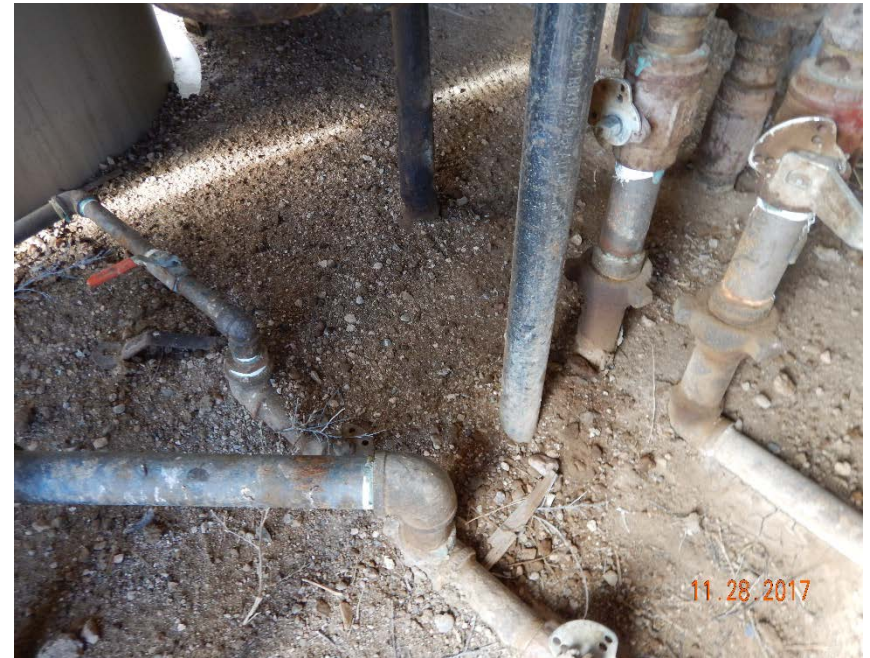
Photo #22 – Localized, oil-stained soil inside of separator/treater shed (1).

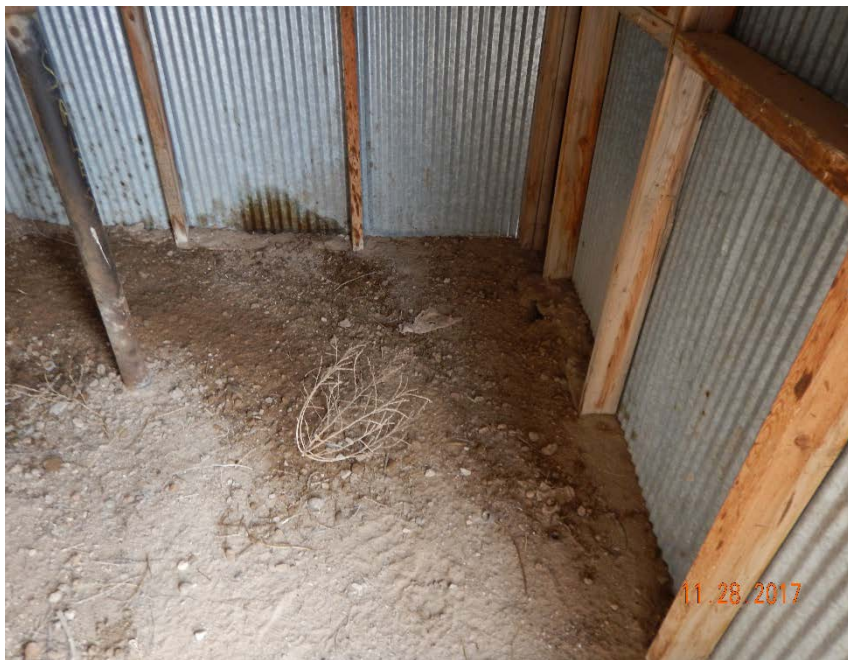
Photo #23 - Localized, oil-stained soil inside of separator/treater shed (2).

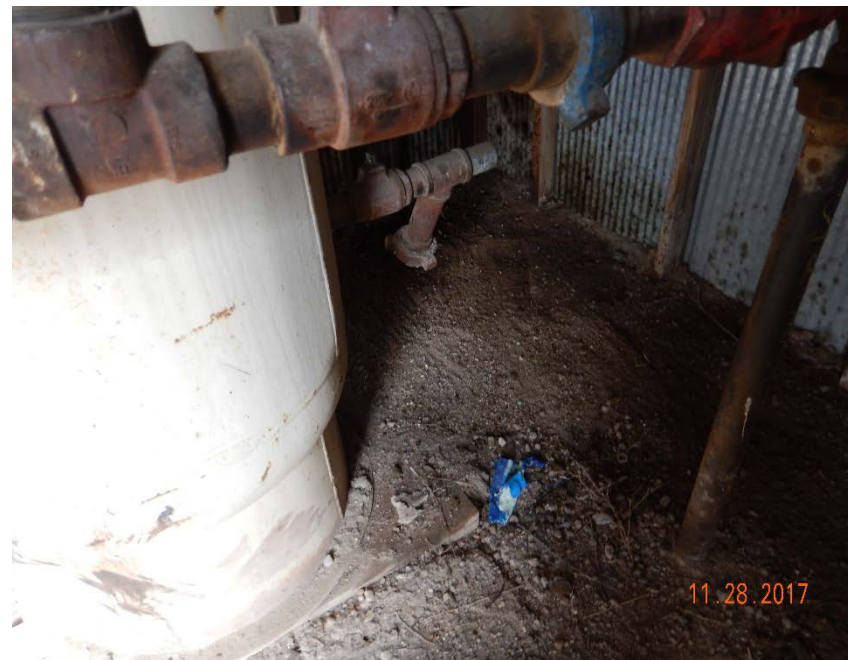
Photo #24 - Localized, oil-stained soil inside of separator/treater shed (3).

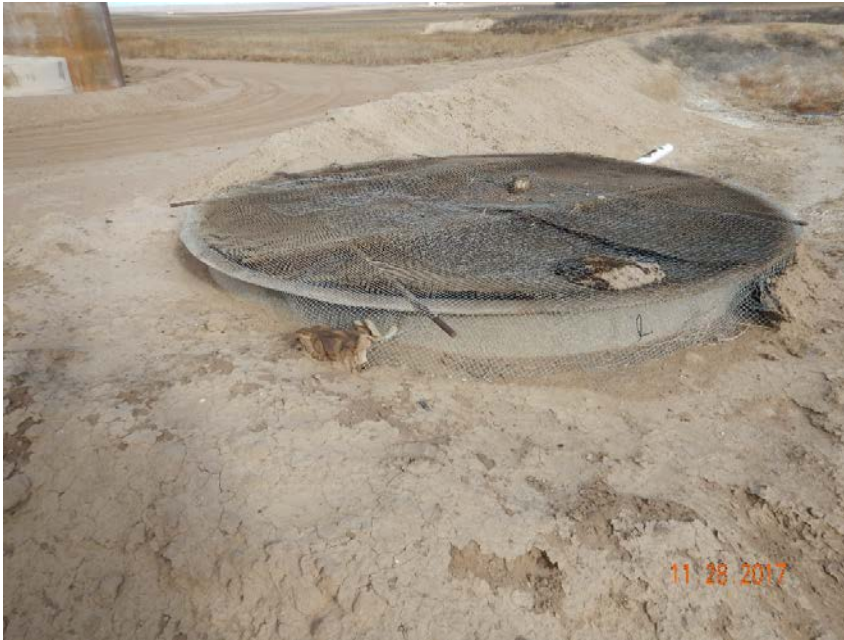
**Photo #25 – View of open-top skim tank from SE corner.
Note oily rag and small stockpile of oily waste at skim tank.**

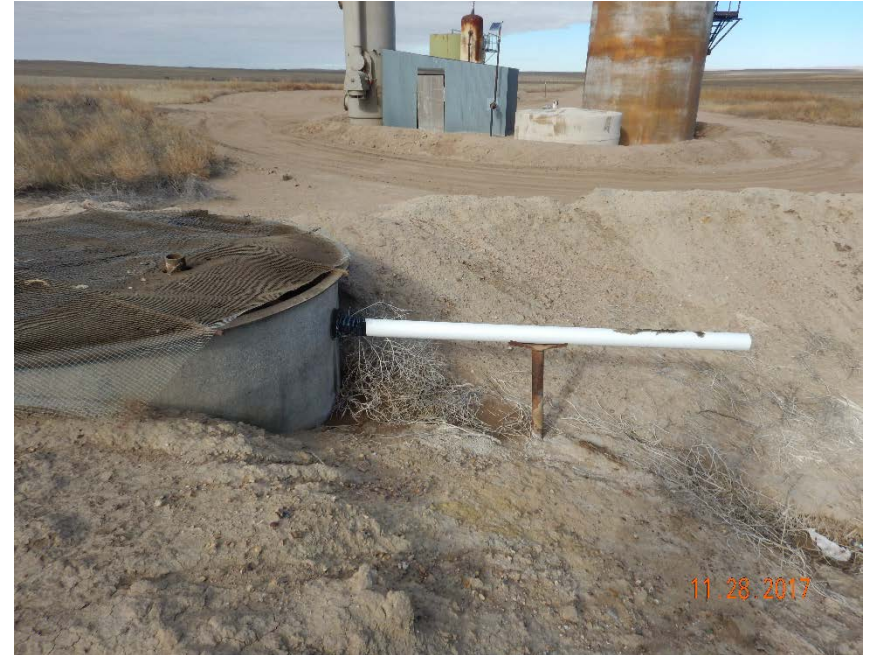
Photo #26 – View of skim tank outlet to south produced water pit. Note presence of oil-stained soil and weeds at tank outlet.

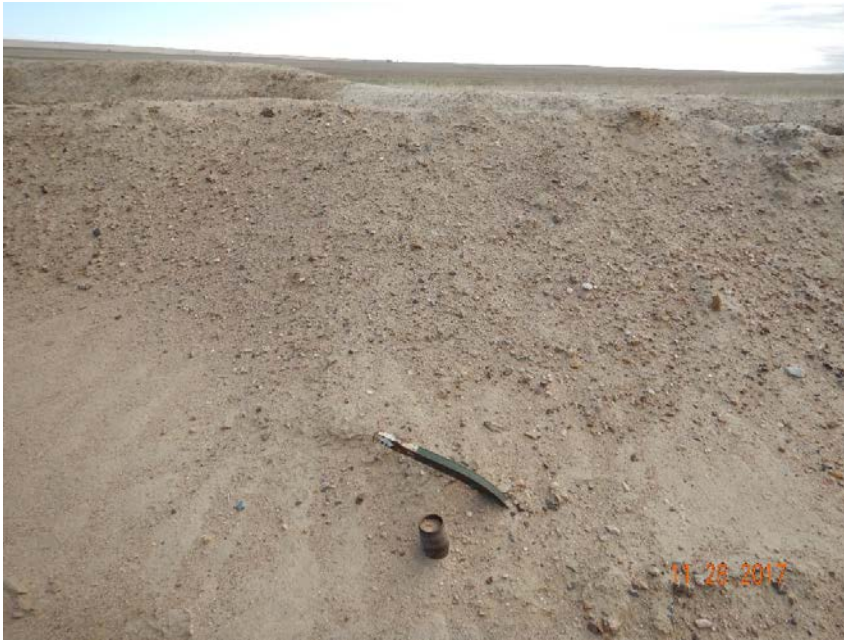
Photo #27 – 2” pipe riser north of produced water pit.

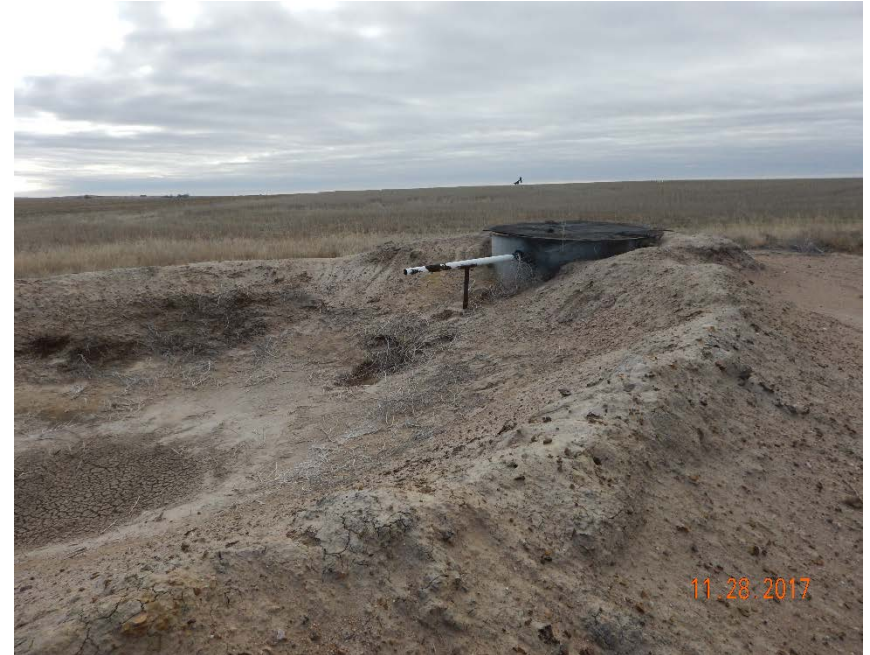
Photo #28 – SW portion of south produced water pit (Facility ID #273442). Note abundance of weeds and oil-stained soil.

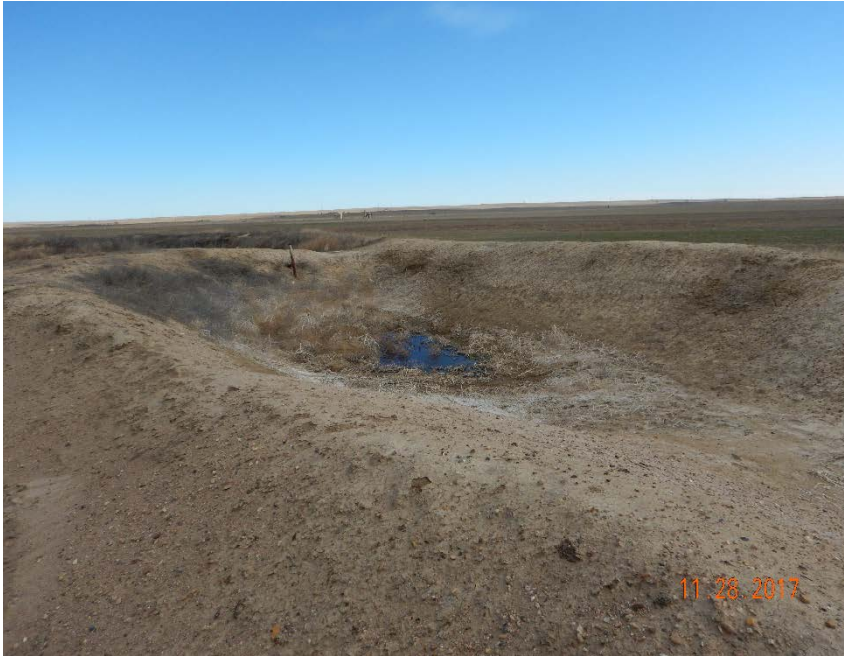
Photo #29 - NE portion of south produced water pit (Facility ID #273442). Note abundance of weeds and water present in pit.

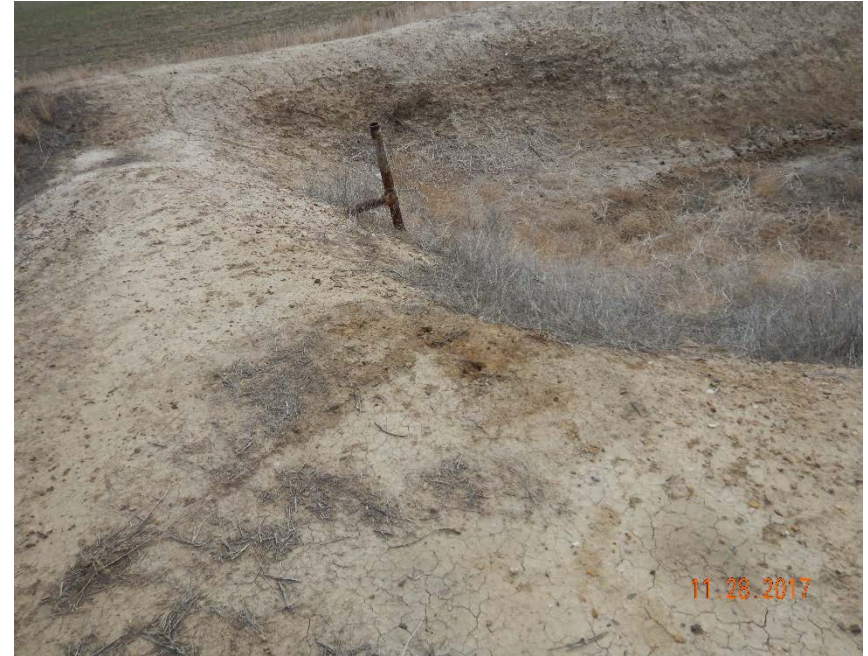
Photo #30 – Oil-stained soil and pipe riser at NE section of south produced water pit.

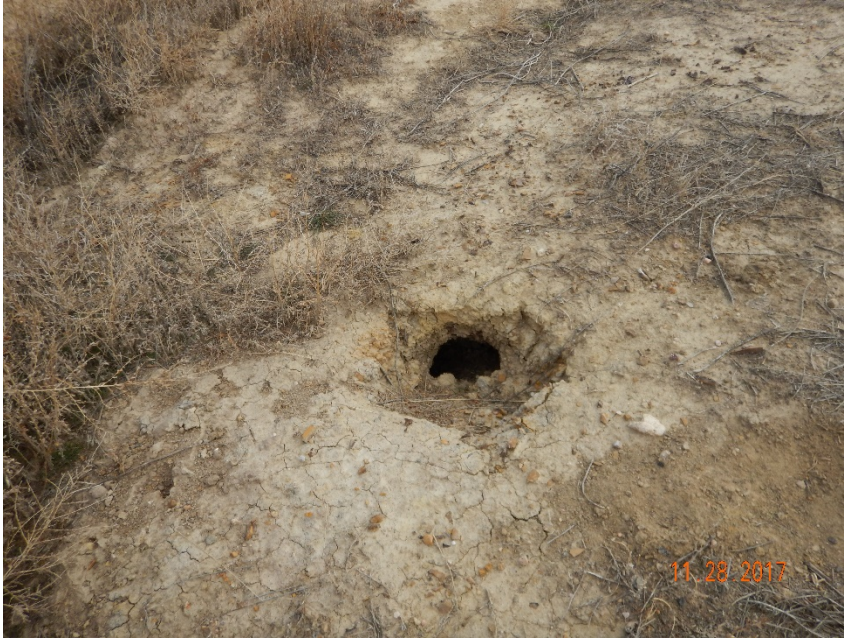
Photo #31 – Example of burrows observed in pit berms (1).

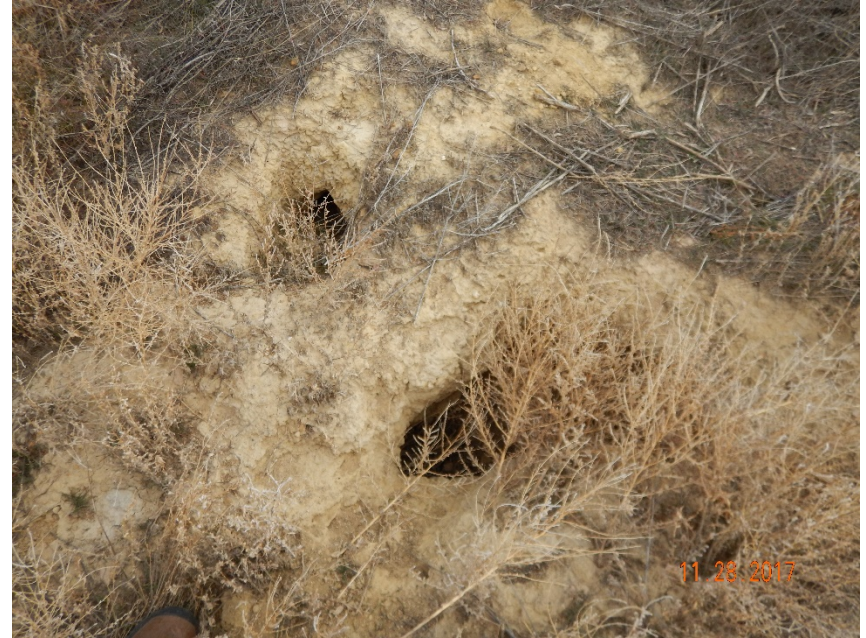
Photo #32 – Example of burrows observed in pit berms (2).

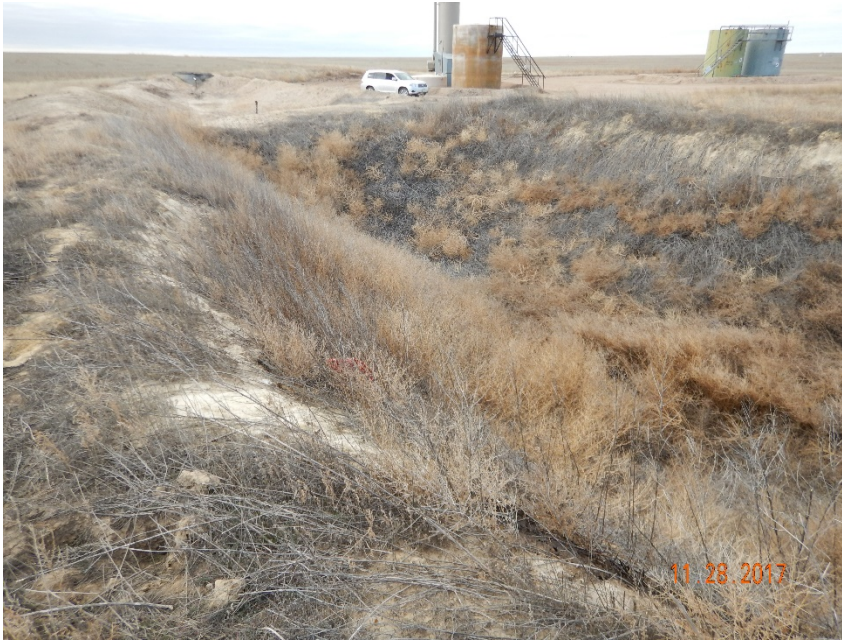
Photo #33 – Abundant weeds growing inside of berms of north produced water pit (Facility ID #273443), view from SE corner. Note oil-stained soil inside of berms in foreground.

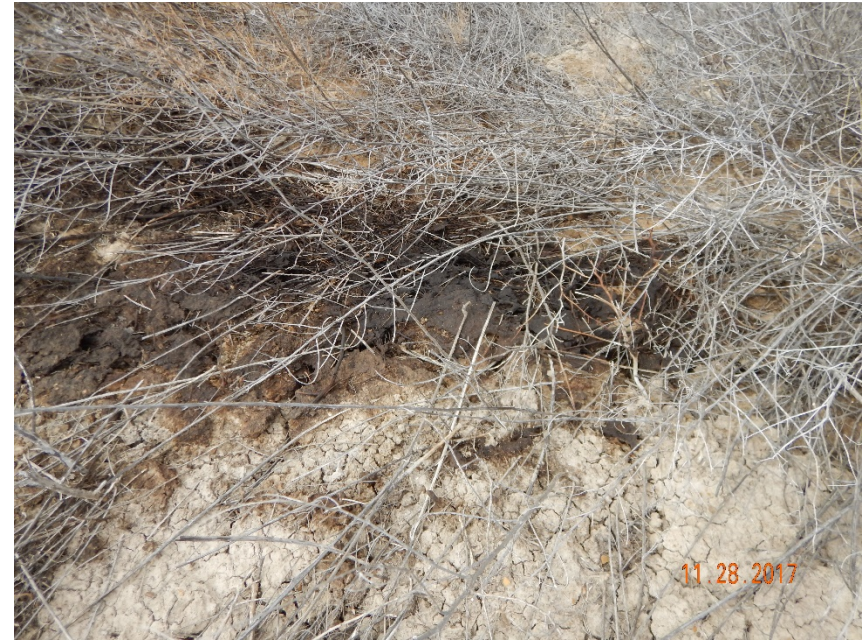
Photo #34 – Oil-stained soil and weeds inside of berms of north produced water pit (Facility ID #273443).
