- Robin Frazier GU PLA 9 1
- 05-067-07588

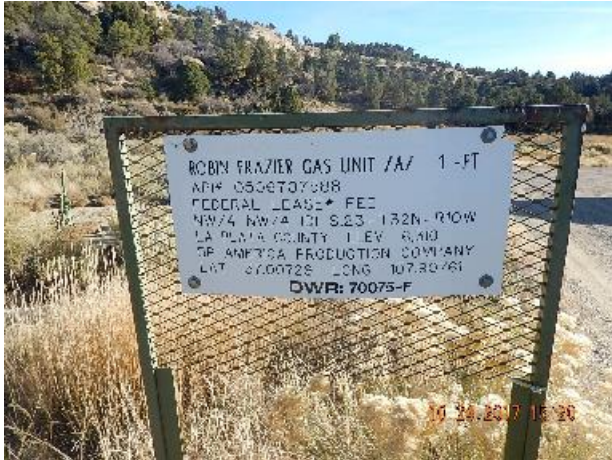
Photo 1: Wellhead sign. Previous inspection document number 685303916.

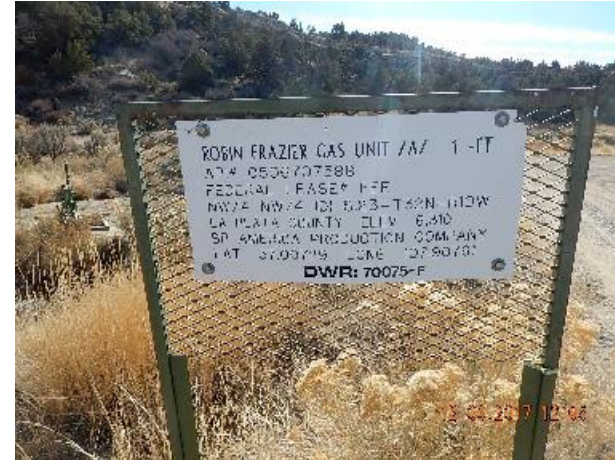
Photo 2: Wellhead sign. Current inspection.

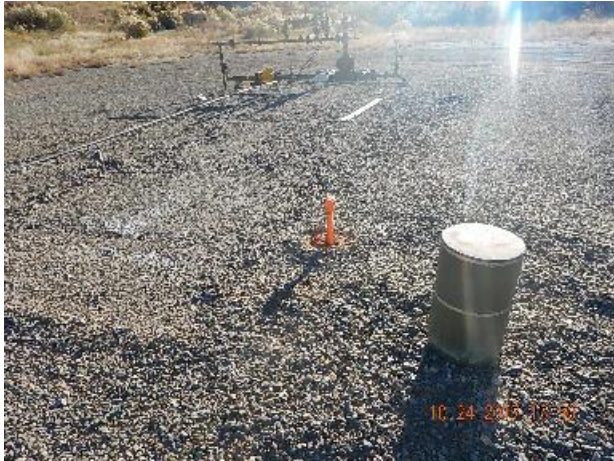
**Photo 3: Painted, plugged, and tagged unused riser/flowline.**  
**Previous inspection document number 685303916.**

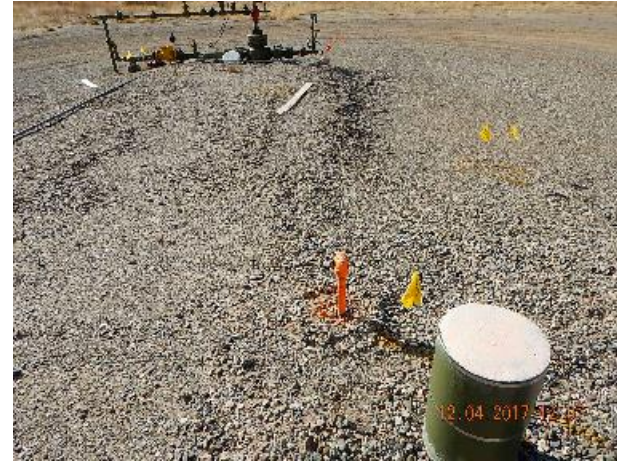
**Photo 4: Painted, plugged, and tagged unused riser/flowline.**  
**Current inspection.**

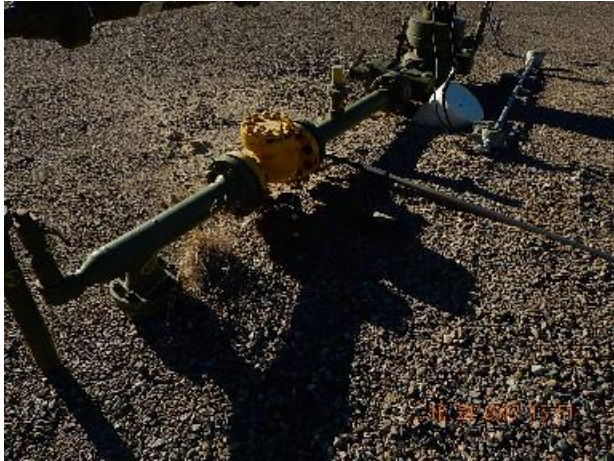
**Photo 5: Valve, nipple, and production related materials at wellhead. Previous inspection document number 685303916.**

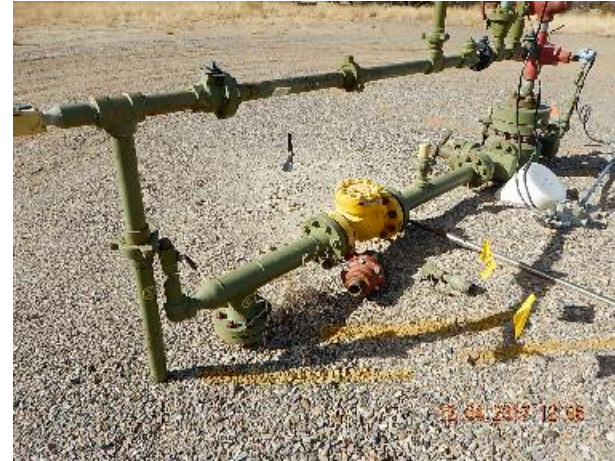
**Photo 6: Valve, nipple, and production related materials at wellhead. Current inspection.**

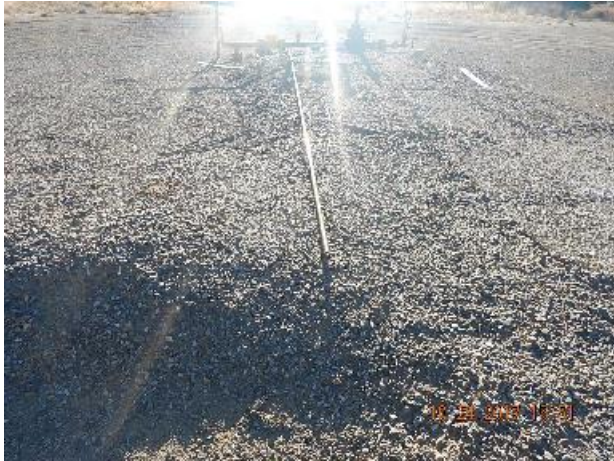
**Photo 7: Polished rod at wellhead. Previous inspection document number 685303916.**

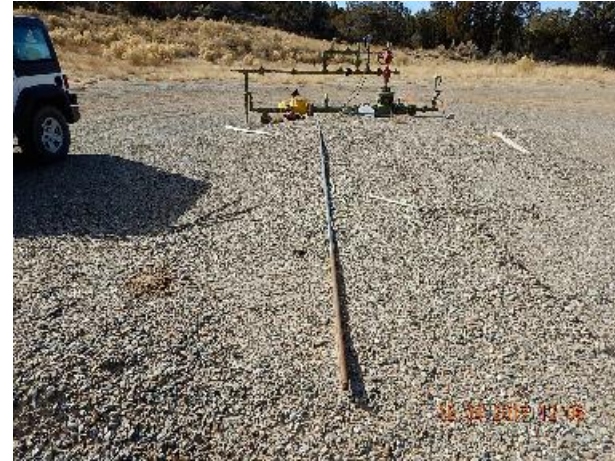
**Photo 8: Polished rod at wellhead. Current inspection.**

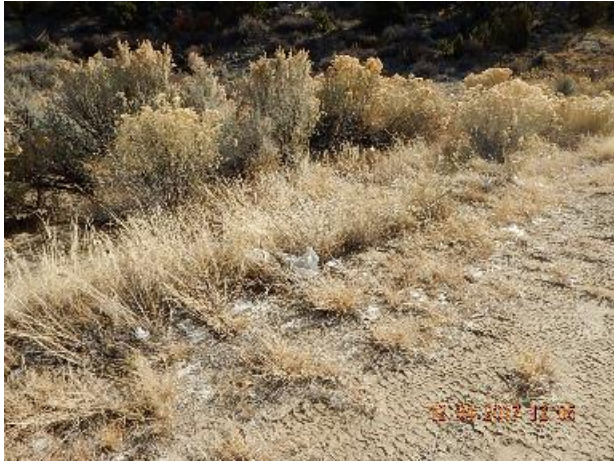
**Photo 9: Plastic debris along E access road 1. Current inspection.**

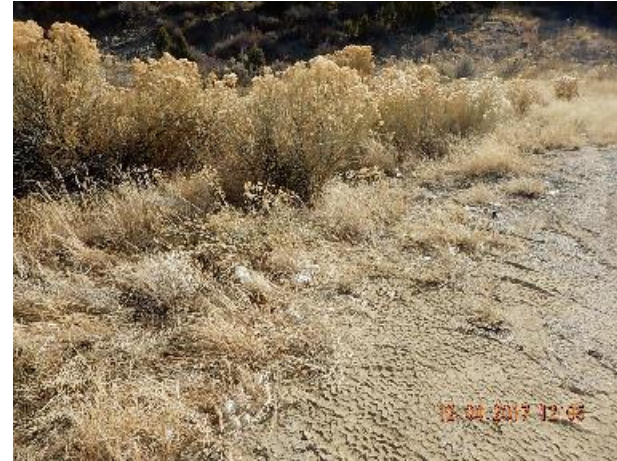
**Photo 10: Plastic debris along E access road 2. Current inspection.**

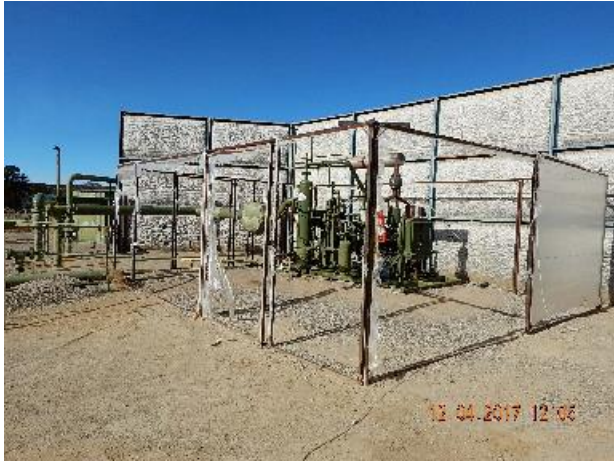
**Photo 11: Framing around compressor where plastic debris is tearing away from. Current inspection.**

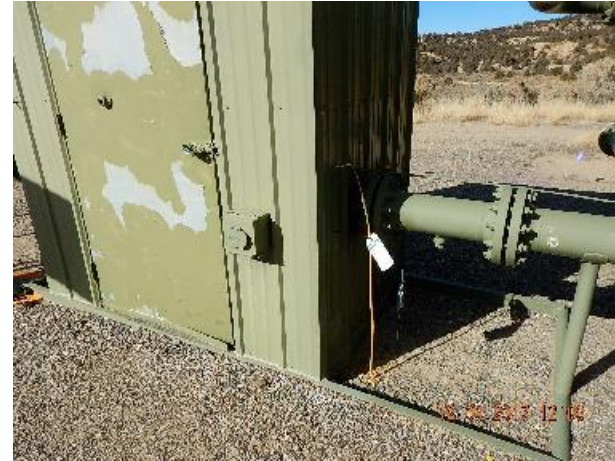
**Photo 12: Painted and tagged stainless steel line at gas meter house. Current inspection.**
