Hoffman Inspection

12.6.17

Inspection Photos
Location Name: Hoffman #34-10
API: 05-123-20097
Inspection Date: November 28, 2017

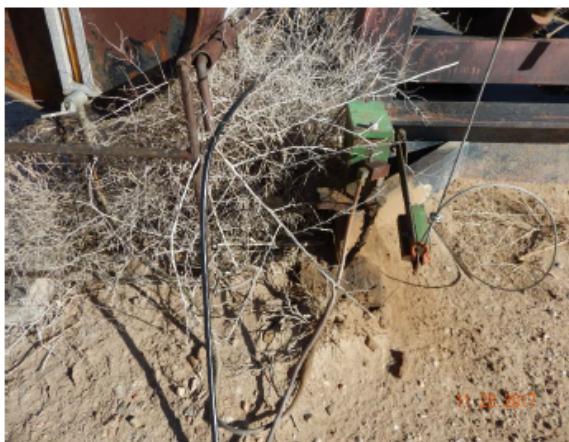
Photo #3 – Localized accumulation of oil-stained soil and wind-blown weeds beneath day tank and SW corner of pump jack.

Type	WEEDS		
Comment:	Accumulation of wind-blown weeds at pump jack and wellhead. Uncontrolled weeds growing inside/along both produced water pits, as indicated in previous Field Inspection Reports. See photos.		
Corrective Action:	Comply with Rule 603.f.	Date:	10/08/2017

Wind blown weeds and tank without containment removed from location per COGCC write-up.

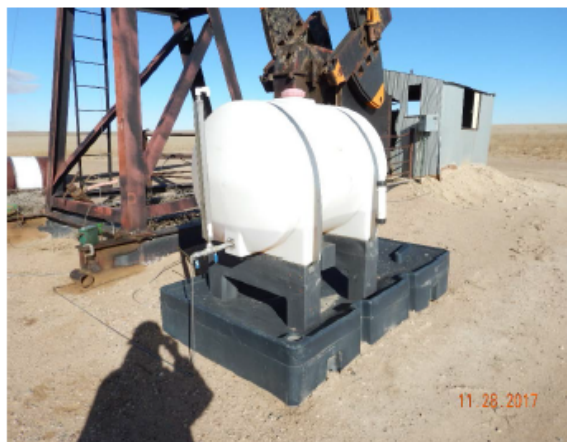
Photo #4 – Day tank at SE corner of pump jack has adequate secondary containment device.

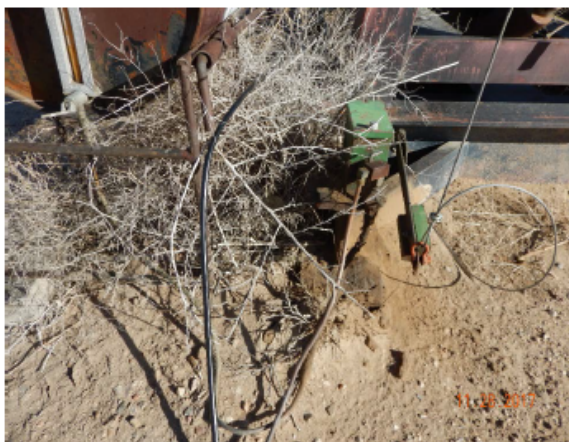
Photo #3 – Localized accumulation of oil-stained soil and wind-blown weeds beneath day tank and SW corner of pump jack.

Type: Ancillary equipment	# 2		
Comment:	Two day tanks located at SW and SE corners of pump jack. 55-gallon drum used as day tank at SW corner of pump jack lacks secondary containment. See photos. This corrective action remains unresolved from previous FIR.		
Corrective Action:	Repair or install berms or other secondary containment devices per Rule 908.d.(1). (day tanks)		Date: 11/24/2017

Wind blow weeds and tank without containment removed from location per COGCC write-up.

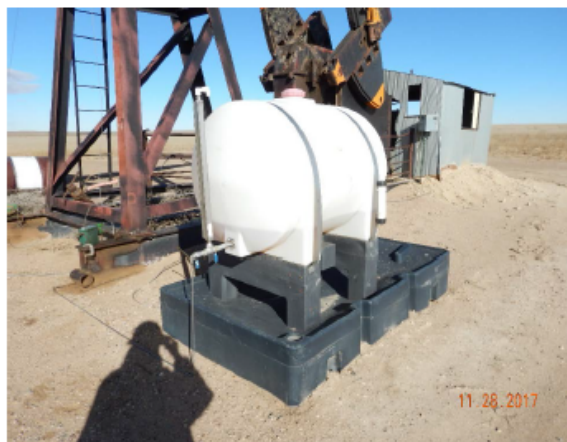
Photo #4 – Day tank at SE corner of pump jack has adequate secondary containment device.

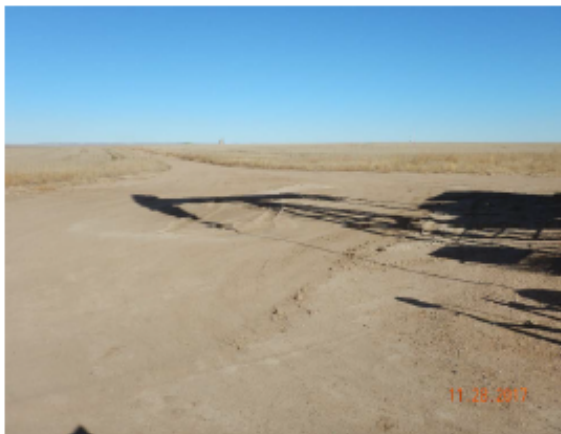
Photo #11 – Rutted well pad northwest of pump jack.

Comment: Deep ruts at NW, SW, and SE sides of pump jack have allowed precipitation to pool on-site during previous inspections. While no precipitation was observed on date of this report, the ruts and depressions remained at the well pad.

Added new H2S warning sign at tank battery. 2 following photos show that ruts have been removed.

Corrective Action: Install or repair required BMPs per Rule 1002.f.

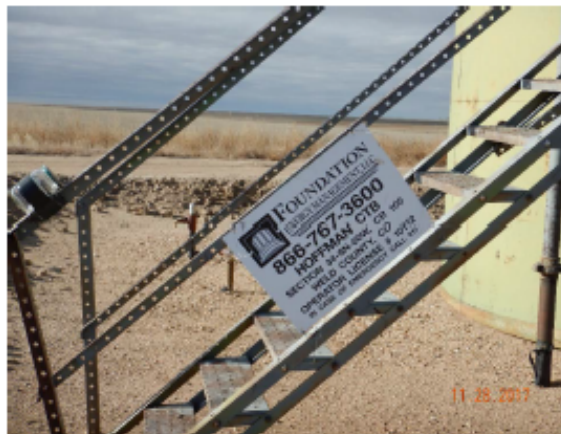
Photo #12 – Battery sign.

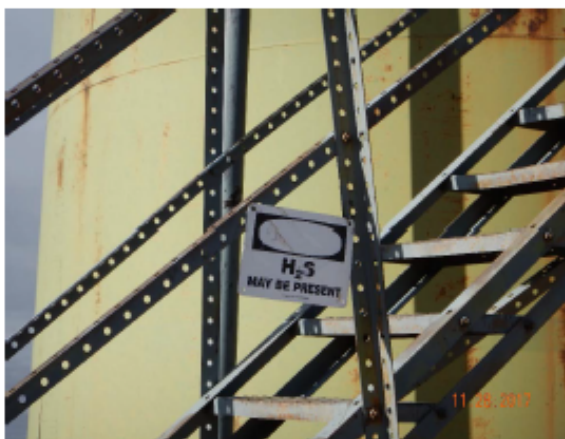
Photo #13 – H2S warning sign is faded.

H2S sign at tank battery replaced on the right. Signs have also been installed at water tank and on the pumping unit shown in subsequent photos.

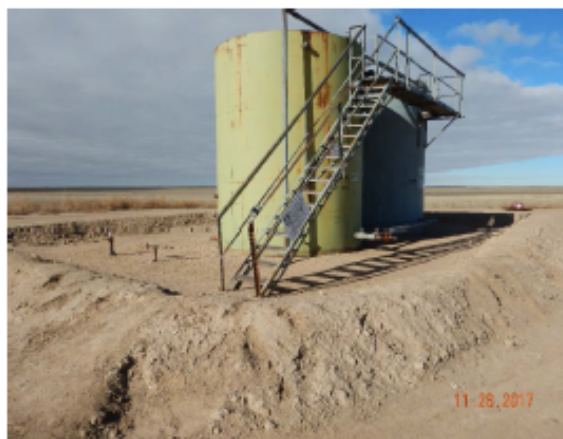
Photo #14 – View of crude oil tank battery from southeast corner. Note erosion of earthen berm and two (2) 2" steel flowline risers SW of tanks.

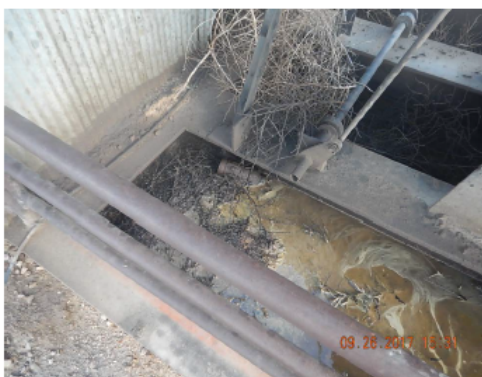
Photo 9: Stained soil, oily fluid at pump jack

Documentation of COGCC inspections from 9/26/17 compared to 11/28/17 on the right. Clear evidence of removal of stained soil from engine house. Unsure of what staining is referenced in pictures from 11/28/17. Installed buckets to act as “drip pans” in effort to keep oil from ground.

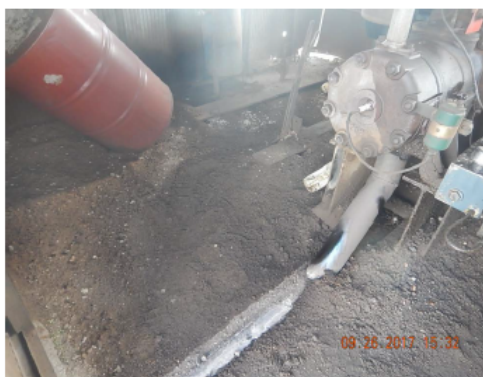
Photo 10: Stained soil at ajax engine

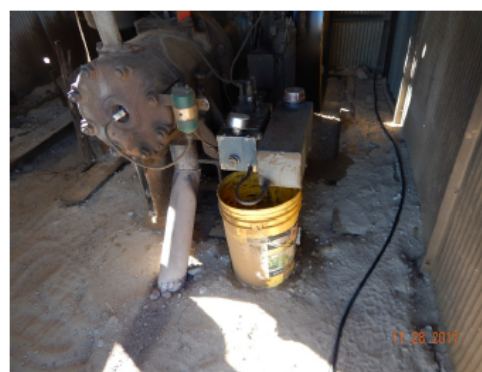
Photo #9 - Historical accumulation of oil-stained soil beneath prime mover (1).

Lube Oil	Pump Jack	<= 1 bbl		
Comment:	Localized accumulations of oil-stained soil beneath prime mover and exhaust. See photos. This corrective action remains unresolved from previous FIRs.			
Corrective Action:	Remove and properly dispose of non-E&P waste in accordance with Rule 907A. (prime mover)			Date: 10/26/2017

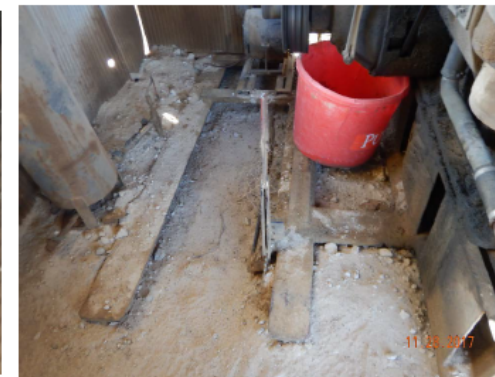
Photo #10 - Historical accumulation of oil-stained soil beneath prime mover (2).

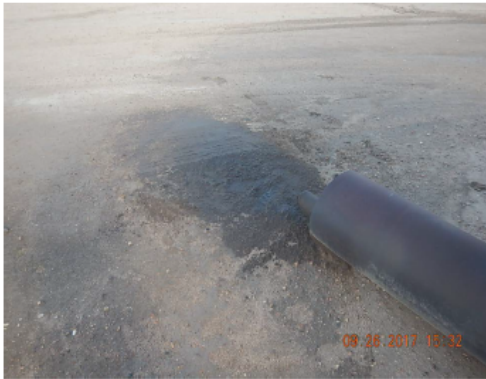
Photo 11: Stained soil at ajax exhaust

Comparison of site from 9/26/17 to 11/28/17. Subsequent photo shows clean location behind muffler. We will be installing a plastic 55 gal drum to contain any other contaminants from hitting the ground. Also inverted the muffler from last inspection to try to eliminate the problem.

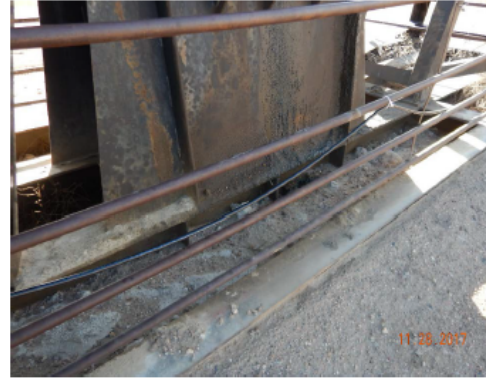
Photo #7 – Oil-stained soil and equipment on west side of pump jack.

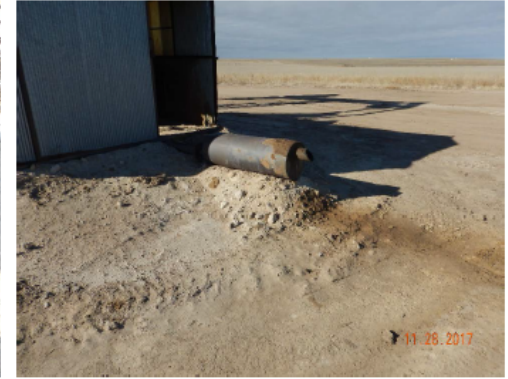
Photo #8 – Localized accumulation of oil-stained soil at prime mover exhaust.
